## Archaeological Watching Brief

## Updated Report

Marketing Suite,  
Great Jackson  
Street,  
Castlefield,  
Manchester

2020/107

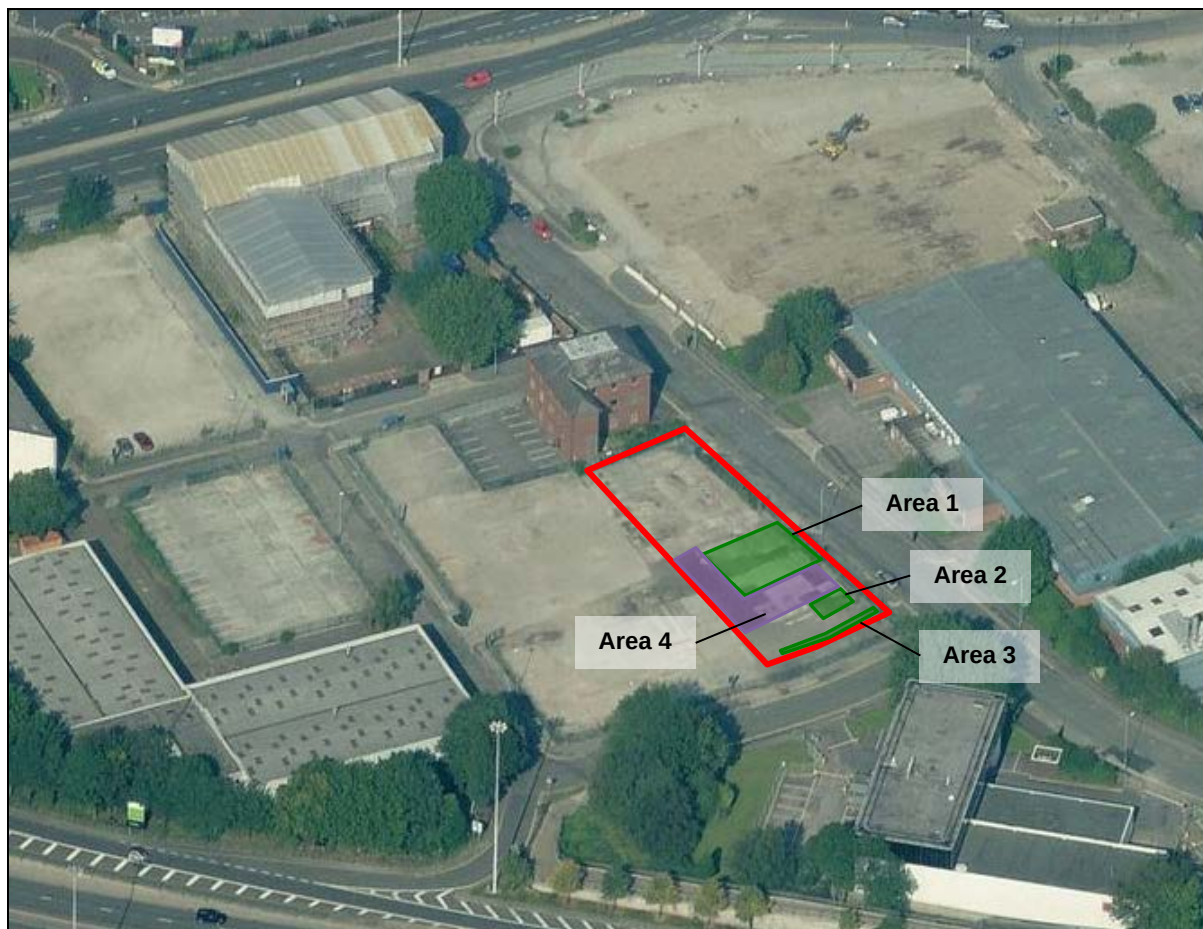
*Plate 3: Recent aerial view showing the areas of the watching brief*

The ground-reduction works required for the marketing suite in 2018 were focused on two areas, together with the excavation of a narrow service trench. The first of the areas monitored (Area 1) lay within what was until recently a car park, and was excavated to create a foundation for the new marketing suite. This area measured approximately 20m x 18m. A depth of at least 0.5m was required for the foundations of this building, which was later filled with a crushed aggregate. Area 2 was excavated at a later date, and comprised an area measuring 12.2m x 5.4m located to the south of Area 1, close to Melbourne Street. Area 3 consisted of a small service trench across the southern part of the Site. This trench was up to 0.75m in depth and 2.5m in width.

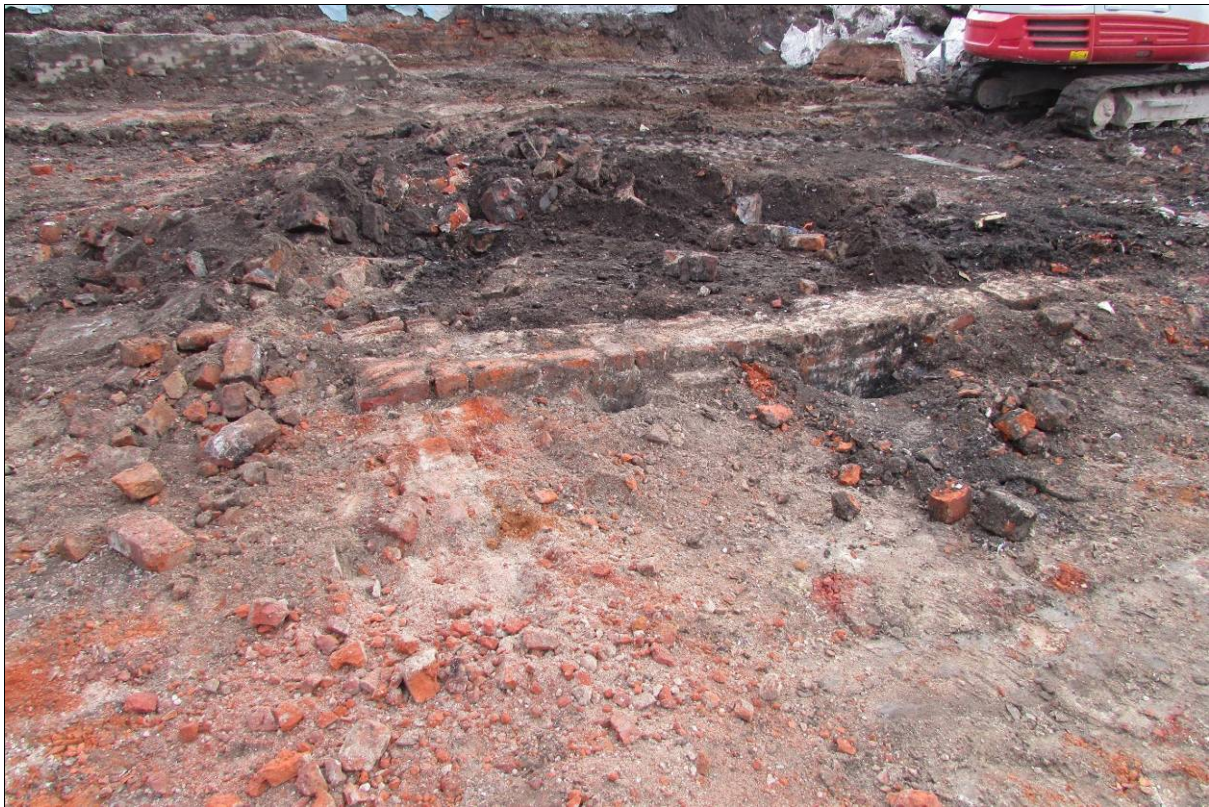
*Plate 4: View of wall **201** looking south. The threshold can be seen in the far left while the degraded north-eastern return can be seen in the foreground*

Wall **201** was three brick-courses wide (0.4m) with up to four layers of bricks exposed to a maximum wall height of (0.51m). The average brick measurements were 0.34m in length, 0.11m in width, and 0.075m in height. Both the northern and southern faces of wall **201** appear to have been white-washed. At the western end of wall **201** was a two-course thick wall, which continued to the north-east, but its full extent was not exposed; a 1.3m section was revealed during the watching brief. Wall **201** appeared to be contemporary with several other degraded and only partly revealed brick walls (Plate 4).

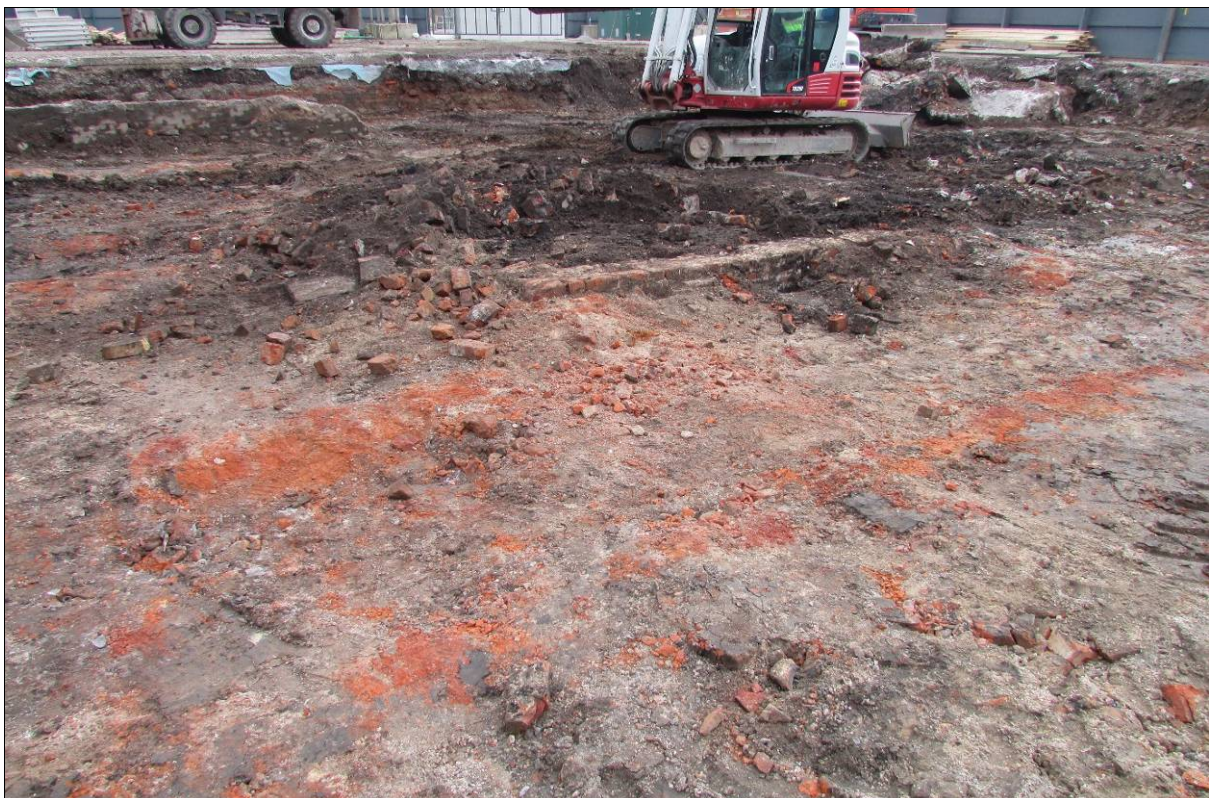
*Plate 5: Wall **201** with associated degraded and truncated walls in the foreground*

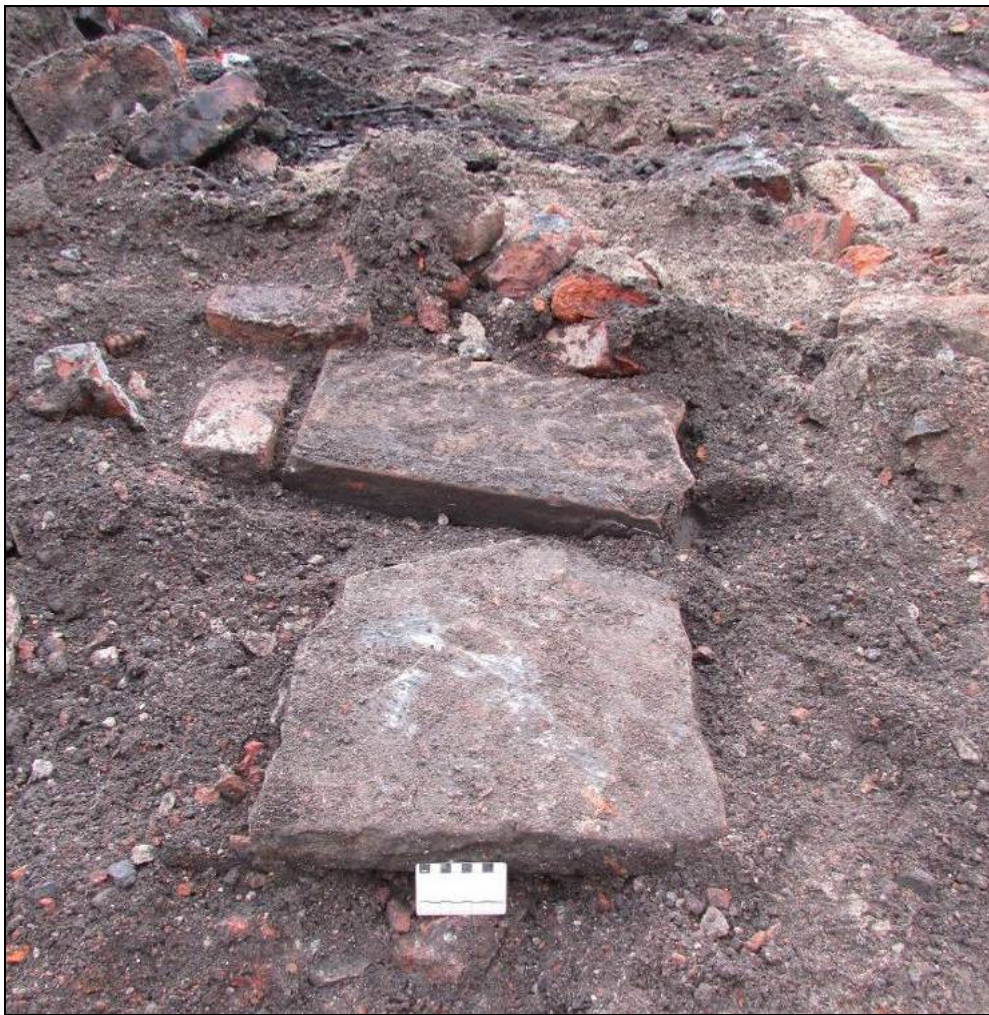
*Plate 6: Remains of threshold related to wall **201**, looking south-west*

At the north-eastern end of the north-east/south-west-aligned section of wall **201** was a return that was orientated perpendicular to it, parallel to Great Jackson Street. This portion of wall **201** was truncated and disturbed and its full extent is unknown. A heavily degraded wall may also have continued along this same axis north-west. On the north-eastern side of wall **201** were the remains of what is most likely a threshold. This feature had had been disturbed and was only partially *in-situ* (Plate 6). The most westerly visible stone comprised red sandstone, which was not encountered anywhere else on site. It measured 0.5m in length, 0.25m in width, and 0.09m in height. To the east of this block was large broken flagstone which measured 0.45m in length, 0.4m in width, and was 0.06m thick.

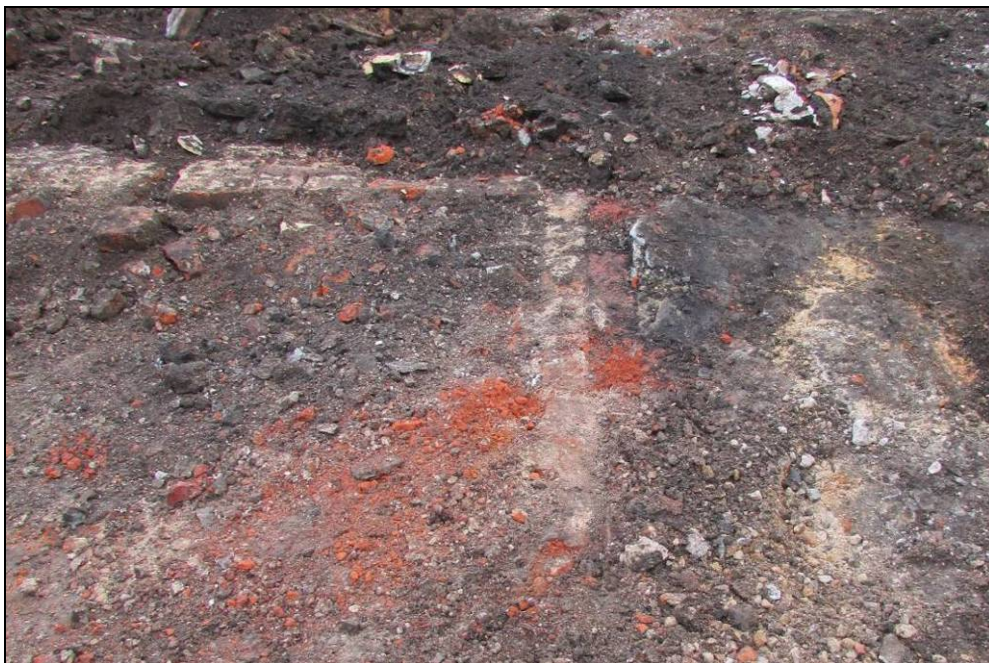
*Plate 7: View looking south-east showing a degraded return of wall **201***

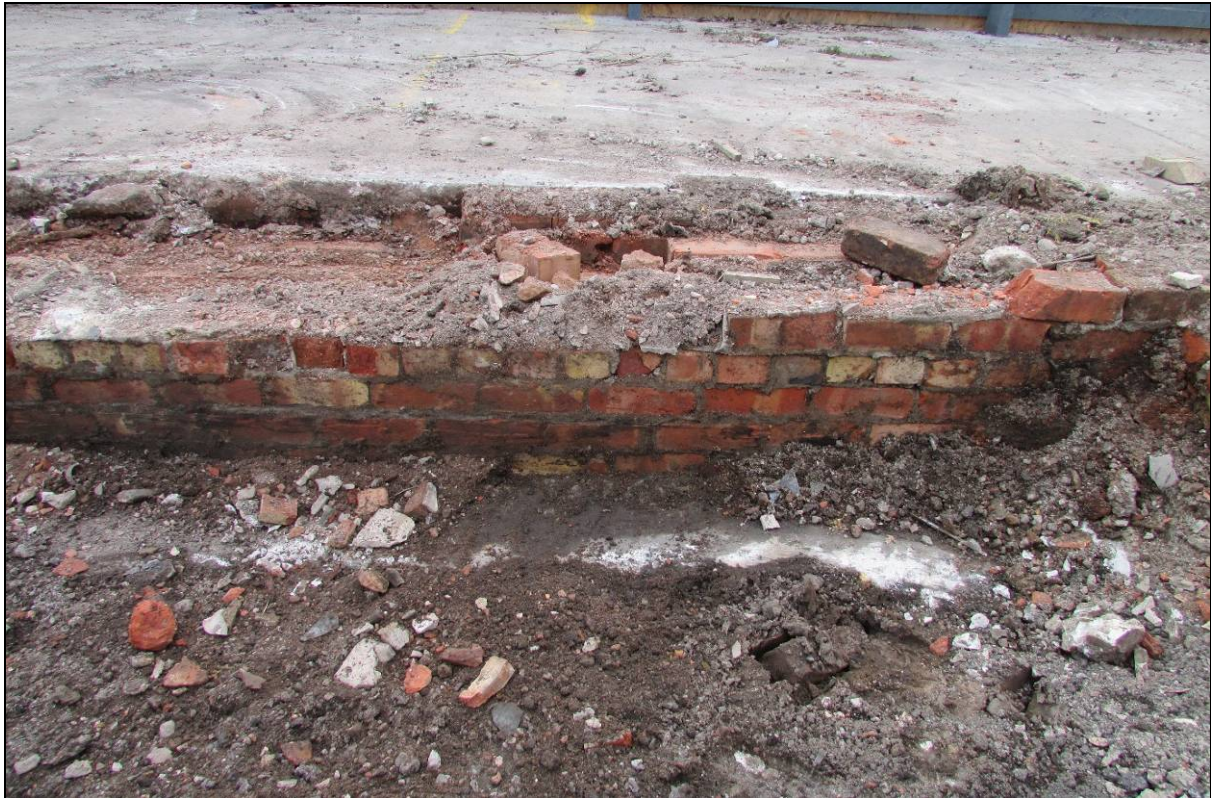
*Plate 8: View of wall **202** looking south-west. The remains of the concrete floor can be seen in front of the brick wall*

Wall **202** comprised the remains of modern brick wall in the most north-westerly part of the excavation area (Plate 8). Wall **202** was constructed of modern machine-made bricks and was bonded with a hard grey cement, indicative of a 20<sup>th</sup>-century construction date. This wall survived to a maximum of five courses and was exposed to a maximum thickness of four courses. At the bottom of the the brick wall, 0.5m below the ground surface, was a concrete floor surface. Wall **202** was made up of two surviving walls, once aligned north-east/south-west, and aligned north-west/south-east. Wall **201** was clearly associated with the light industrial buildings dating to the mid-20<sup>th</sup> century, and was not considered of archaeological significance.

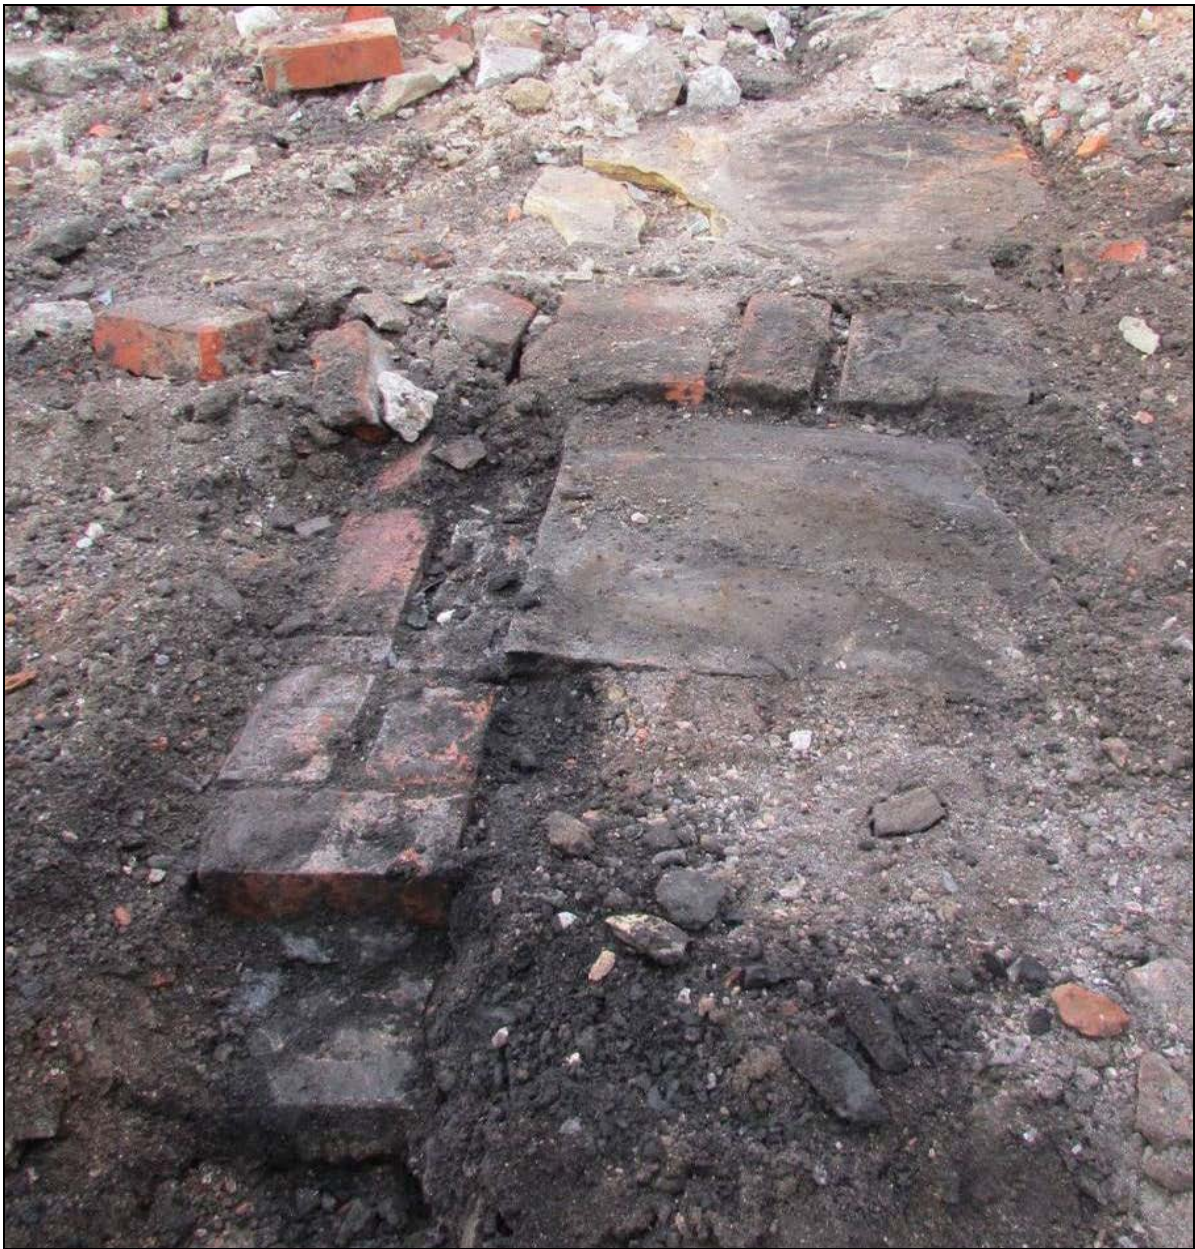
*Plate 9: Photograph looking north-west showing feature **203** in centre with the remains of **202** in the upper left corner*

Feature **203** was a partly disturbed feature constructed of flagstones and bricks. The foundations were not exposed, and its purpose is unclear from what was uncovered during the watching brief but it was almost certainly represented some form of culvert or drain. The maximum extent of the feature uncovered 0.9 x 2.1m. The feature appeared to have been orientated north-east/south-west. Three flagstones were uncovered, the largest and most complete of which measured 0.6 x 0.7 x 0.06m. The bricks were bonded with a hard black mortar, and the uppermost flagstone was 0.4m below the surface of the modern concrete. Within and around **203** was a very dark grey-black silty sooty fill.

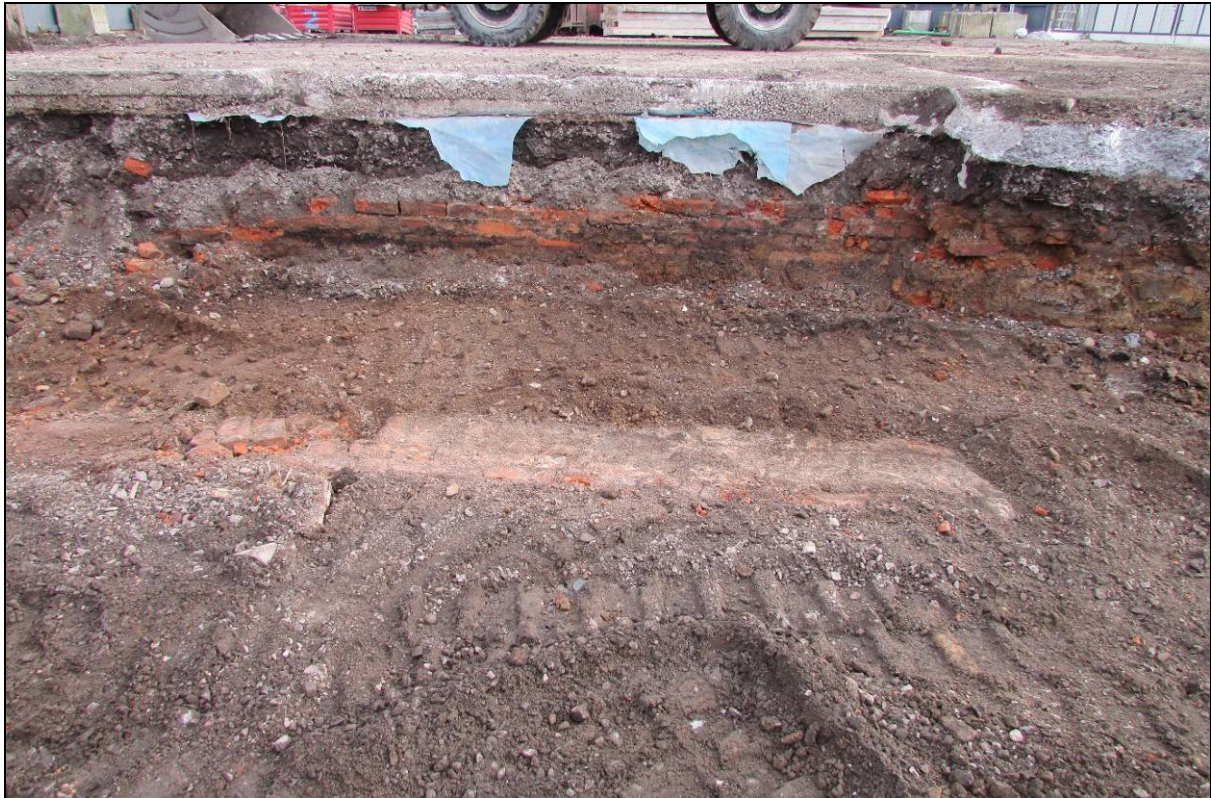
*Plate 10: Photograph looking south-east; wall **204** is in the foreground and **205** is in the background*

Wall **204** was aligned north-east/south-west, parallel to Melbourne Street (Plate 9). The wall was four courses thick (0.45m) with only the uppermost layer of bricks visible, and as such its maximum depth is unknown. The top of the wall was exposed at a depth of 0.7m below the concrete ground surface. The wall was bonded with a yellow sandy silty mortar. A section of wall approximately 3.5m in length was uncovered during this watching brief, but its maximum length to the north-east and south-west remains unknown.

Wall **205** was visible in the southern baulk of the excavation Area 1. The uppermost bricks of **205** were exposed at a depth of 0.6m below the concrete ground level. The wall survived to a height of six courses, and the base of the wall was 1.05m below the ground surface. The wall was bonded with a yellow sandy mortar. In the south-westerly most point of **205** the wall extended an additional two courses northwards, although this had been disturbed in modernity and the full width of the the wall remains unknown. At the base of the wall was a very hard surface, which can be seen in Plate 10. This surface was embedded with small cobbles which were set into a a very dark grey-black silty material. This surface suvived to a maxium of 0.4m to the north from **205**. Sturctural remains **204** and **205** lay parallel to each other and were set 1.5m apart.

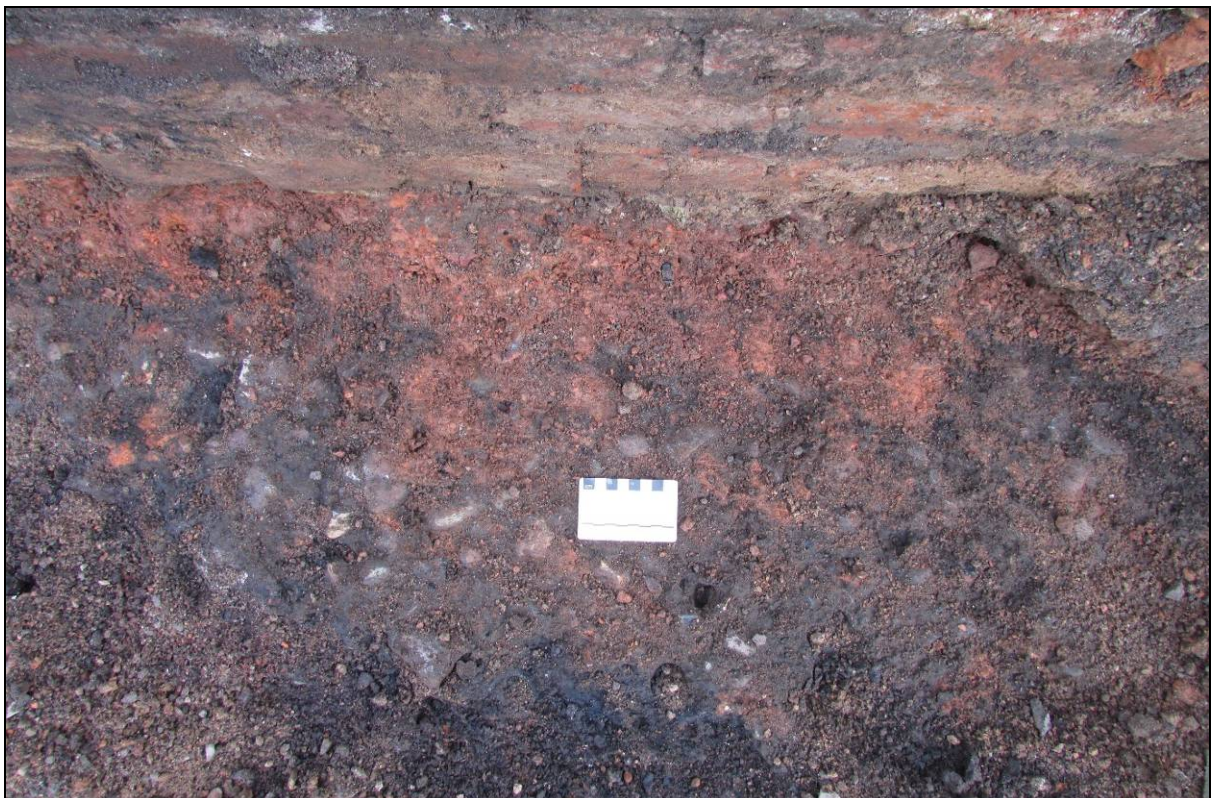
*Plate 11: Detailed view of the base of wall **205**, showing the semi-cobbled surface*

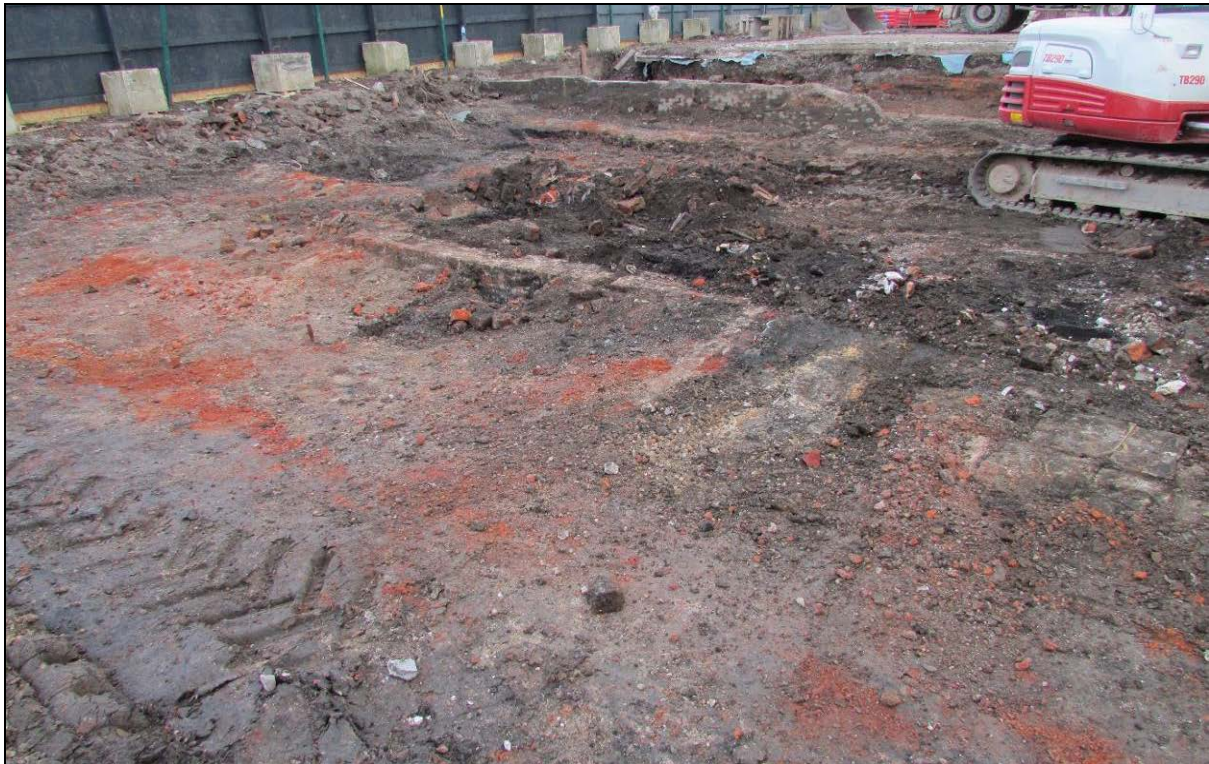
*Plate 12: View looking south showing wall **201** in the centre with the truncated remains of walls at the bottom and left*

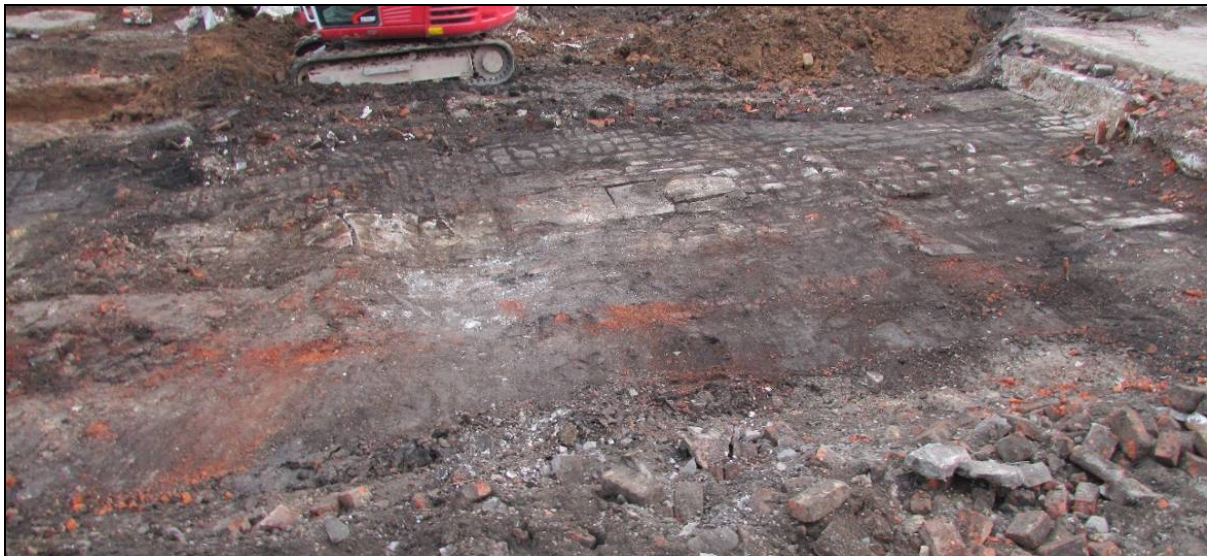
*Plate 13: View looking south-west, showing the extent of surface 206*

Feature **206** was a large cobbled surface that was exposed for an area of approximately 5.5 x 3.2m. It was located at the south-western end of the excavation Area 1 (Fig 7). This area was 0.6m below the ground surface, and was constructed of rounded and regular cobbles, with a single line of curbstones on its northern edge. The cobbles comprising **206** regularly measured 0.18 x 0.22m.

The northern side of cobbled surface **206** was lined with large kerbstones (Plates 13 and 14). These measured up to 0.45m x 0.12m. A line of flagstones, **209**, extended from the cobbles towards the south-east, where they had been truncated by later activity. Flagstones **209** were 0.6m in width and at least 4.7m in length. On the northern side of this line of flagstones was a brick surface, **208**, (with bricks on edge), which measured 1.2 x 4.7m. On the southern side of the line of flagstones was a second brick surface, **207** (with bricks laid as headers), which measured 3 x 1.8m. The largest area was that of the cobbles which survived to a high degree. Cobble surface **206** was located to the north, east, and south-east of flagstones **209**, and measured 3.2 x 5.5m, respectively. To the north of the line of kerbstones was the degraded remains of a north-west/south-east-aligned brick wall, **210**. While heavily degraded and truncated it was possible to suggest that **210** was two bricks across, or 0.3m. The most southwesterly of the flagstones, **209**, had been overlain with 0.05m of later concrete.

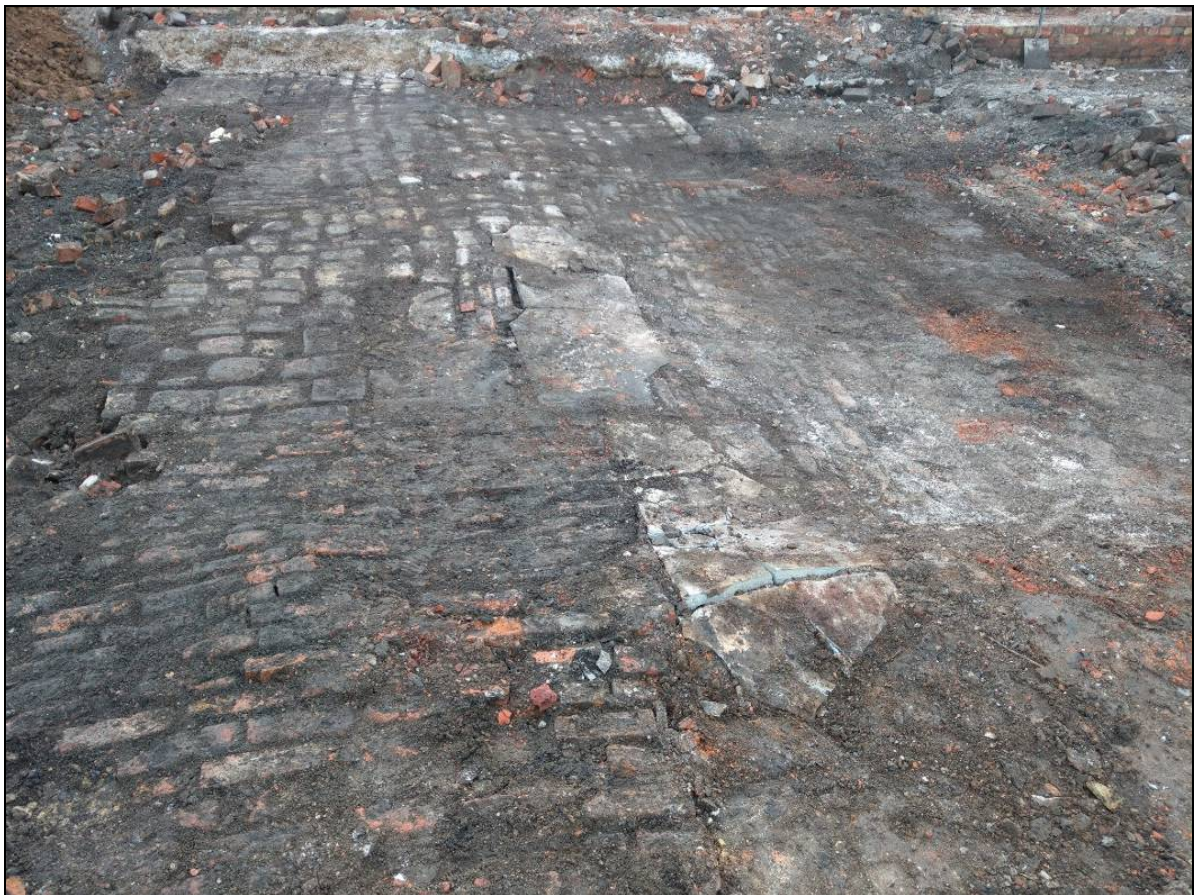
*Plate 14: View looking north-west, showing surface 206*

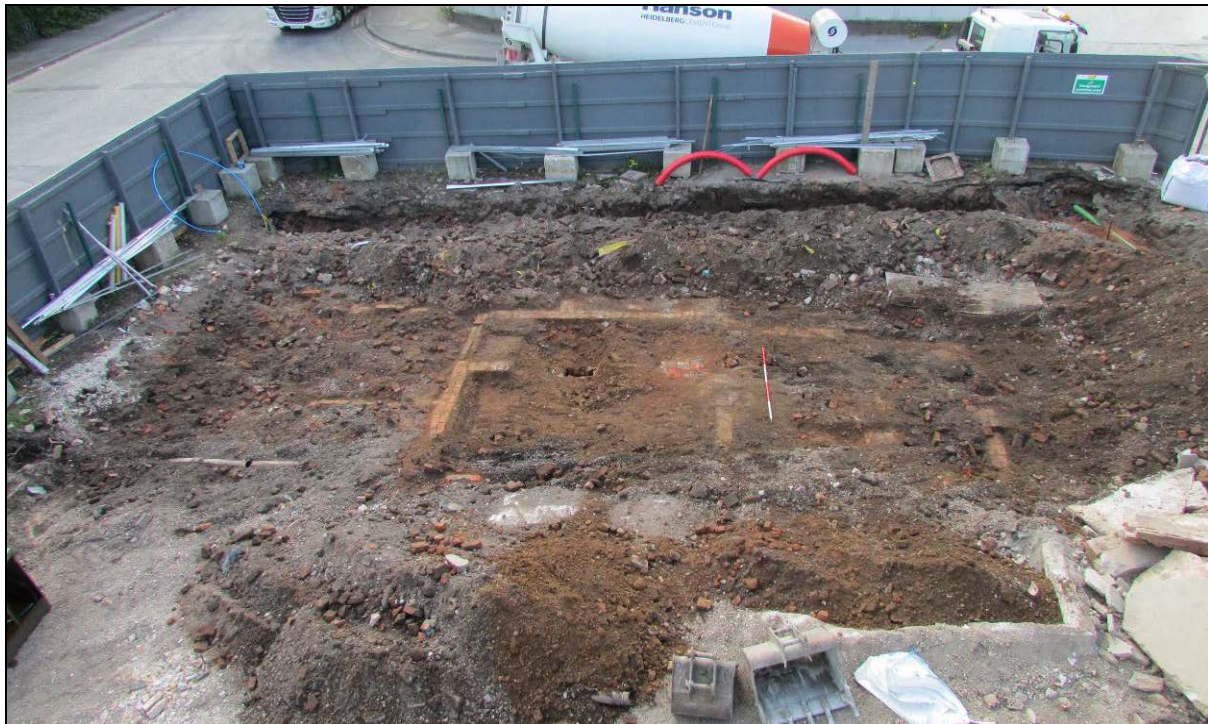
*Plate 15: General view of Area 2, with service trench (Area 3) in the background, looking south-east*

Area 2 was located in the southern part of the Site, across the footprint of double-depth workers' houses that fronted onto Great Jackson Street, together with the yards to the rear, as shown on 19<sup>th</sup>-century mapping (Figs 3 and 4). This exposed the upper surviving courses of the foundations for these houses, many of which had been truncated and were in a general poor condition (Plate 15).

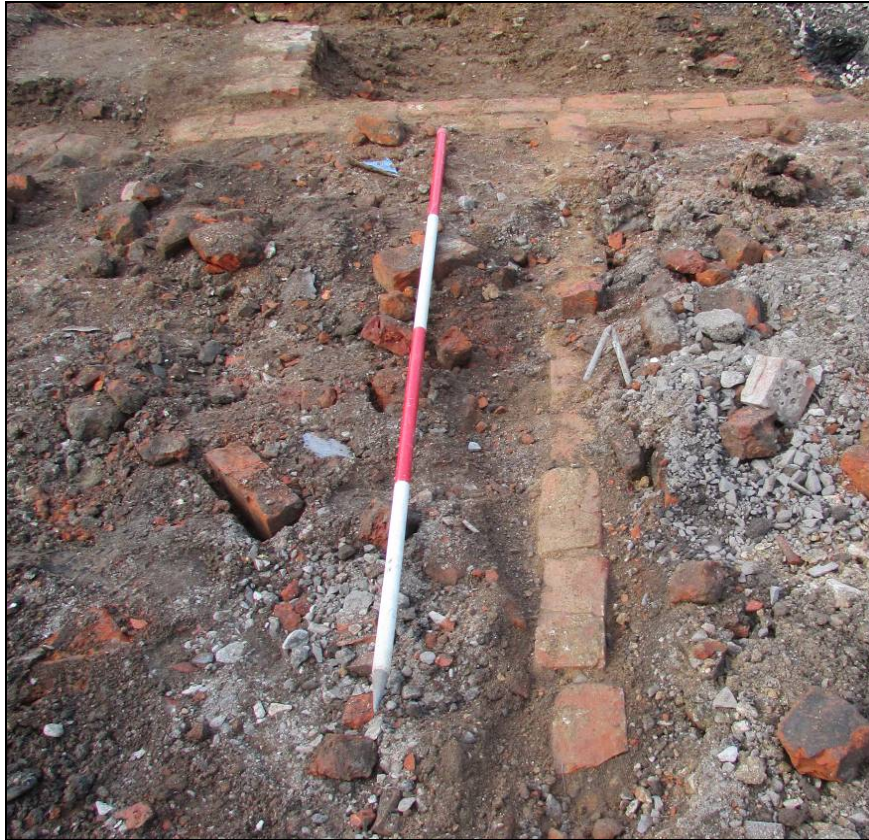
*Plate 16: Walls 003 and 004, looking south-west*

Wall **003** was a double-skinned brick wall bonded with sandy yellow-white mortar, 3.6m in length and 0.24m in width. The depth of wall **003** remains unknown, as with most of the walls encountered in Area 1. Wall **003** was orientated south-east/north-west and was joined, as a return, at its north-eastern end by wall **007**. Wall **004** was a small segment of single-skinned brick wall 2.2m in length, which connected perpendicularly to wall **003**, 0.8m from its most westerly surviving point (Plate 16). On its western side, wall **003** had been cut by a modern service trench. This cut for a modern ceramic pipe was aligned north-east/south-west, and was 0.8m wide and cut across Area 2. Structure **005** consisted a very small segment of brick wall immediately to the south of the modern pipe truncation, and was aligned north-west/south-east. Wall **005** comprised a single-skinned hand-made brick wall bonded with a hard, grey, lime-mortar. It was located 0.2m below the level of the modern concrete and measured 0.11m x 0.4m.

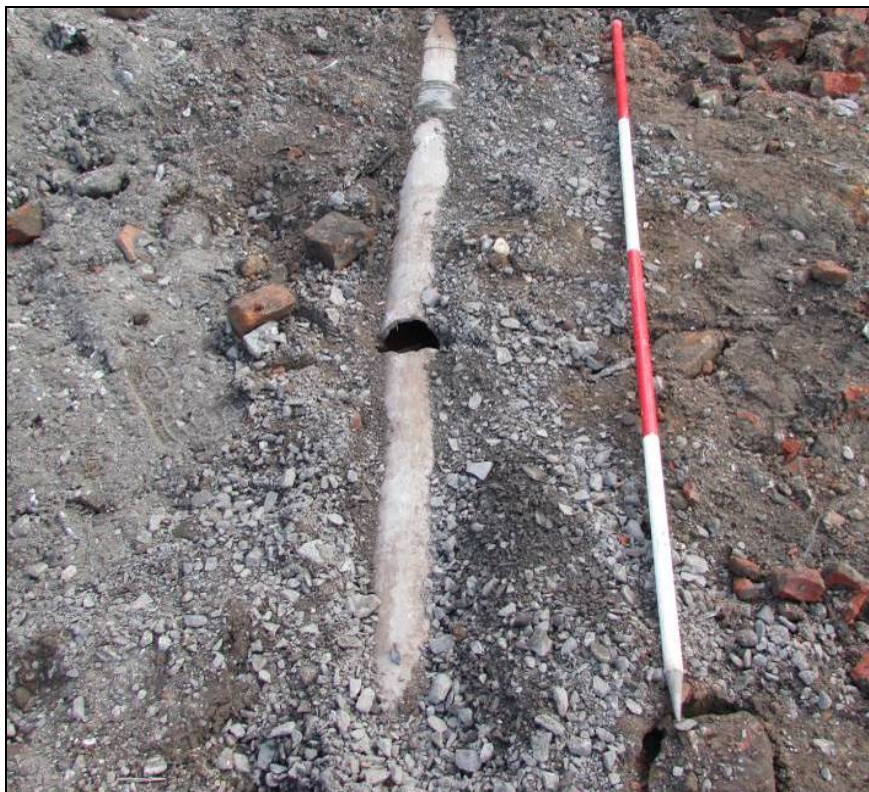
*Plate 17: Modern ceramic pipe cutting across Area 2*

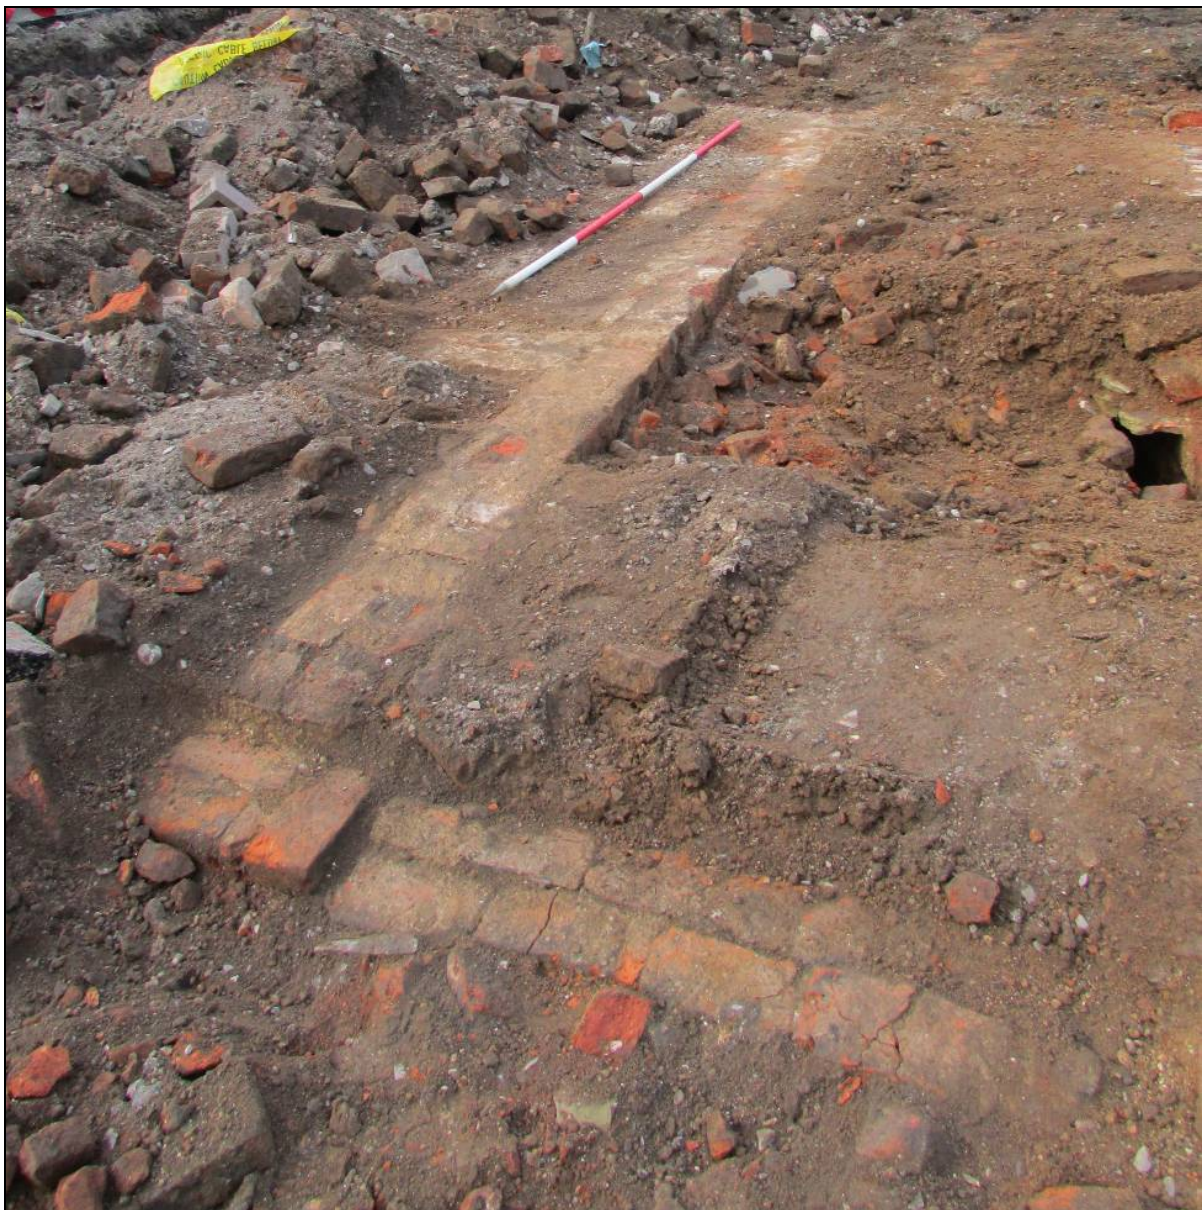
*Plate 18: Wall **008**, showing fireplace cheeks **009** and **010***

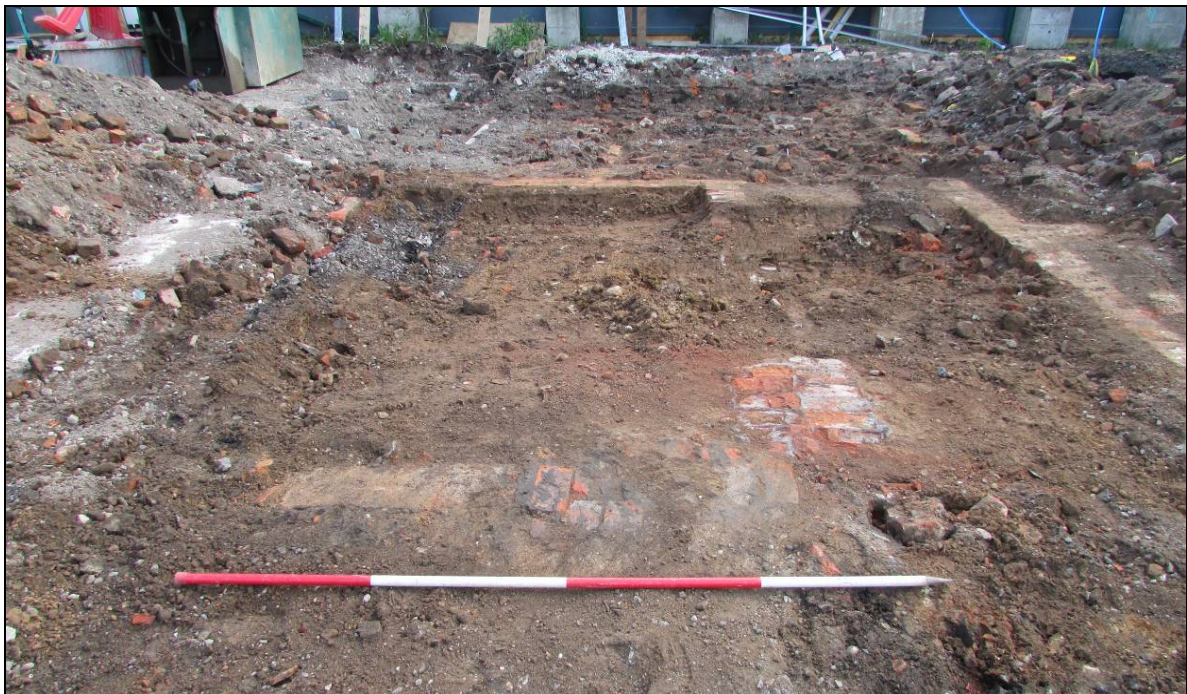
*Plate 19: General view across Area 2*

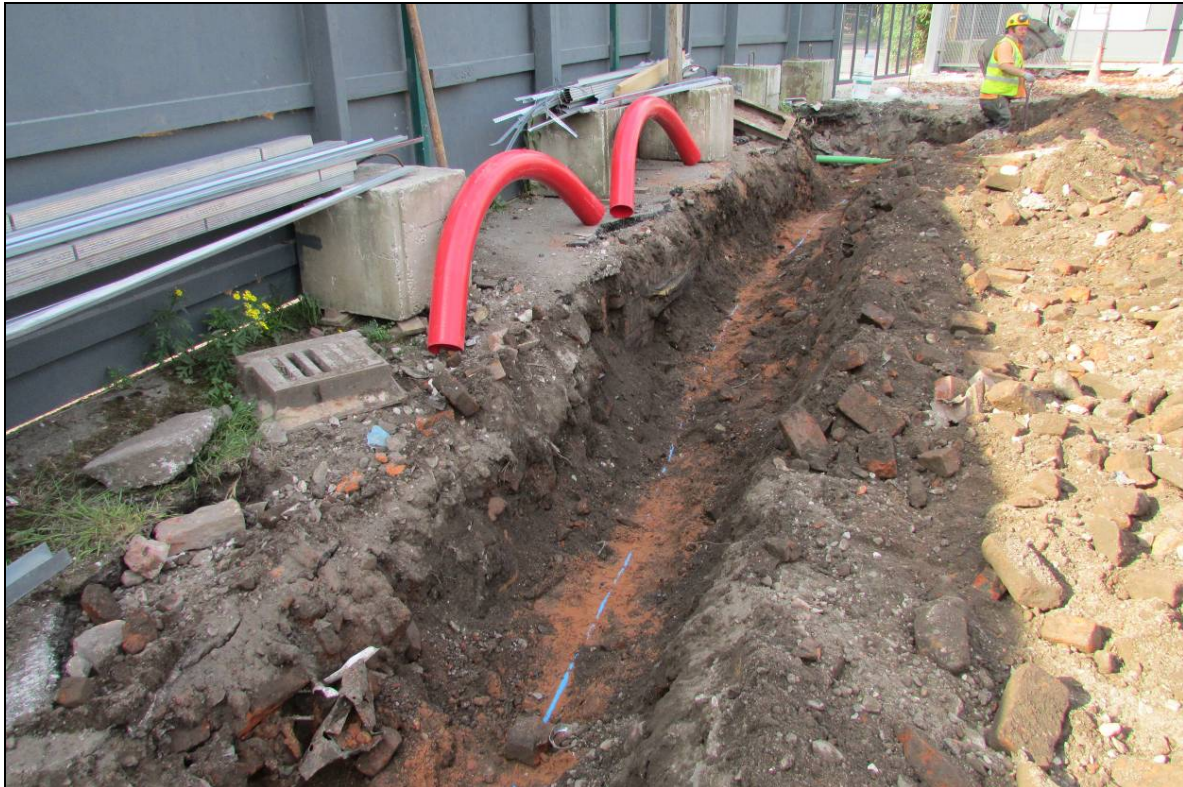
*Plate 20: View along the excavated service trench (Area 3)*

A narrow service trench was excavated across the footprint of 26 Jackson Street, along the southern boundary of the Site (Plate 20). Short sections of walls were revealed in the trench, including wall **101**, which was situated 5m north-east from the trench edge. The wall consisted of a single skin of hand-made bricks bonded together with lime mortar, indicative of an early 19<sup>th</sup>-century construction date. The wall was exposed for a distance of 1.20m and was aligned north-west/south-east. It is likely to have represented an internal partition, given its width.

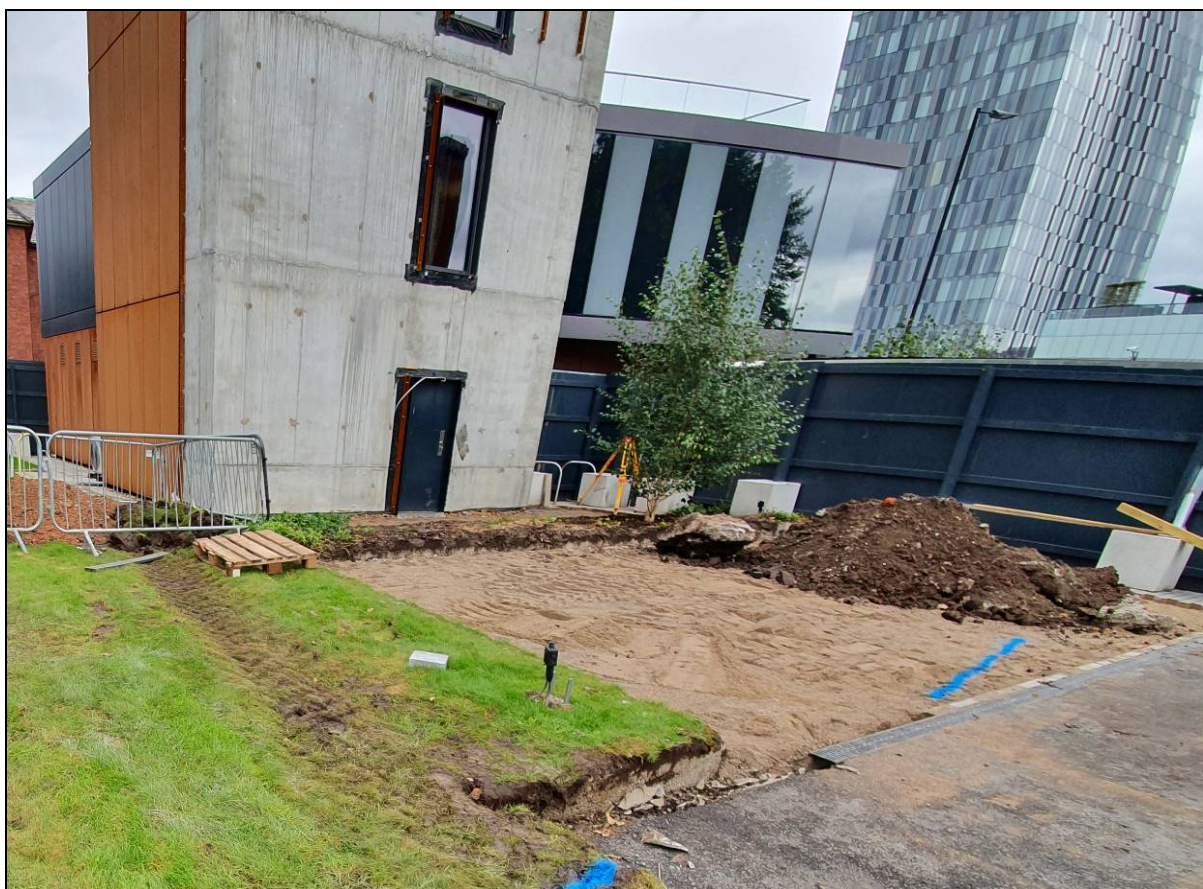
*Plate 21: General view across the area to the south of the 2018 building, showing the initial excavation of the ground surface*

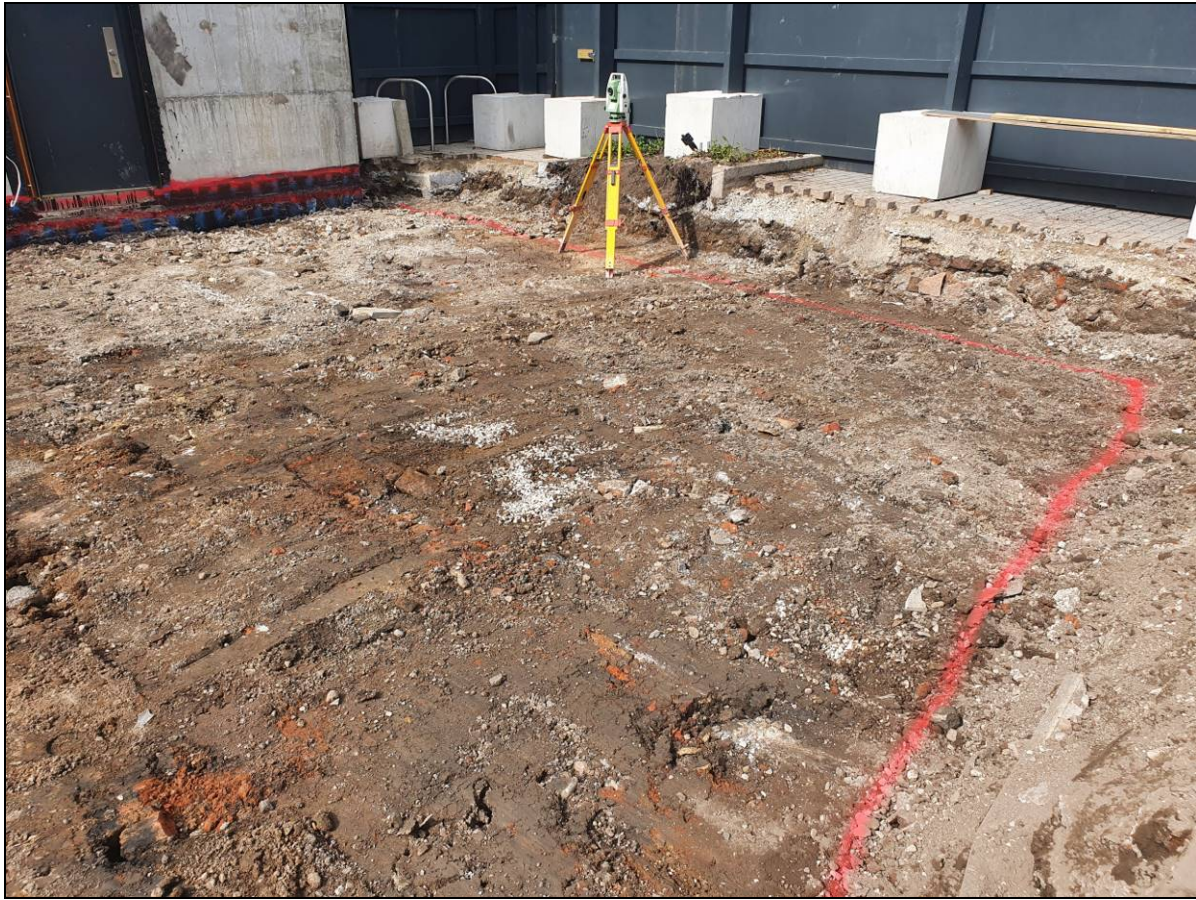
*Plate 22: View across the area to the south of the 2018 building, showing the 20<sup>th</sup>-century demolition material, overlying the natural geology*
