## Archaeological Watching Brief

## Updated Report

Marketing Suite,  
Great Jackson  
Street,  
Castlefield,  
Manchester

2020/107

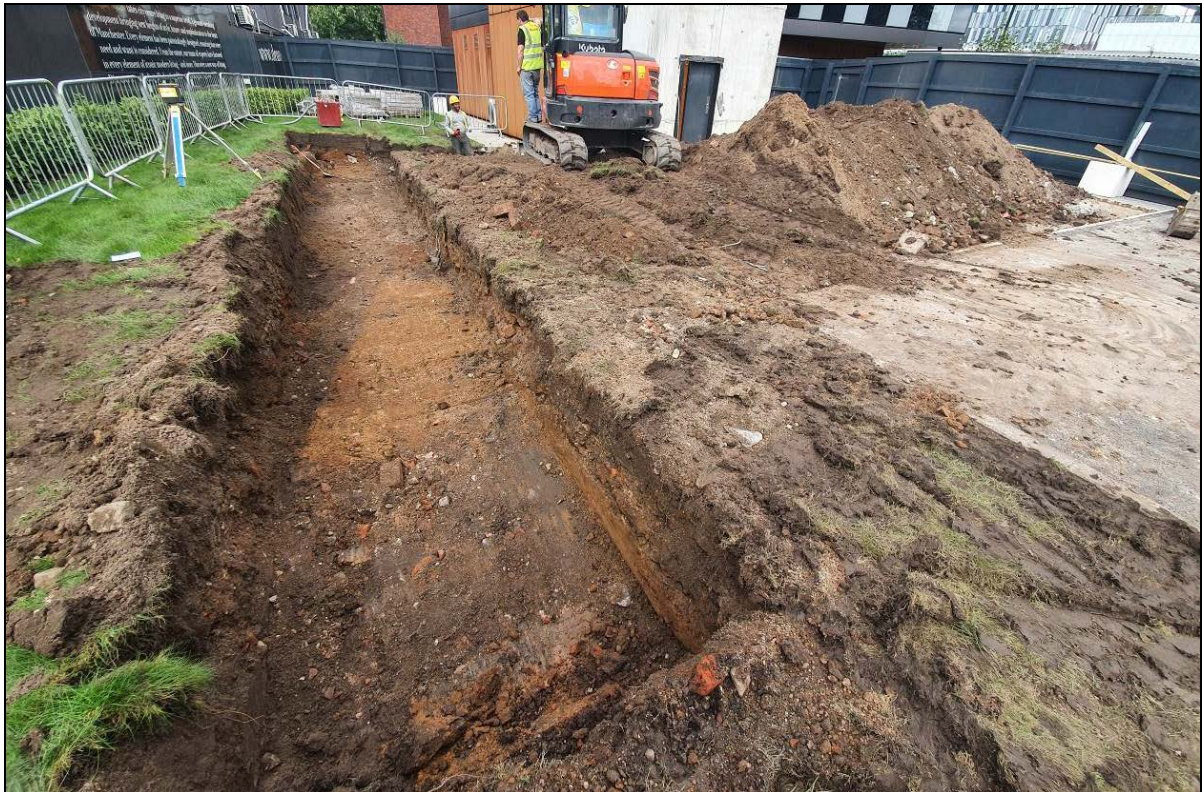
*Plate 23: Trench excavated along the western side of the 2018 building, showing a modern service trench cut into the natural drift geology, and vestiges of modern mixed demolition material overlying the natural geology*

The second phase of the ground works necessitated the excavation of ground to the west and south-west of the 2018 building. Initially, this comprised the excavation of a 1.80m-wide trench to a depth of c. 1m, exposing a thick deposit of sandy clay with patches of gravel, clearly representing the natural drift geology. This was overlain by a mixed deposit that contained 20<sup>th</sup>-century demolition material, which was exposed immediately beneath the modern topsoil. The layer of mixed demolition material had been cut by a modern service trench that was aligned broadly north/south along the central part of the excavated trench (Plate 23). No features of archaeological interest were identified, and no finds were recovered.

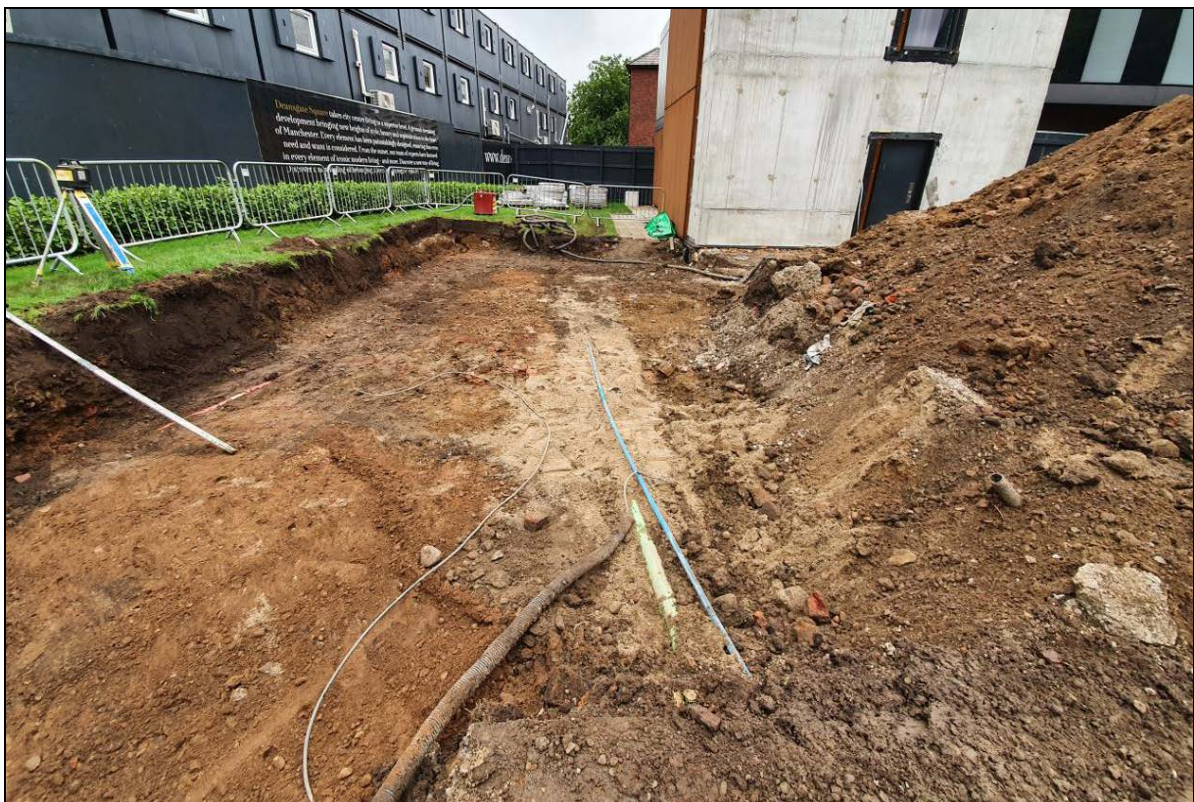
*Plate 24: The second area fully excavated*

Following the excavation of the initial trench, a larger area was subject to ground-reduction works. This revealed the same simple stratigraphic sequence that was exposed in the initial trench, comprising the natural drift geology overlain directly by a layer of modern mixed demolition material sealed beneath topsoil (Plate 24). A second modern service trench was also exposed, cut into the natural geology and backfilled with a pale yellowish-cream coloured sand. No features of archaeological interest were identified, and no finds were recovered.

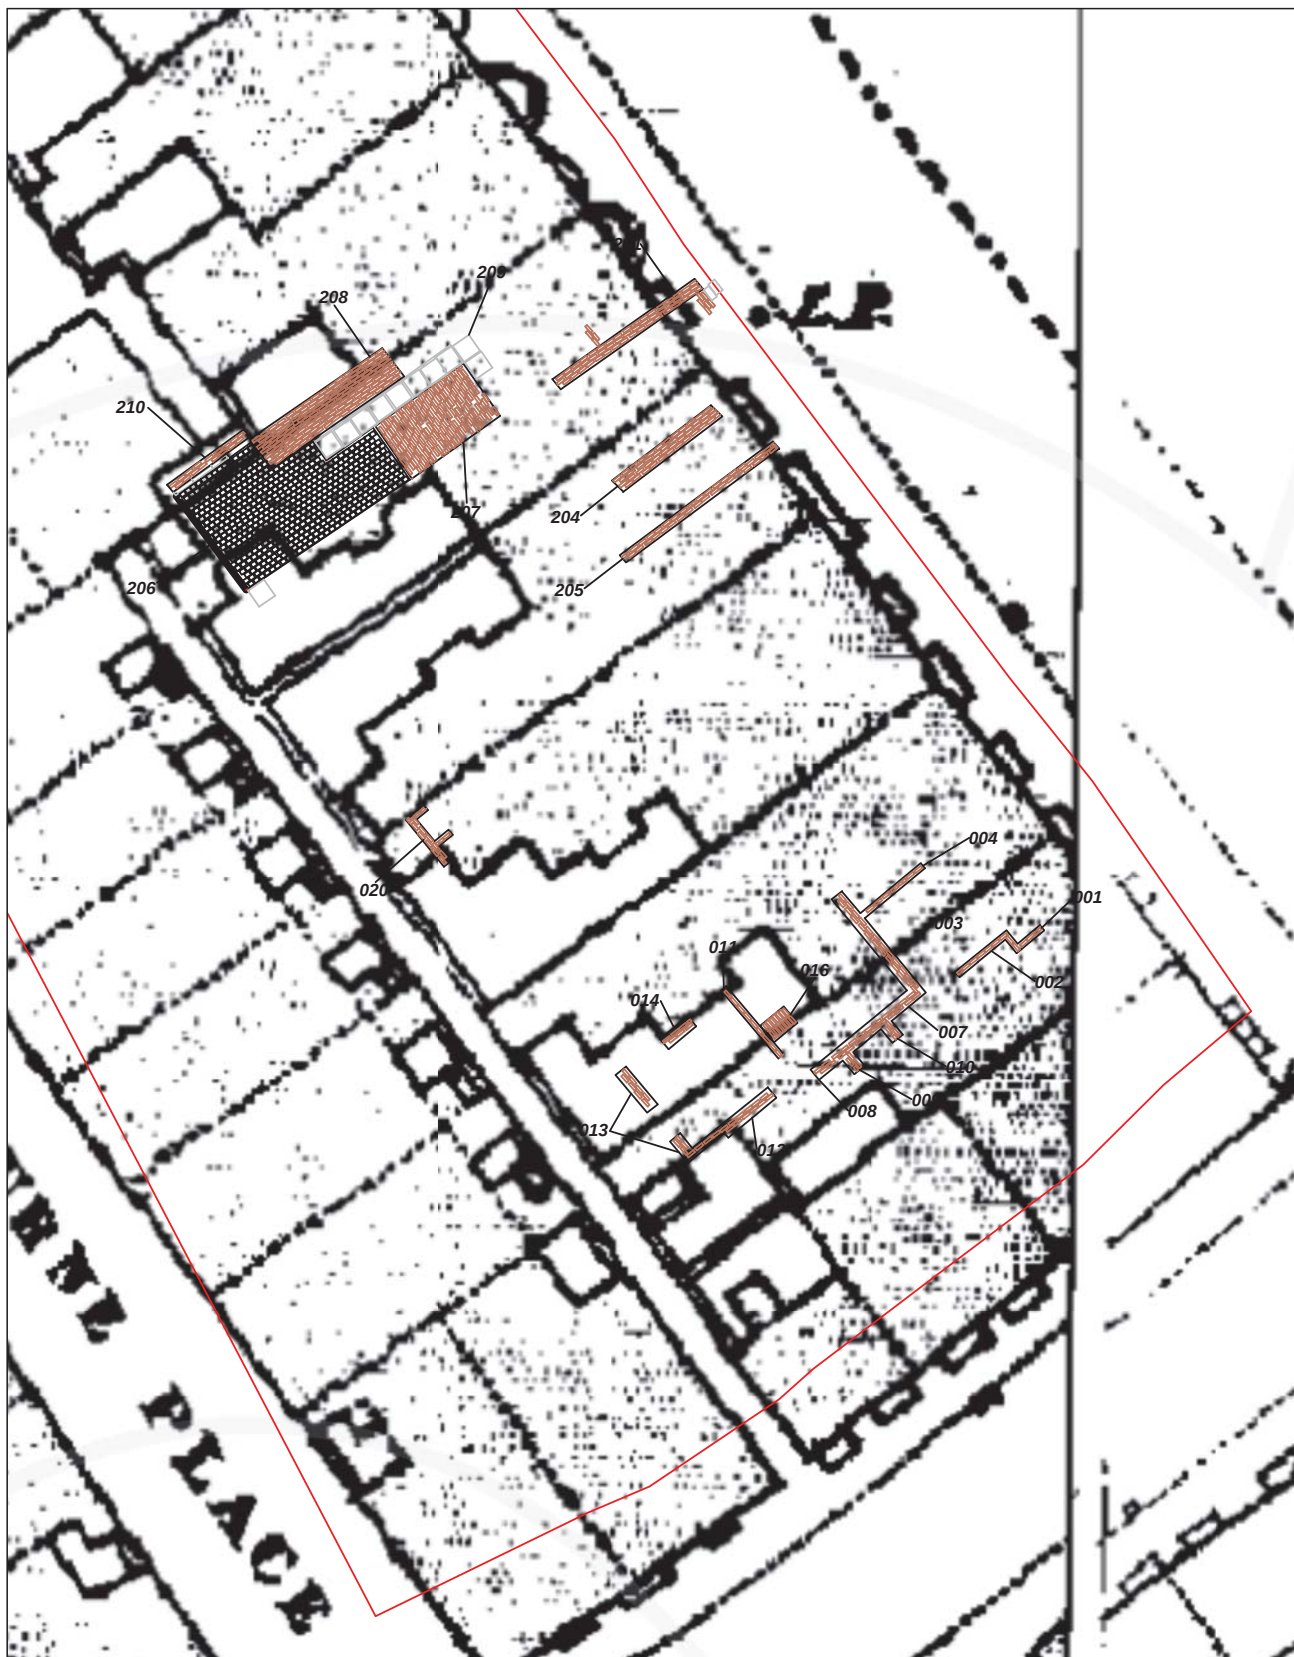
Crown Street Marketing Suite Watching Brief with archaeological features overlaying 1851 OS map

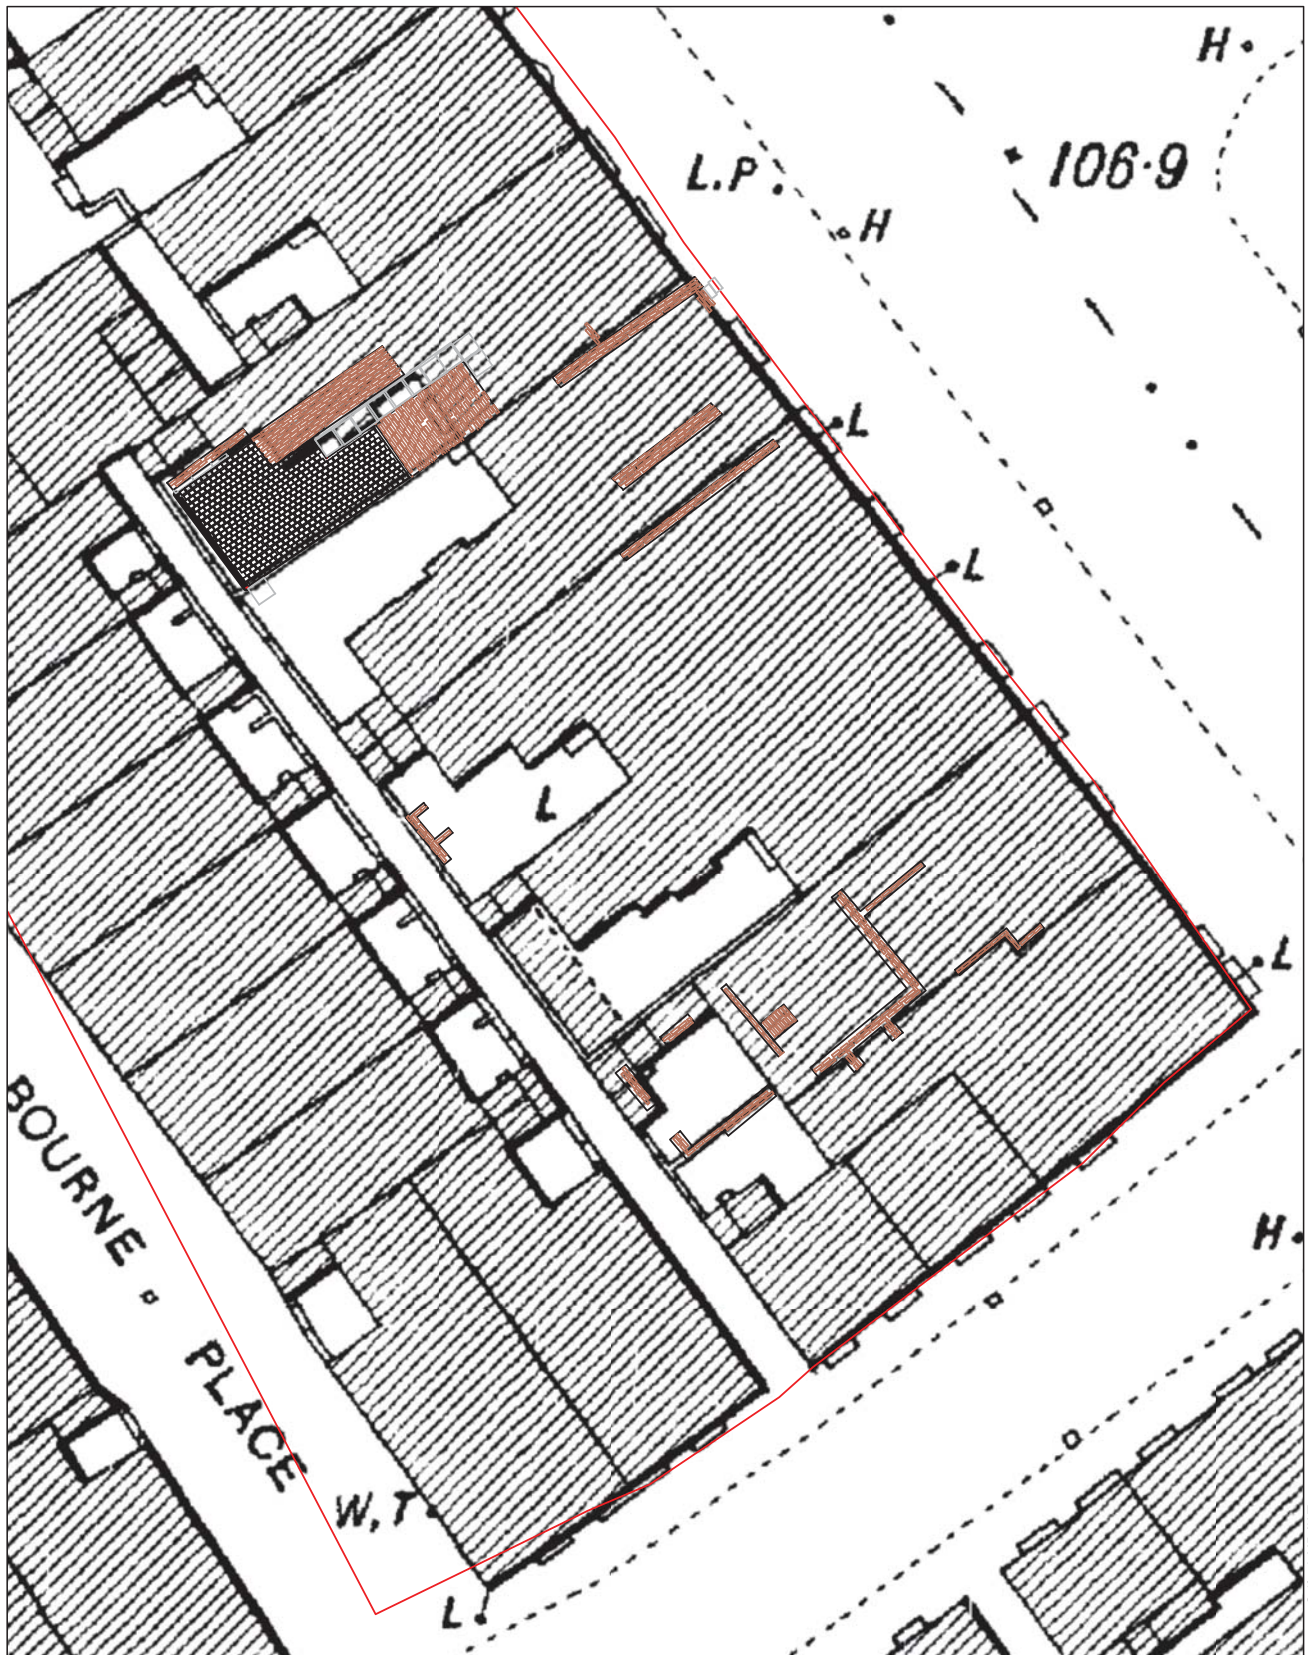
Crown Street Marketing Suite Watching Brief with archaeological features overlaying 1891 OS map
