# TV RECEPTION SURVEY REPORT

**DATE OF SURVEY:** 13th December 2019  
TBAER027 - 159978

Mason Street,  
Manchester

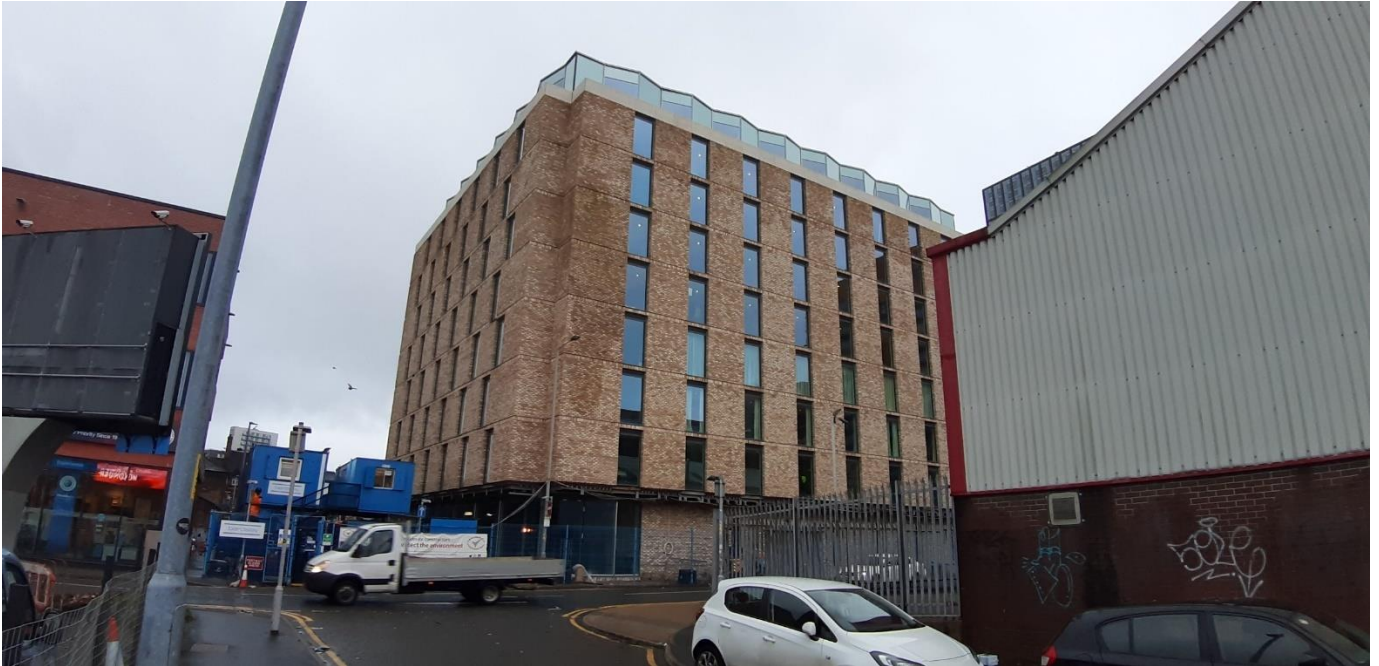
**PHOTO A: THE DEVELOPMENT LOCATION**

Photograph A: - The development's location  
Photograph B: - View directly to the north of the development.  
Photograph C: - View directly to the east of the development.  
Photograph D: - View directly to the south of the development.  
Photograph E: - View directly to the west of the development.
