**Document:** Heritage Impact Assessment

**Project:** Manchester Jewish Museum  
Cheetham Hill, Manchester

**Date:** October 2020

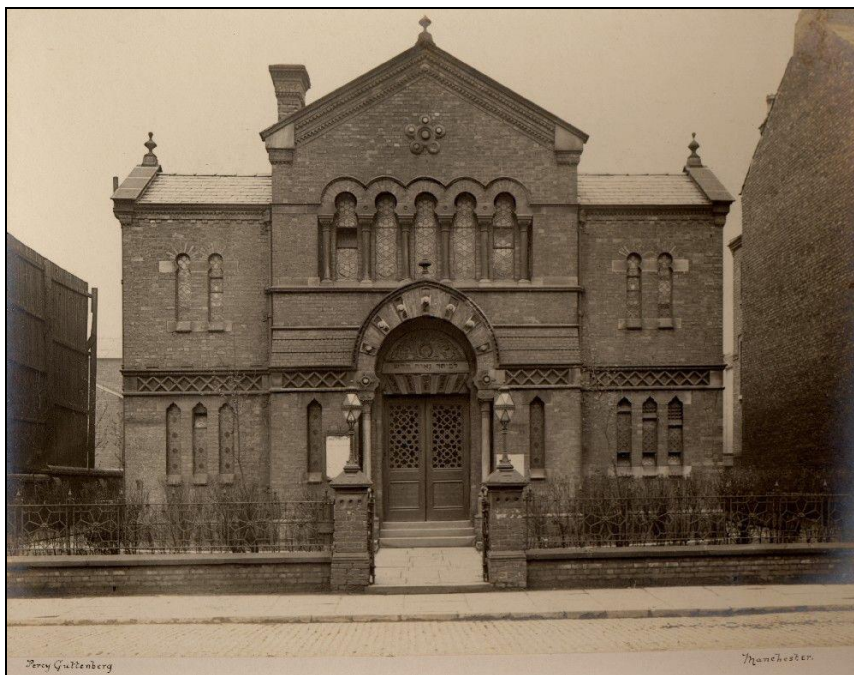
The Spanish & Portuguese Synagogue c 1903

The Sephardi Jews first arrived in Manchester in 1827 and initially worshiped with the larger Ashkenazi Jewish Community at The Manchester Great Synagogue, lower down Cheetham Hill Road. In the 1860s the community rented their own room in New Bridge Street, Strangeways, for prayer. They later moved to Southall Street, then York Street Road, finally settling at the old Jews school at number 78 Cheetham Hill Road. From 1869 to 1872 the community discussed plans to build a new Synagogue of their own, due to an upheaval within the Ashkenazi congregation. In 1872 they obtained approval and financial support from the Bevis Marks Synagogue in London and purchased a plot of land on York Street (now Cheetham Hill Road) and built their own Synagogue. This became known as the Manchester Spanish and Portuguese Synagogue, and was opened on the 6<sup>th</sup> of May 1874.

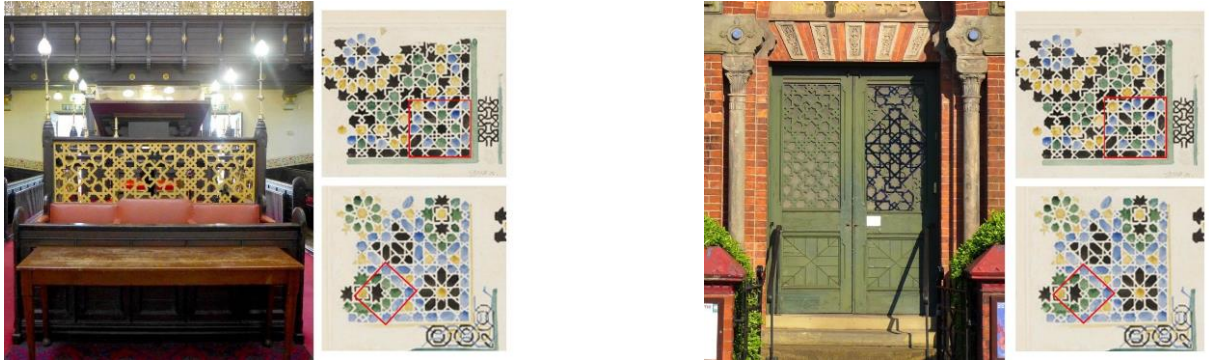
Synagogue Decorative influences from Owen Jones Studies in Moorish Architecture

Salomons expressly acknowledged the influence of Owen Jones (and his studies of the geometric patterns from the Alhambra Palace in Granada) within the Synagogue, and draws on Jones' delicate Moorish detailing in the slender columns, delicate horseshoe arches and vibrant geometric patterning displayed throughout the building.

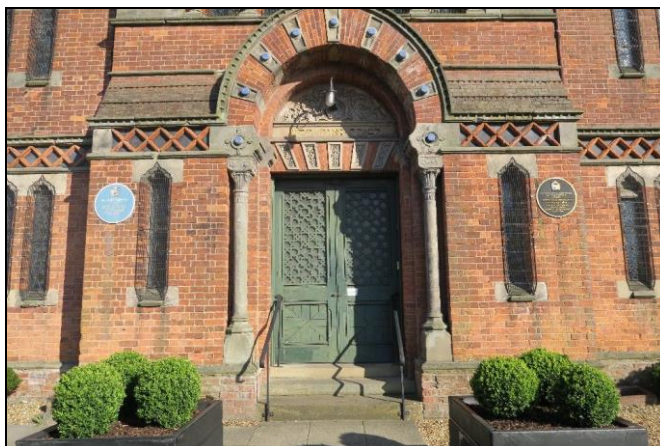
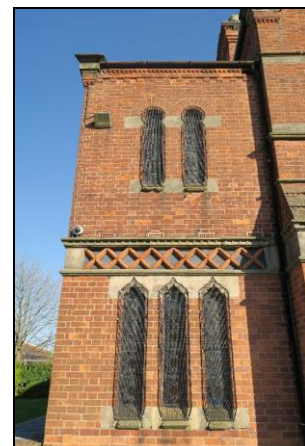
The entrance to the Synagogue is framed within a large horseshoe arch that echoes the shape of the Puerta del Vino at the Alhambra and is inlaid with blue 'vitrified' marble bosses and supported by slender columns. The horseshoe motif and slender columns are repeated in the window heads of the five-light arcade on the floor above, and can be found throughout Owen Jones' drawings of the Alhambra.

The blue marble bosses are repeated in the stone cinquefoil motif in the gable above the arcade. The original Moorish style *mashrabiya* wood latticework door is still in place; today painted green and slid out of view during Museum opening hours. This door pattern appears to be a simplified version of the original Alhambra design <sup>7</sup>.

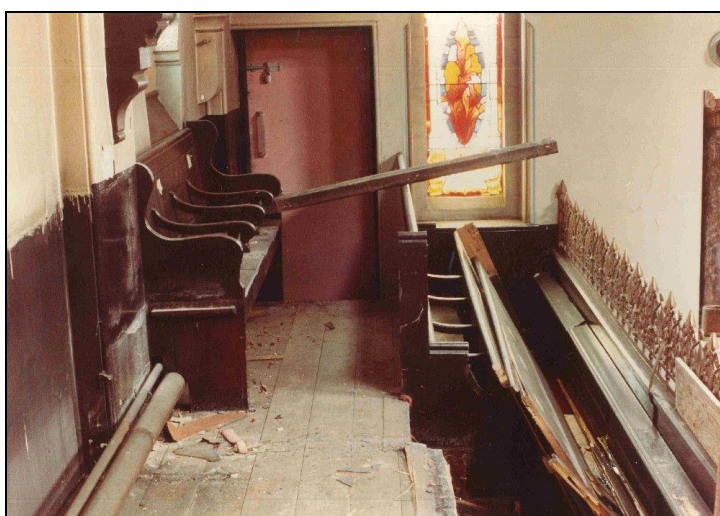
Works to the Ladies Gallery c 1983/4. Raked platform & seating removed.

However, the tiered platform and raised seating to the Ladies Gallery has all been removed. This has been stripped back to the flat floor of the balcony structure so that space can be provided for the Museums display cases.

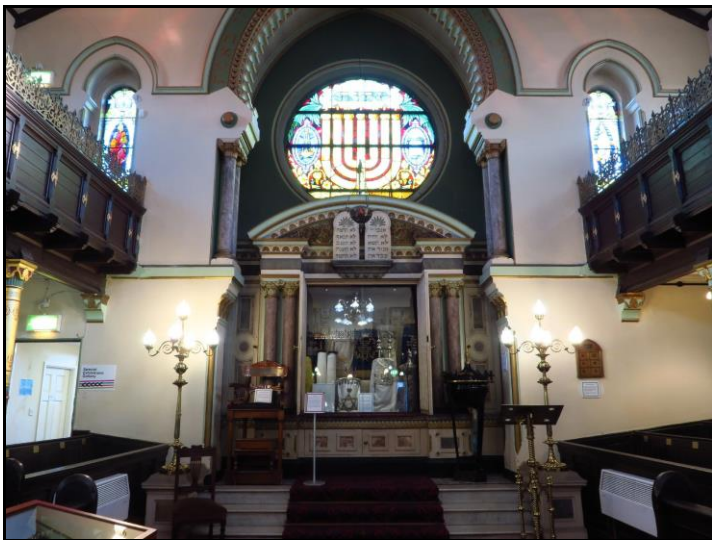
Ark & East End

Almost all of the internal features still remain intact within the Worship Area. Despite the extensive works by the Museum circa 1984 in converting the first floor Ladies Waiting Room and the rear Sukkah building, they have left the interior of the Synagogue at ground floor level largely unchanged.

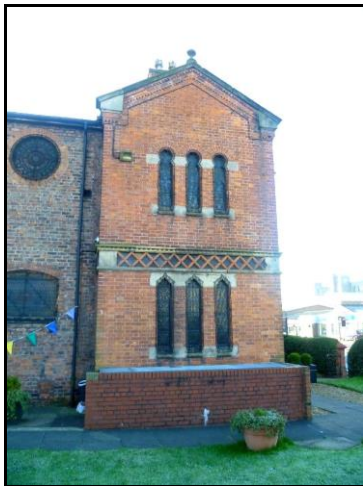
Ground Floor triple windows to North West wing to be relocated to form new access route.

The physical links between the new and existing structures will have a high impact. The ground floor link will involve the removal of 3.no decorative windows and the creation of an new supported opening to the north wing lower wall. However the proposals consist of rebuilding the removed wall and recreating the 3.no windows adjacent to the new Museum entrance. The intention is to create an impression of an 'extruded element' that has been taken from the existing building and relocated approximately 3m to the north.

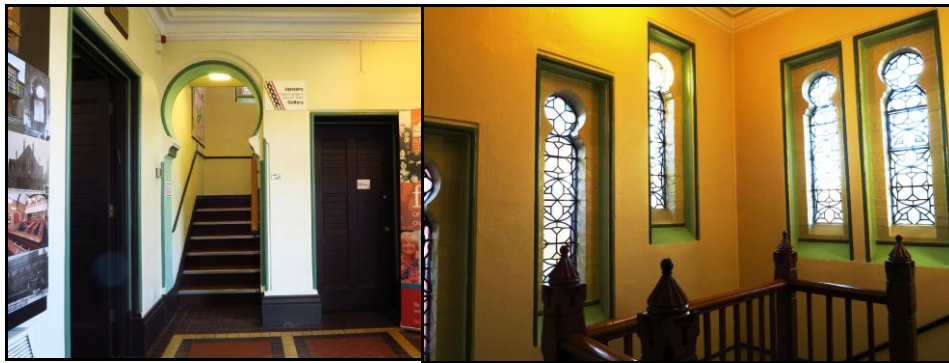
Moorish Arch to the Entrance

Moorish Arched windows to the Staircase

In mitigation the link will enable the first floor to be better accessed and for a circulation route to be created between both buildings. The brickwork to the north wall is common brick, to this part of the structure, and is not the smooth Cheshire red facings noted to the main entrance elevations. The new access is intended to create a 'moorish' arched opening into the synagogue which creates a graphic design link with the shapes used by Salomon in openings elsewhere e.g. to the ground floor lobby staircase.

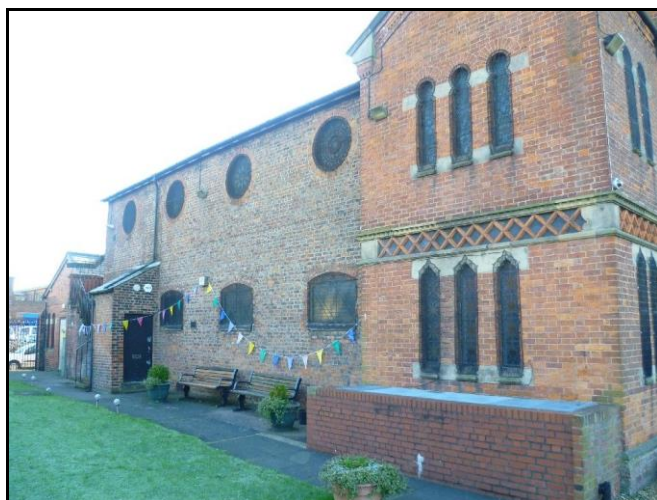
North Elevation & existing garden

The greatest impact on the existing setting is the loss of the amenity to the north side of the site; namely the garden and landscaping. However this is not an original feature to the building and was an area of former wasteland or an access route as indicated on the 1891 OS plan.

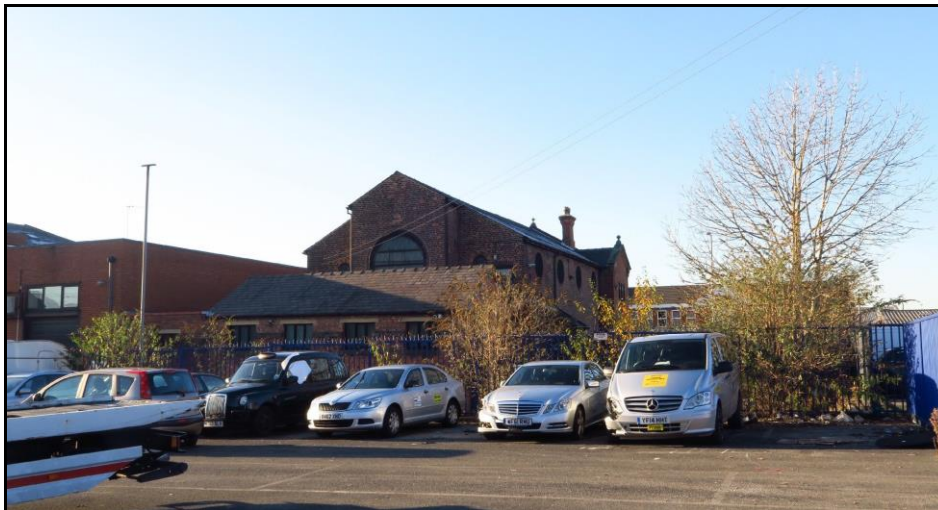
Malloy Place looking North

The Eastern elevation onto Malloy Place will be altered. The existing railings will be removed (and used elsewhere to the south side). The new two store extension will impact on views from the eastern aspect. However the local amenity value is poor and the new building will be a significant improvement on existing views.

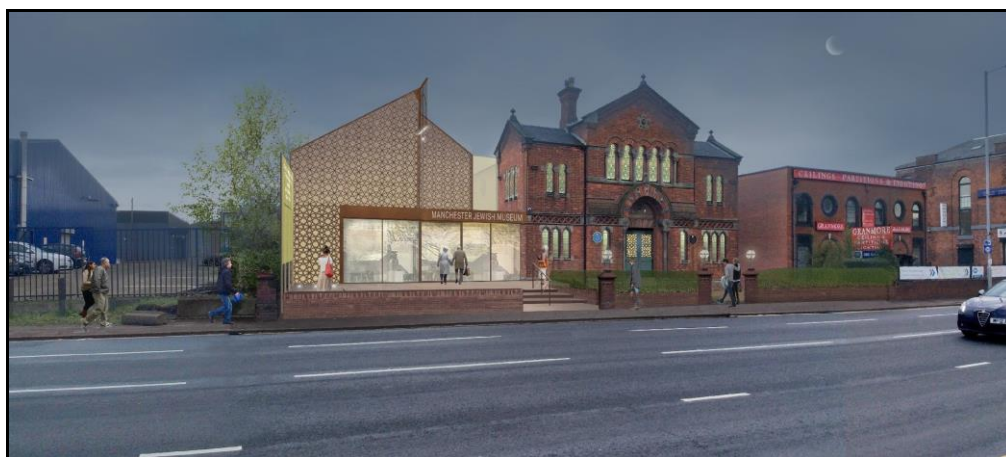
Cheetham Hill Road – proposed setting

It is not an embellishment to state that the Manchester Jewish Museum have 'saved' the listed Synagogue Building and its special interior. However their needs, as an organisation, have now outgrown the existing building. Without an extension, the needs of the Museum are not likely to be met within the existing building and an alternative accommodation solution will have to be found.

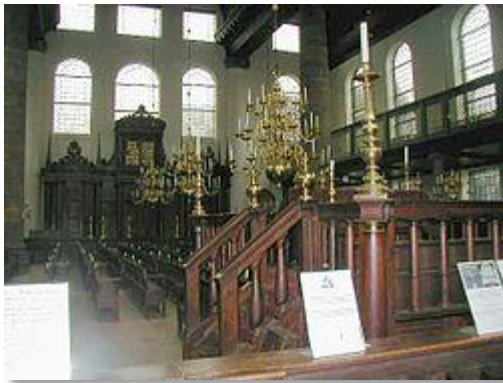
Interior of the Portuguese Synagogue of Amsterdam, with the tebáh (bema) in the foreground and the *Hekhál* (Torah ark) in the background.

Most Spanish and Portuguese synagogues are, like those of the Italian and Romaniote Jews, characterised by a bipolar layout, with the *tebáh* (*bema*) near the opposite wall to the *Hechál* (Torah ark). The Hekhál has its *parochet* (curtain) inside its doors, rather than outside. The *sefarim* (Torah scrolls) are usually wrapped in a very wide mantle, quite different from the cylindrical mantles used by most Ashkenazi Jews. *Tikim*, wooden or metal cylinders around the *sefarim*, are typically not used. These were reportedly used, however, by the Portuguese Jewish community in Hamburg.

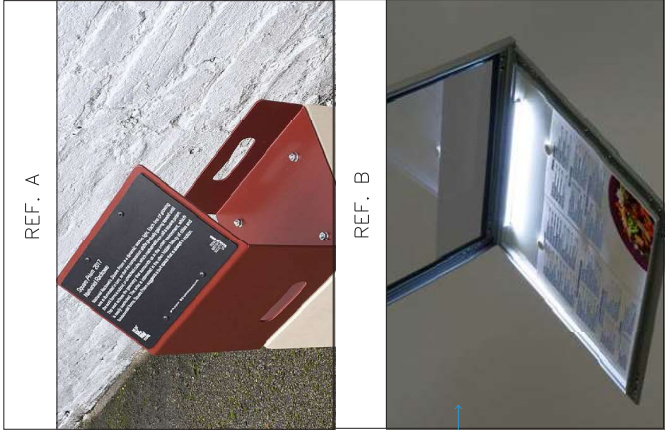
Opening mechanism.  
Please refer to "mode of use"  
drawing next page
