## GeoEnvironmental Investigation

38 Broughton Street

Manchester

August 2020

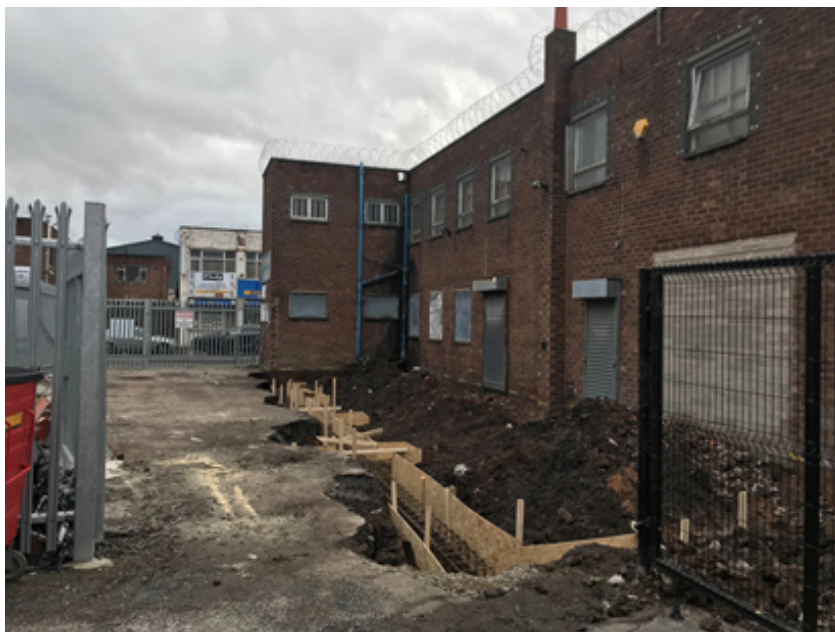
Photograph taken looking across site looking south

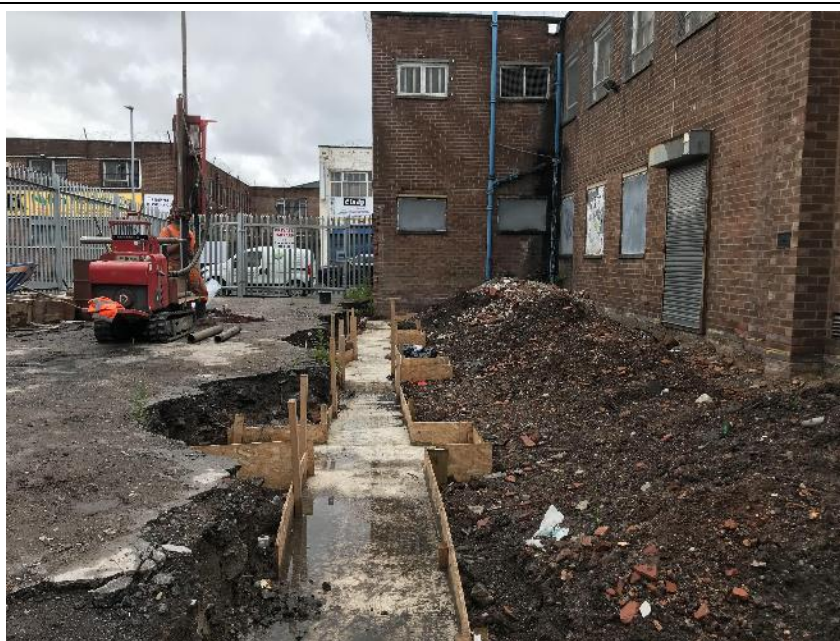
Photograph taken across site during the ground investigation looking south

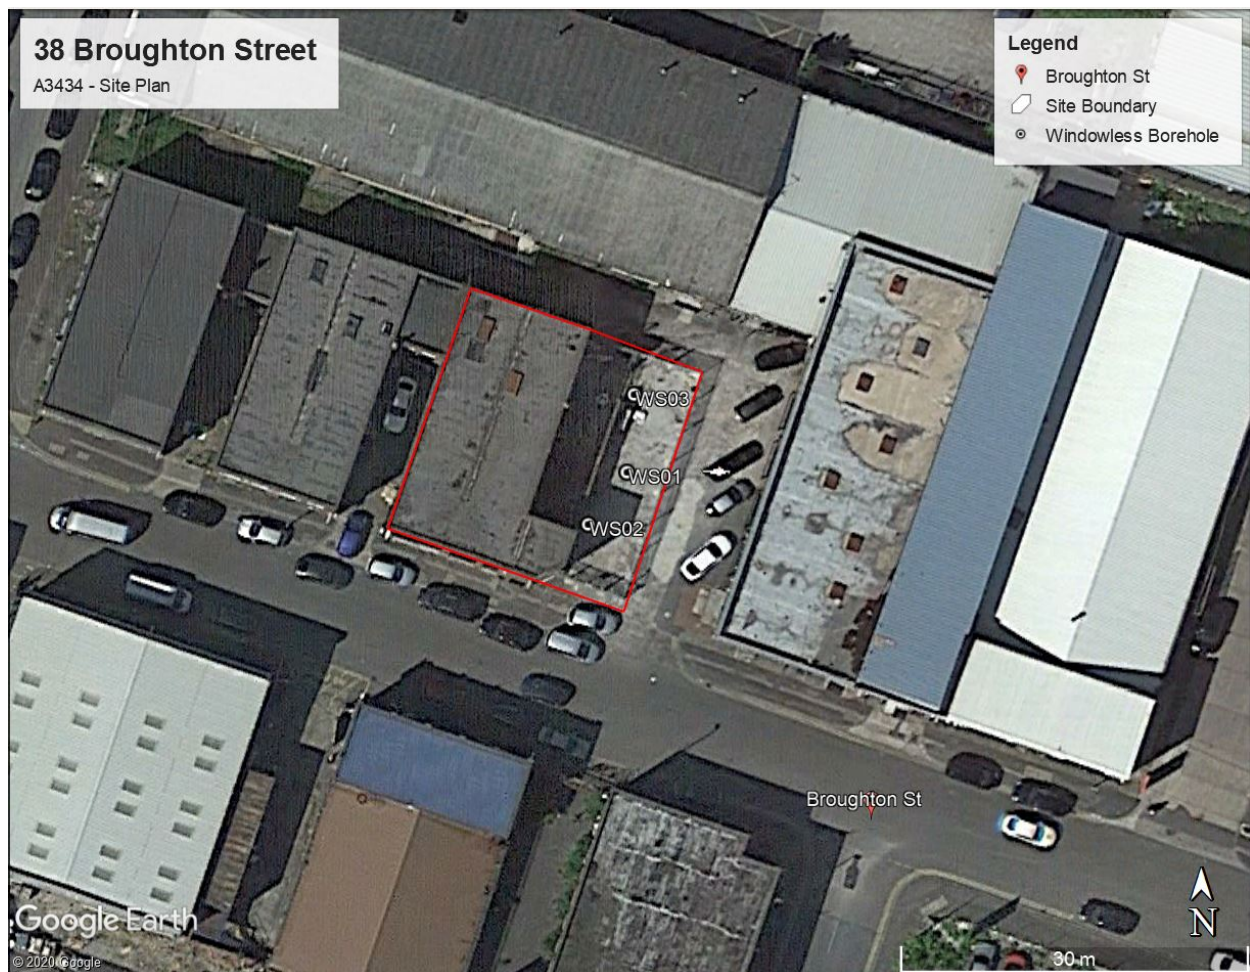
**Figure 4: Exploratory Hole Location Plan**

An Exploratory Hole Location Plan is presented as Figure 4 overleaf.
