# Television Post-Construction Reception Survey

Circle Square – Plots 2, 3, 4 and 14

September 2020

The Circle Square building development in Manchester, UK, is underway with some plots having been completed. Planning conditions require assessment of the development's impact on terrestrial television reception in the surrounding area. Reception survey measurements have been undertaken in the development's shadow zone, where interference is the most likely. Specifically, the survey locations have considered the completed Plot 14 and the zones associated with plots 2, 3 and 4.

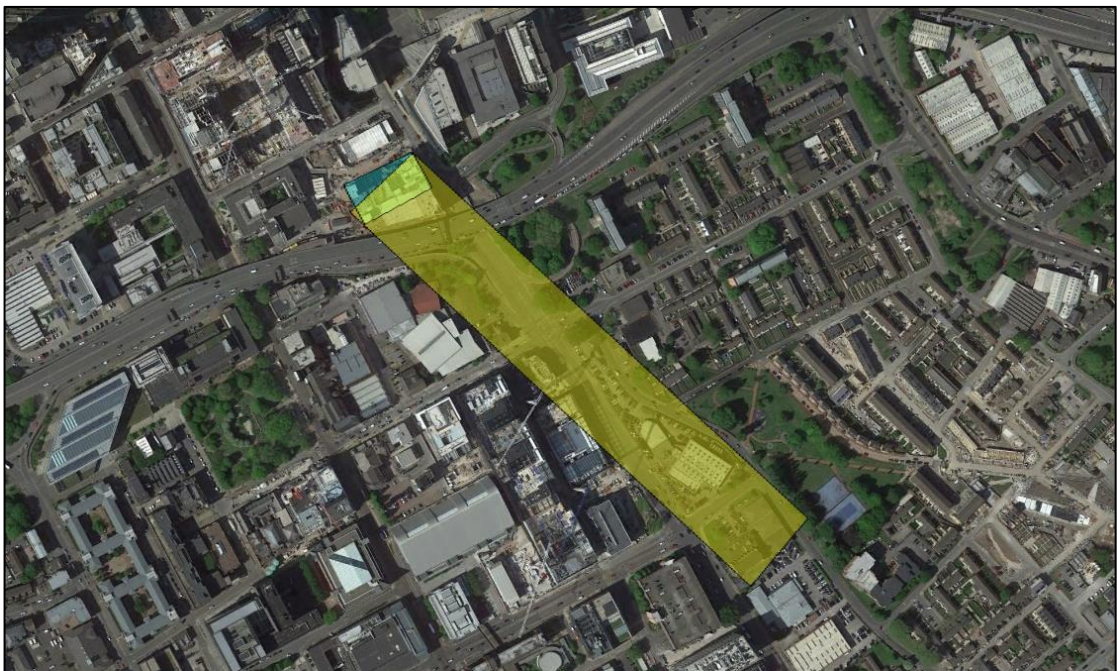
Figure 6 Zone of interest for interference reports (plot 14)

If interference to local multiplexes was to be reported in the shadow zone for Circle Square within approximately 500m of the building, the reported effects should be evaluated in the context of the survey results. It would be good practice to arrange for a local aerial installer to visit the reported interference location if the affected channels corresponded to one of the weaker multiplexes. The zone in which interference reports should be considered the most carefully is illustrated in Figure 6 below<sup>5</sup>.

It is considered unlikely that such reports will be raised because noticeable effects are not predicted.

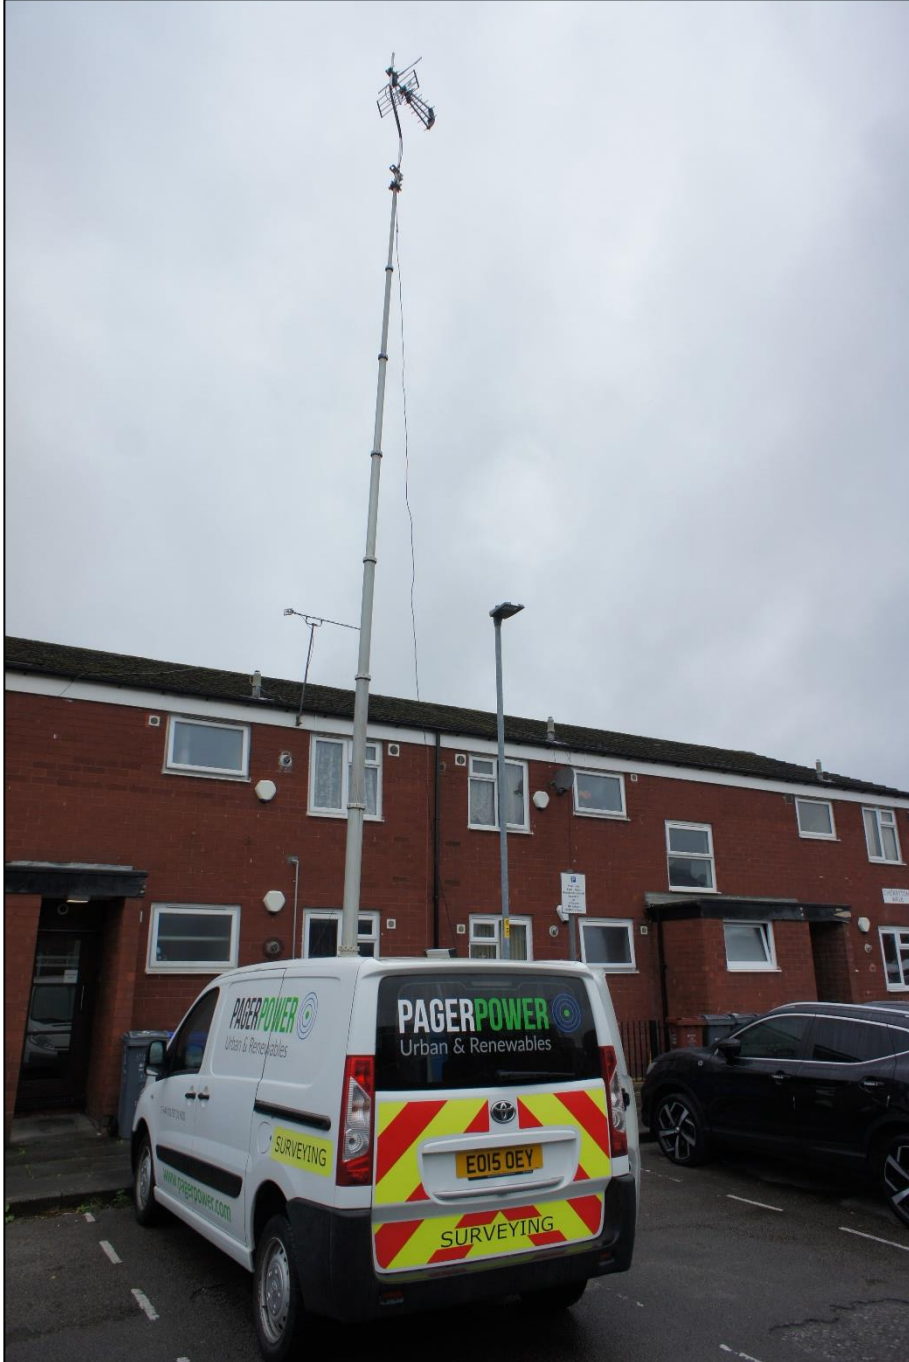
## Location 4 – Plot 14

| Location | Approximate distance from development (km) | Results summary | Conclusions |
|---|---|---|---|
| 4<br>(Plot 14) | 0.9 | All multiplexes were received with good picture and audio quality. | The development was not found to be having a noticeable effect on receivers in the area because all channels remain available. |

Notes: HP UHF aerials directed towards Winter Hill were observed.

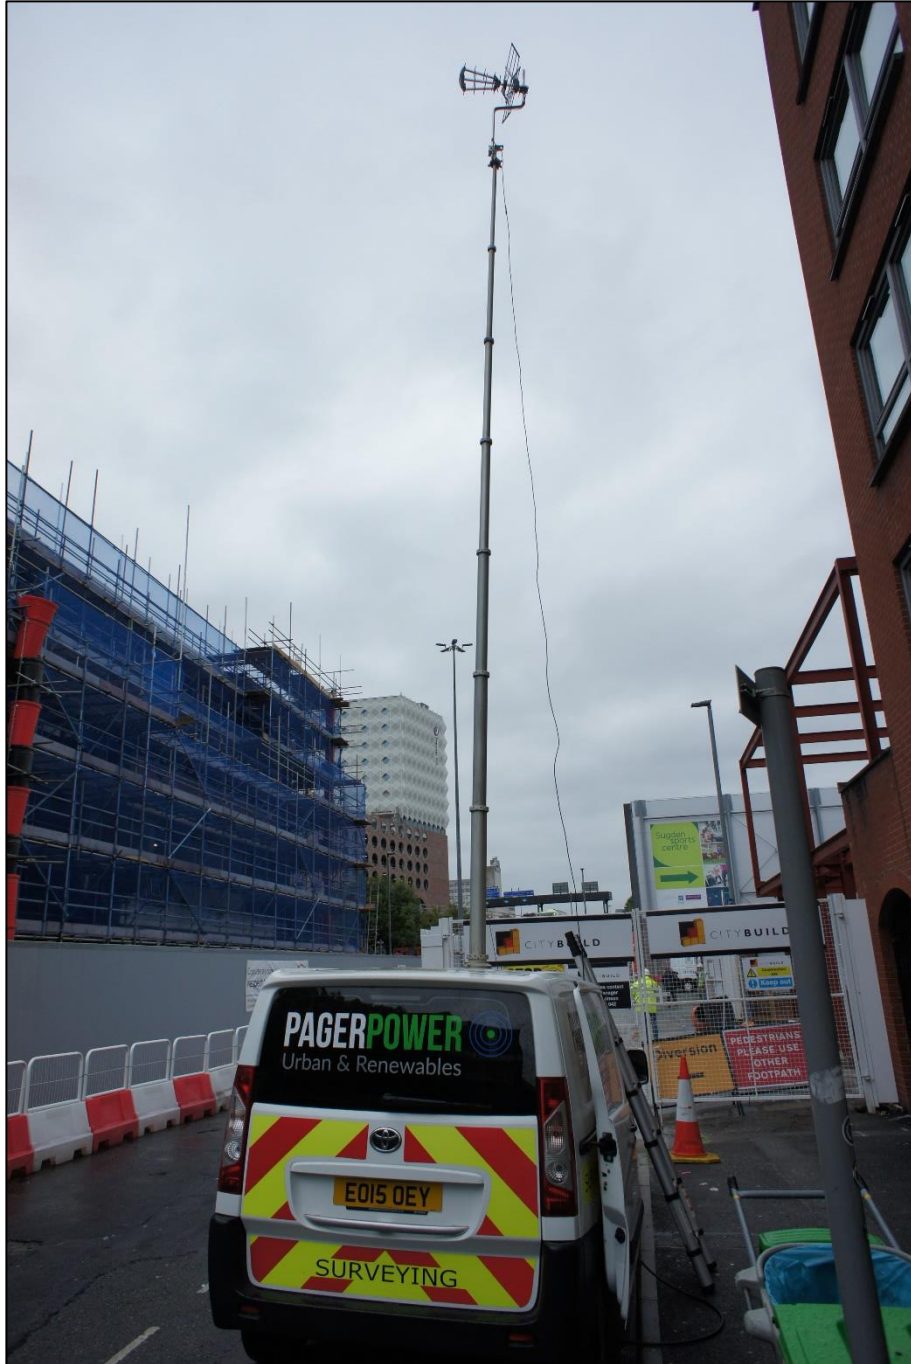
Location 1 – Plots 2, 3 and 4

| Location | Approximate distance from development (km) | Results summary | Conclusions |
|---|---|---|---|
| 1<br>(Plots 2, 3 and 4) | 0.2 | Six multiplexes were received with good picture and audio quality. Four multiplexes were not decoded, including two that appeared to be local channels broadcast at lower power. | <p>One of the local channels in particular shows variable reliability in the city centre.</p> <p>The overall signal strength and channel availability appears slightly reduced when compared with historical measurements around this location.</p> <p>The development is likely a contributor to reduced signal strength at this location, and may not be having a noticeable effect on receivers in the area.</p> |
