# Television Baseline Survey Report

## Crown Street Phase 2

December, 2019

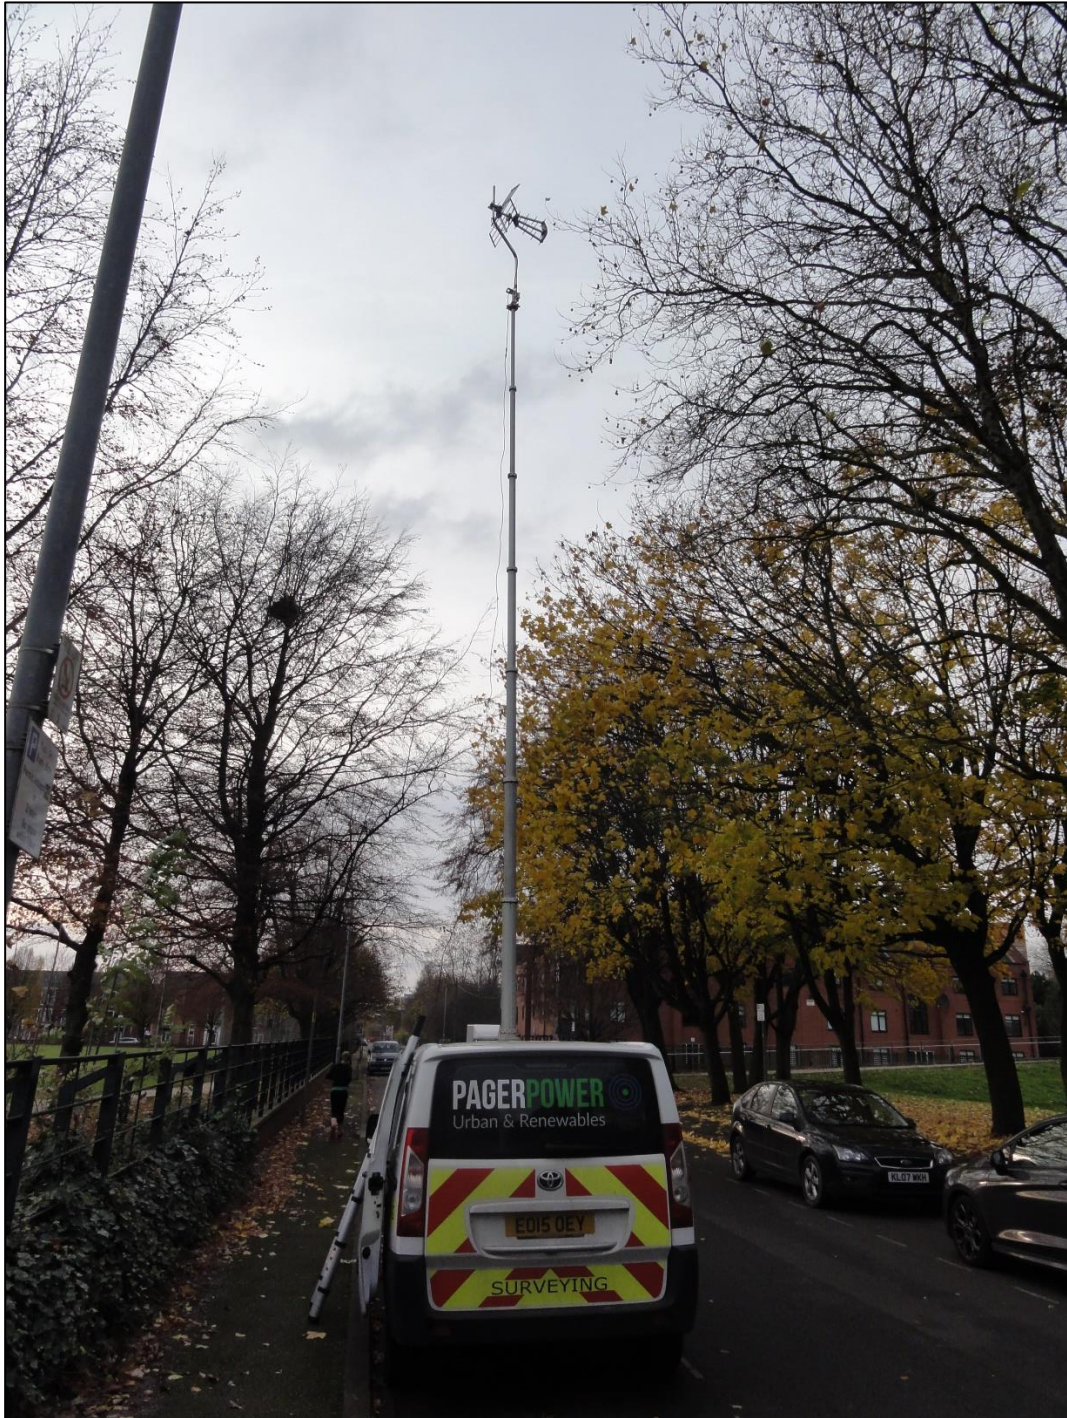
### Location 1

| Location | Average Measured Signal Strength (dB) | Remarks | High Level Conclusion |
|---|---|---|---|
| 1 | Main TV MUX: 45 (Moderate)<br>Local TV MUX: 37 (Moderate) | <p>Aerials were not observed at this survey location.</p> <p>One main and two local multiplexes were not received at this location. Another local multiplex showed intermittent interference. The remaining multiplexes displayed fine picture and audio quality, with signal fluctuations of less than 1dB and no signs of interference.</p> | <p>The survey location is within 200m of the closest of the Proposed Development.</p> <p>Effects are possible based on the proximity to the Proposed Development. This could depend on the relative height of the building development and any receiving aerials.</p> |

Notes: UHF aerials were not observed at this location. The survey aerial was screened by a nearby tree.

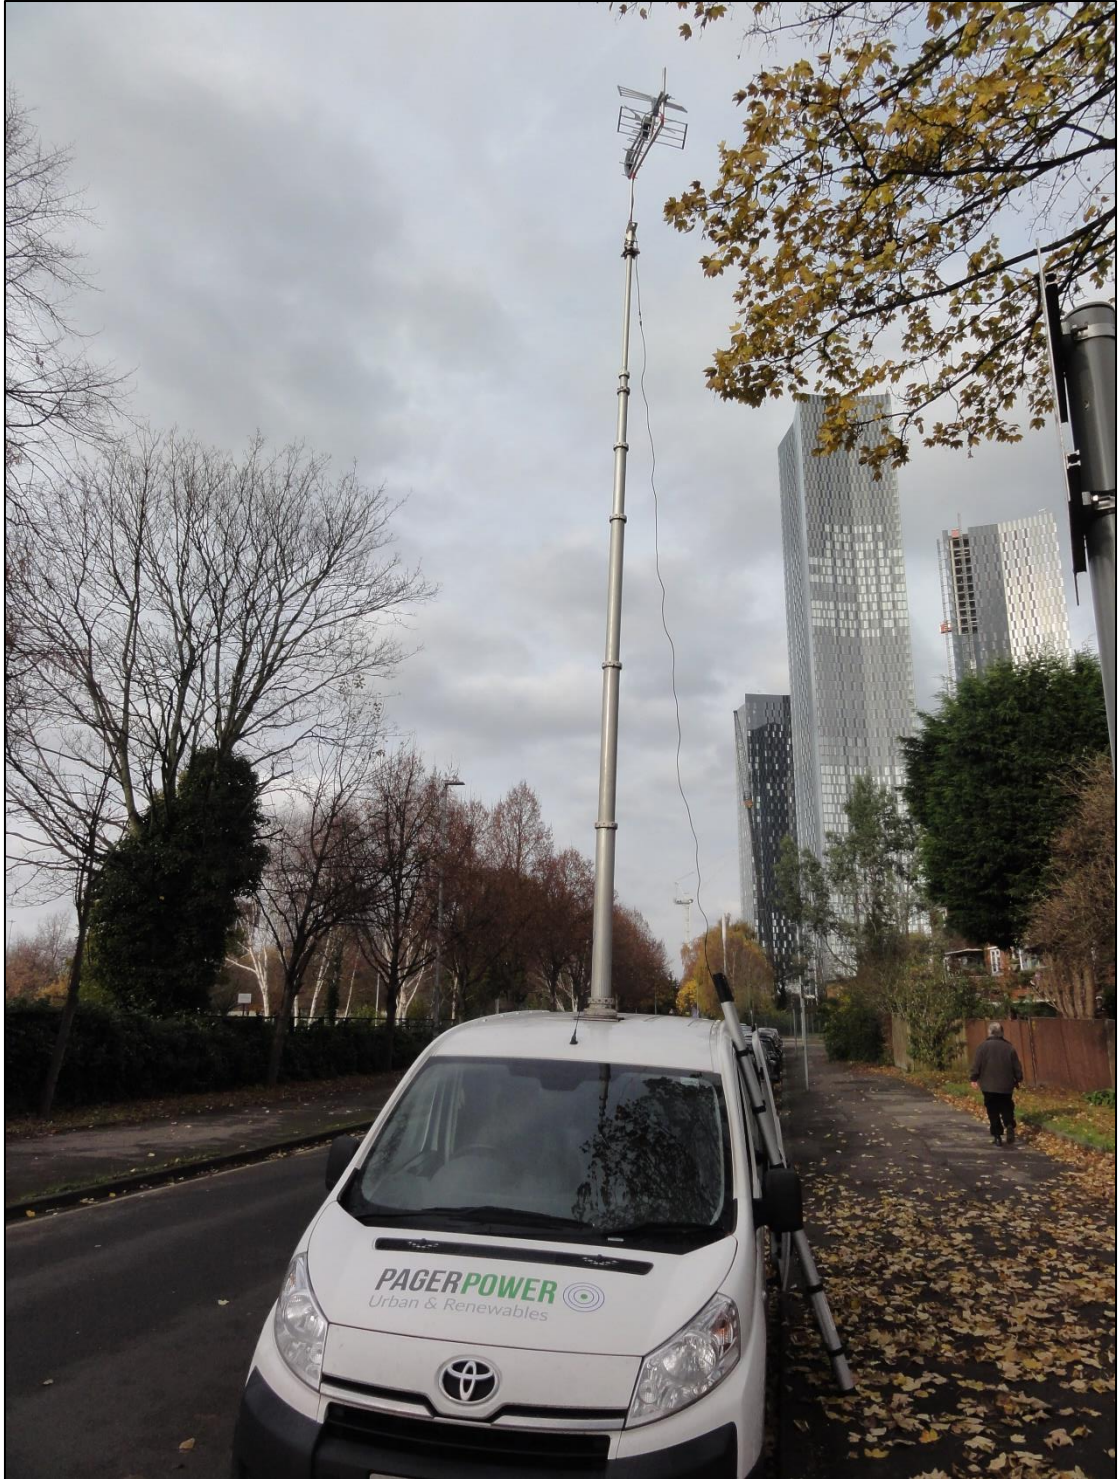
Location 2

| Location | Average Measured Signal Strength (dB) | Remarks | High Level Conclusion |
|---|---|---|---|
| 2 | <p>Main TV MUX: 60 (Very Good)</p> <p>Local TV MUX: 44 (Moderate)</p> | <p>Horizontally polarised aerials directed towards the Winter Hill transmitter and satellite dishes were observed. The survey aerial was not at its maximum height due to trees at the survey location.</p> <p>All main multiplexes displayed fine picture and audio quality, with signal fluctuations of less than 1dB and no signs of interference.</p> <p>One local multiplex was not decoded at this location.</p> | <p>The survey location is within 400m of the closest of the Proposed Development.</p> <p>The existing signal strength is high, particularly for the main multiplexes, however effects are possible at this range.</p> |

Notes: UHF aerials directed towards the Winter Hill transmitter were observed. The survey aerial was not fully erected due to a tree at the survey location.

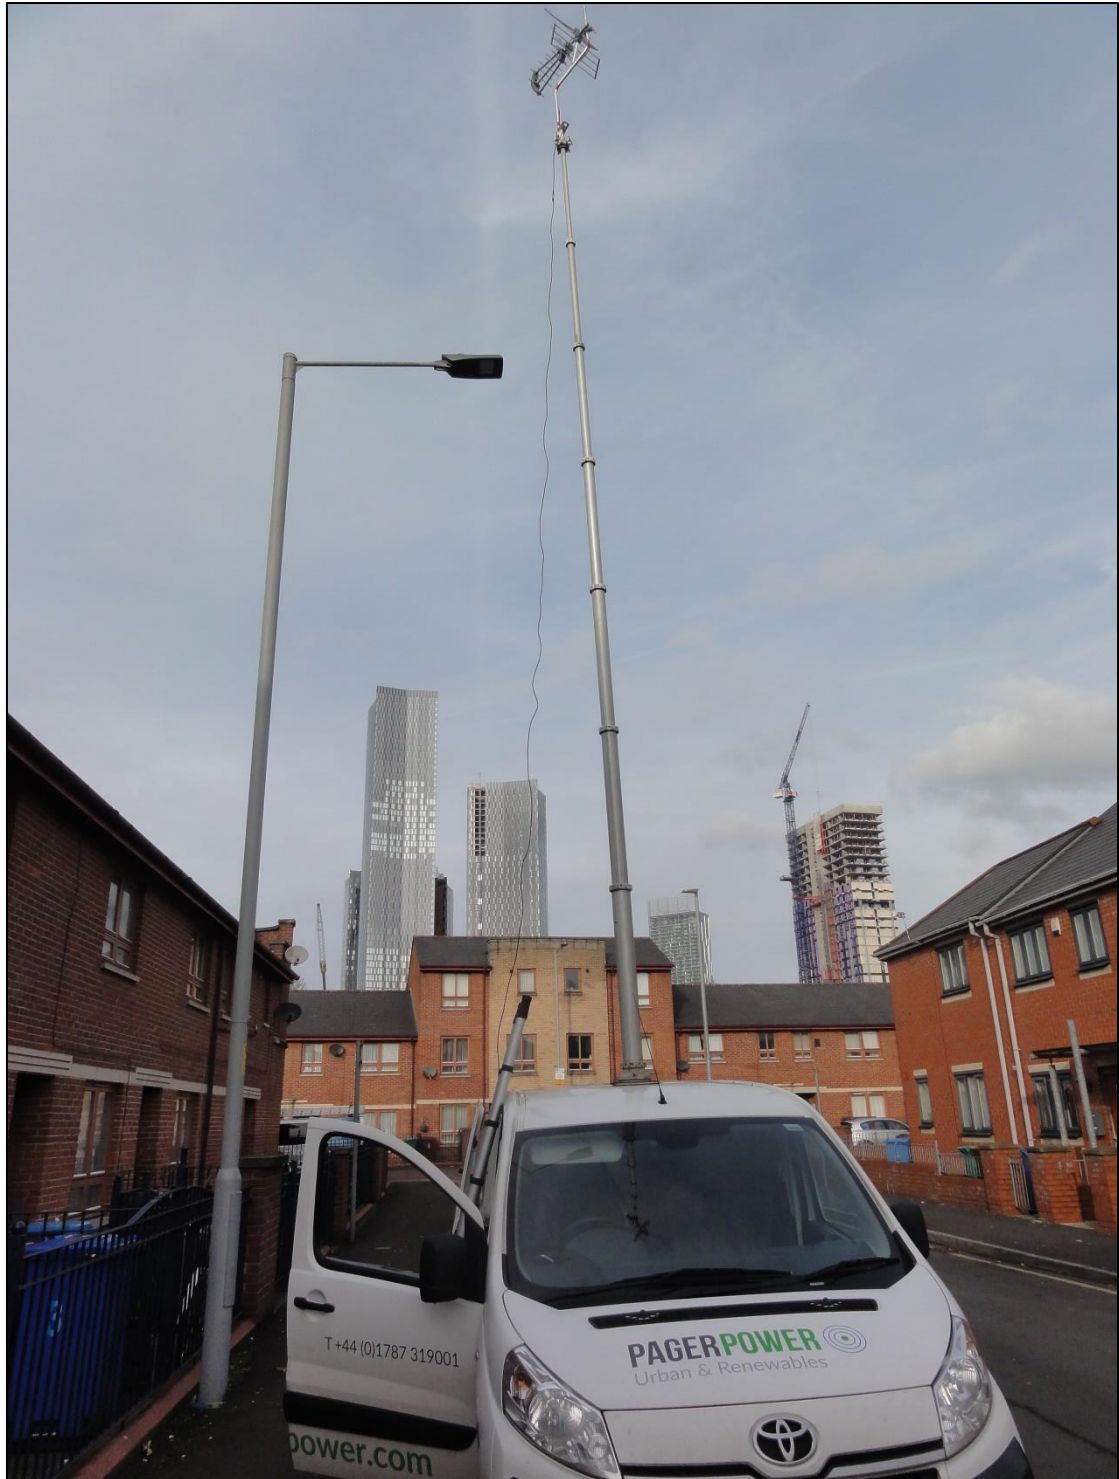
Location 3

| Location | Average Measured Signal Strength (dB) | Remarks | High Level Conclusion |
|---|---|---|---|
| 3 | <p>Main TV MUX: 51 (Good)</p> <p>Local TV MUX: 41 (Moderate)</p> | <p>Horizontally polarised aerials directed towards the Winter Hill transmitter and many satellite dishes were observed.</p> <p>All main multiplexes displayed fine picture and audio quality, with signal fluctuations of less than 1dB and no signs of interference.</p> <p>Two local multiplexes were not decoded at this location.</p> | <p>The survey location is approximately 500 m of the closest of the Proposed Development.</p> <p>It is possible that the signal will be affected at this range, which could be noticeable for the channels of moderate strength.</p> |

Notes: UHF aerials directed towards the Winter Hill transmitter and many satellite dishes were observed.

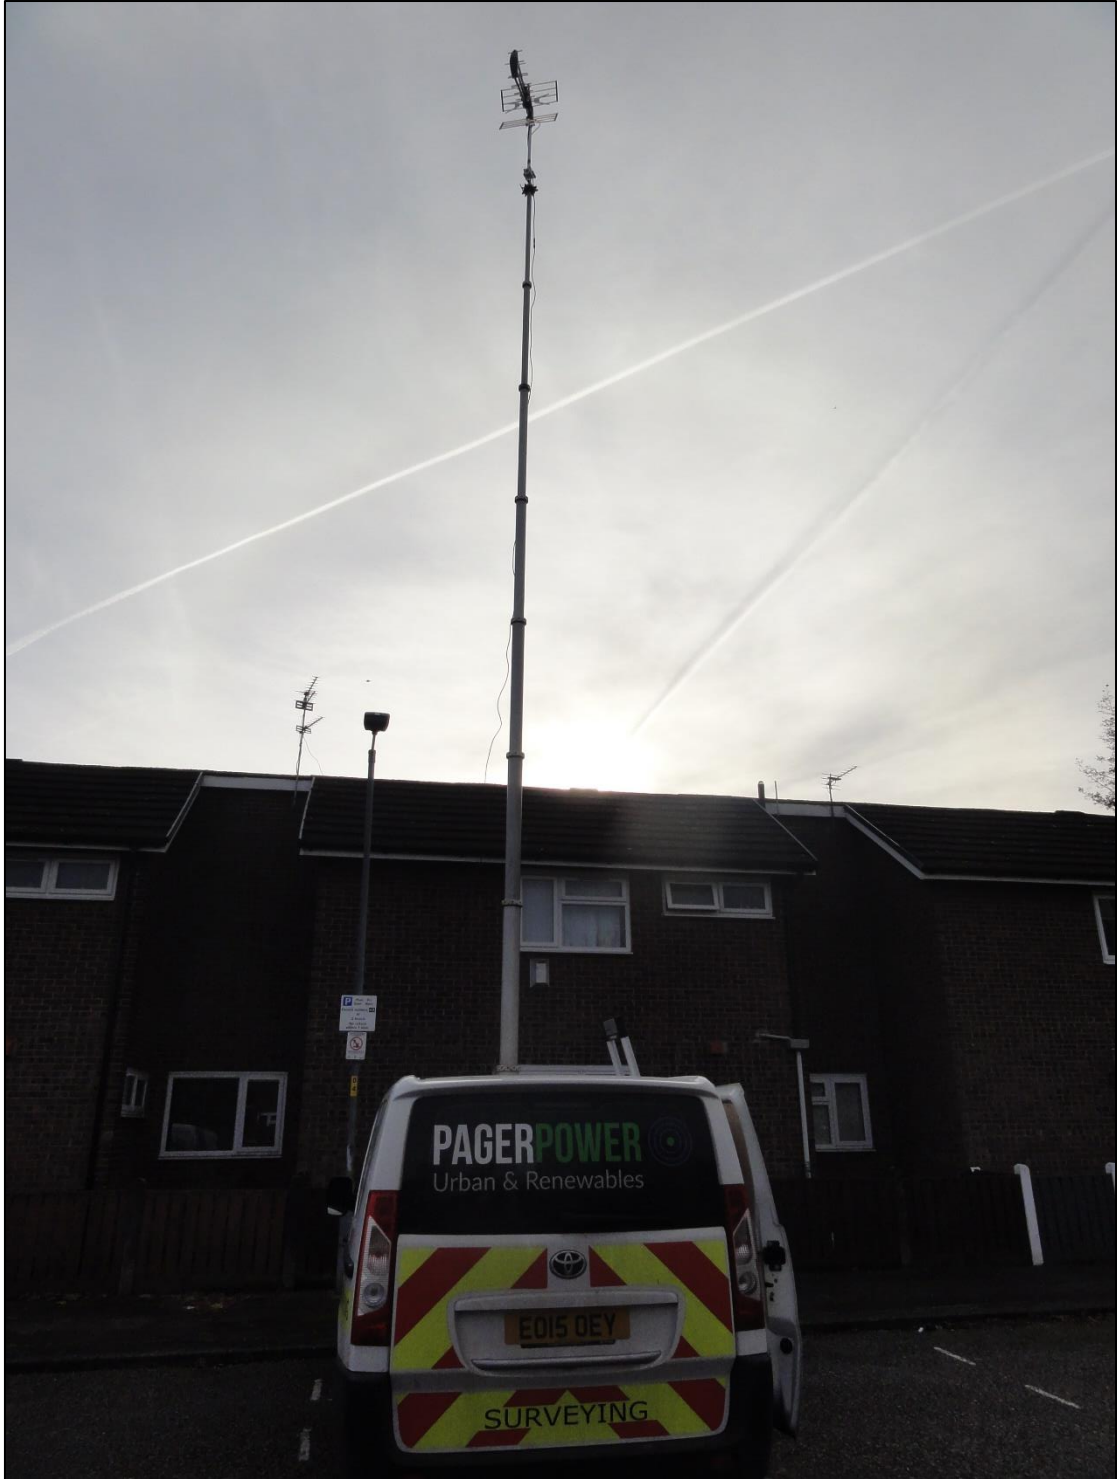
Location 4

| Location | Average Measured Signal Strength (dB) | Remarks | High Level Conclusion |
|---|---|---|---|
| 4 | <p>Main TV MUX: 47 (Good)</p> <p>Local TV MUX: 39 (Moderate)</p> | <p>Horizontally polarised aerials directed towards the Winter Hill transmitter and satellite dishes were observed.</p> <p>All main multiplexes displayed fine picture and audio quality, with signal fluctuations of less than 1dB and no signs of interference.</p> <p>Two local multiplexes were not decoded at this location.</p> | <p>The survey location is more than 1 km from the Proposed Development.</p> <p>It is unusual for significant signal degradation to manifest itself at ranges of more than 1 km.</p> <p>Significant interference is unlikely, however the possibility cannot be ruled out, particularly for the weakest multiplexes.</p> |

Notes: UHF aerials directed towards the Winter Hill transmitter and many satellite dishes were observed.

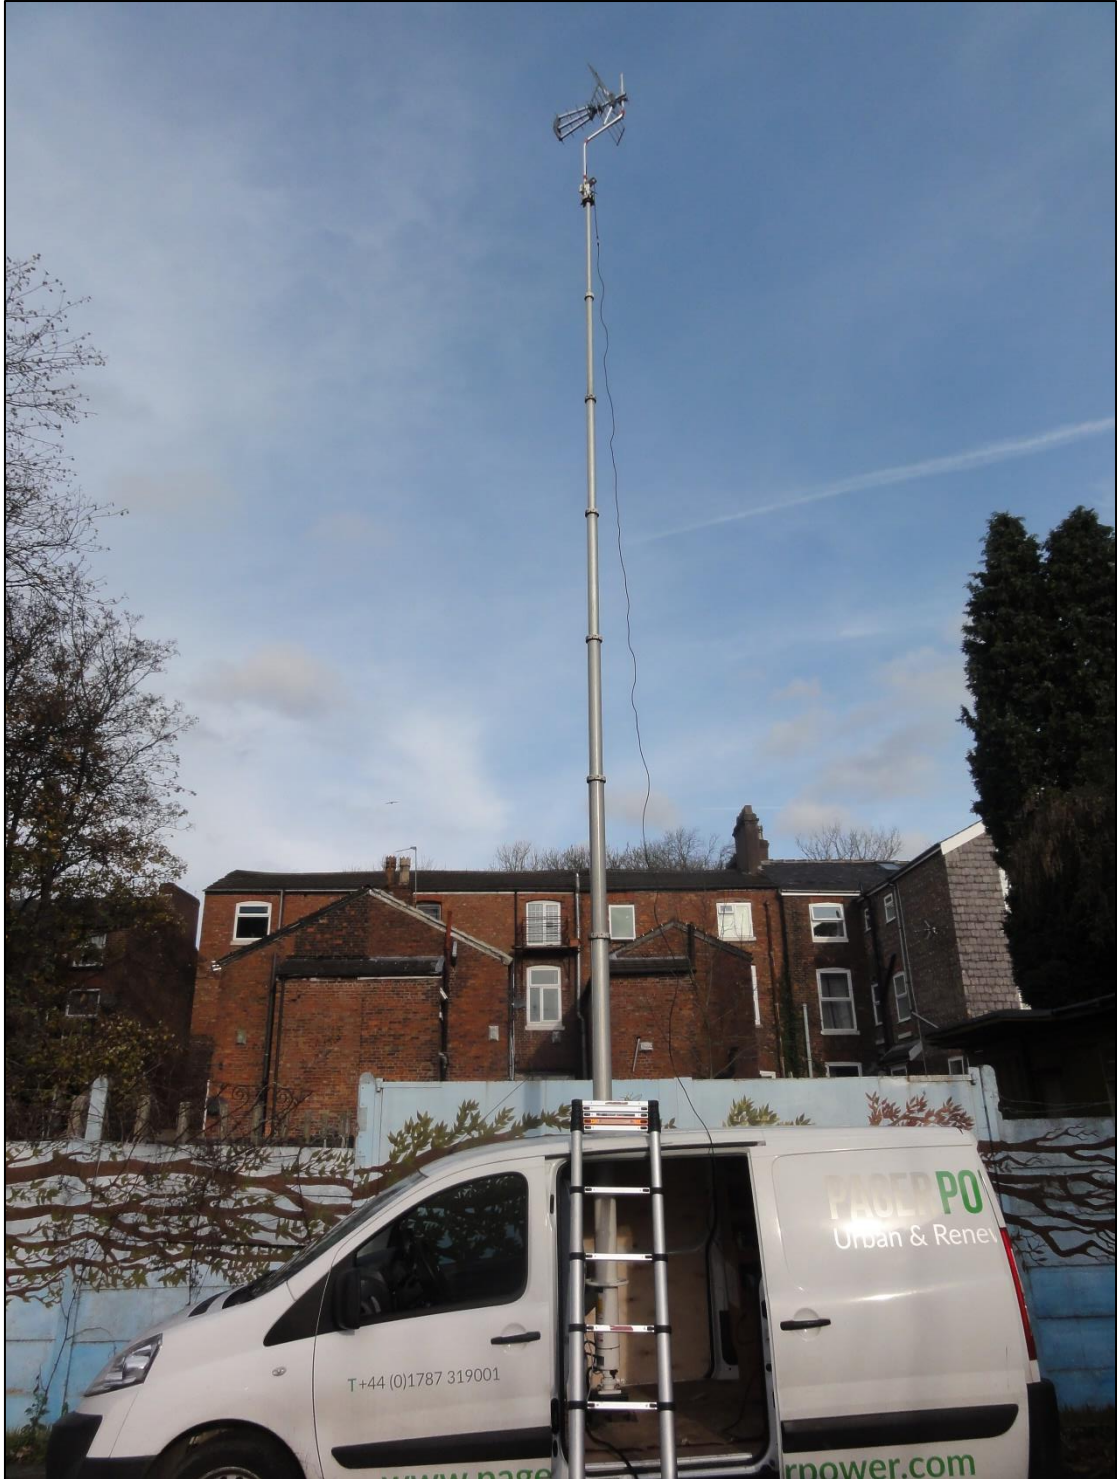
Location 5

| Location | Average Measured Signal Strength (dB) | Remarks | High Level Conclusion |
|---|---|---|---|
| 5 | <p>Main TV MUX: 58 (Very Good)</p> <p>Local TV MUX: 38 (Moderate)</p> | <p>Horizontally polarised aerials directed towards the Winter Hill transmitter and many satellite dishes were observed.</p> <p>All main multiplexes displayed fine picture and audio quality, with signal fluctuations of less than 1dB and no signs of interference.</p> <p>One local multiplex was not decoded at this location.</p> | <p>It is unlikely that significant losses would be experienced at this location (approximately 2.2km from the Proposed Development) considering the existing signal strength and distance. Impacts are unlikely.</p> |

Notes: UHF aerials directed towards the Winter Hill transmitter and many satellite dishes were observed.

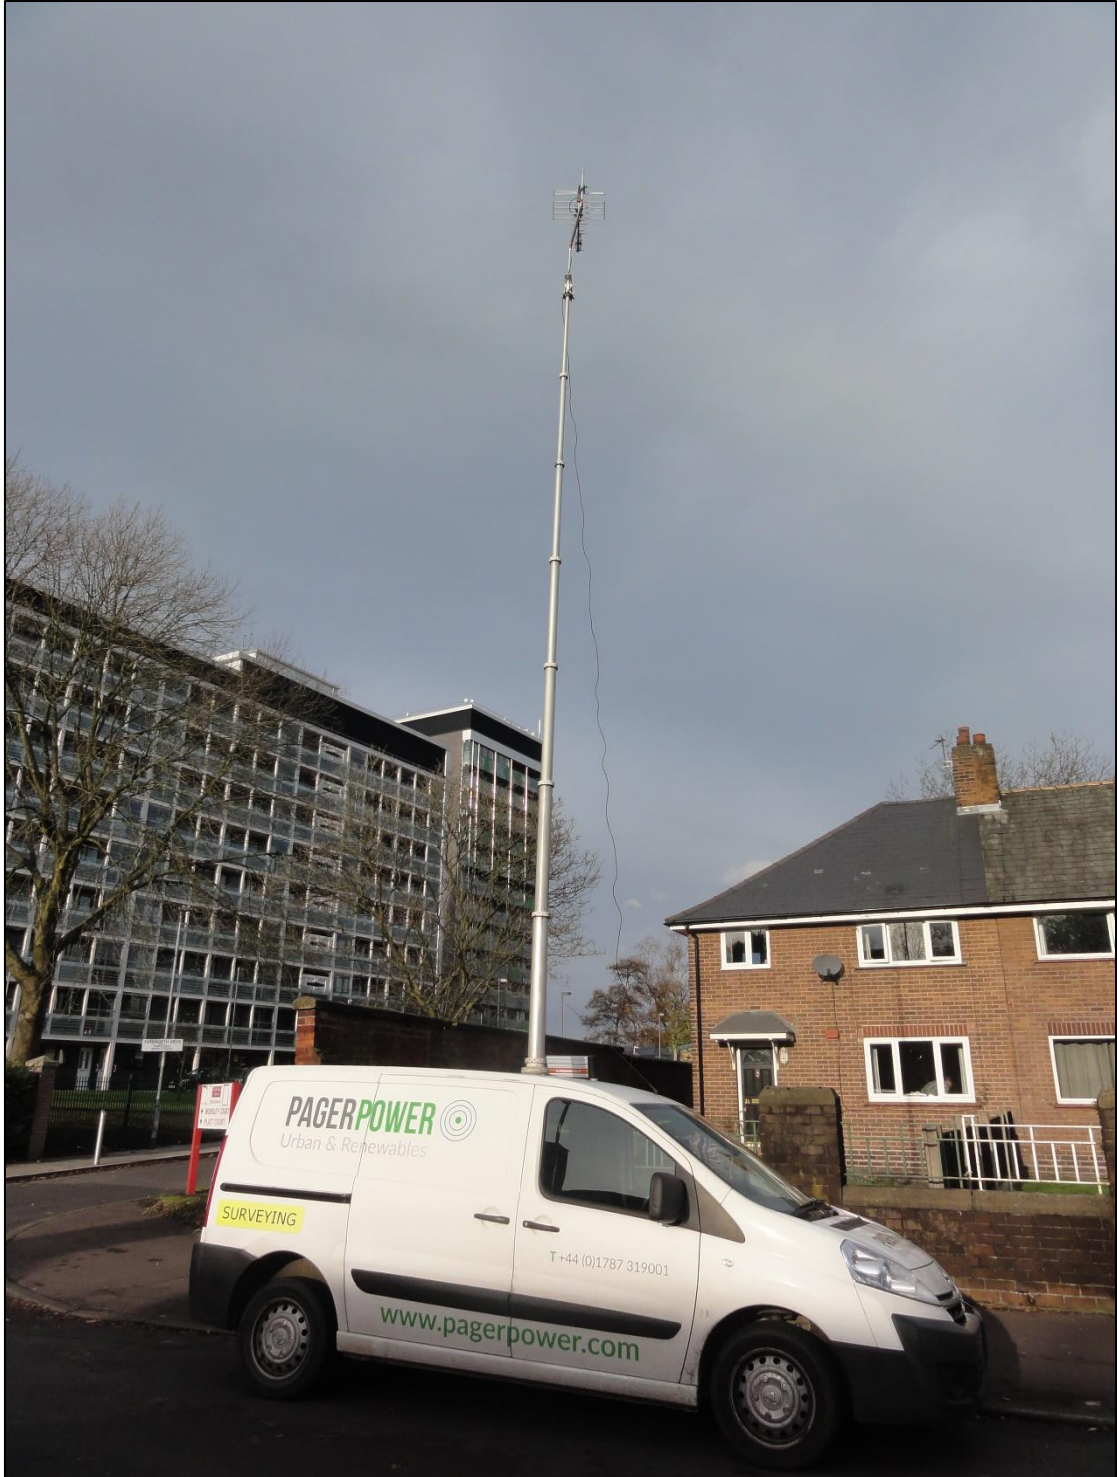
Location 6

| Location | Average Measured Signal Strength (dB) | Remarks | High Level Conclusion |
|---|---|---|---|
| 6 | <p>Main TV MUX: 70<br/>(Very Good)</p> <p>Local TV MUX: 52<br/>(Good)</p> | <p>Horizontally polarised<br/>aerials directed<br/>towards the Winter<br/>Hill transmitter and<br/>satellite dishes were<br/>observed.</p> <p>All main multiplexes<br/>displayed fine picture<br/>and audio quality, with<br/>signal fluctuations of<br/>less than 1dB and no<br/>signs of interference.</p> <p>One local multiplex<br/>was not decoded at<br/>this location.</p> | <p>It is unlikely that noticeable<br/>losses would occur at the outer<br/>extremities (3.3 km) of the<br/>shadow zone. No interference is<br/>predicted.</p> |

Notes: UHF aerials directed towards the Winter Hill transmitter and satellite dishes were observed.

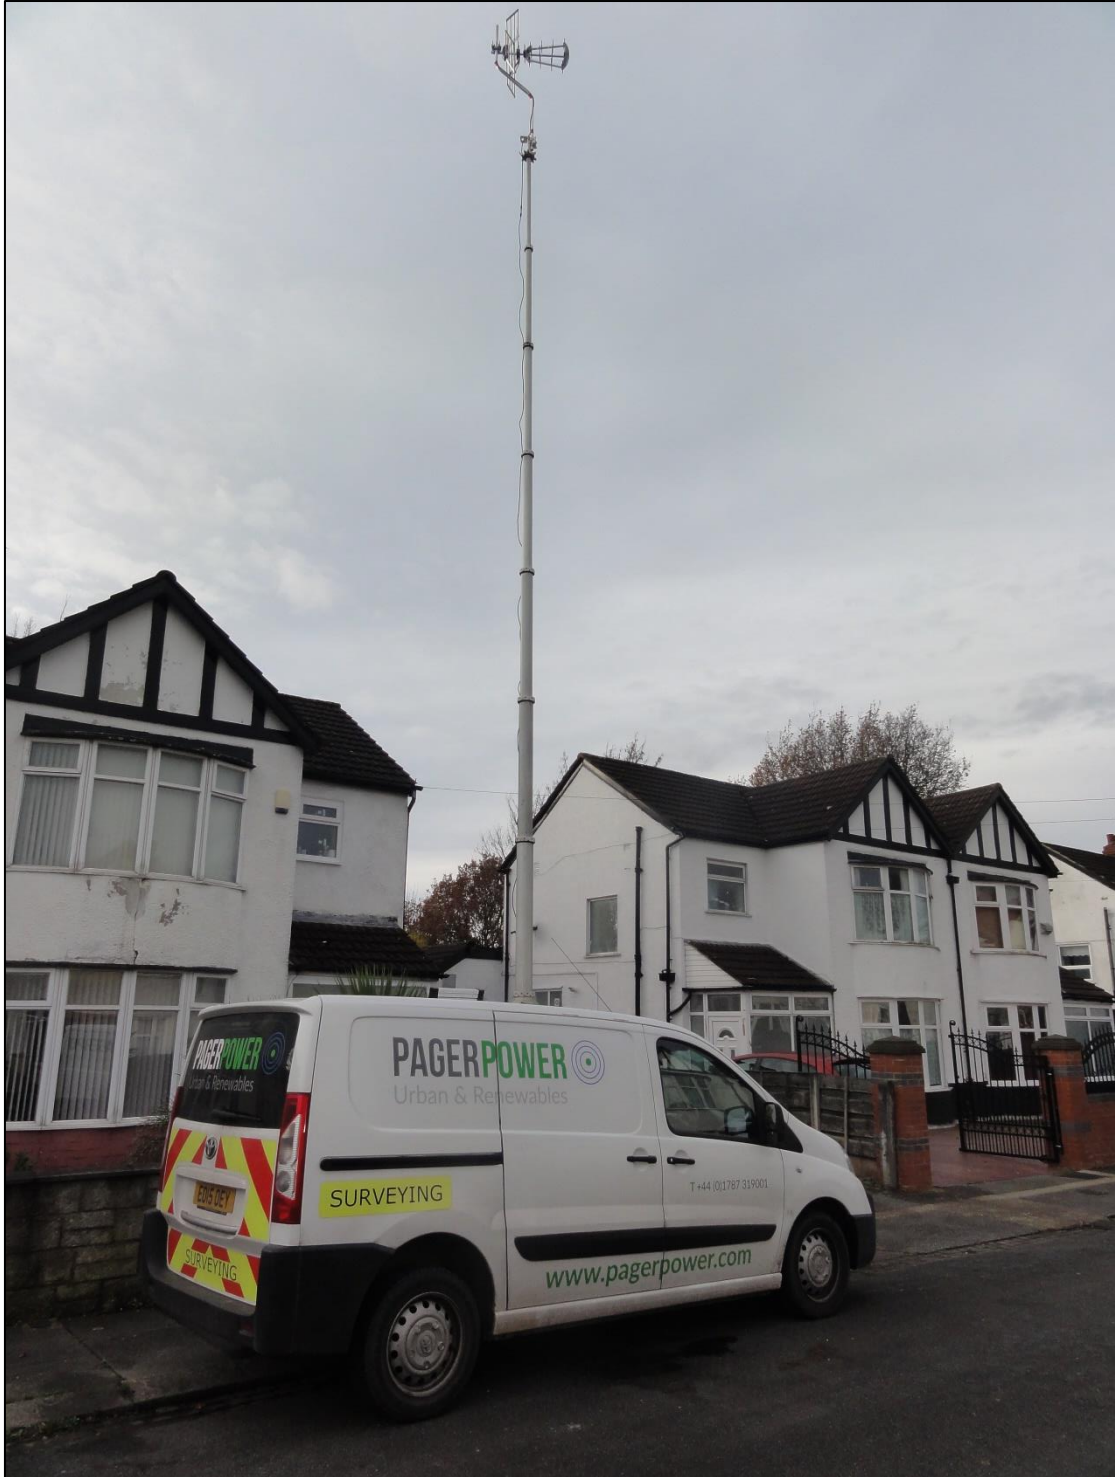
Location 7

| Location | Average Measured Signal Strength (dB) | Remarks | High Level Conclusion |
|---|---|---|---|
| 7 | <p>Main TV MUX: 68<br/>(Very Good)</p> <p>Local TV MUX: 50<br/>(Good)</p> | <p>Horizontally polarised<br/>aerials directed<br/>towards the Winter<br/>Hill transmitter and<br/>some satellite dishes<br/>were observed.</p> <p>All main multiplexes<br/>displayed fine picture<br/>and audio quality, with<br/>signal fluctuations of<br/>less than 1dB and no<br/>signs of interference.</p> <p>One local multiplex<br/>was not decoded at<br/>this location.</p> | <p>It is unlikely that noticeable<br/>losses would occur at the outer<br/>extremities (4.8 km) of the<br/>shadow zone. No interference is<br/>predicted.</p> |

Notes: UHF aerials directed towards the Winter Hill transmitter and some satellite dishes were observed.
