# Television Post-Construction Reception Survey

Circle Square – Plots 2, 3, 4 and 14

September 2020

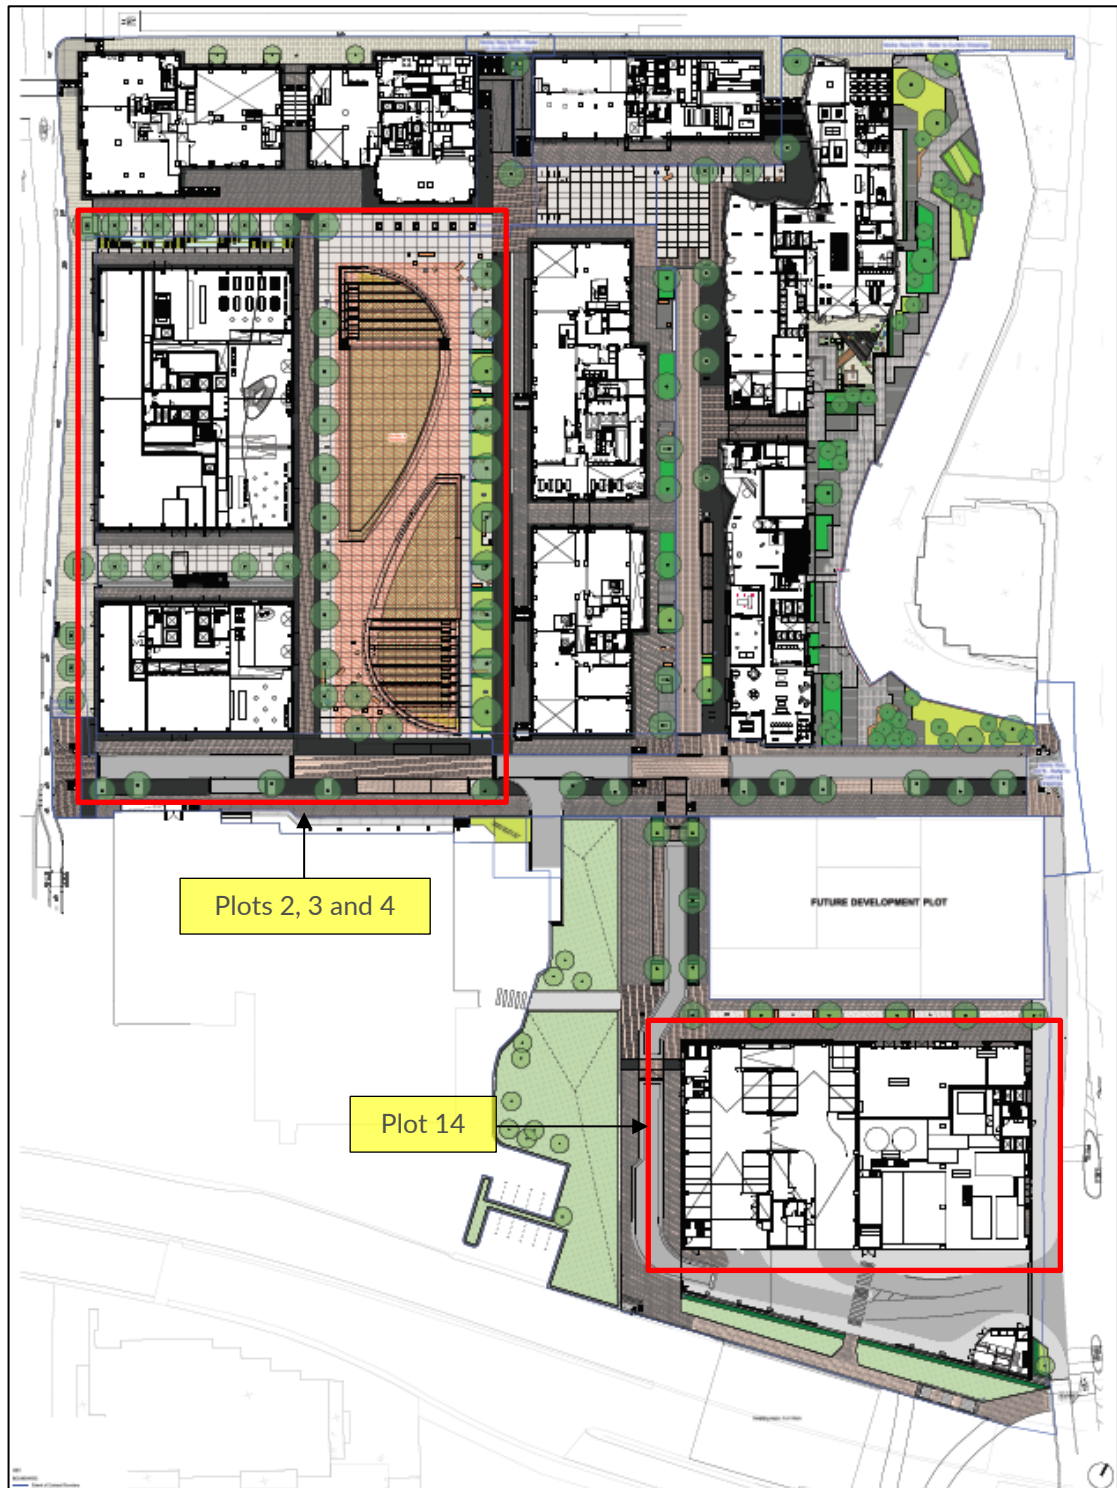
Figure 1 Circle Square site plan

Figure 1 on the following page<sup>1</sup> shows a site plan of Circle Square and highlights the relevant plots.

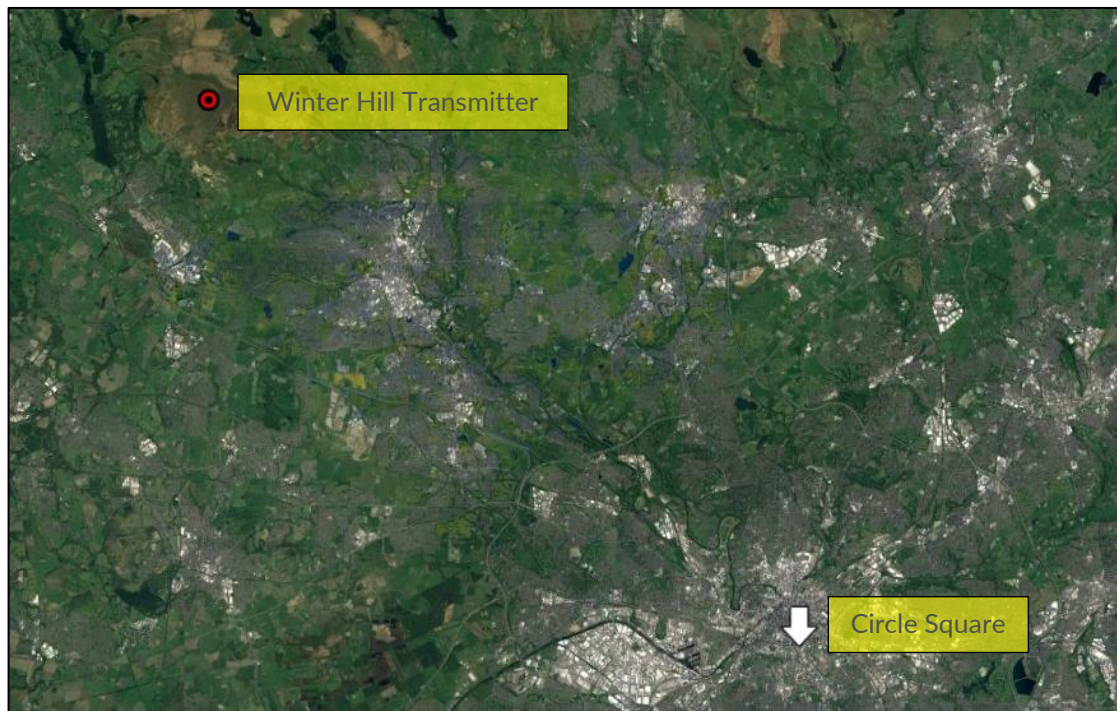
Figure 2 Transmitter and development relative location

Figure 2 below<sup>2</sup> shows the location of the development relative to the transmitter.

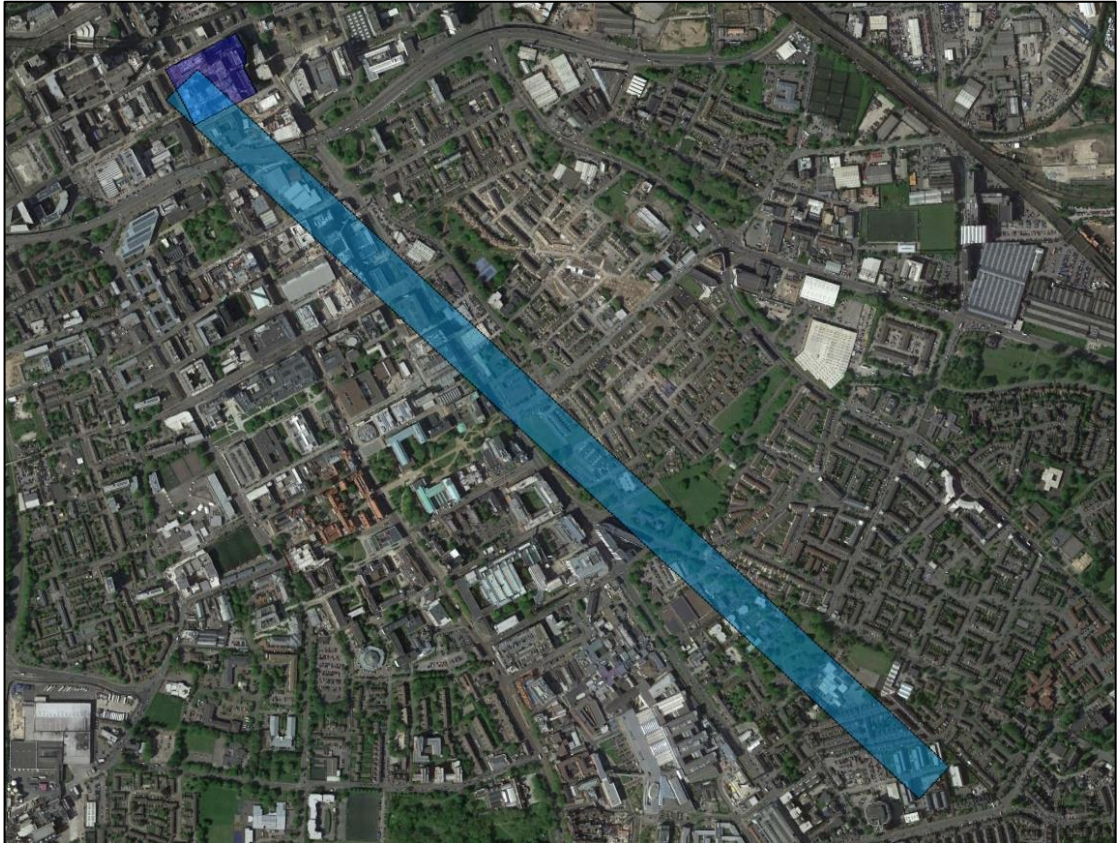
Figure 8 Zone of interest for interference reports (plots 2, 3 and 4)

If interference to local multiplexes was to be reported in the shadow zone for Circle Square within approximately 2 km of the building, the reported effects should be evaluated in the context of the survey results. It would be good practice to arrange for a local aerial installer to visit the reported interference location if the affected channels corresponded to one of the weaker multiplexes. The zone in which interference reports should be considered the most carefully is illustrated in Figure 8 below<sup>7</sup>.

If interference is reported from residential locations within 2 km of Plots 2, 3 and 4 and within their shadow zone (see Section 4), the reported effects should be evaluated in the context of the survey results. It would be good practice to arrange for a local aerial installer to visit the reported interference location if the affected channels corresponded to one of the weaker multiplexes with a view to restoring this if possible.

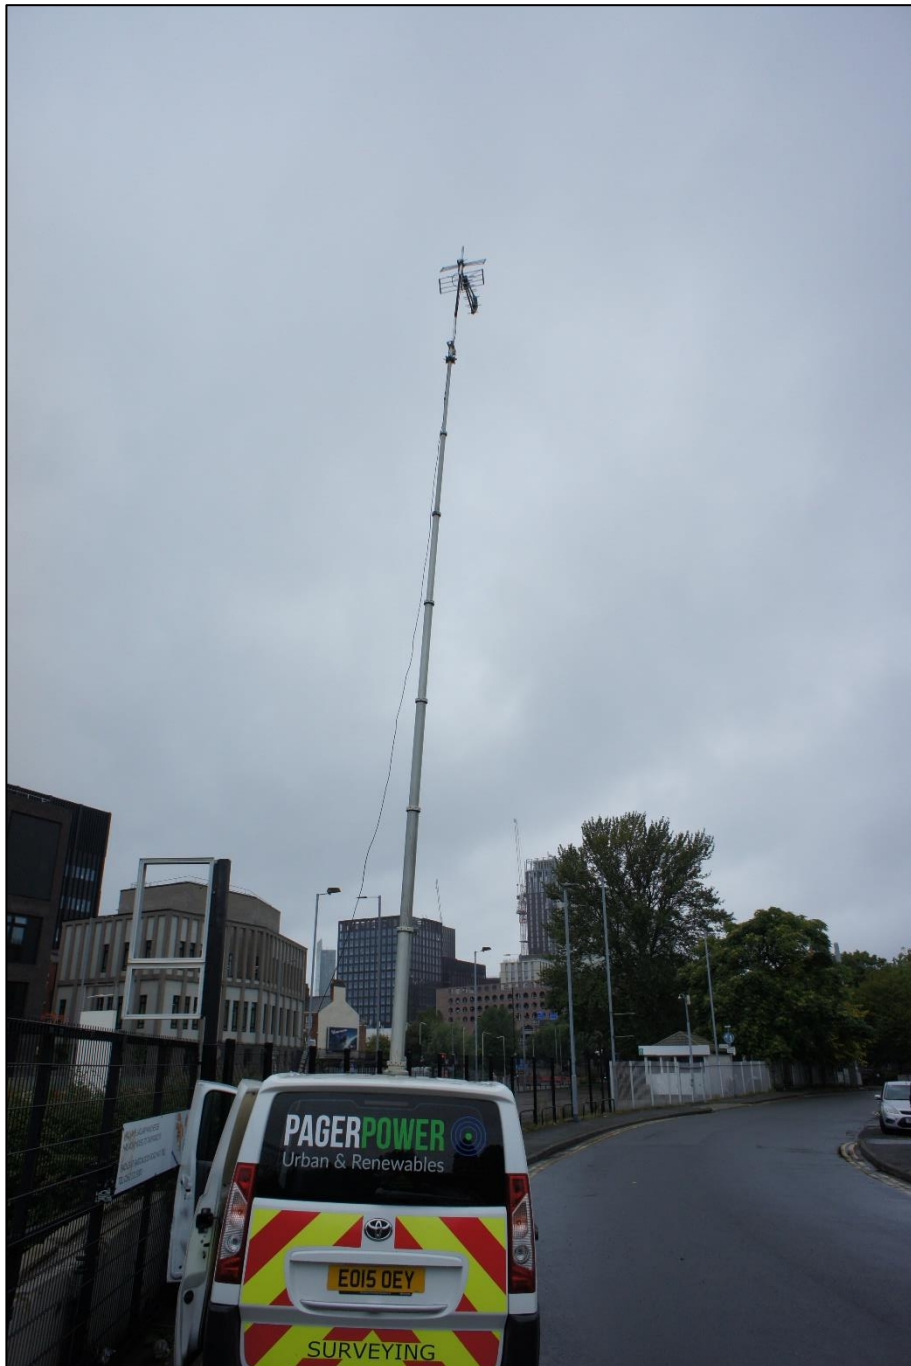
### Location 1 – Plot 14

| Location | Approximate distance from development (km) | Results summary | Conclusions |
|---|---|---|---|
| 1<br>(Plot 14) | 0.3 | Seven multiplexes were received with good picture and audio quality. Three multiplexes were not decoded, including two that appeared to be local channels broadcast at lower power. | <p>One of the local channels in particular shows variable reliability in the city centre.</p> <p>The overall signal strength and channel availability is broadly consistent with historical measurements around this location.</p> <p>The development is likely a contributor to reduced signal strength at this location but may not be having a noticeable effect on receivers in the area.</p> |

Notes: Horizontally Polarized (HP) Ultra-High Frequency (UHF) aeriels directed towards Winter Hill was observed at some distance.

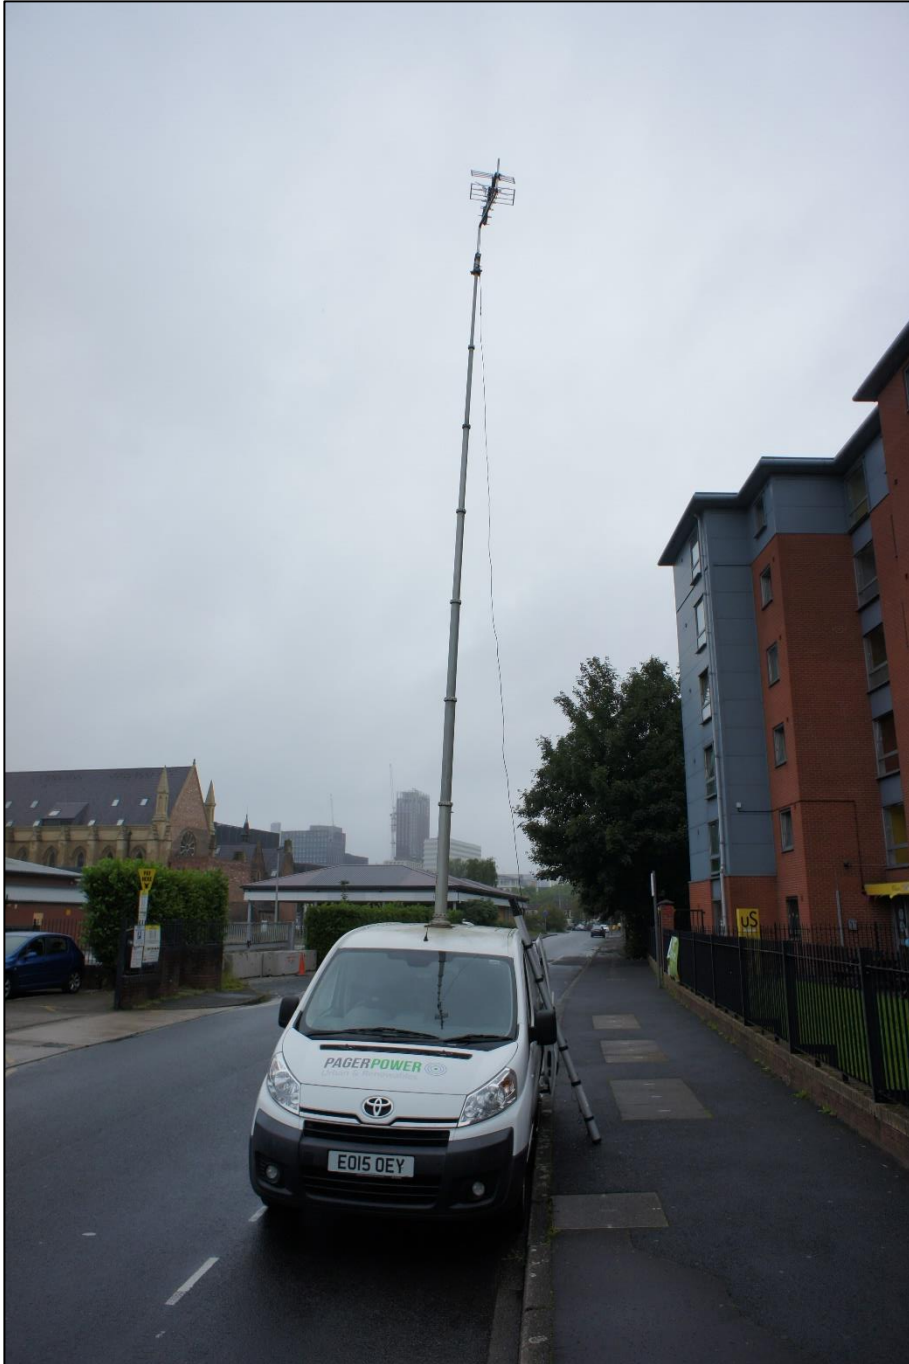
Location 2 – Plot 14

| Location | Approximate distance from development (km) | Results summary | Conclusions |
|---|---|---|---|
| 2<br>(Plot 14) | 0.6 | All multiplexes were received with good picture and audio quality. | The development was not found to be having a noticeable effect on receivers in the area because all channels remain available. |

Notes: HP UHF aerials directed towards Winter Hill were observed.

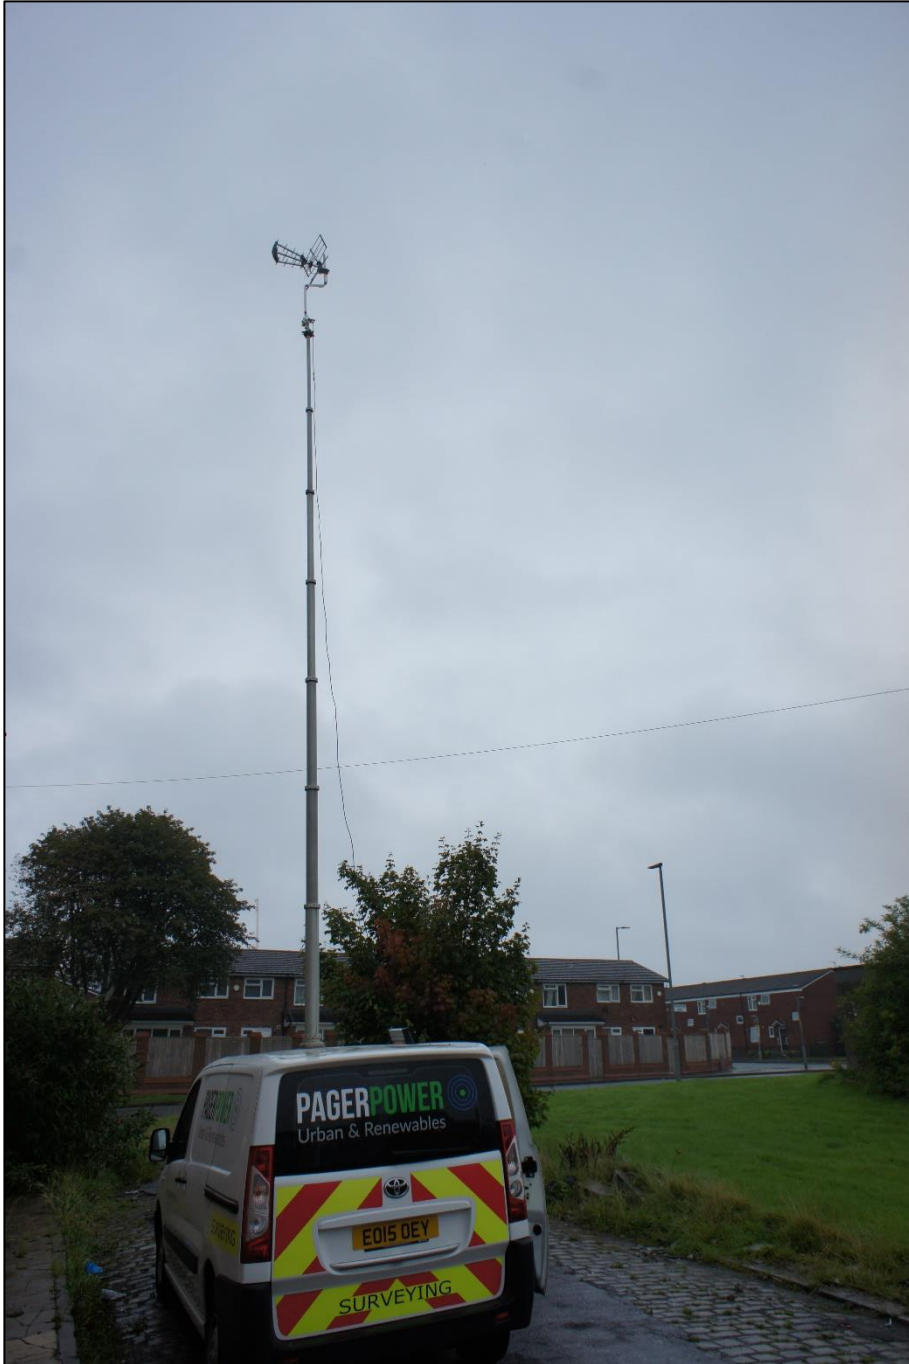
Location 3 – Plot 14

| Location | Approximate distance from development (km) | Results summary | Conclusions |
|---|---|---|---|
| 3<br>(Plot 14) | 0.7 | All multiplexes were received with good picture and audio quality. | The development was not found to be having a noticeable effect on receivers in the area because all channels remain available. |

Notes: HP UHF aerials directed towards Winter Hill were observed.

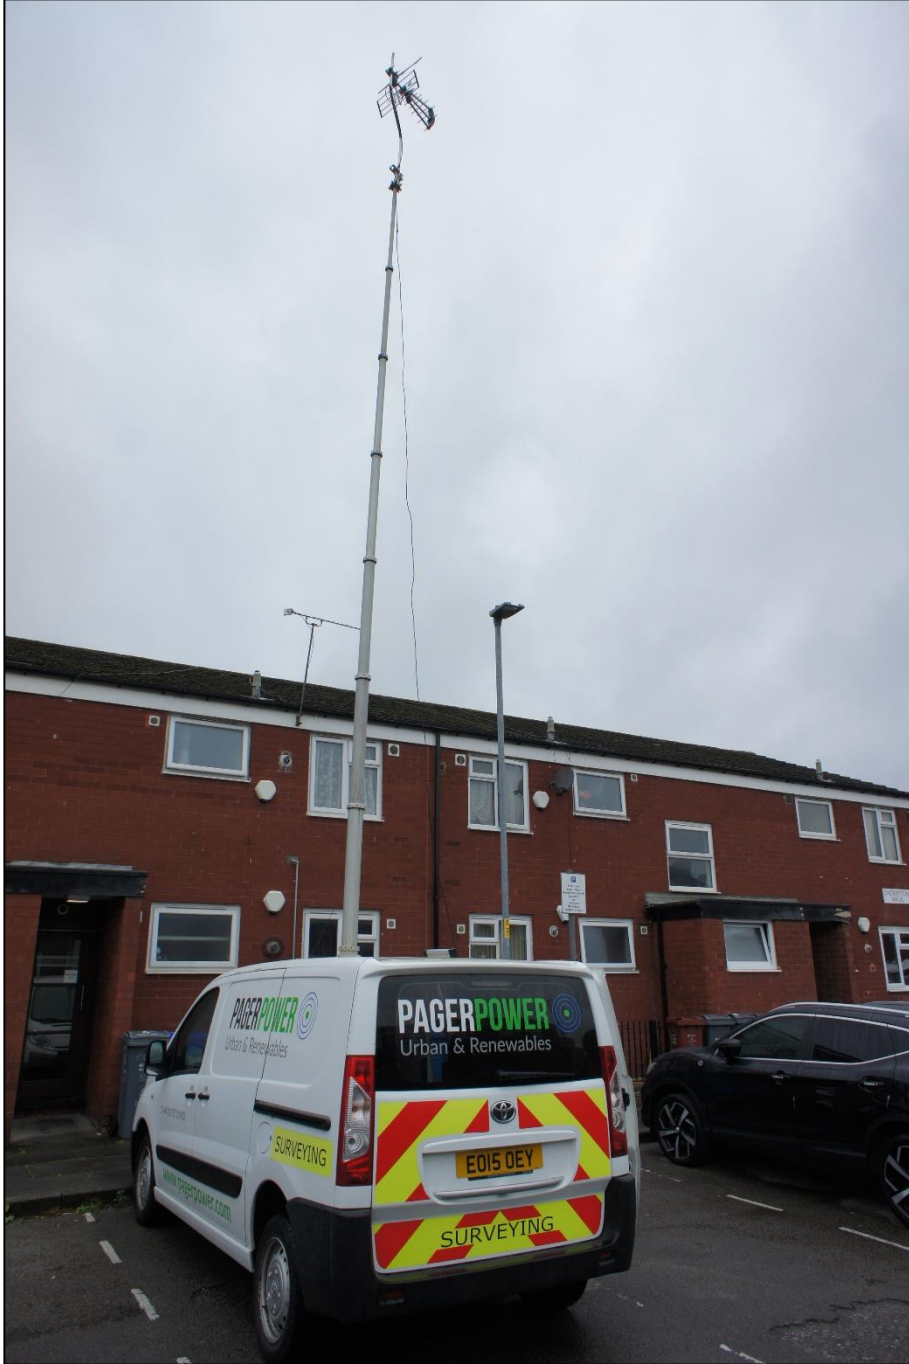
## Location 4 – Plot 14

| Location | Approximate distance from development (km) | Results summary | Conclusions |
|---|---|---|---|
| 4<br>(Plot 14) | 0.9 | All multiplexes were received with good picture and audio quality. | The development was not found to be having a noticeable effect on receivers in the area because all channels remain available. |

Notes: HP UHF aerials directed towards Winter Hill were observed.

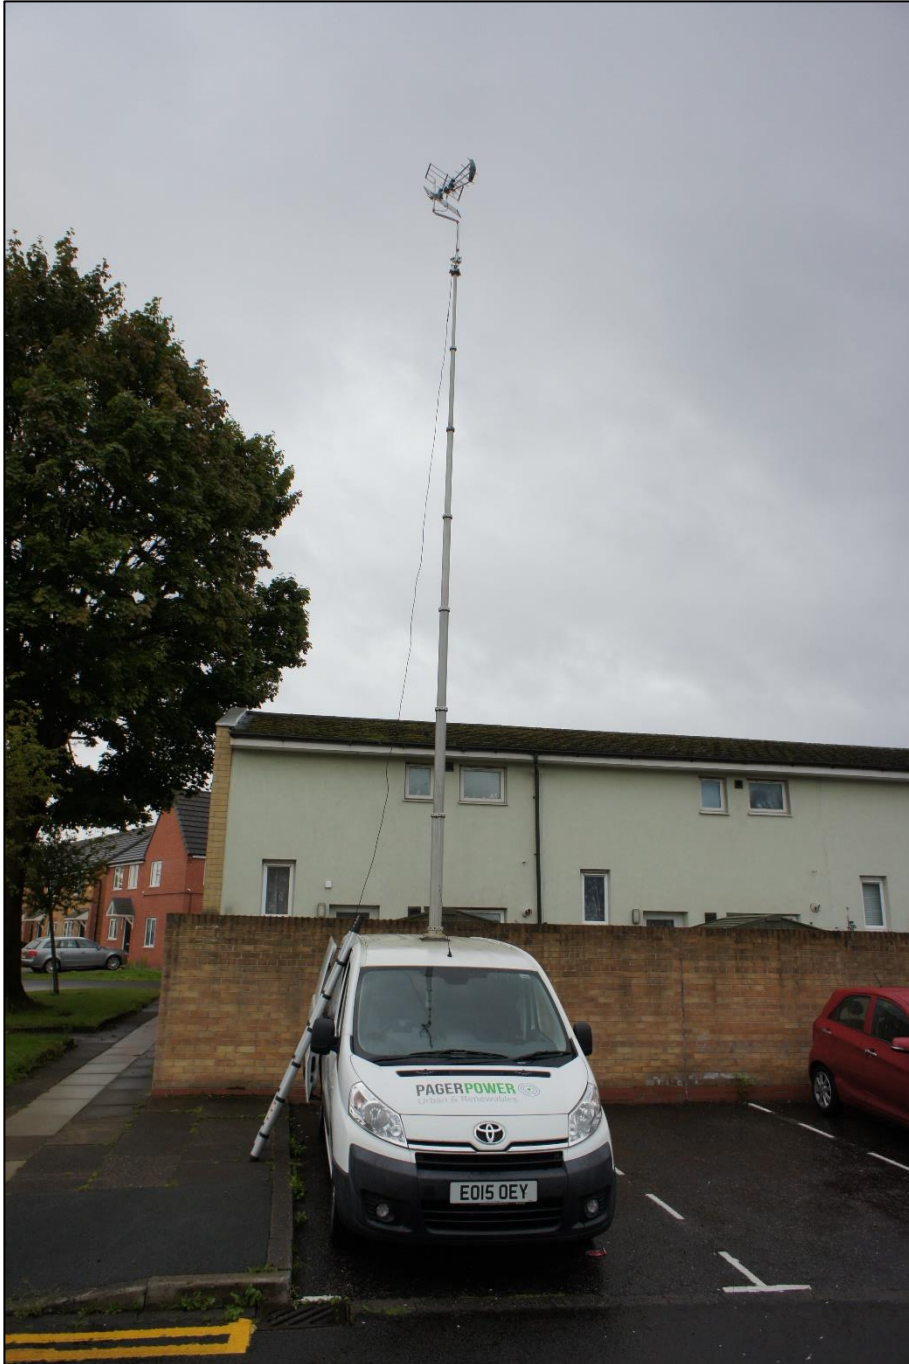
Location 5 – Plot 14

| Location | Approximate distance from development (km) | Results summary | Conclusions |
|---|---|---|---|
| 5<br>(Plot 14) | 1.2 | All multiplexes were received with good picture and audio quality. | The development was not found to be having a noticeable effect on receivers in the area because all channels remain available. |

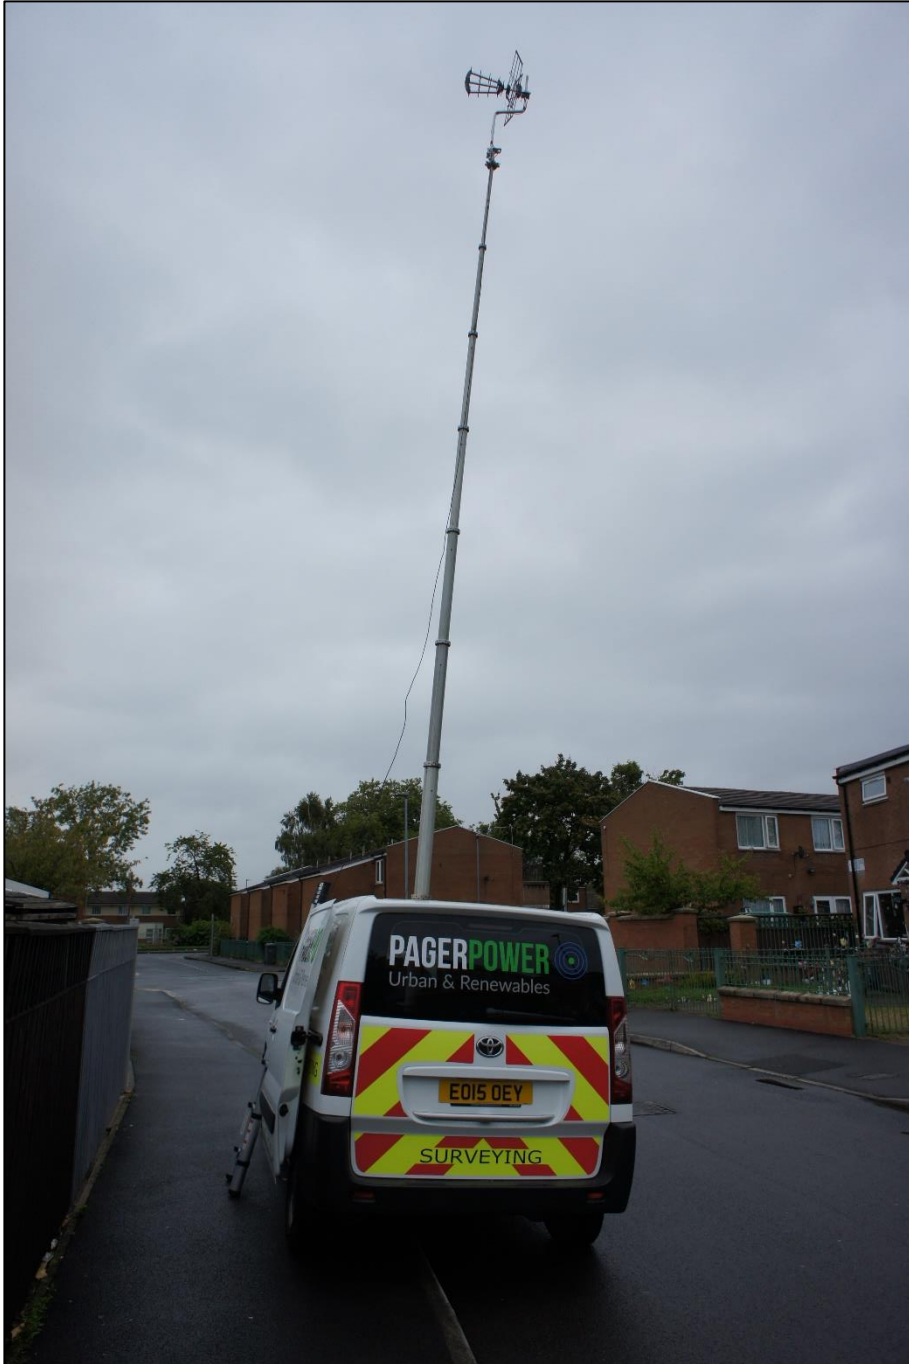
Location 6 – Plot 14

| Location | Approximate distance from development (km) | Results summary | Conclusions |
|---|---|---|---|
| 6<br>(Plot 14) | 1.8 | All multiplexes were received with good picture and audio quality. | The development was not found to be having a noticeable effect on receivers in the area because all channels remain available. |

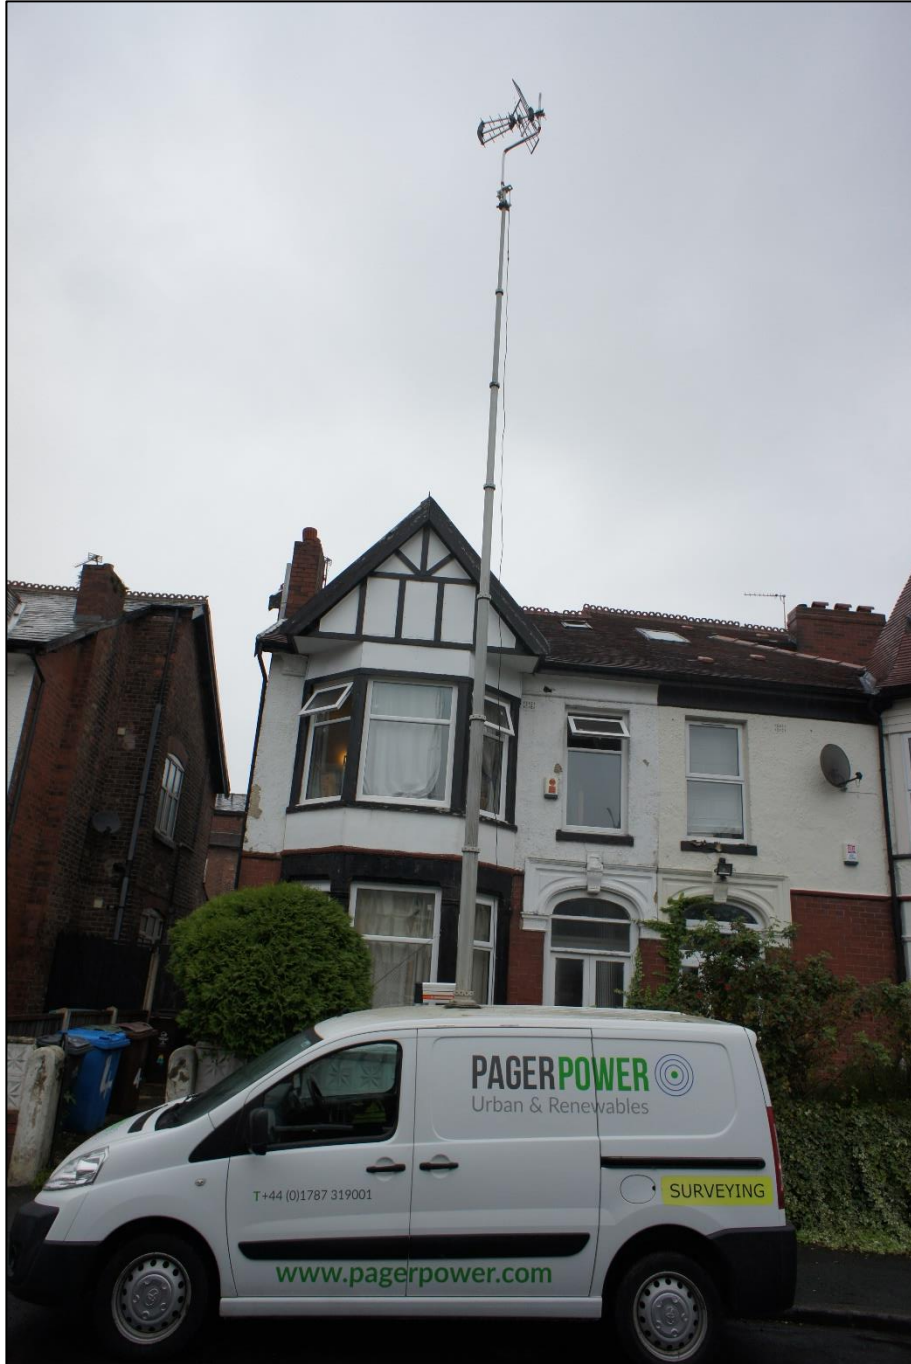
Location 7 – Plot 14

| Location | Approximate distance from development (km) | Results summary | Conclusions |
|---|---|---|---|
| 7<br>(Plot 14) | 2.3 | All multiplexes were received with good picture and audio quality. | The development was not found to be having a noticeable effect on receivers in the area because all channels remain available. |

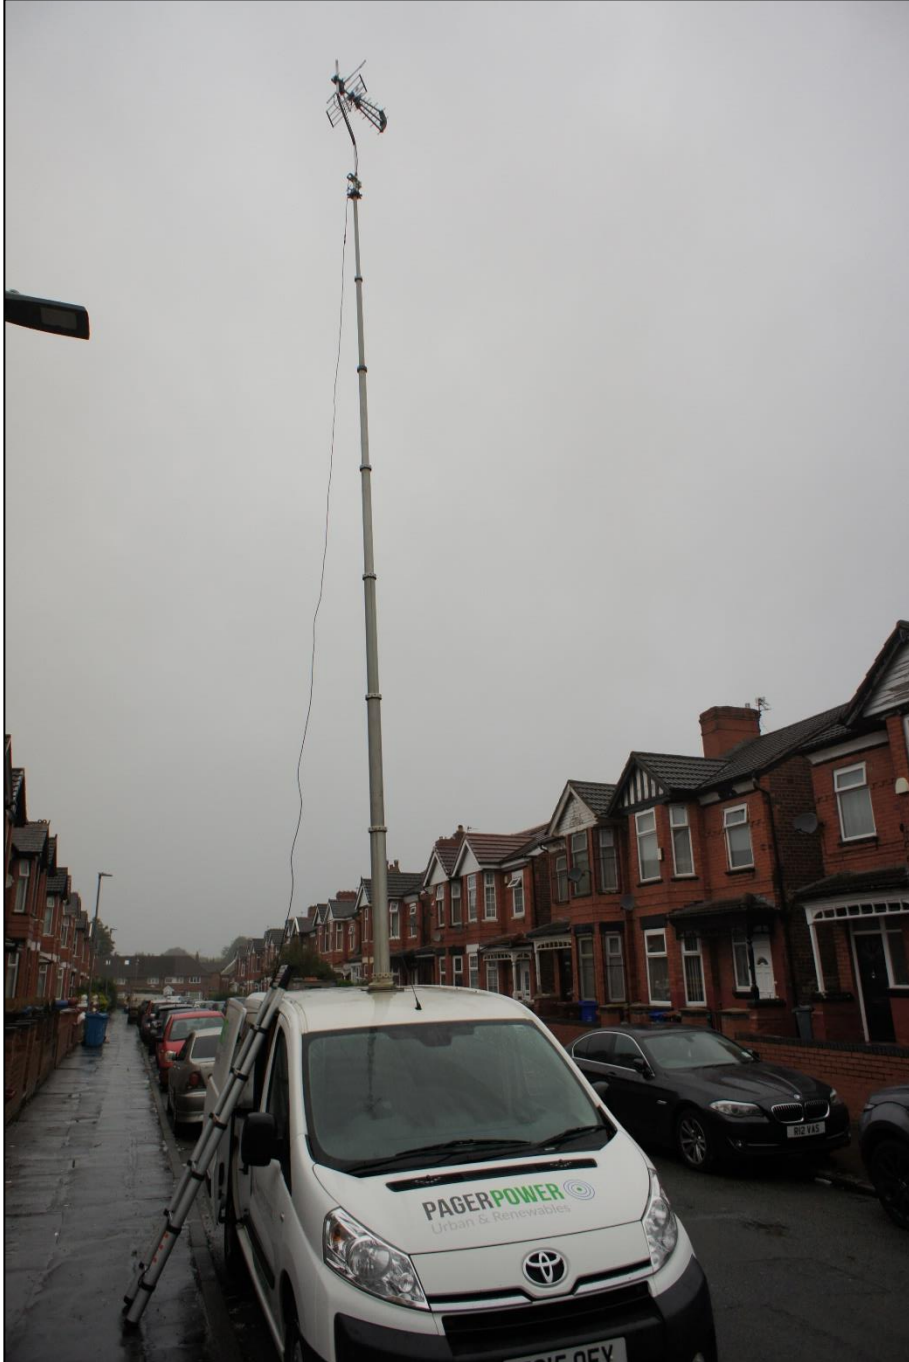
Location 8 – Plot 14

| Location | Approximate distance from development (km) | Results summary | Conclusions |
|---|---|---|---|
| 8<br>(Plot 14) | 3.1 | All multiplexes were received with good picture and audio quality. | The development was not found to be having a noticeable effect on receivers in the area because all channels remain available. |

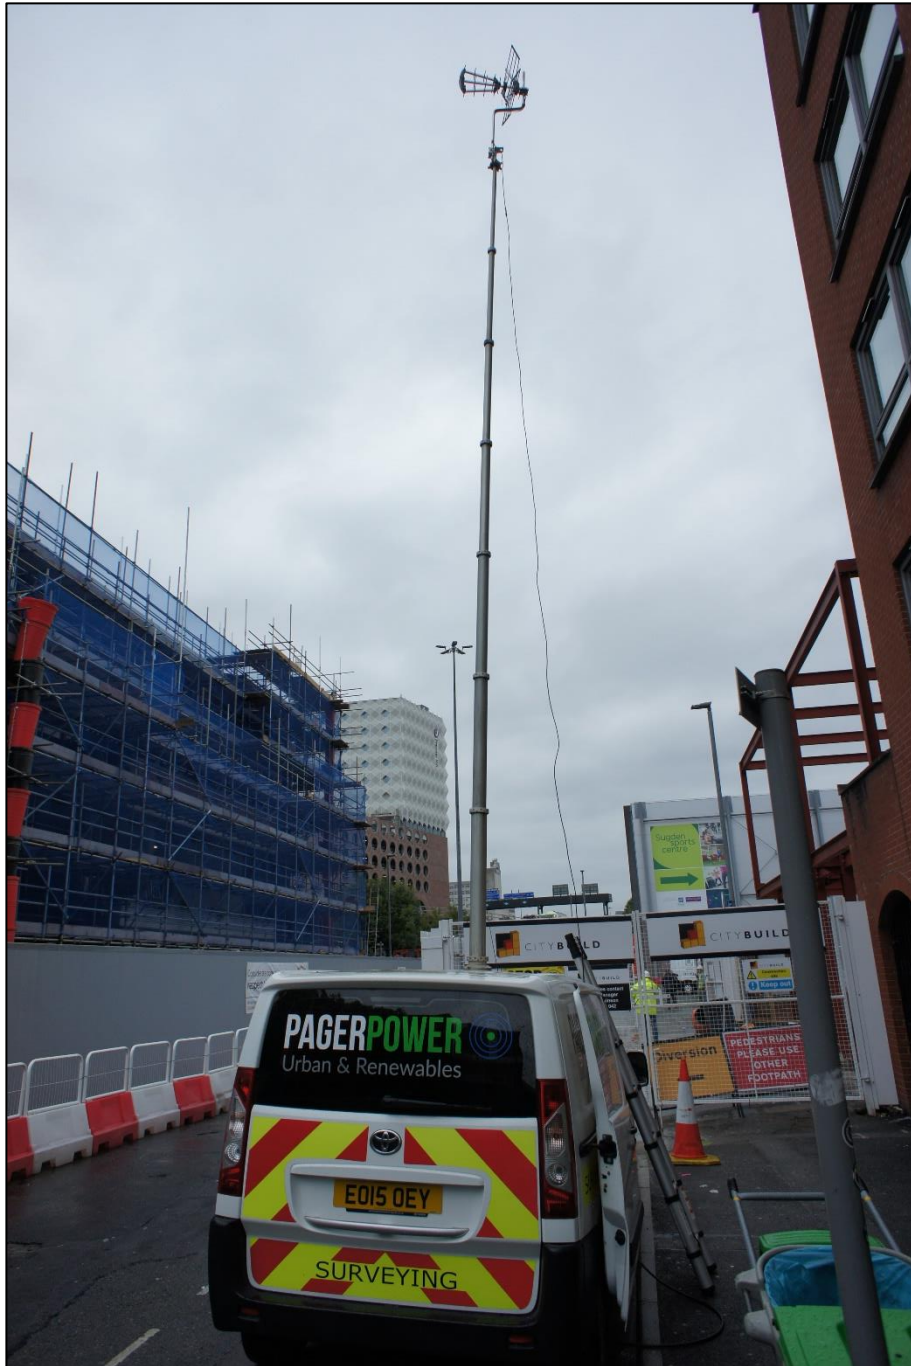
Location 1 – Plots 2, 3 and 4

| Location | Approximate distance from development (km) | Results summary | Conclusions |
|---|---|---|---|
| 1<br>(Plots 2, 3 and 4) | 0.2 | Six multiplexes were received with good picture and audio quality. Four multiplexes were not decoded, including two that appeared to be local channels broadcast at lower power. | <p>One of the local channels in particular shows variable reliability in the city centre.</p> <p>The overall signal strength and channel availability appears slightly reduced when compared with historical measurements around this location.</p> <p>The development is likely a contributor to reduced signal strength at this location, and may not be having a noticeable effect on receivers in the area.</p> |

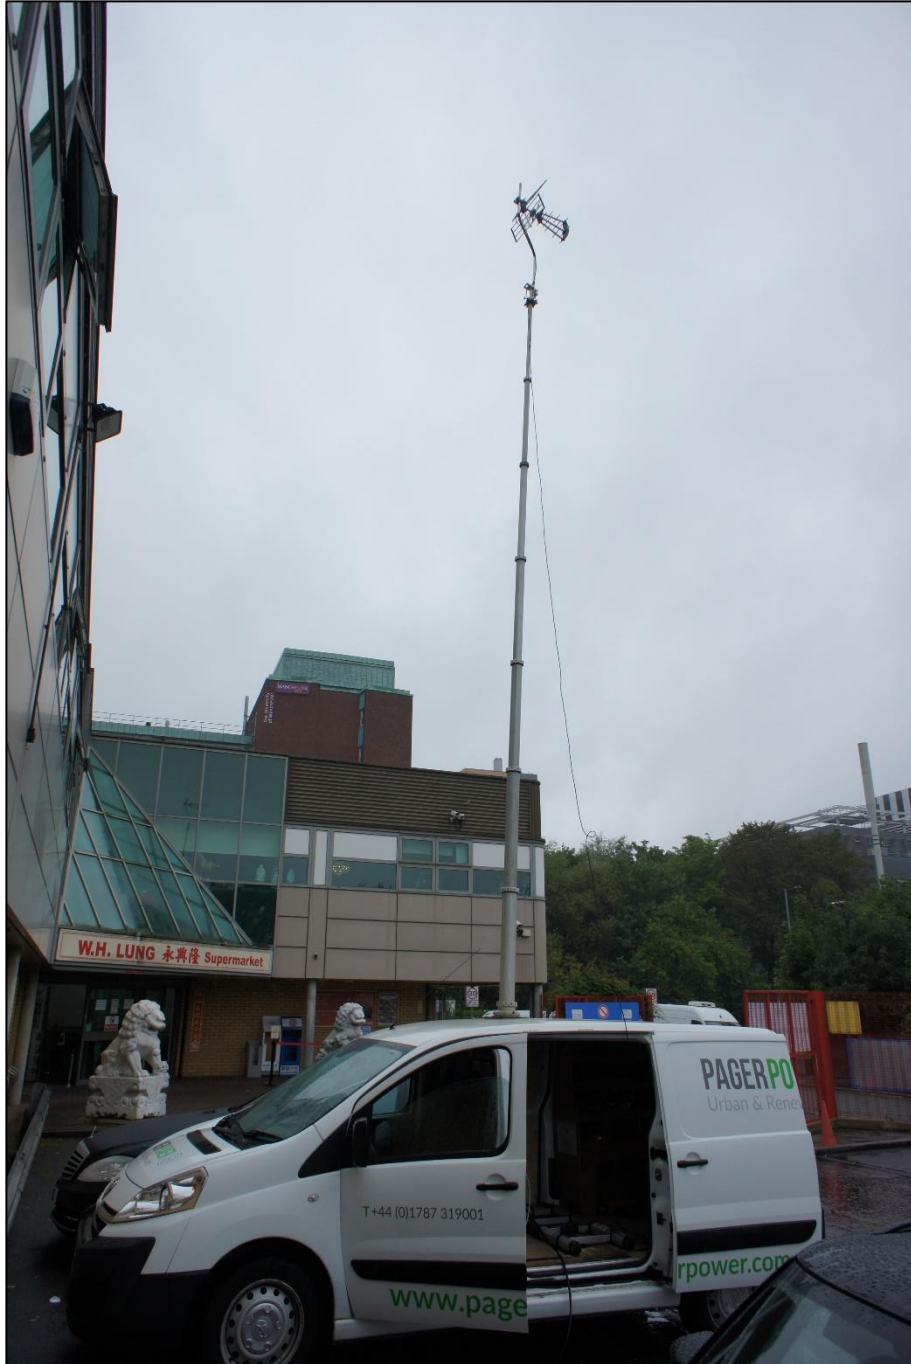
Location 2 – Plots 2, 3 and 4

| Location | Approximate distance from development (km) | Results summary | Conclusions |
|---|---|---|---|
| 2<br>(Plots 2, 3 and 4) | 0.8 | Seven multiplexes were received with good picture and audio quality. Two local multiplexes were not decoded, and one showed intermittent interference. | <p>The overall signal strength and channel availability is broadly consistent with historical measurements around this location.</p> <p>The development is likely a contributor to reduced signal strength at this location but may not be having a noticeable effect on receivers in the area.</p> |

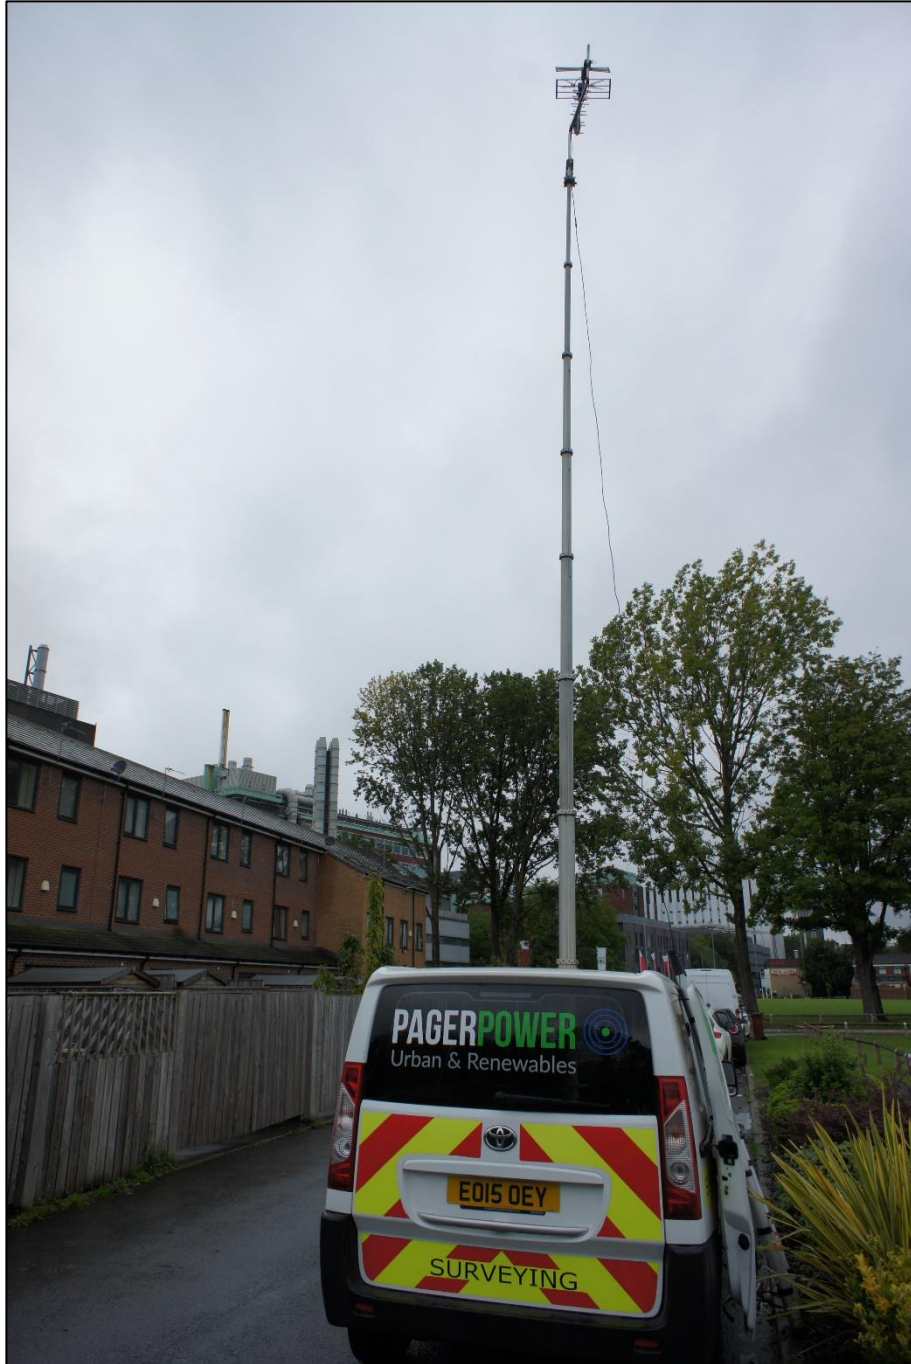
Location 3 – Plots 2, 3 and 4

| Location | Approximate distance from development (km) | Results summary | Conclusions |
|---|---|---|---|
| 3<br>(Plots 2, 3 and 4) | 1.0 | Eight multiplexes were received with good picture and audio quality. Two multiplexes were not decoded including one that appeared to be local channels broadcast at lower power. | <p>The overall signal strength and channel availability appears slightly reduced when compared with historical measurements around this location.</p> <p>The development is likely a contributor to reduced signal strength at this location, but may not be having a noticeable effect on receivers in the area.</p> |

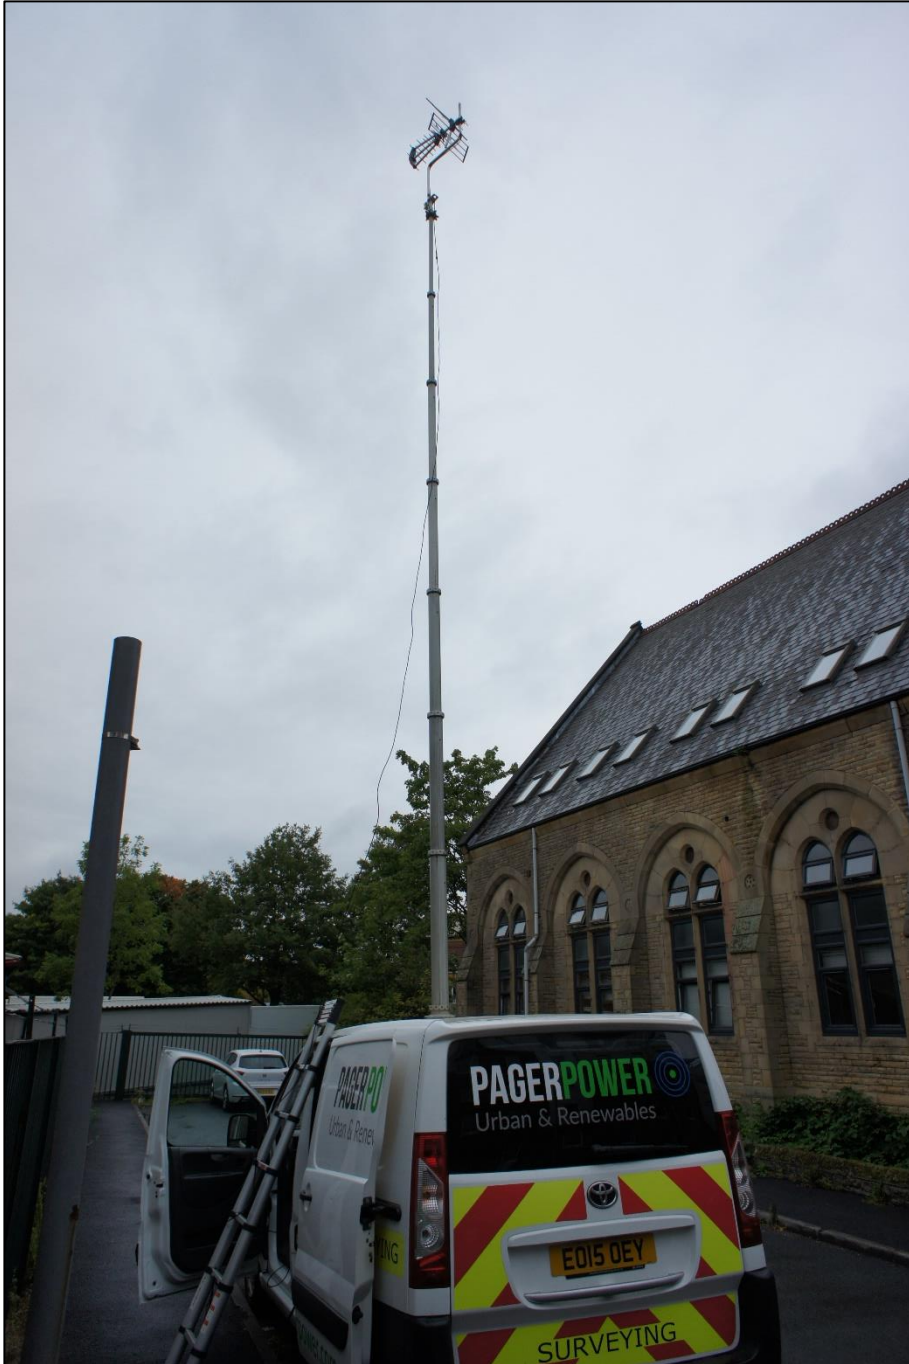
Location 4 – Plots 2, 3 and 4

| Location | Approximate distance from development (km) | Results summary | Conclusions |
|---|---|---|---|
| 4<br>(Plots 2, 3 and 4) | 1.5 | Nine multiplexes were received with good picture and audio quality. One local multiplex was not decoded. | <p>The overall signal strength and channel availability appears slightly reduced when compared with historical measurements around this location.</p> <p>The development is likely a contributor to reduced signal strength at this location, but may not be having a noticeable effect on receivers in the area.</p> |

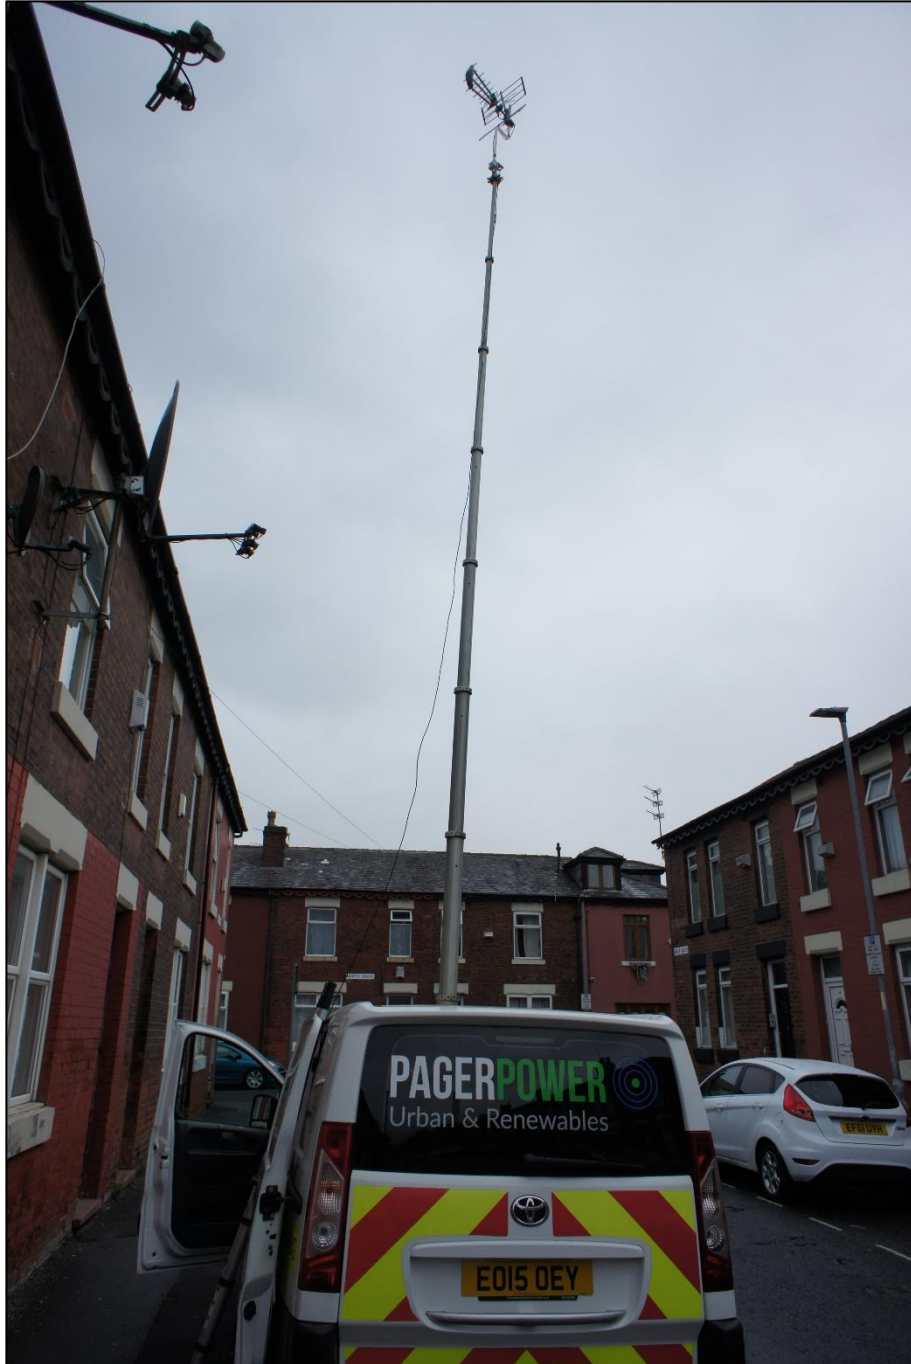
Location 5 – Plots 2, 3 and 4

| Location | Approximate distance from development (km) | Results summary | Conclusions |
|---|---|---|---|
| 5<br>(Plots 2, 3 and 4) | 1.8 | Seven multiplexes were received with good picture and audio quality. Two local multiplexes were not decoded, and one showed intermittent interference. | <p>The overall signal strength and channel availability appears significantly reduced when compared with historical measurements around this location – however at this range such differences are unlikely to be solely due to Circle Square.</p> <p>The development is likely a contributor to reduced signal strength at this location, but may not be having a noticeable effect.</p> |
