# Television Post-Construction Reception Survey

Circle Square – Plots 2, 3, 4 and 14

September 2020

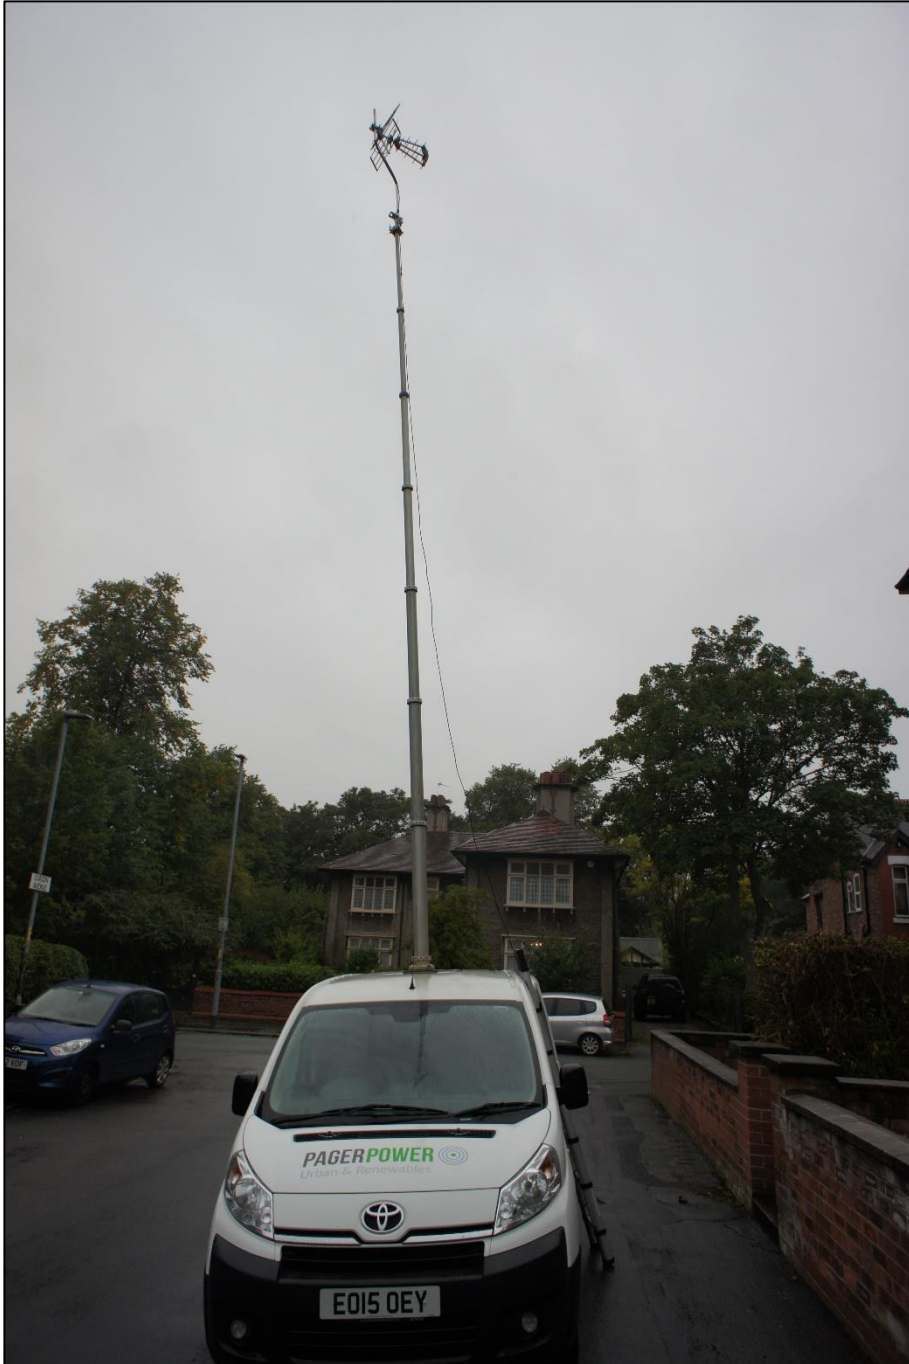
Location 6 – Plots 2, 3 and 4

| Location | Approximate distance from development (km) | Results summary | Conclusions |
|---|---|---|---|
| 6<br>(Plots 2, 3 and 4) | 2.5 | All multiplexes were received with good picture and audio quality. | The development was not found to be having a noticeable effect on receivers in the area because all channels remain available. |

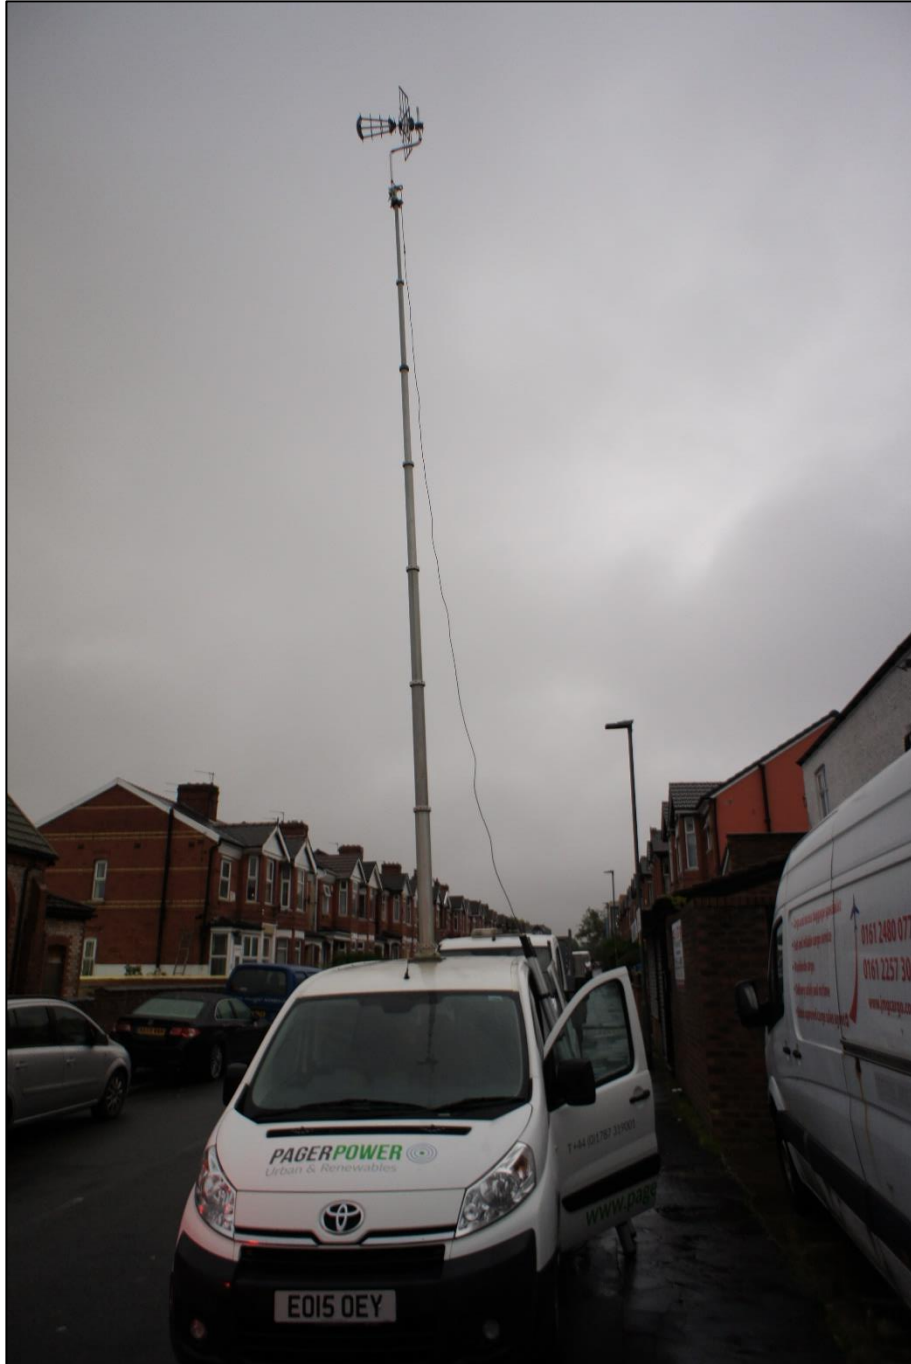
Location 7 – Plots 2, 3 and 4

| Location | Approximate distance from development (km) | Results summary | Conclusions |
|---|---|---|---|
| 7<br>(Plots 2, 3 and 4) | 3.2 | All multiplexes were received with good picture and audio quality. | The development was not found to be having a noticeable effect on receivers in the area because all channels remain available. |
