# **St John's Street – Ecological Assessment**

## **Pareto Properties LLP.**

Version: **V0.2**  
Issue Date: **July 2020**  
Report Ref: **15278**

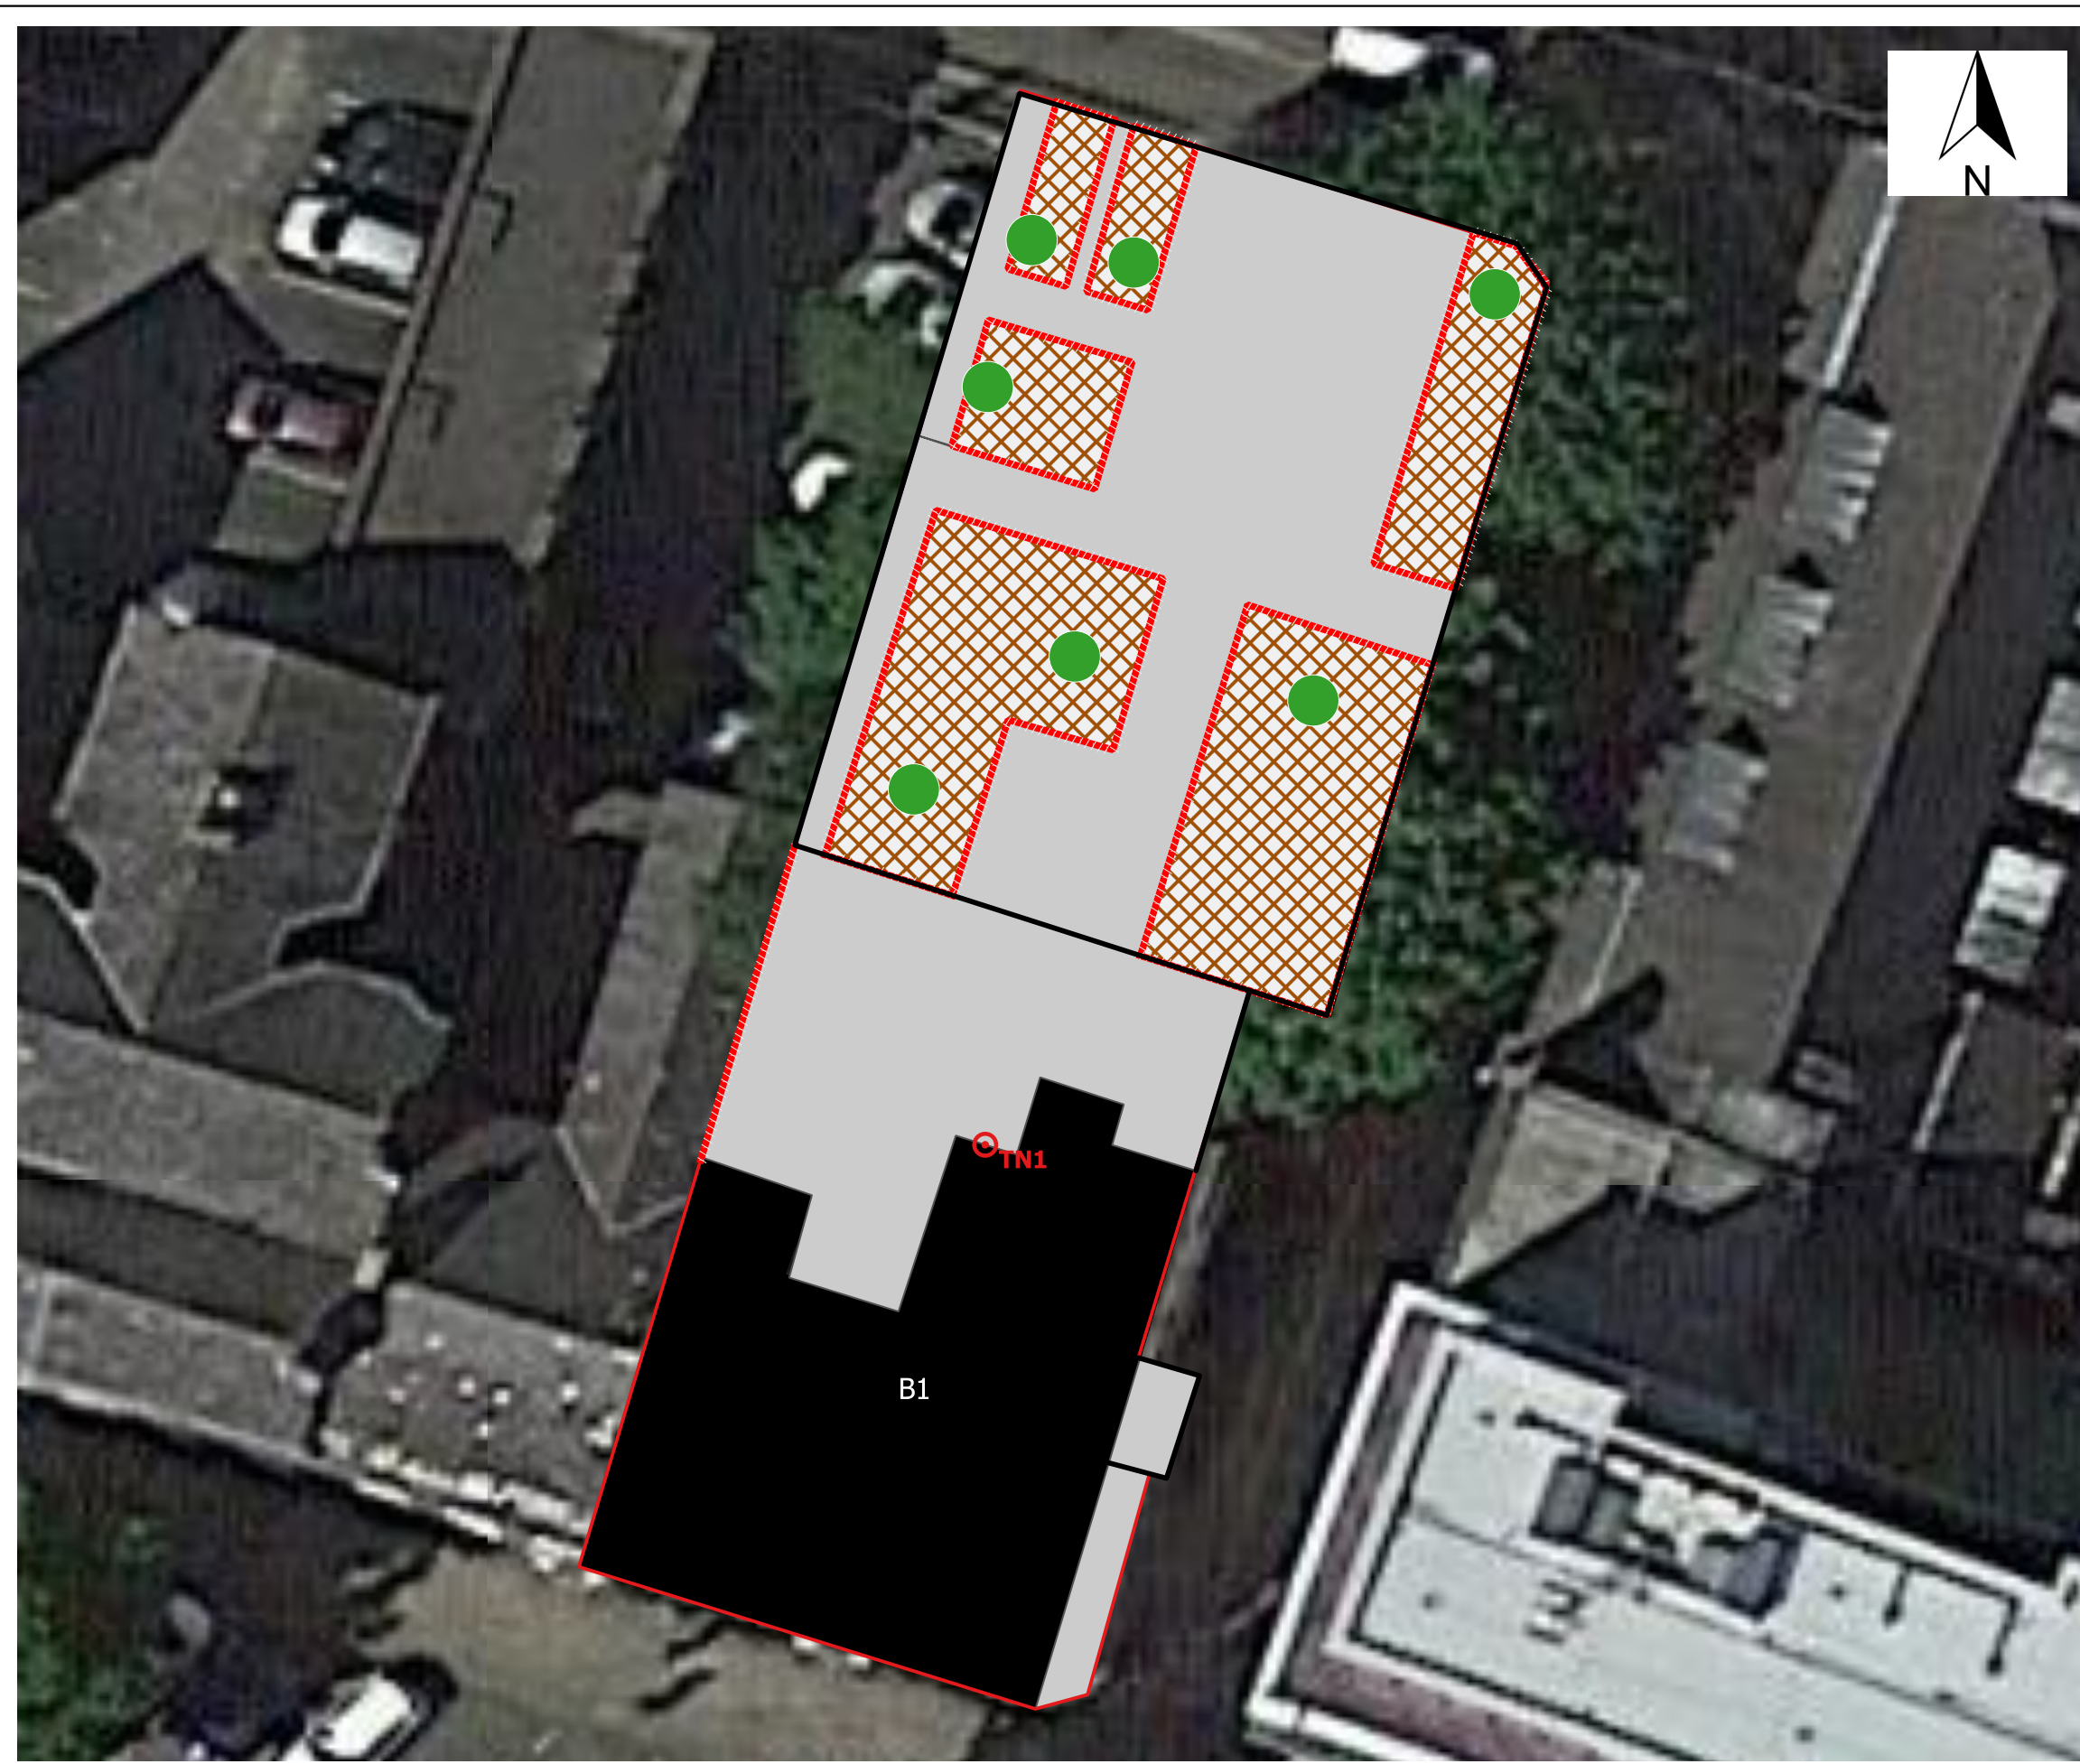
- 3.3.2 The majority of the site is comprised of urban developed land, with a three-storey town house type-building within the southern section of Site (J3.6: B1 in Figure 2;

- 3.3.6 Within the courtyard planters, a number of planted mature broad-leaved trees are present (A3.1 in Figure 2; Photographs 10 – 16, Appendix 1) including Norway maple *Acer platanoides*; and silver birch *Betula pendula*. Self-seeded saplings of hazel *Corylus avellana*; and cherry *Prunus* sp. are also occasionally present within the raised planters.
- 3.3.7 The trees species present are common and widespread throughout the UK with many similar specimens that can be found planted within the surrounding urban environment. The trees do however offer some structural diversity and are therefore considered to be of value to nature conservation at site level only. A full arboricultural impact assessment of the trees present on site has been provided alongside this report (Ecus, 2020).

- 3.4.5 The main building on Site (B1 in Figure 2) was assessed for its suitability to support roosting bats. The building is a three-storey brick built townhouse style dwelling with a pitched slate-tiled roof. The building is in a moderately poor condition with weather damage present on all aspects.

- 3.4.20 A small passerine nest was observed within open air brick located on the northern protruding aspect of the main building (Target Note 1 in Figure 2; Photograph 30, Appendix 1) which appeared to be active during the survey visit. No other nests were observed, however it is reasonably likely that they may be encountered within the canopy of the scattered trees and the denser shrubs. Significant impacts to these habitats are anticipated and, as such, nesting birds should be considered to be a potential receptor to the proposed works.

| Target Note ID | Description |
|---|---|
| TN1 | Small passerine nest within open air brick |

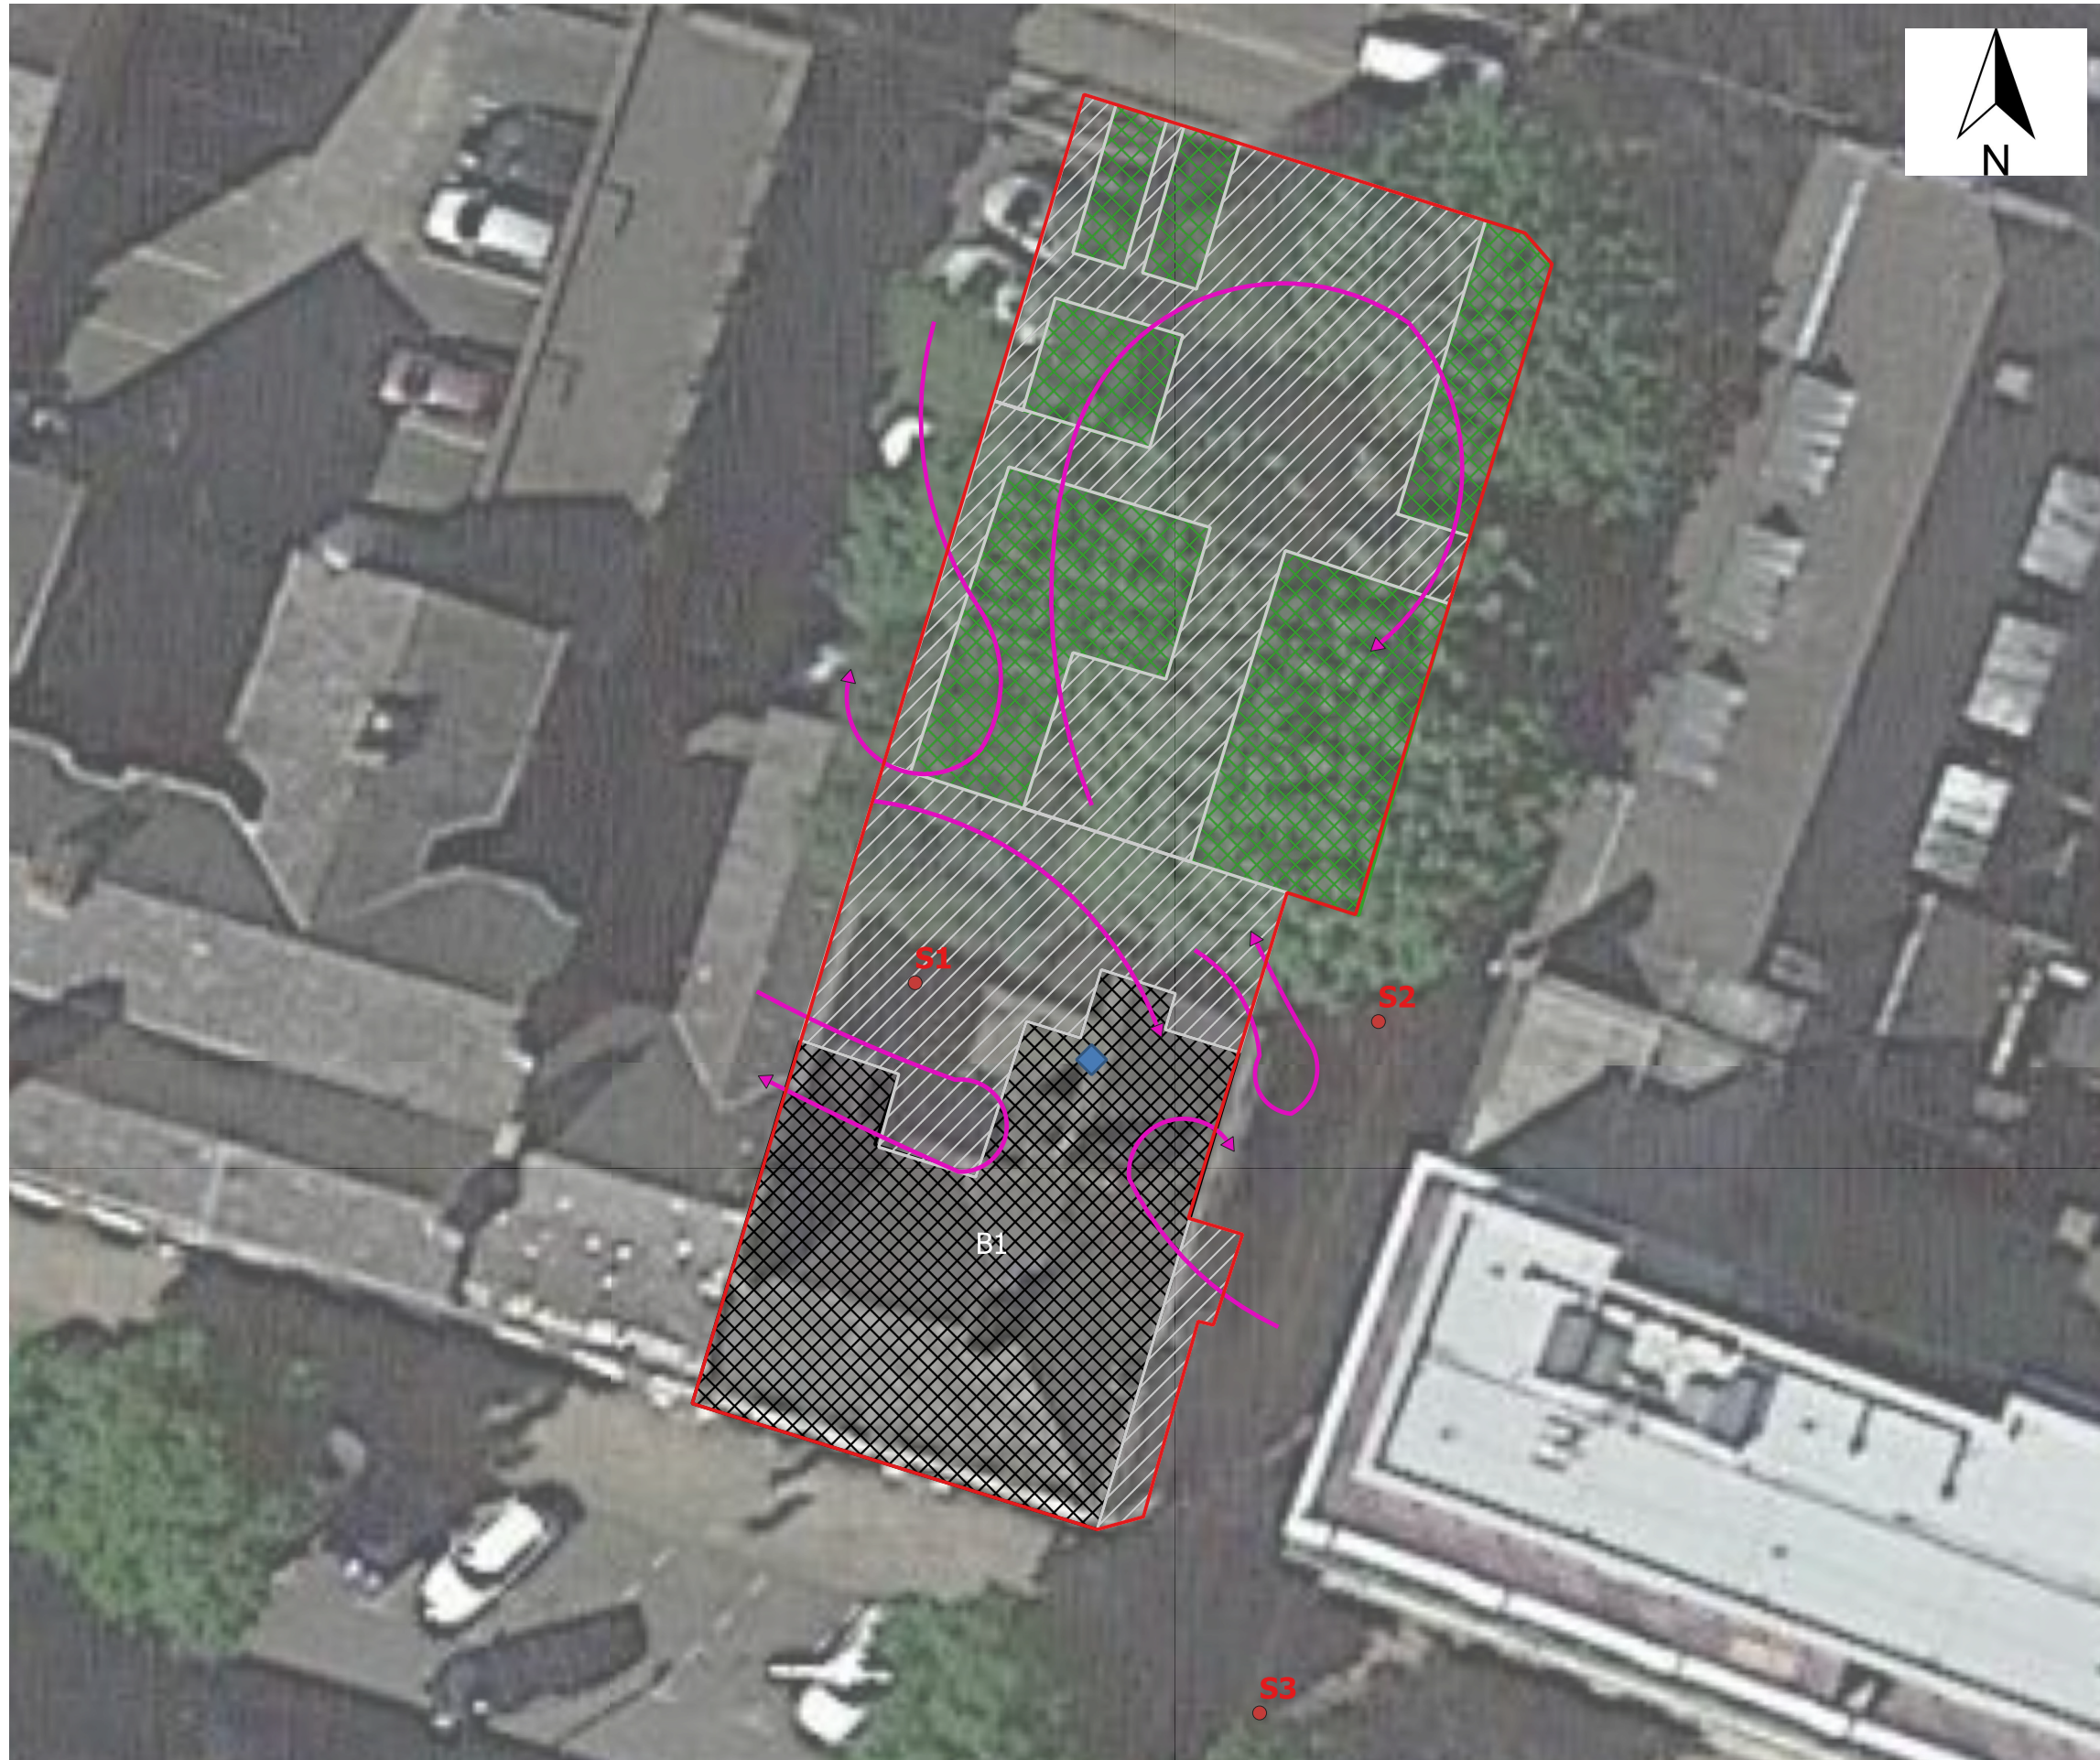
## **Appendix 3. Bat Activity Map**

- 3.4.12 Details of the findings from the nocturnal activity surveys are presented below, alongside a brief summary of any bat activity recorded. Surveyor positions, approximate roost locations and observed bat flight paths are illustrated in Appendix 3.

- 3.4.13 A single common pipistrelle was observed emerging from the upper-roof area, on the NW elevation at approximately 21:55. The exact location could not be identified due to low-lux levels and sighting restrictions, however it is thought to have emerged from a significant gap in the fascia boarding along the verge of the upper-roof (Approximate Roost Location in Appendix 3; Photograph 31 & 32, Appendix 1).

- 3.4.14 The individual bat was then observed foraging around the trees within the courtyard area for the majority of the remainder of the survey, with a second common pipistrelle observed passing several times, high above the building. Pipistrelle activity was observed until 23:03. A single pass of noctule, *Nyctalus noctula*, was also recorded early on during the survey (21:40) but was not seen. It is likely that this individual bat was commuting high above the Site to more optimal foraging areas.

- 3.4.15 Intermittent observations of common pipistrelle were observed throughout survey, with several passes recorded over the building itself, and foraging activity around the trees within the courtyard. Activity was recorded until 04:39. No bats were observed either re-entering or emerging from a roost within the building during this visit.
