**REPORT ON PHASE 2 GEO-ENVIRONMENTAL GROUND INVESTIGATION WORKS**  
**UNDERTAKEN ON LAND**  
**BOUNDED BY**  
**CULCHETH LANE AND TANDLEWOOD MEWS, NEWTON HEATH, MANCHESTER**  
**M40 1LU**

**Q136 SFK (TLC985) rep AOE Style 080518**  
**May 2018**

***Report on Phase 2 Geo-Environmental Ground Investigation Works undertaken on Land Bounded by Culcheth Lane and Tandlewood Mews, Newton Heath, Manchester M40 1LU.***

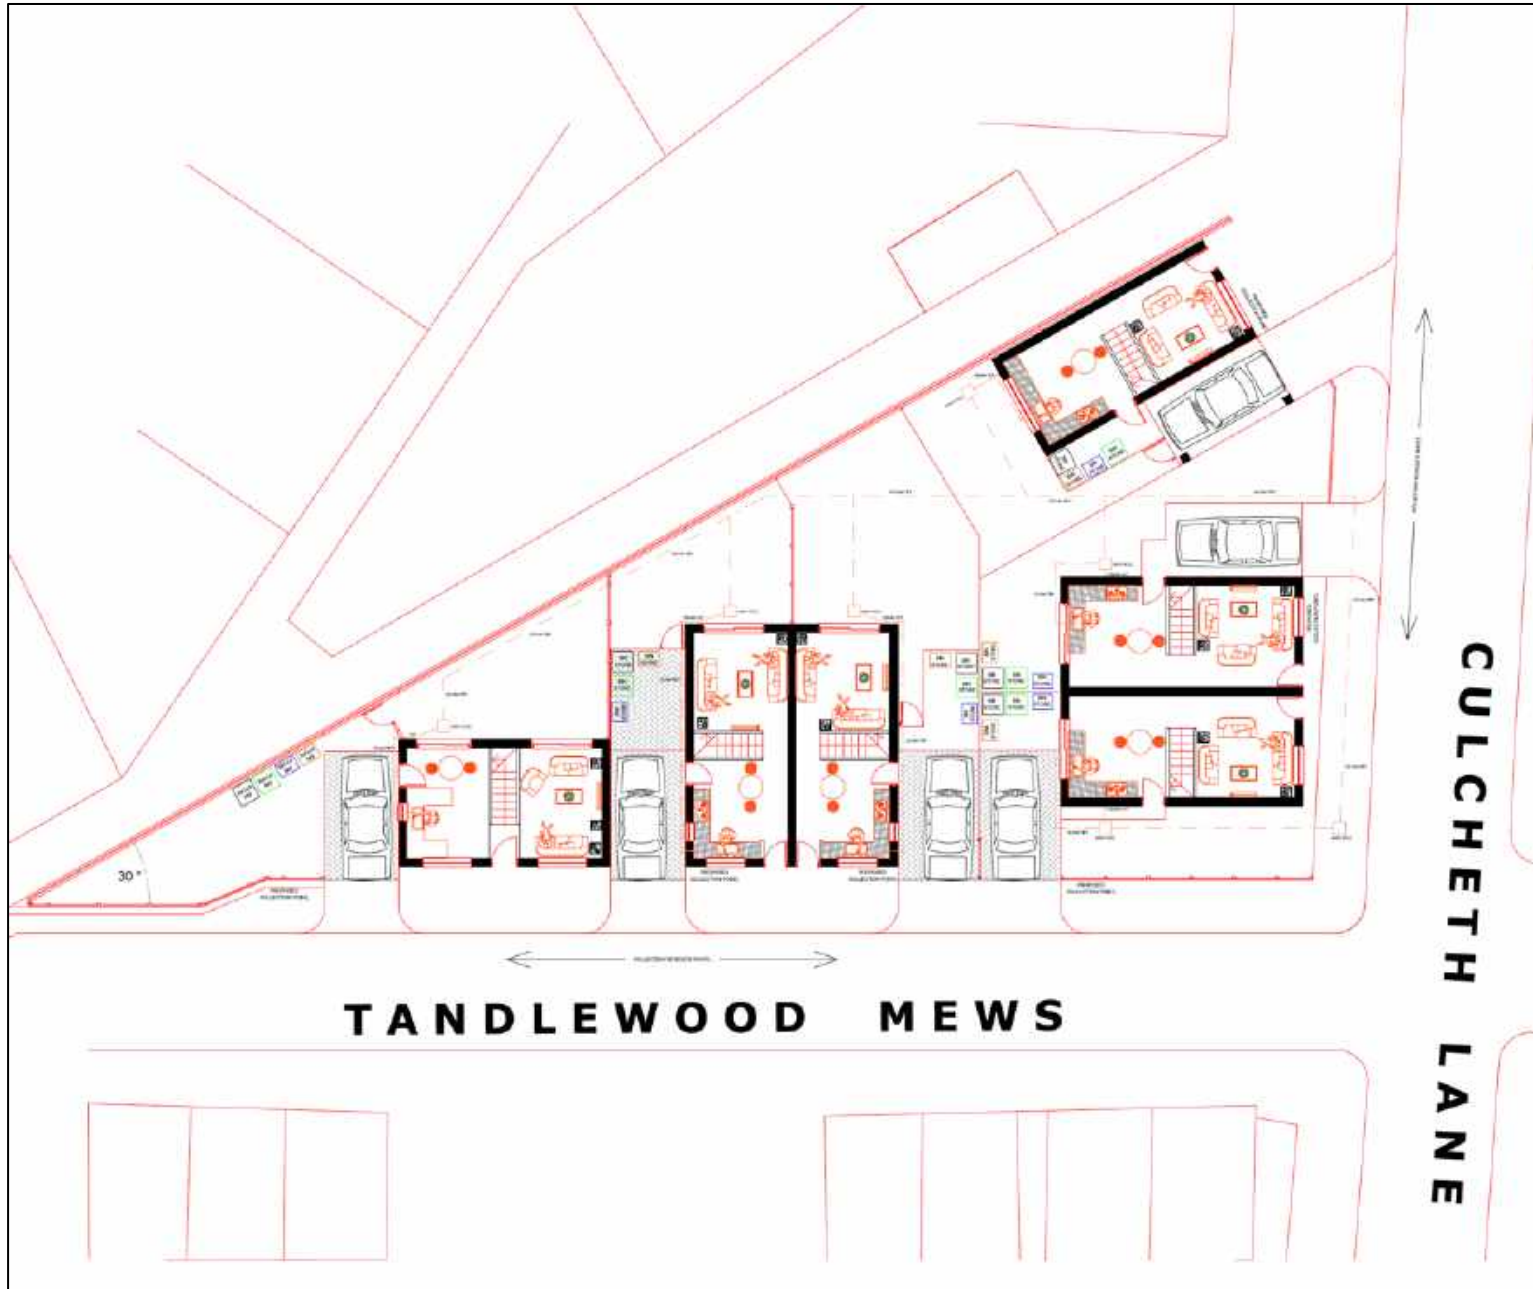
- 1.2 It is understood that this former public house site, is intended to be redeveloped with 6no. three storey townhouses (Class C3), together with parking and small garden areas. A proposed development plan is presented in Drawing No. TLC985/03 in Appendix A.

6.1.1.5 The property is intended to be developed out with residential properties which will incorporate small garden areas. A proposed development plan is displayed on Drawing No. TLC985/03 in Appendix A. The chemical testing results obtained have therefore been compared to screening concentrations derived for the residential with plant uptake scenario.

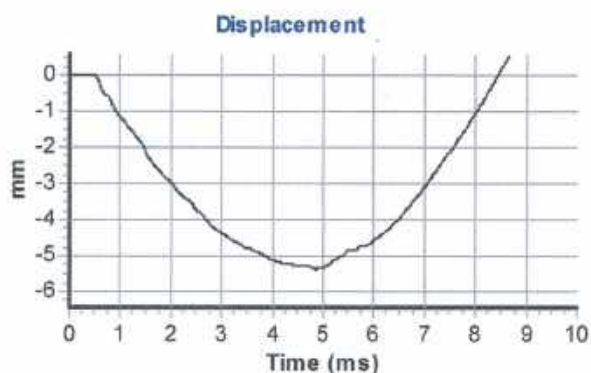
CALIBRATION

Area of Rod A ( $\text{mm}^2$ ): 905  
Theoretical Energy  $E_{\text{theor}}$  (J): 473  
Measured Energy  $E_{\text{meas}}$  (J): 316
