# Television Post-Construction Survey

Sisk Group

Circle Square Affinity Living: Plot 7 and 8

July, 2020

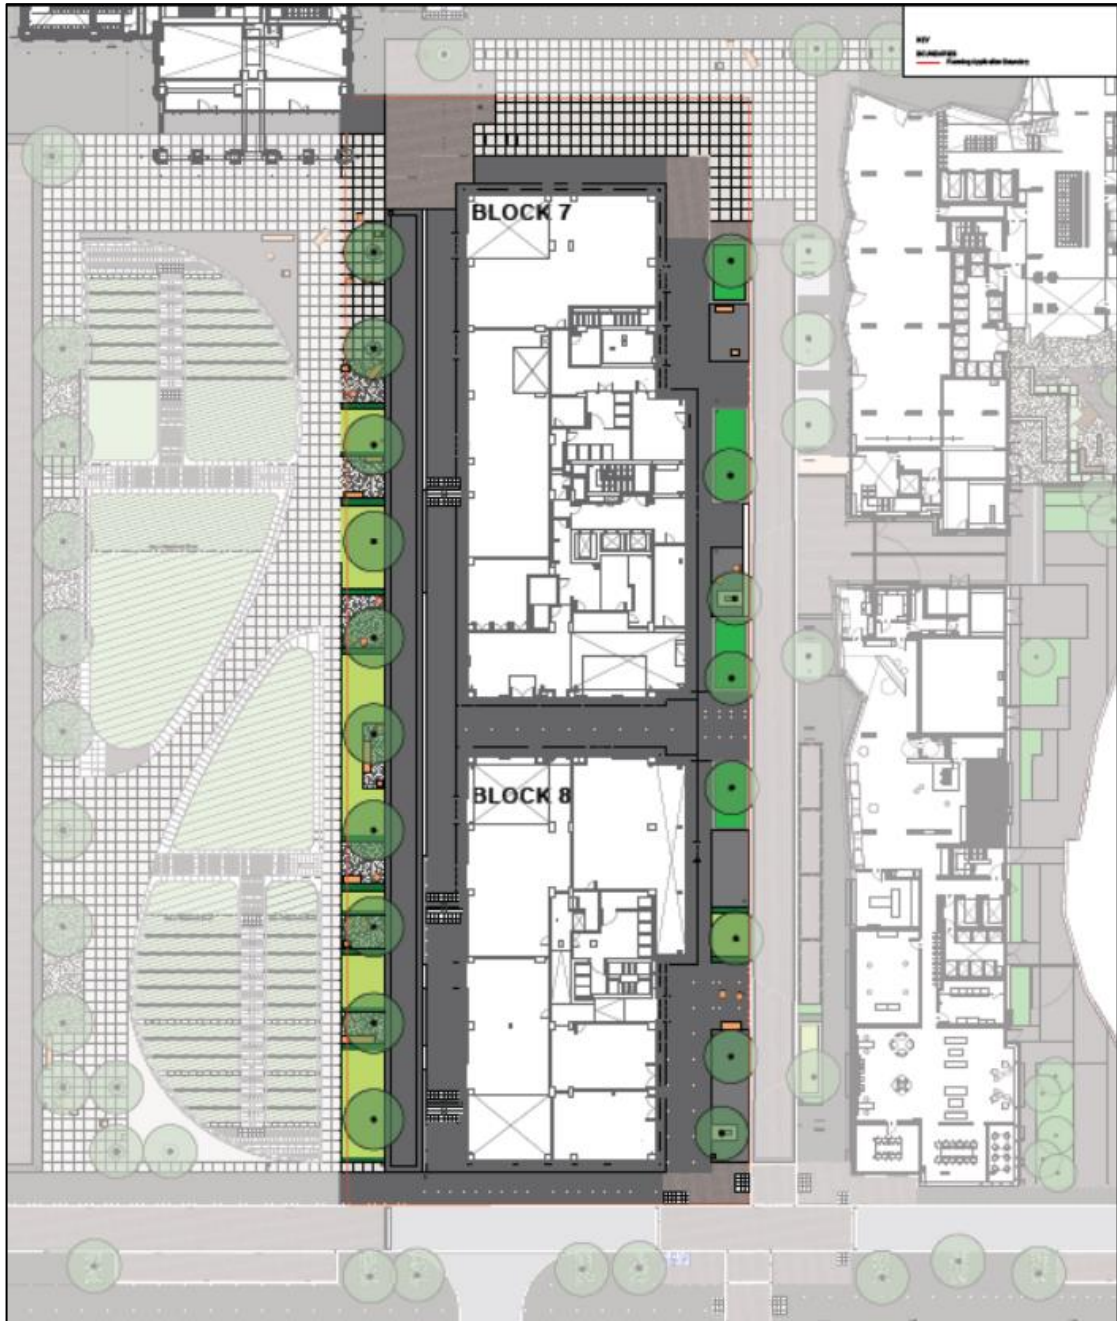
Figure 3 Masterplan showing Plots 7 and 8

An extract of the masterplan showing Plots 7 and 8 is presented in Figure 3<sup>5</sup> below.

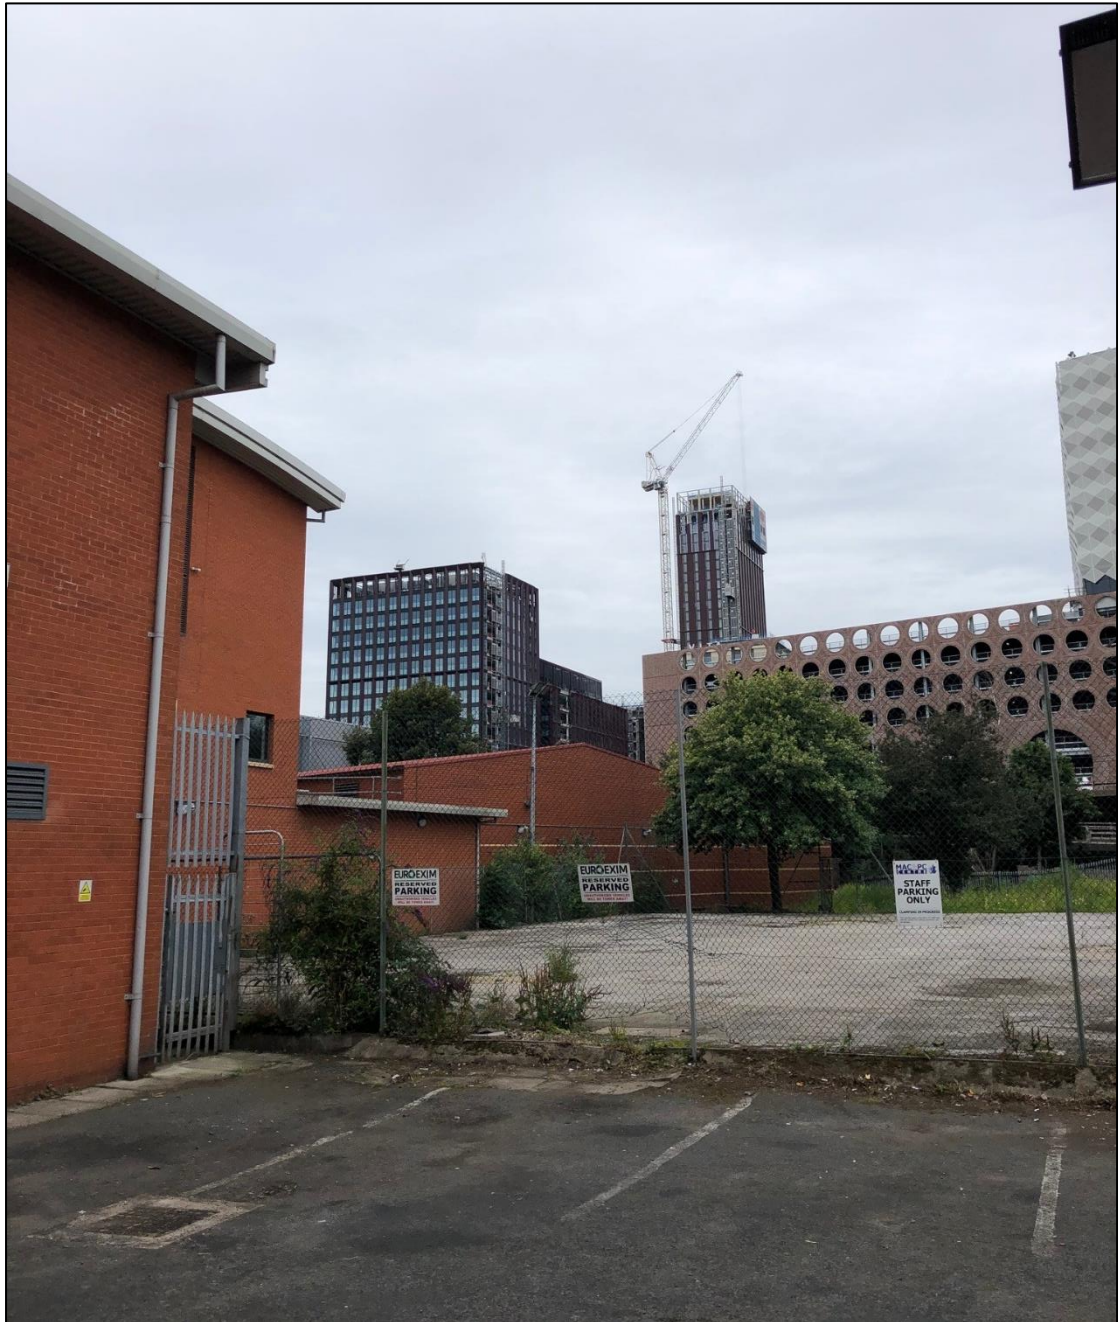
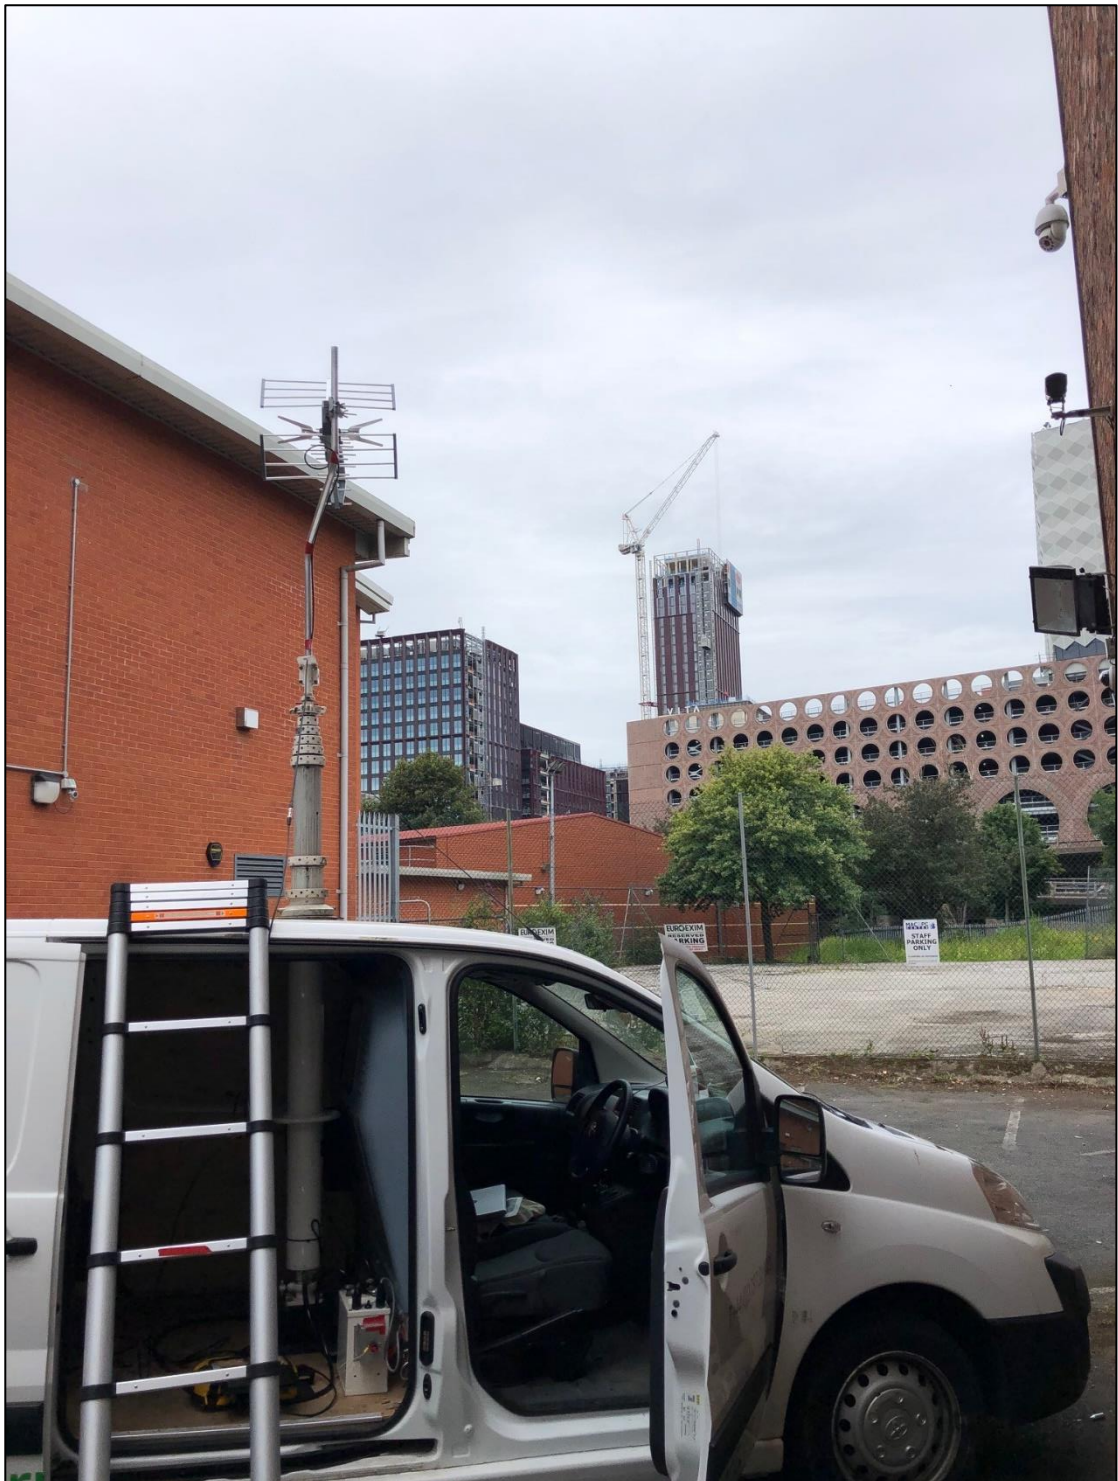
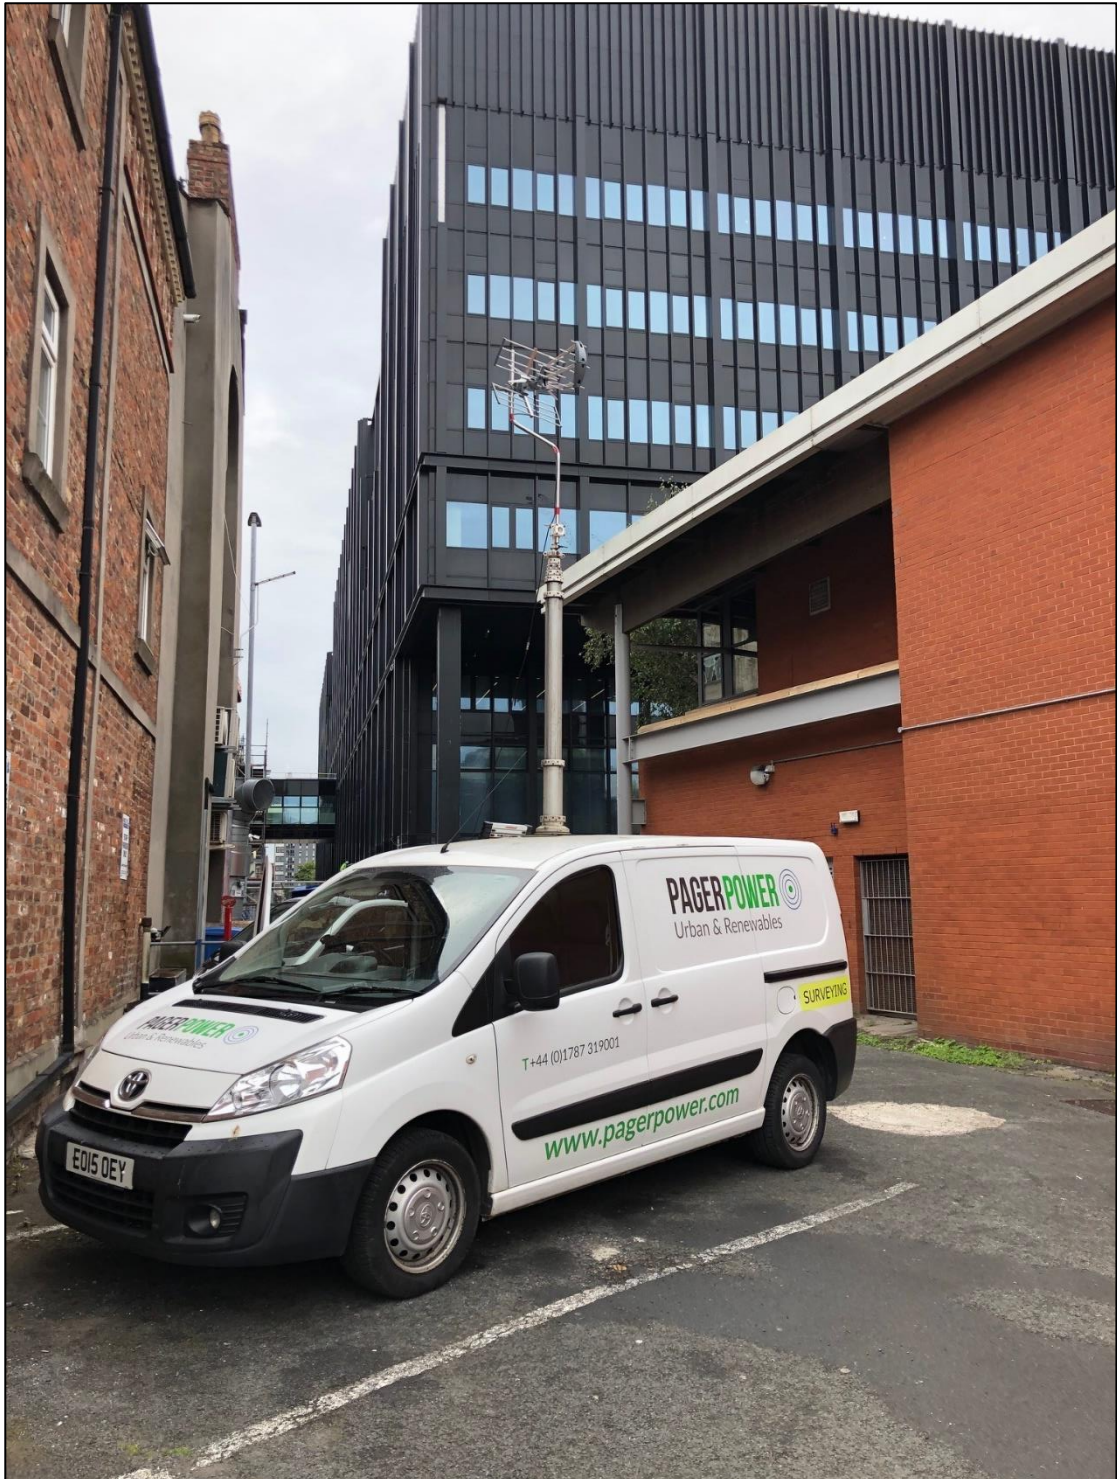
### Location 1

| Location | Average Measured Signal Strength (dB) | Distance from development | Remarks | Conclusion |
|---|---|---|---|---|
| 1 | <p>Main multiplexes = 41.8<br/>(Moderate)</p> <p>Local multiplexes = 37.8<br/>(Moderate)</p> | <p>0.24km</p> <p>Just outside the development's shadow zone.</p> | <p>All main multiplexes decoded with fine picture and sound quality. Two local multiplexes did not decode.</p> <p>HP<sup>14</sup> UHF aerials and satellite dishes observed.</p> | <p>The signal strength was moderate at this location for main multiplexes.</p> <p>New tall buildings in this area of the city will be having some effect on the quality of the signal at this location, not just Plot 7 and 8.</p> <p>The results for this location (the closest to the development) are not significantly different to the results for other survey locations in terms of the channels that decoded.</p> <p>Any interference complaint at this location within the shadow zone should however be investigated due to its proximity.</p> |

Notes: All aerals observed orientated towards Winter Hill. Satellite dishes observed. Survey location amongst taller buildings. New commercial building under construction directly behind survey location and also directly south of the built up city.

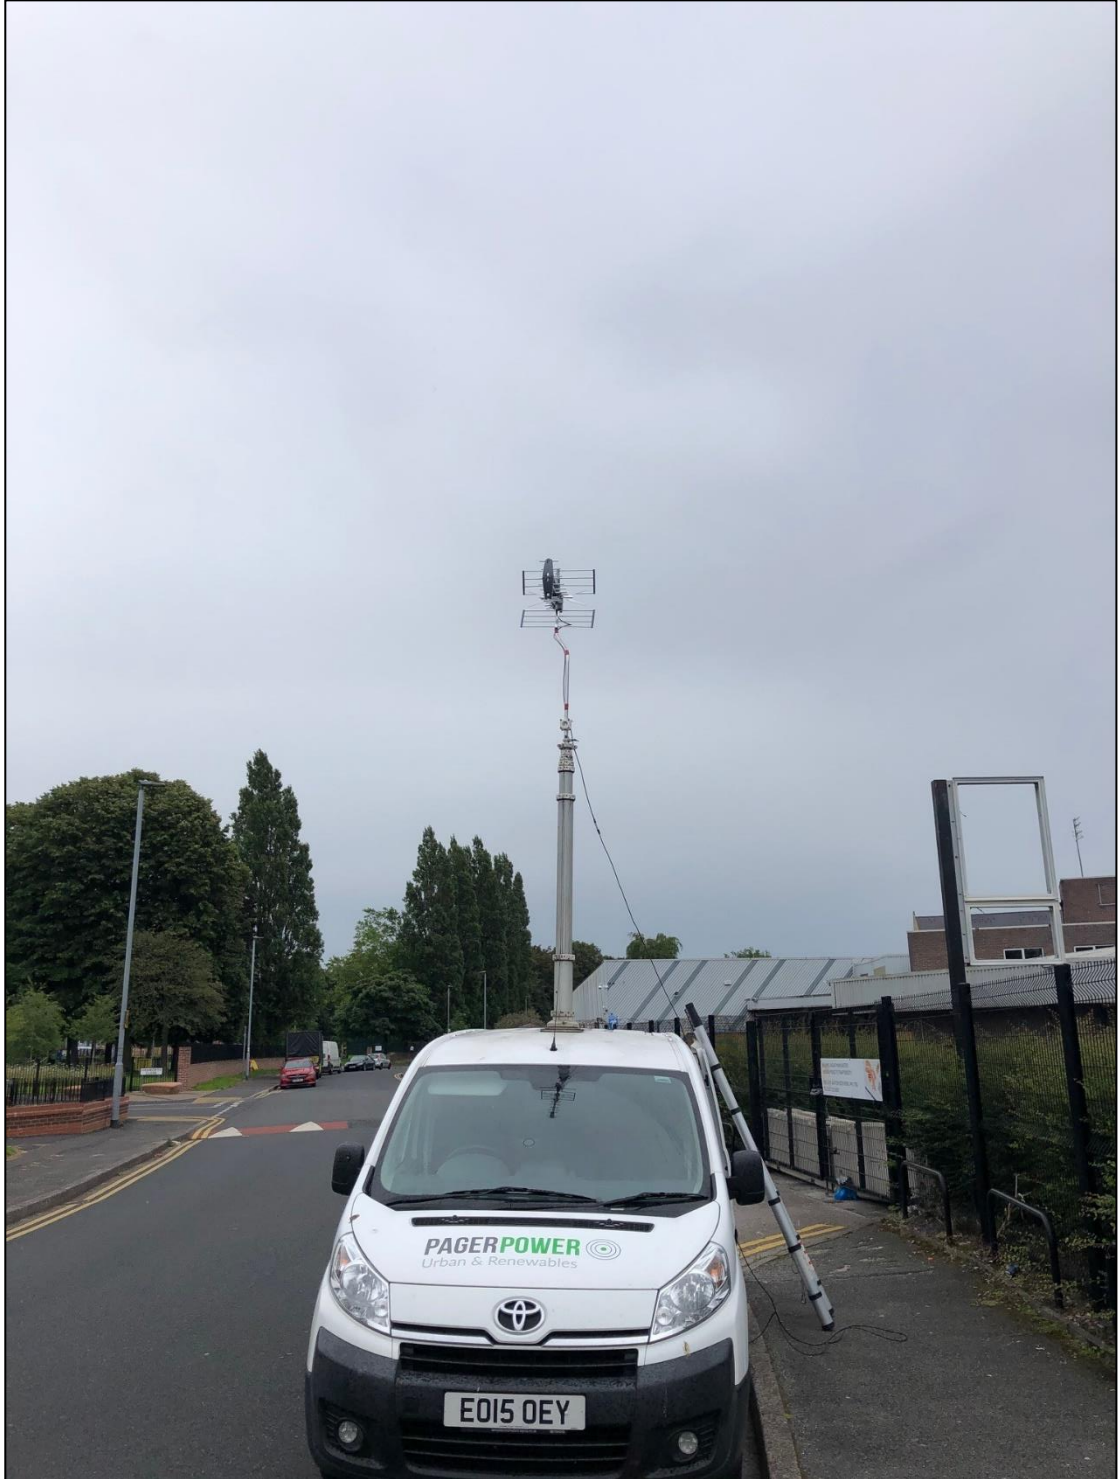
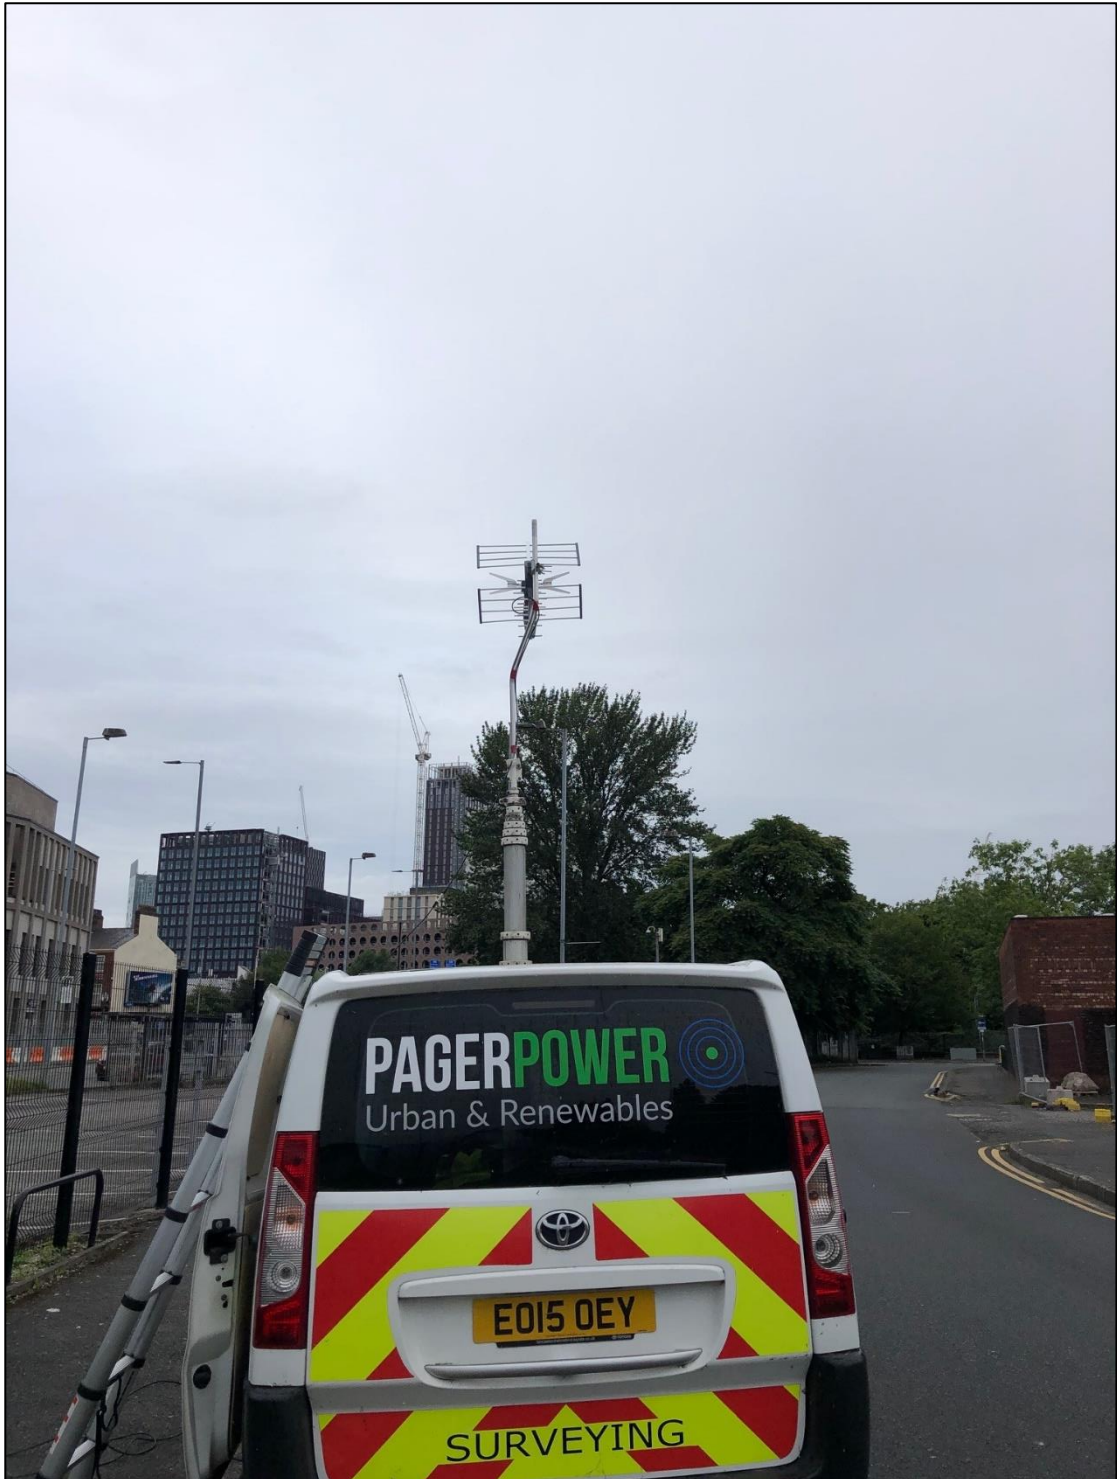
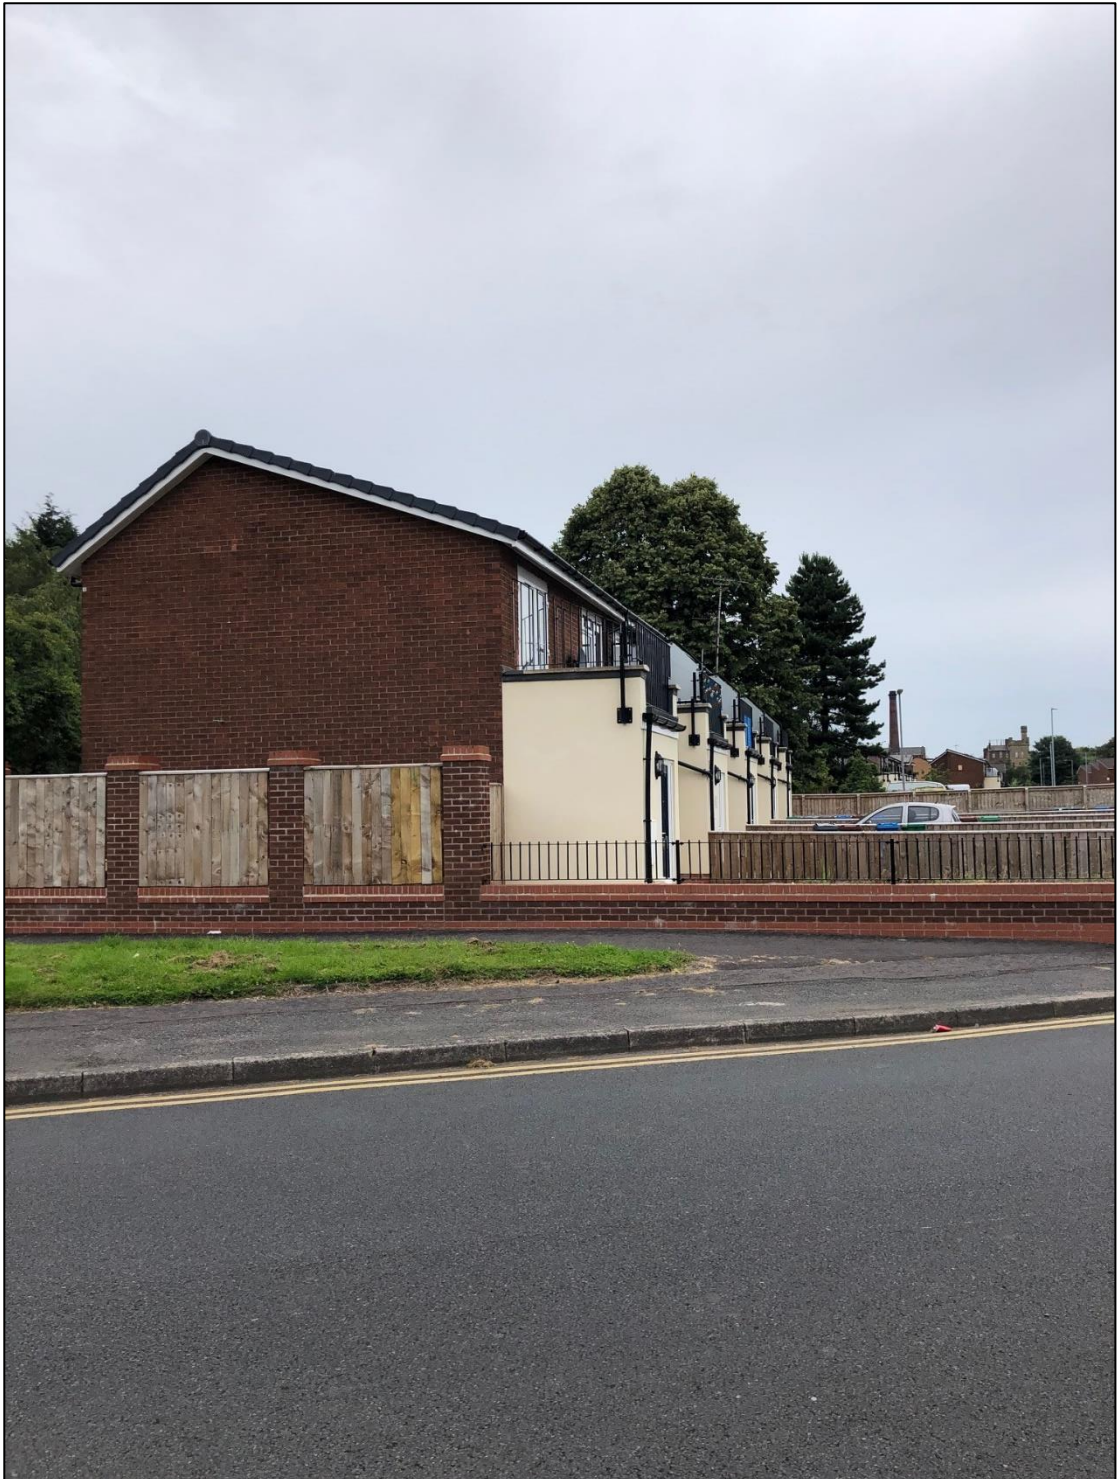
Location 2

| Location | Average Measured Signal Strength (dB) | Distance from development | Remarks | Conclusion |
|---|---|---|---|---|
| 2 | <p>Main multiplexes = 38.8<br/>(Moderate)</p> <p>Local multiplexes = 36.0<br/>(Moderate)</p> | <p>0.38km</p> <p>Within the development's shadow zone.</p> | <p>All but one main multiplexes decoded with fine picture and sound quality. Two local multiplexes did not decode.</p> <p>HP UHF aerials and satellite dishes observed.</p> | <p>The signal strength was moderate at this location for main multiplexes.</p> <p>New tall buildings in this area of the city will be having some effect on the quality of the signal at this location, not just Plot 7 and 8.</p> <p>Any interference complaint at this location within the shadow zone should be investigated.</p> |

Notes: All aerials observed orientated towards Winter Hill. Satellite dishes observed. Survey location had few dwellings but also fewer aerials. The survey location was relatively flat but directly south of the built up city.

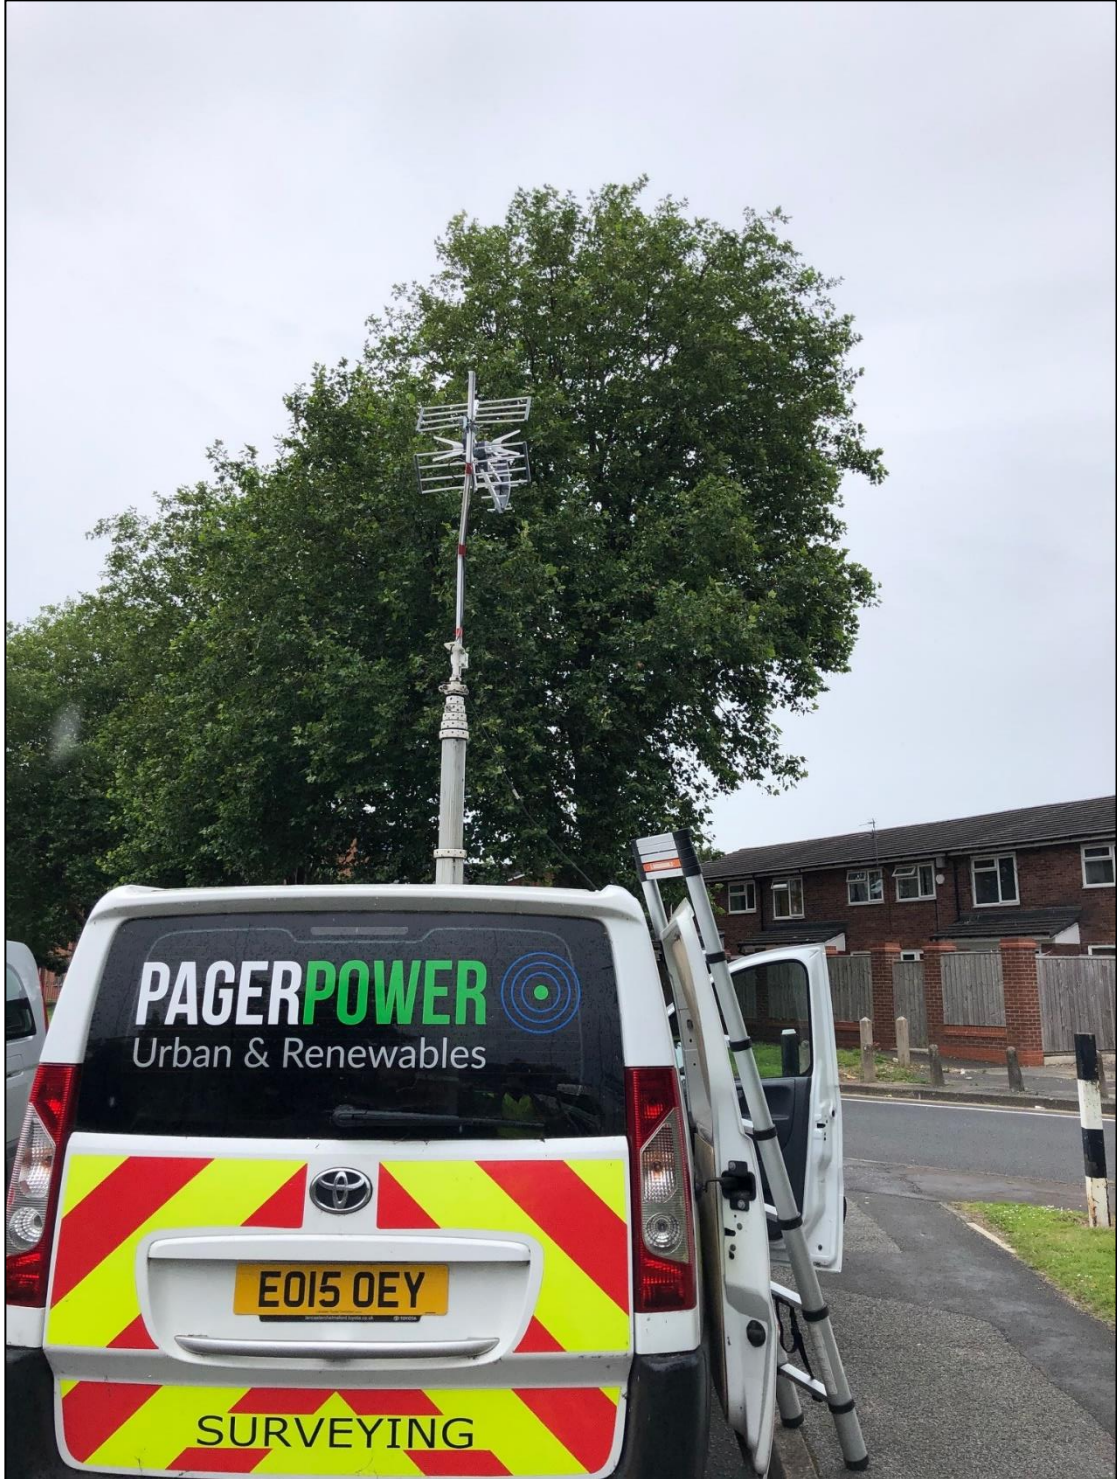
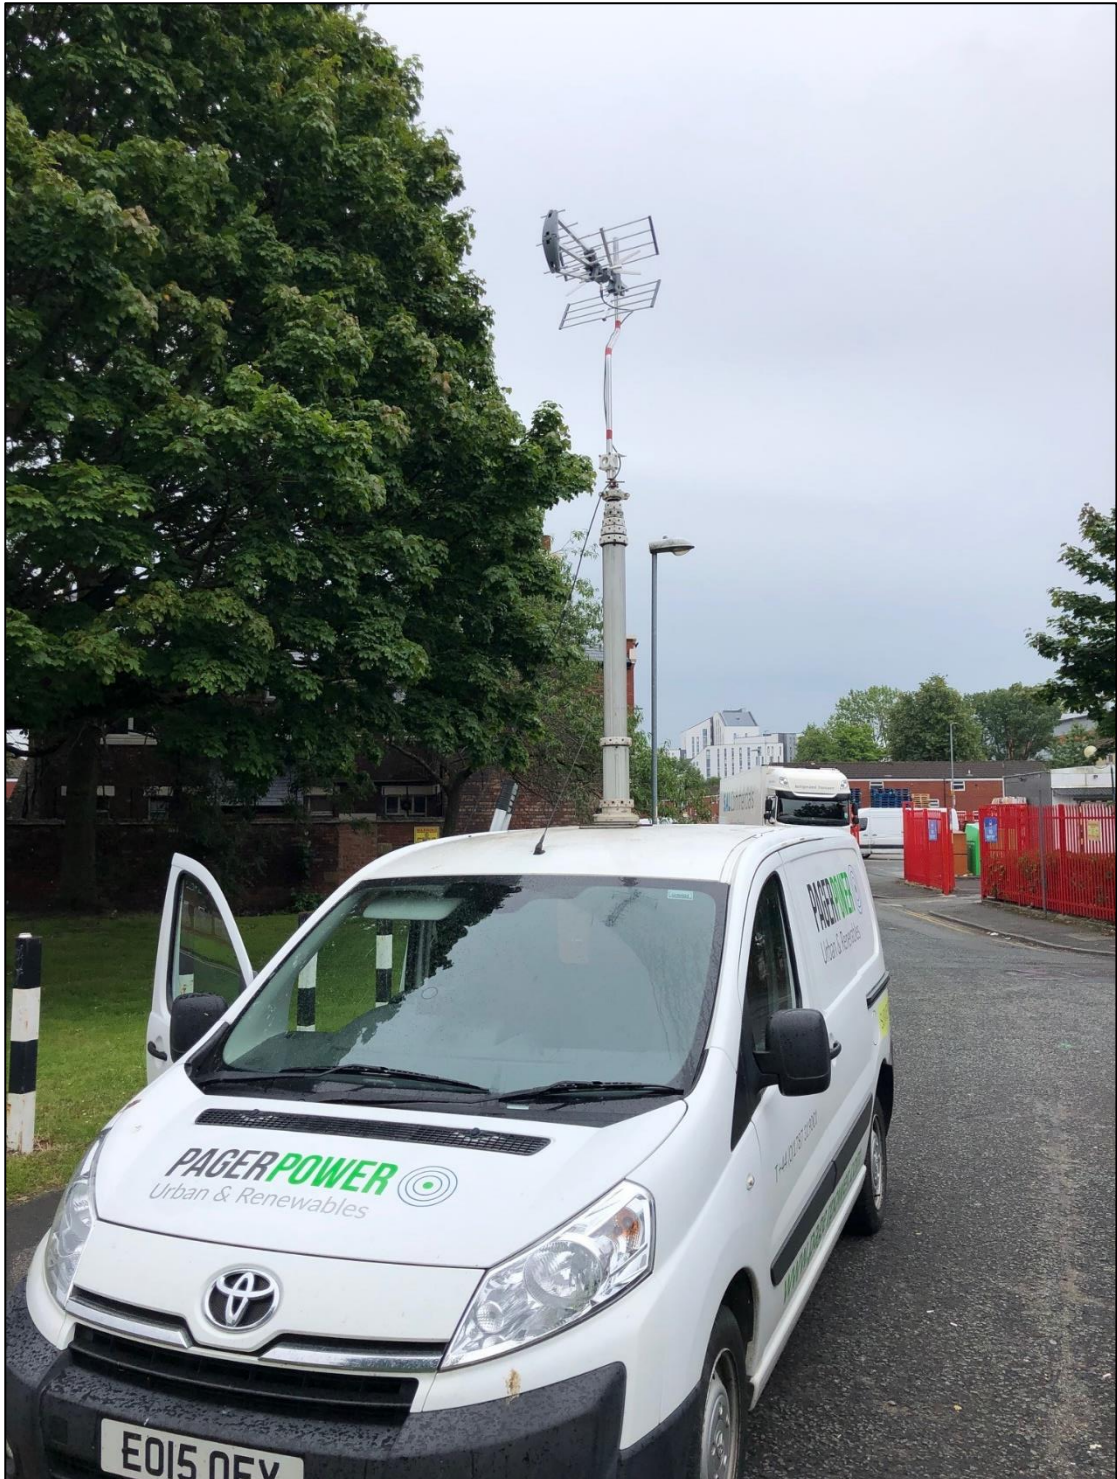
Location 3

| Location | Average Measured Signal Strength (dB) | Distance from development | Remarks | Conclusion |
|---|---|---|---|---|
| 3 | <p>Main multiplexes = 45.0<br/>(Moderate)</p> <p>Local multiplexes = 39.6<br/>(Moderate)</p> | <p>0.77km</p> <p>Within the development's shadow zone.</p> | <p>All main multiplexes decoded with fine picture and sound quality. Two local multiplexes did not decode.</p> <p>HP UHF aerials and satellite dishes observed.</p> | <p>The signal strength was moderate at this location for main multiplexes.</p> <p>Any interference complaint at this location within the shadow zone should be investigated.</p> |

Notes: All aerials observed orientated towards Winter Hill. Satellite dishes observed. One vertically polarised aerial observed.

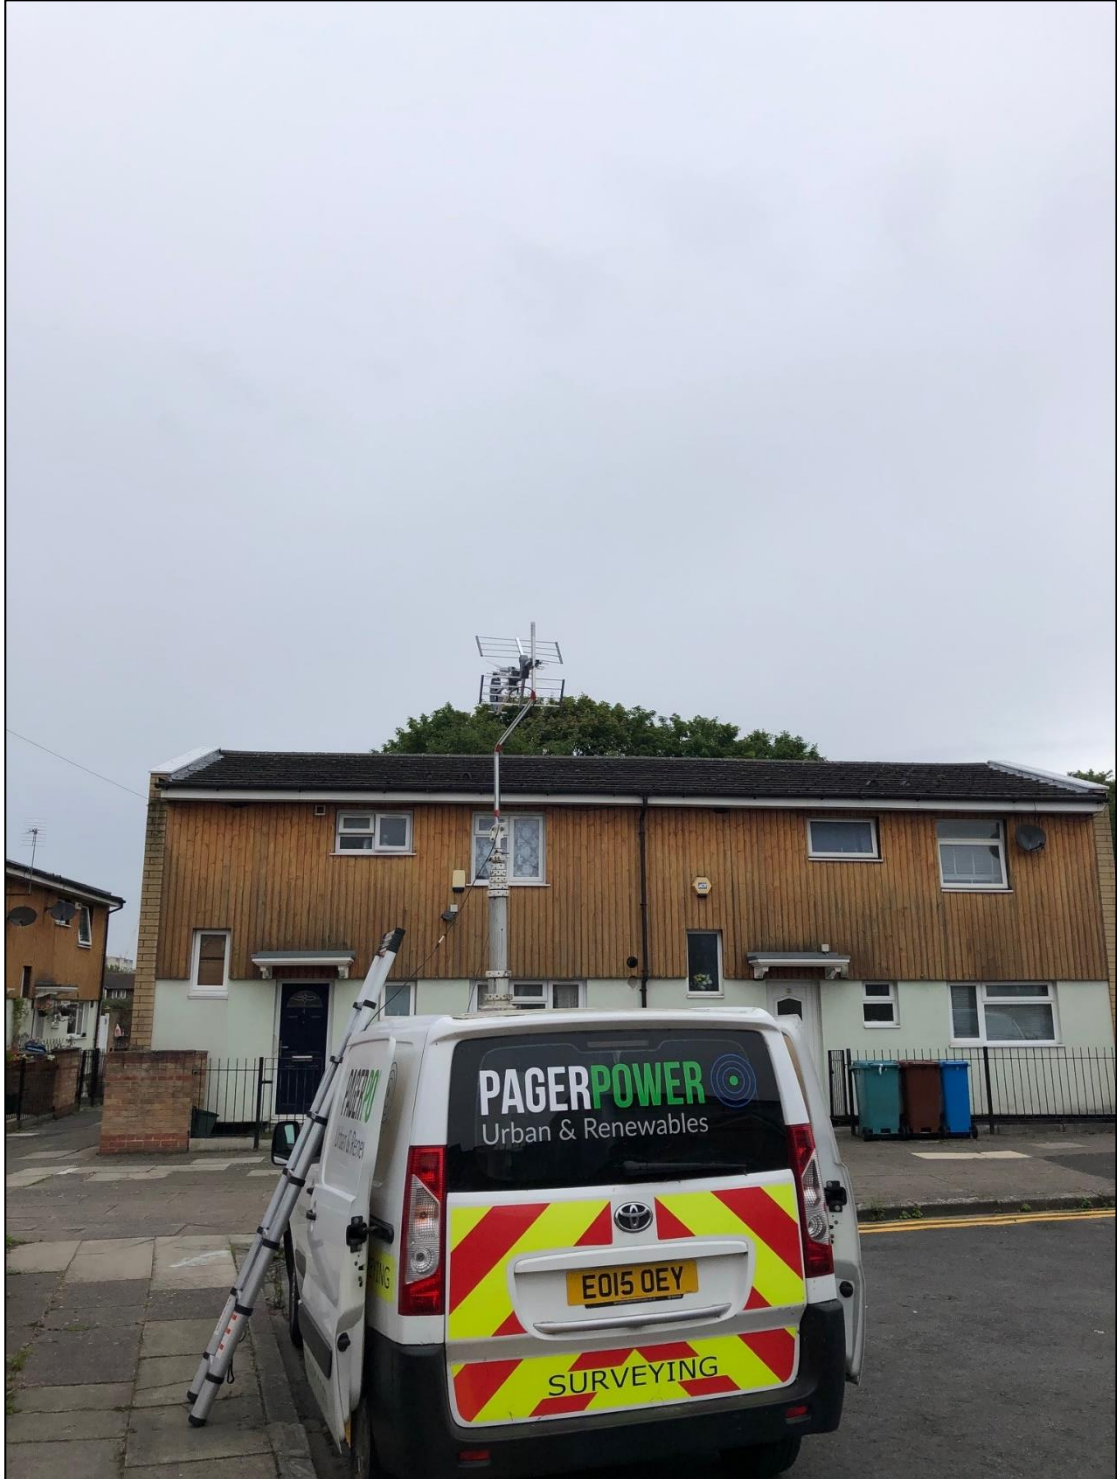
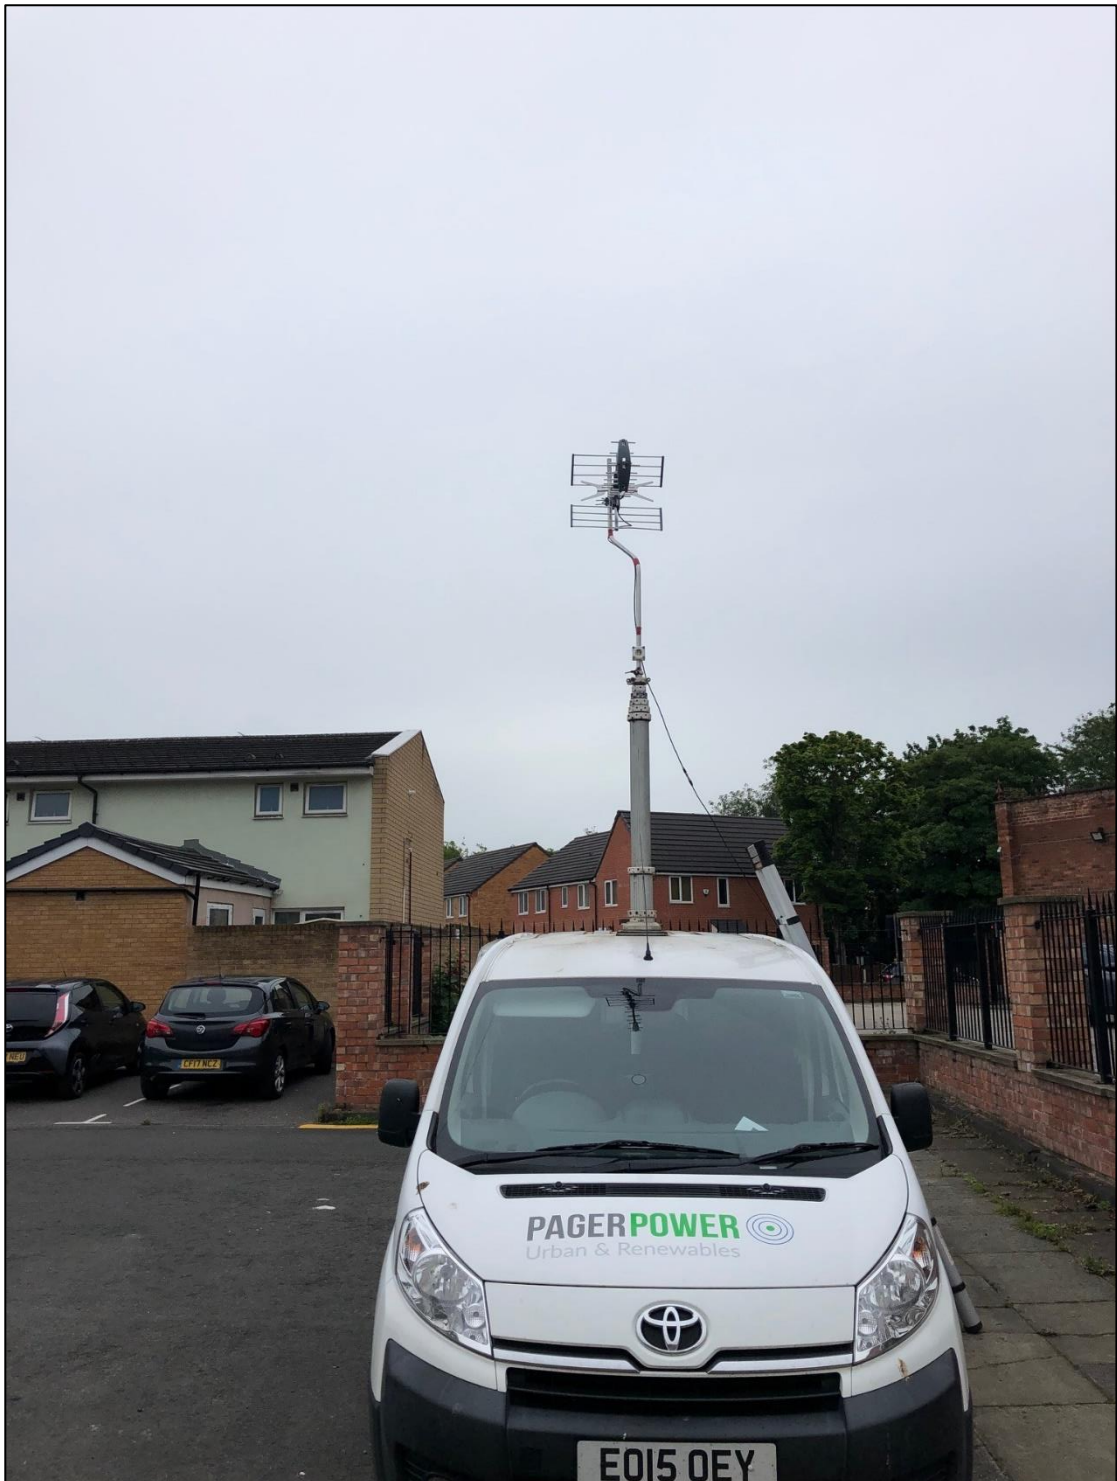
Location 4

| Location | Average Measured Signal Strength (dB) | Distance from development | Remarks | Conclusion |
|---|---|---|---|---|
| 4 | Main multiplexes = 44.3<br>(Moderate)<br>Local multiplexes = 39.3<br>(Moderate) | 1.07km<br>Within the development's shadow zone. | All main multiplexes decoded with fine picture and sound quality. Two local multiplexes did not decode.<br>HP UHF aerials and satellite dishes observed. | The signal strength was moderate at this location for main multiplexes. It begins to rise in strength from this location outward from Plot 7 and 8.<br>Considering the results and the distance, it is unlikely that any interference would be attributable to the development. |

Notes: All aerials observed orientated towards Winter Hill. Satellite dishes observed.

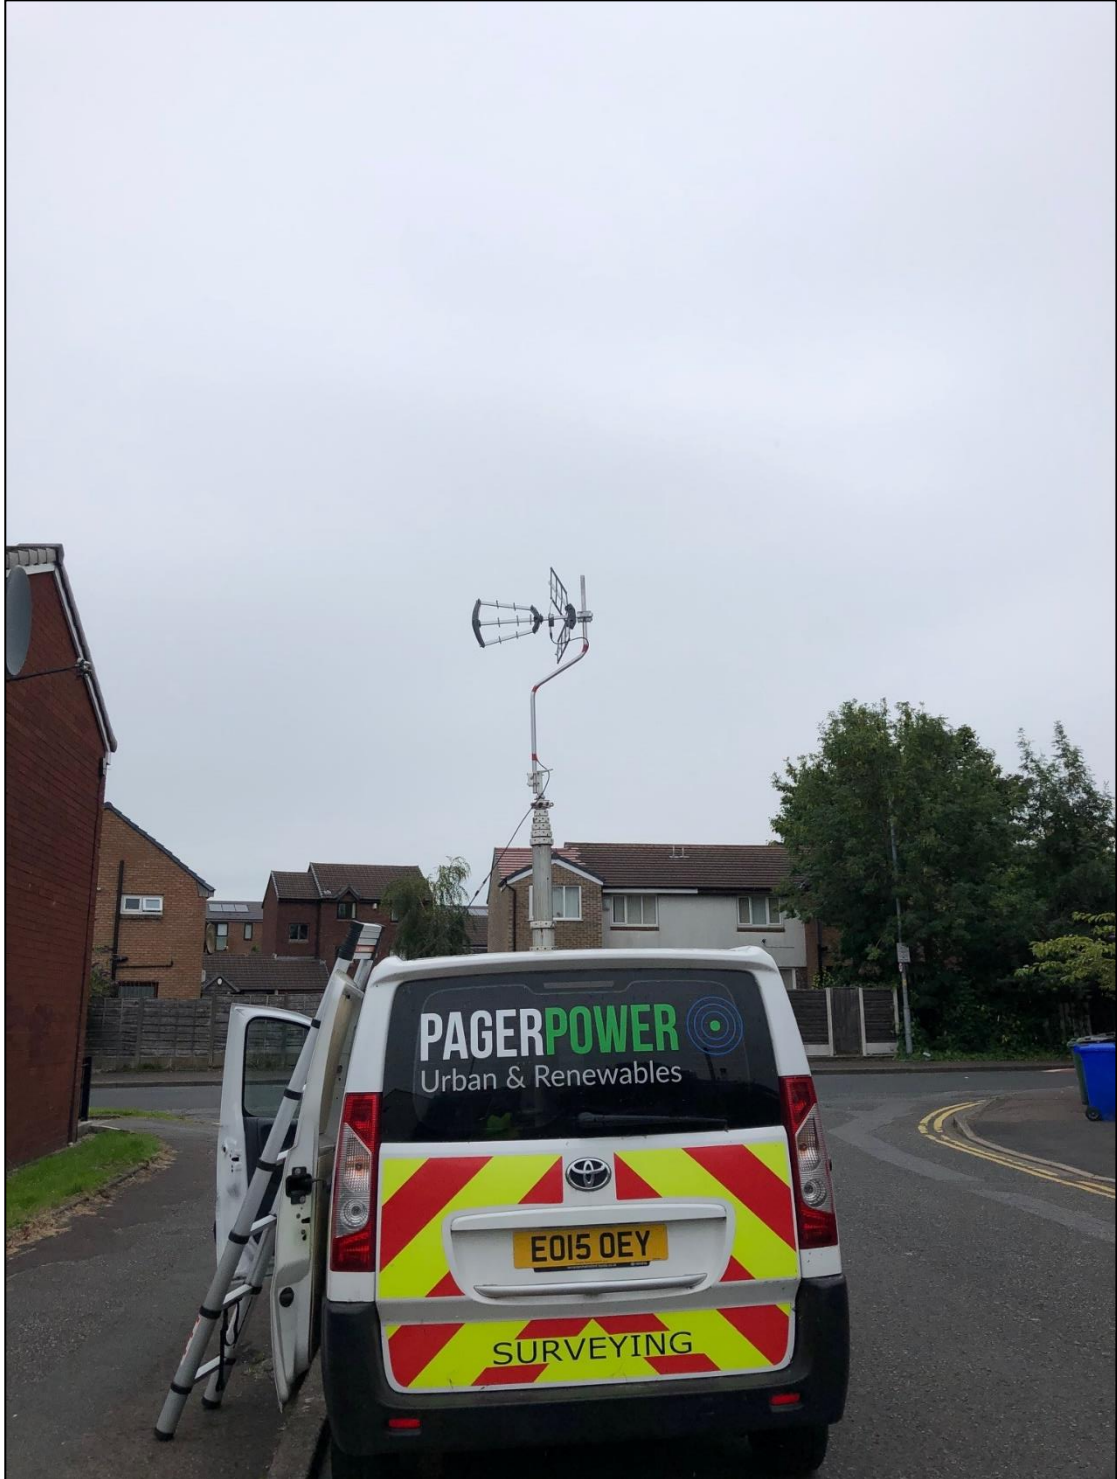
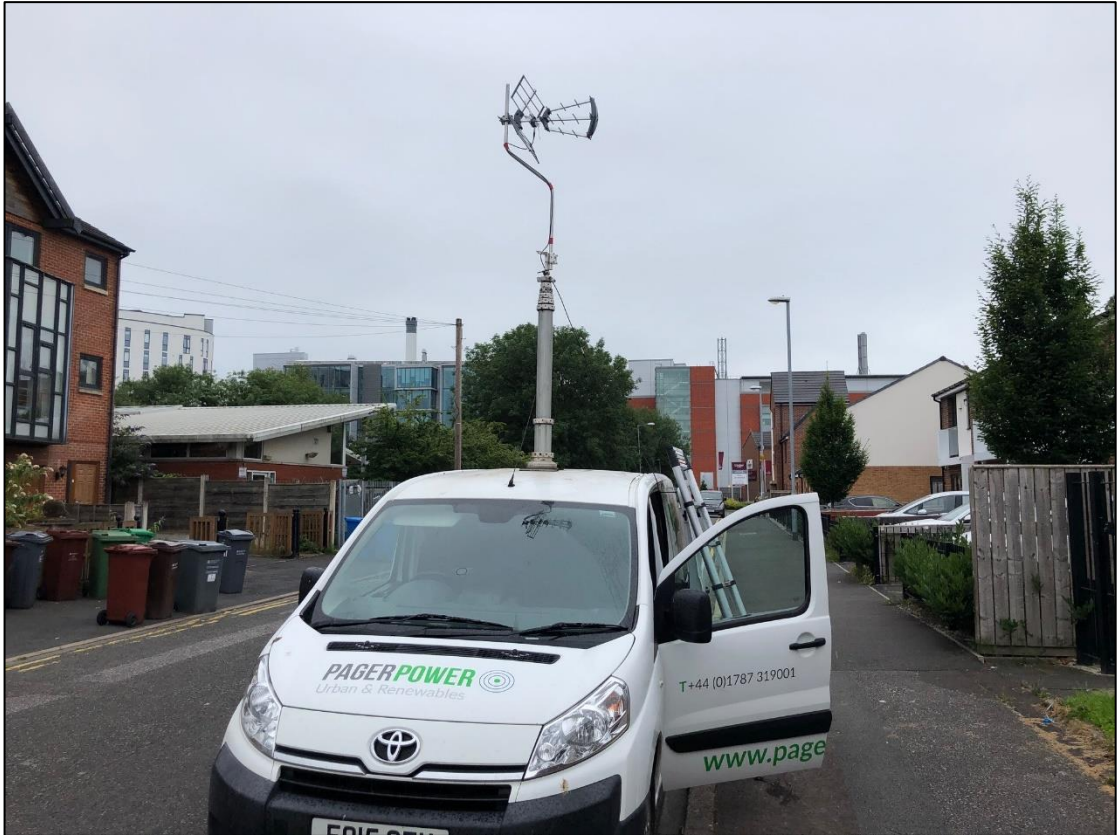
Location 5

| Location | Average Measured Signal Strength (dB) | Distance from development | Remarks | Conclusion |
|---|---|---|---|---|
| 5 | Main multiplexes = 48.4<br>(Good)<br>Local multiplexes = 42.7<br>(Moderate) | 1.31km<br>Within the development's shadow zone. | All main multiplexes decoded with fine picture and sound quality. One local multiplex did not decode.<br>HP UHF aerials and satellite dishes observed. | The signal strength was good at this location for main multiplexes.<br>Considering the results and the distance, it is unlikely that any interference would be attributable to the development. |

Notes: All aerials observed orientated towards Winter Hill. Satellite dishes observed.
