# Television Post-Construction Survey

Sisk Group

Circle Square Affinity Living: Plot 7 and 8

July, 2020

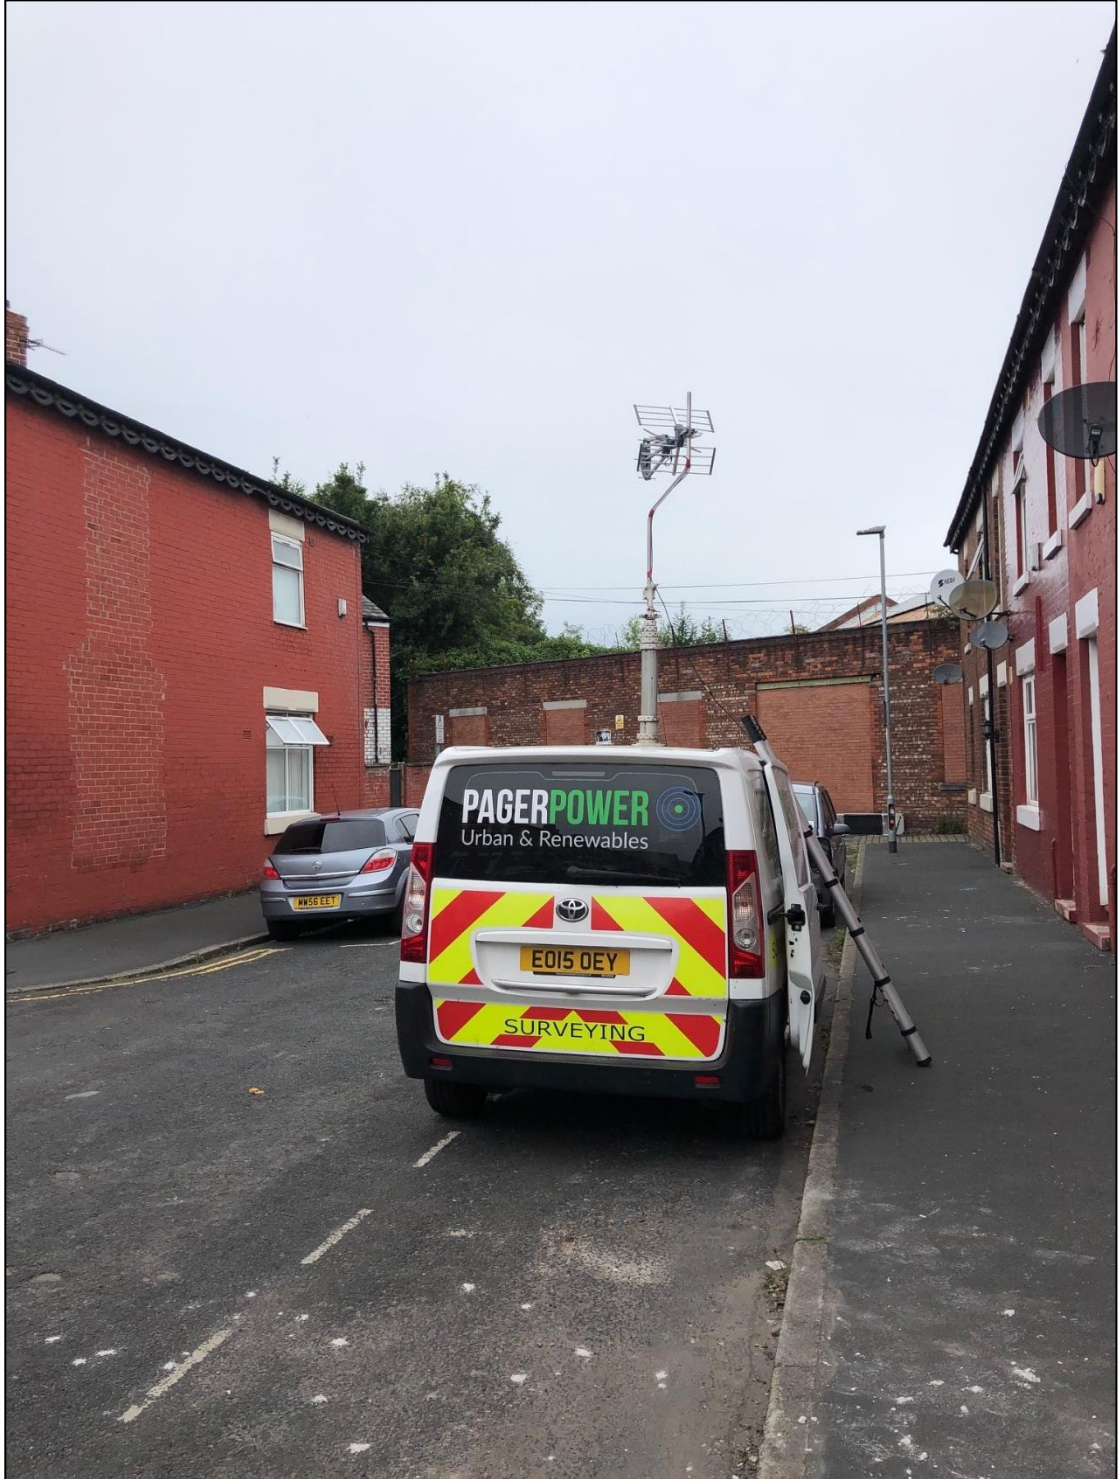
Location 6

| Location | Average Measured Signal Strength (dB) | Distance from development | Remarks | Conclusion |
|---|---|---|---|---|
| 6 | Main multiplexes = 49.1<br>(Good)<br>Local multiplexes = 42.4<br>(Moderate) | 1.78km<br>Within the development's shadow zone. | All main multiplexes decoded with fine picture and sound quality. One local multiplex did not decode.<br>HP UHF aerials and satellite dishes observed. | The signal strength was good at this location for main multiplexes.<br>Considering the results and the distance, it is unlikely that any interference would be attributable to the development. |

Notes: All aerials observed orientated towards Winter Hill. Satellite dishes observed.

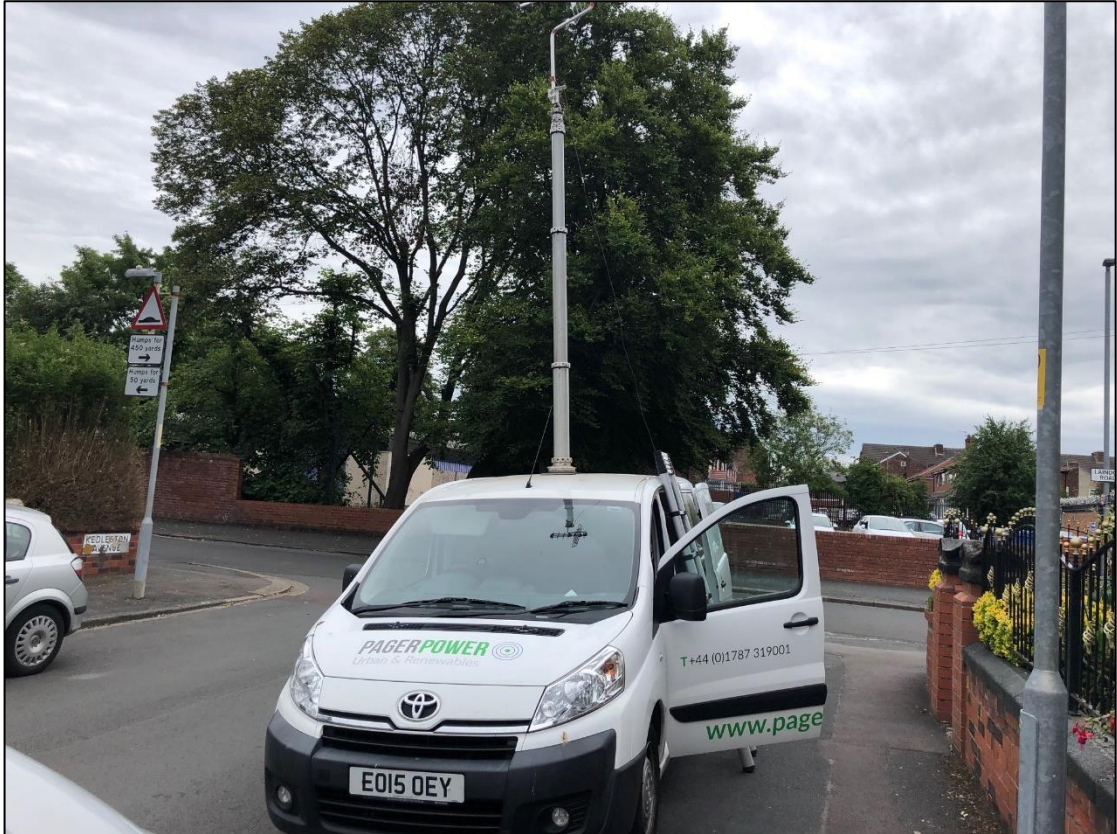
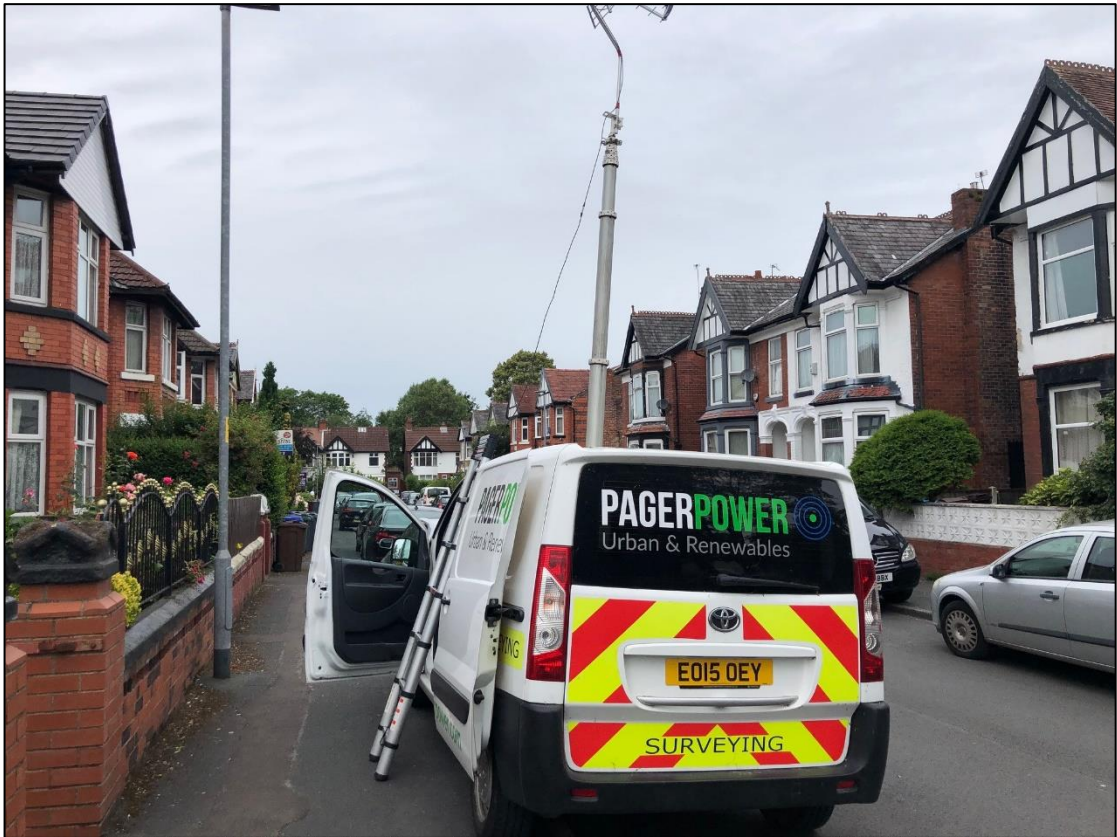
Location 7

| Location | Average Measured Signal Strength (dB) | Distance from development | Remarks | Conclusion |
|---|---|---|---|---|
| 7 | Main multiplexes = 53.6<br>(Good)<br>Local multiplexes = 43.7<br>(Moderate) | 2.43km<br>Within the development's shadow zone. | All main multiplexes decoded with fine picture and sound quality. Two local multiplexes did not decode.<br>HP UHF aerials and satellite dishes observed. | The signal strength was good at this location for main multiplexes.<br>Considering the results and the distance, it is very unlikely that any interference would be attributable to the development. |

Notes: All aerials observed orientated towards Winter Hill. Satellite dishes observed.
