| Project: LONDON ROAD FIRE STATION | | | | |
| Drg Title: BASEMENT OBSERVATIONS<br>SHEET 1 OF 3 | | | | |
| Drg No:<br>060270 / 10-B01-01 | | | | Rev:<br>V01 |

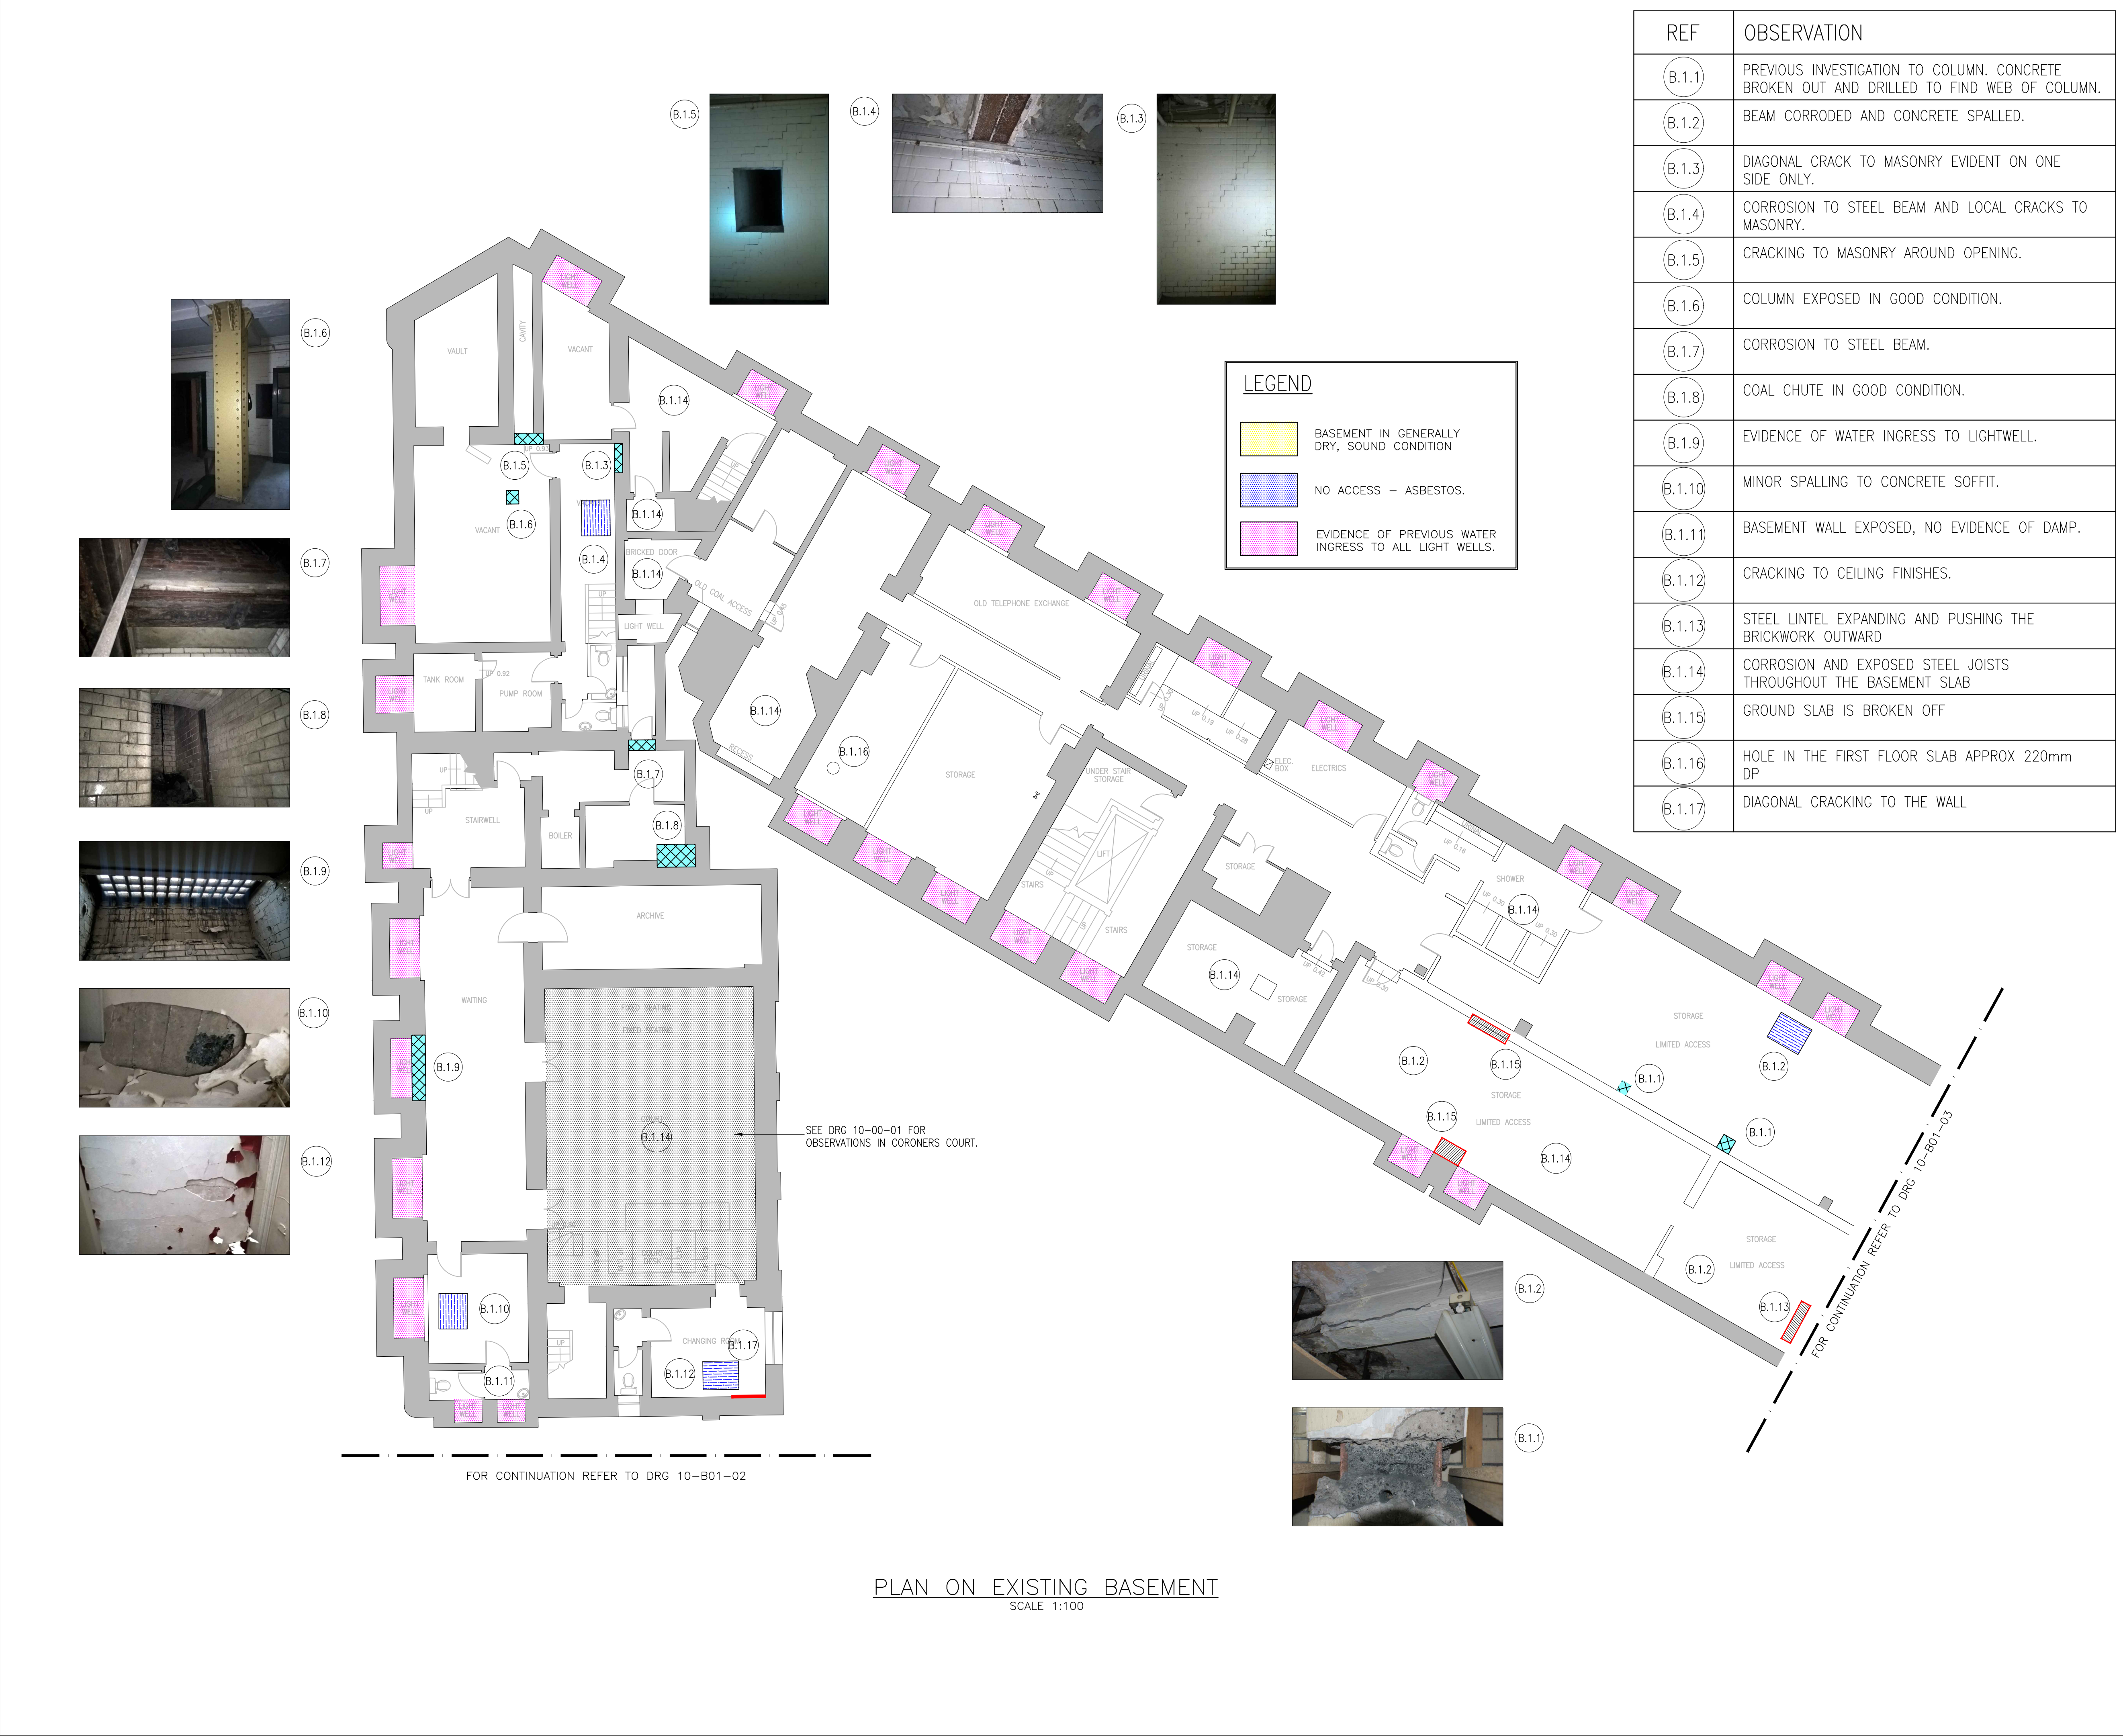
| REF | OBSERVATION |
|---|---|
| B.1.1 | PREVIOUS INVESTIGATION TO COLUMN. CONCRETE BROKEN OUT AND DRILLED TO FIND WEB OF COLUMN. |
| B.1.2 | BEAM CORRODED AND CONCRETE SPALLED. |
| B.1.3 | DIAGONAL CRACK TO MASONRY EVIDENT ON ONE SIDE ONLY. |
| B.1.4 | CORROSION TO STEEL BEAM AND LOCAL CRACKS TO MASONRY. |
| B.1.5 | CRACKING TO MASONRY AROUND OPENING. |
| B.1.6 | COLUMN EXPOSED IN GOOD CONDITION. |
| B.1.7 | CORROSION TO STEEL BEAM. |
| B.1.8 | COAL CHUTE IN GOOD CONDITION. |
| B.1.9 | EVIDENCE OF WATER INGRESS TO LIGHTWELL. |
| B.1.10 | MINOR SPALLING TO CONCRETE SOFFIT. |
| B.1.11 | BASEMENT WALL EXPOSED, NO EVIDENCE OF DAMP. |
| B.1.12 | CRACKING TO CEILING FINISHES. |
| B.1.13 | STEEL LINTEL EXPANDING AND PUSHING THE BRICKWORK OUTWARD |
| B.1.14 | CORROSION AND EXPOSED STEEL JOISTS THROUGHOUT THE BASEMENT SLAB |
| B.1.15 | GROUND SLAB IS BROKEN OFF |
| B.1.16 | HOLE IN THE FIRST FLOOR SLAB APPROX 220mm DP |
| B.1.17 | DIAGONAL CRACKING TO THE WALL |
