# DAYTIME BAT SURVEY & NESTING BIRD SURVEY AT 84-86 OLDHAM STREET, MANCHESTER

APRIL 2020

**RACHEL HACKING ECOLOGY**

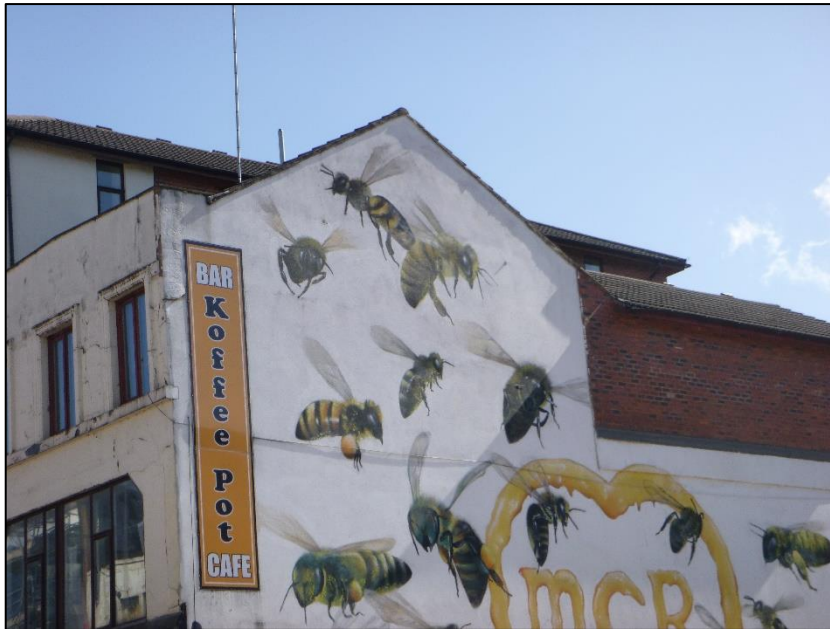
- 3.1 84-86 Oldham Street are a pair of attached properties. The properties are constructed from brick and partially rendered (see Photographs 1 and 2). The external brickwork is complete and intact, offering no damaged bricks for bats to exploit. The render is also complete, with no cracks in the render. The ground-level shops have metal shutters which are well-sealed. The window frames are well-sealed to the surrounding masonry.

Photograph 1 showing the exterior of the property

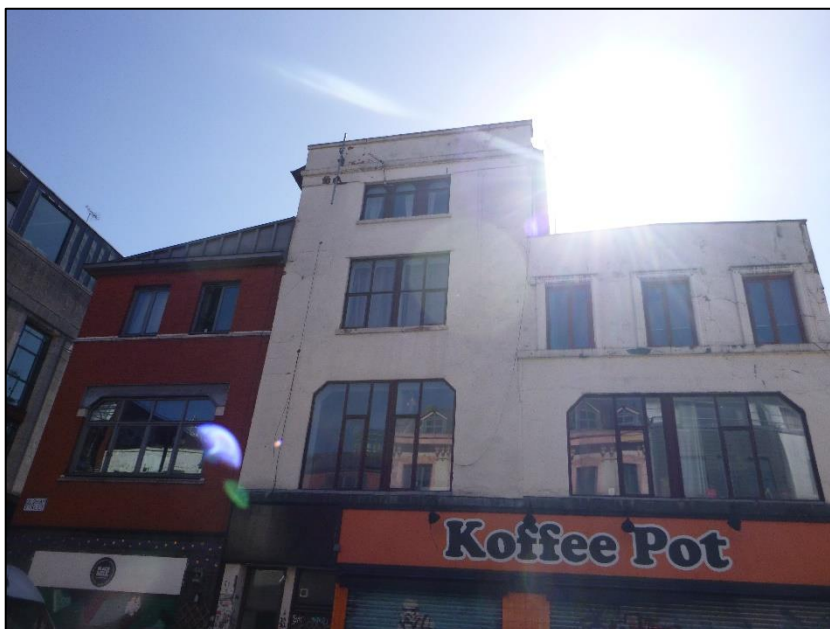
Photograph 2 showing the front elevation

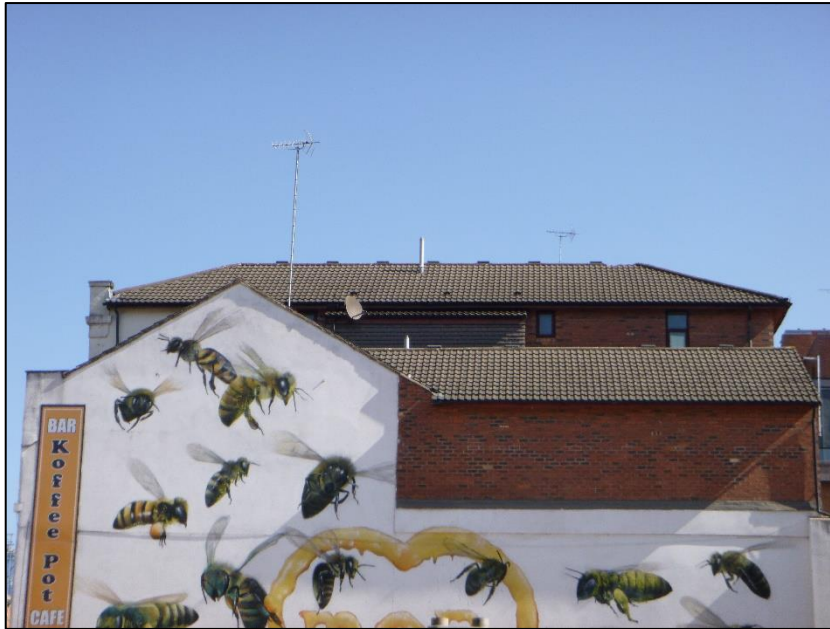
- 3.2 The properties have pitched roofing, which are roofed with clay tiles. The roof tiles are all in situ, and flush to one another (see Photograph 3). The roof edges are mortared. The clay ridge tiles are in position and have ventilation tiles present. None of roof tiles are slipped or broken.

**Photograph 3 showing the roof of the property**

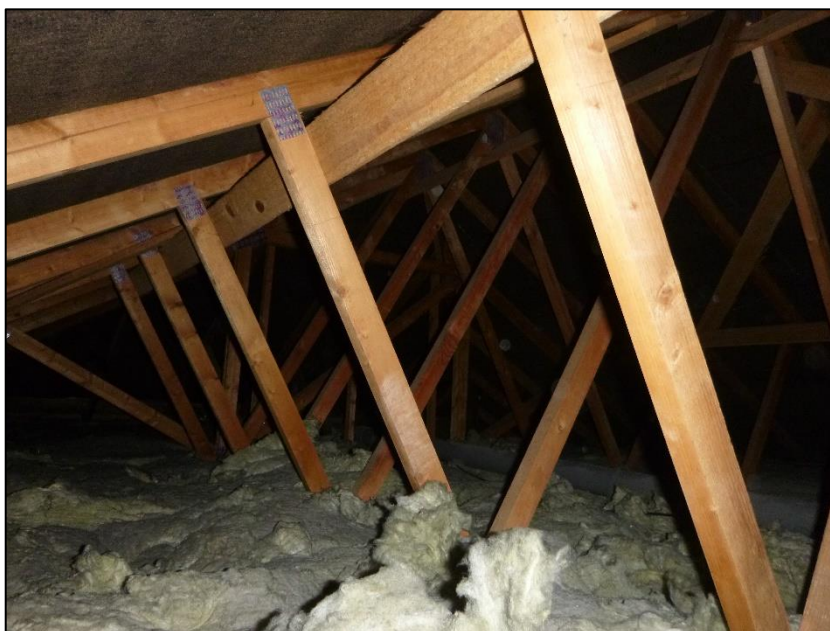
- 3.3 The property upper floors do not provide suitable bat roosting habitat. The property roof voids have wooden roof joists which do not have cracks or gaps for bats to exploit (see Photographs 4 and 5). The roof voids are lined throughout with felt, and there are no major tears or rips in the lining. The roof voids are insulated throughout. The roof voids do not have daylight at the roof edges, suggesting the voids are well-sealed. No evidence of bat activity was found in the roof voids.

**Photograph 4 showing the roof joists**

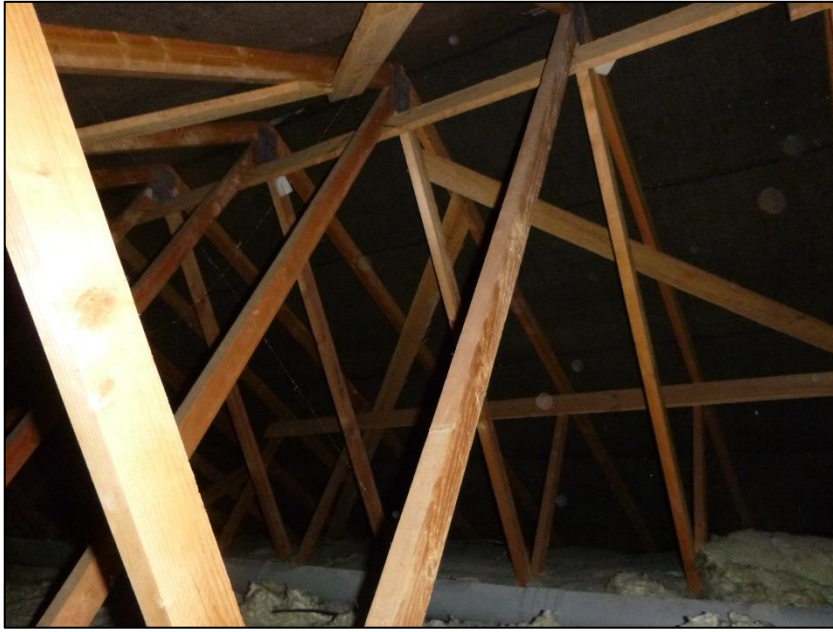
**Photograph 5 showing the roof void**
