# Chandos Hall / Echo Street Additional Ground Investigation, Manchester

## Phase 2 Additional Ground Investigation

Curtins Ref: 065374-CUR-00-XX-RP-GE-005-P02

Site Address: Chandos Hall, Echo Street, Manchester, M1 3QJ

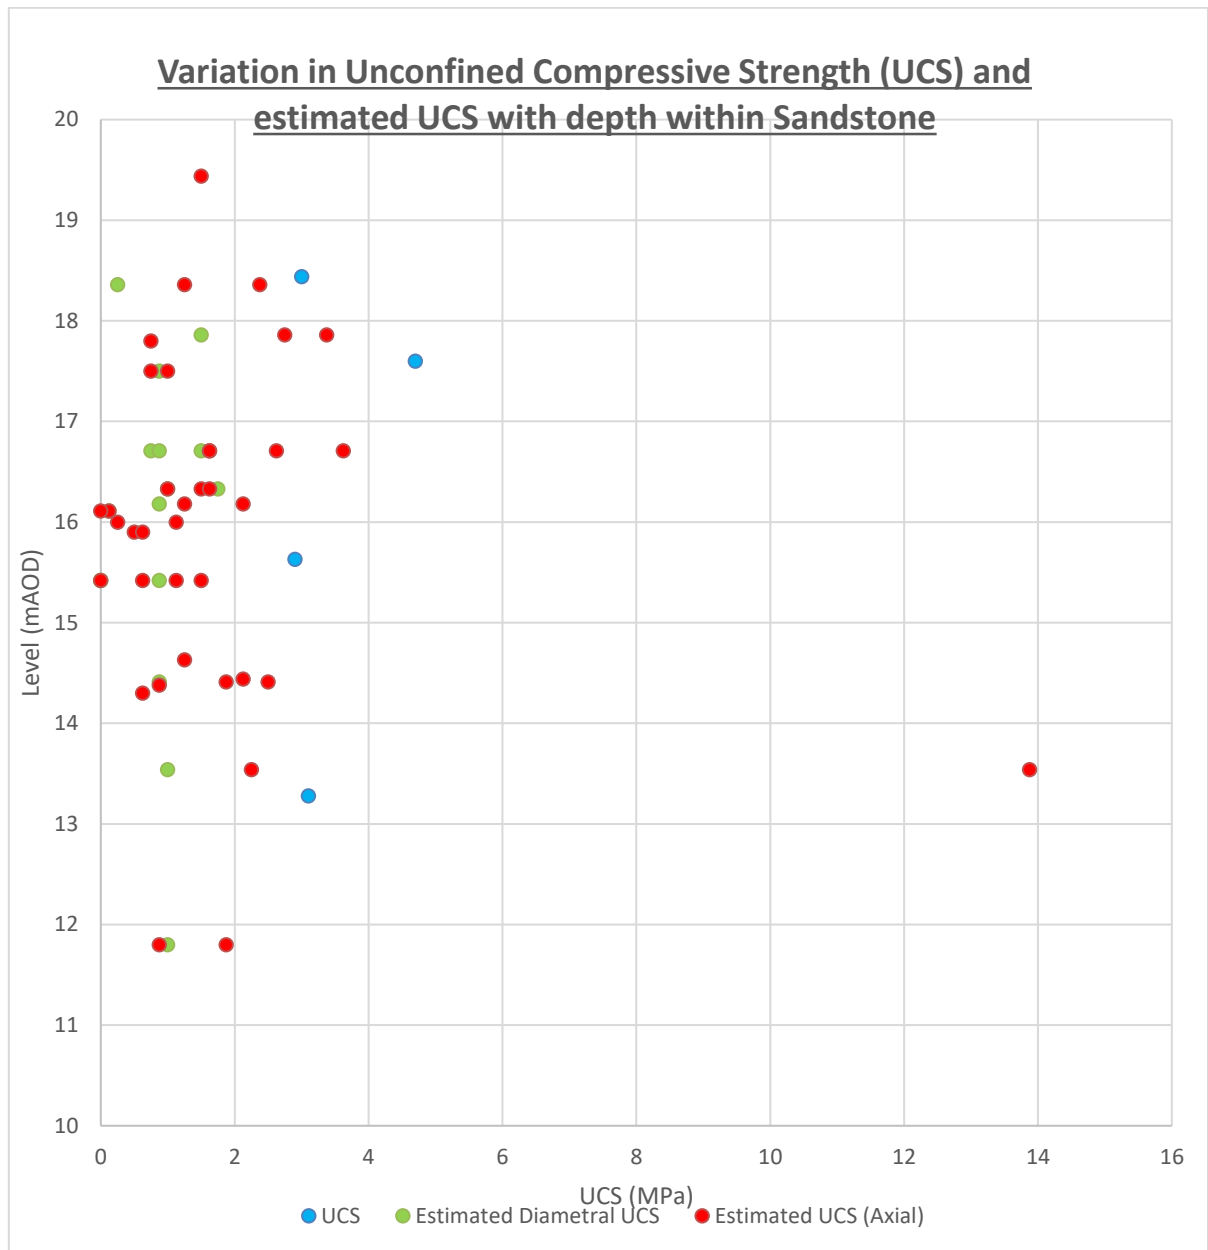
**Figure 4.5b** – UCS and estimated UCS vs Depth within Sandstone.

*Figure 4.5b*, summarises the UCS, estimated axial UCS and estimated diametral UCS test results against depth.

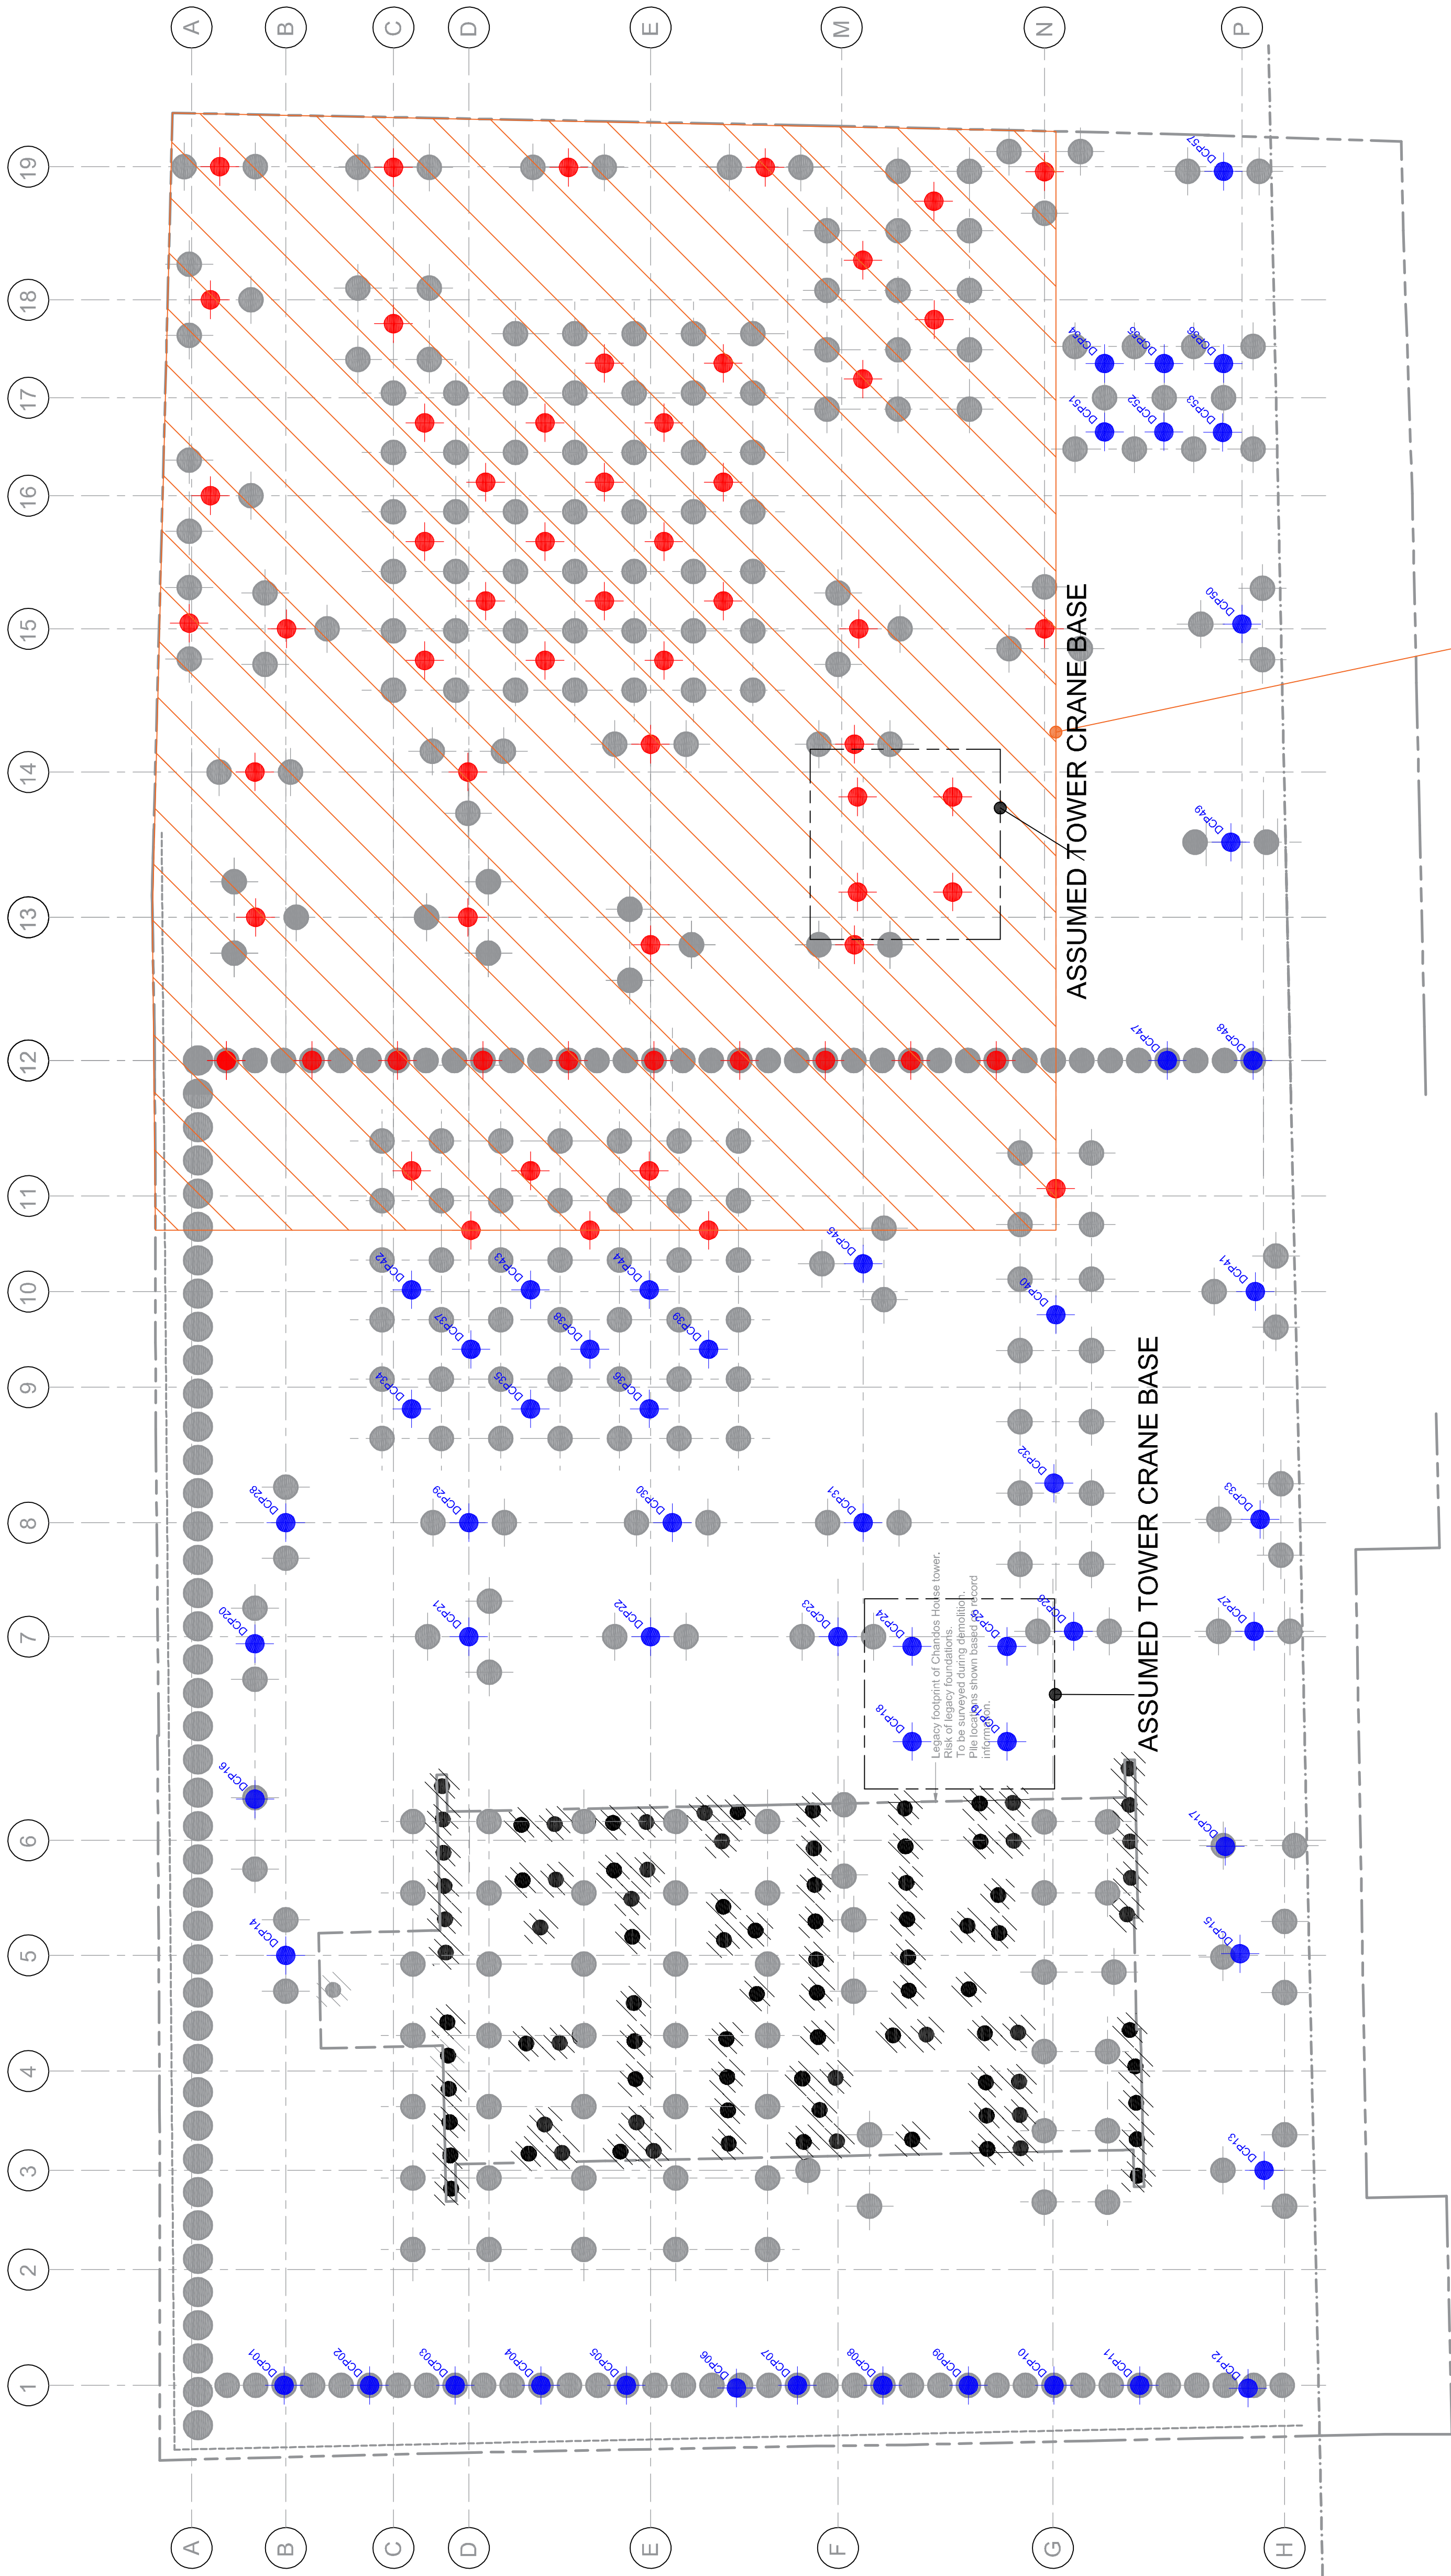
**NB:**  
**ALL EXPLORATORY HOLE LOCATIONS  
HAVE BEEN SURVEYED**

ASSUMED "**MEDIUM RISK**" UXO AREA, AS PER '1ST LINE DEFENCE REPORT'

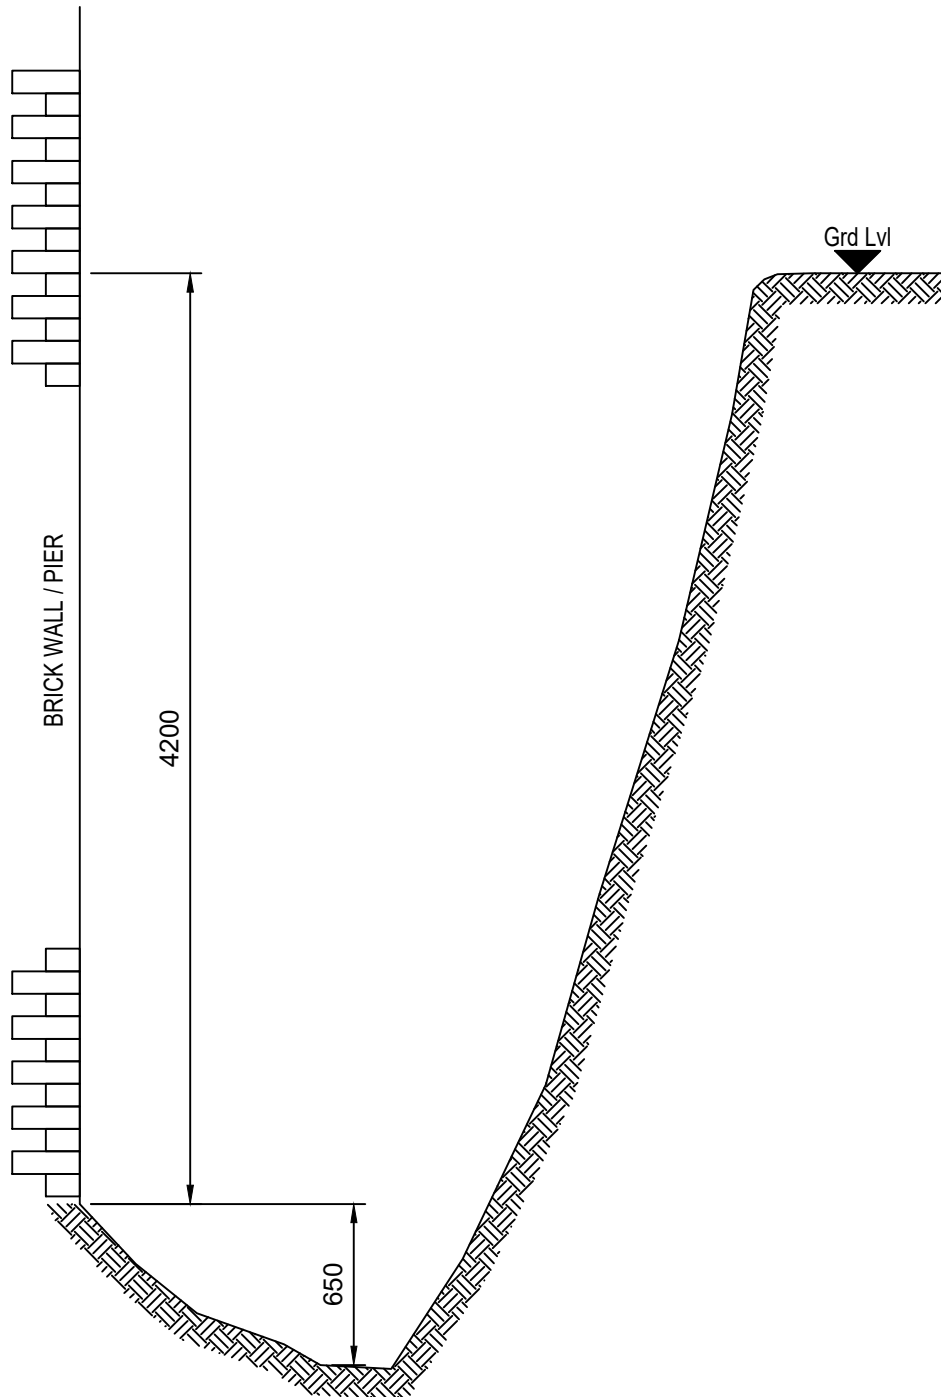
NO EVIDENCE OF FOUNDATIONS IDENTIFIED TO BASE OF HOLE.  
REFER TO CURTINS TRIAL PIT LOG FOR STRATA DETAILS.  
TRIAL PIT UNDERTAKEN AGAINST BRICK PIER.

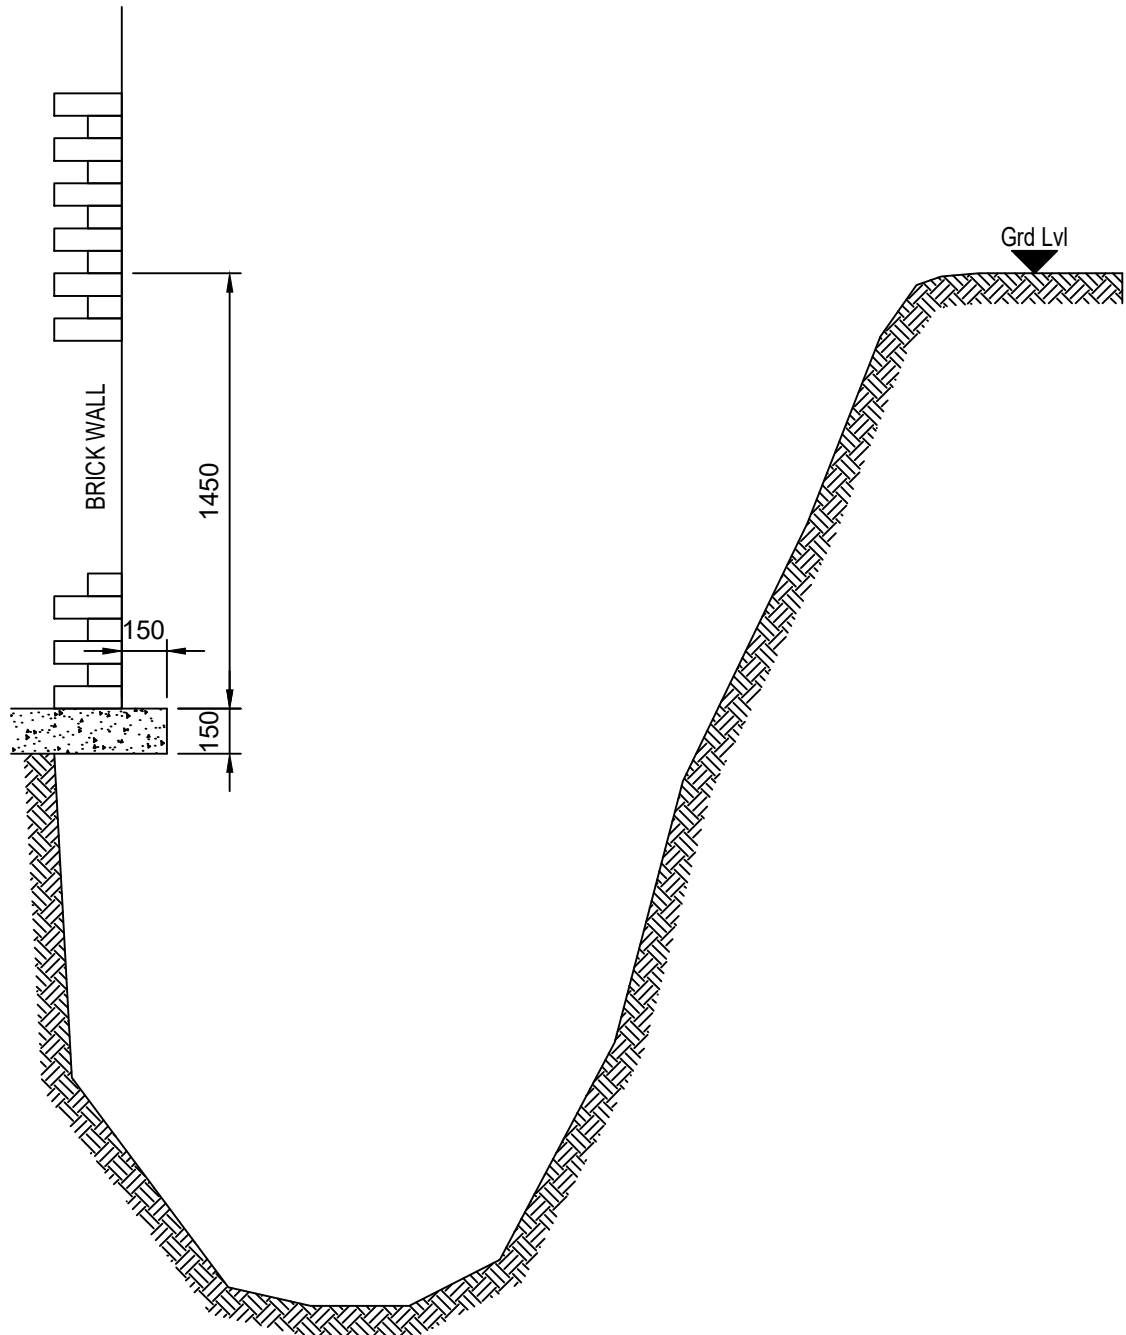
BASE OF FOUNDATION IDENTIFIED NATURAL GROUND BELOW.  
REFER TO CURTINS TRIAL PIT LOG FOR STRATA DETAILS.  
TRIAL PIT UNDERTAKEN PARTLY AGAINST BRICK PIER AND  
PARTLY AGAINST BRICK ARCH INFILL.

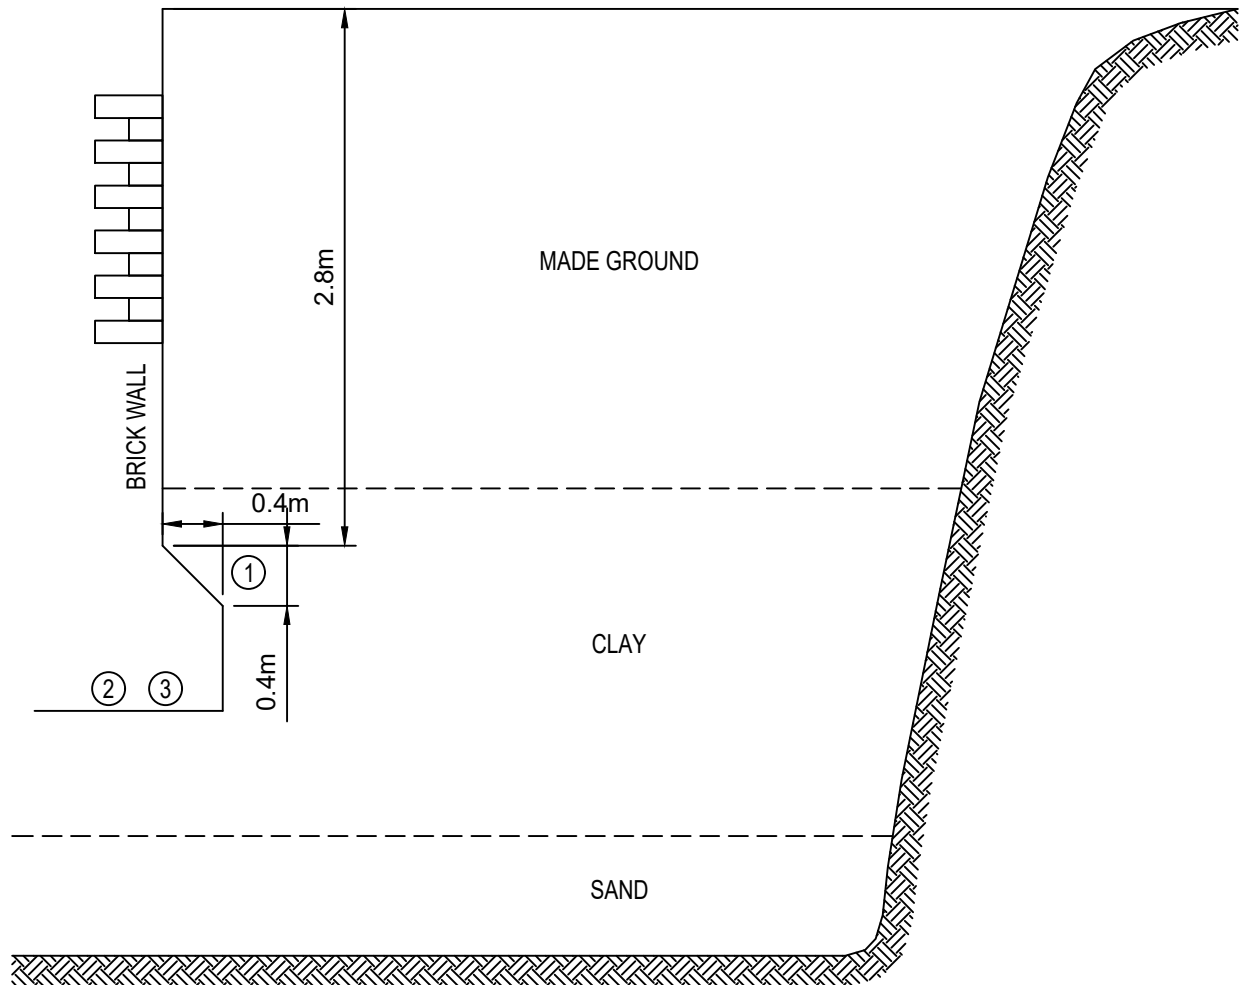
FACING WEST

1. BRICK WALL STEPS OUT 0.40m AT 2.80 bgl.
2. NO PROTRUDING FOUNDATION IDENTIFIED. BRICK WALL RESTS DIRECTLY ONTO UNDERLYING STIFF CLAY STRATA.
3. NO PROTRUDING FOUNDATION IDENTIFIED TO THE WEST. SEE SKETCH C FOR ADDITIONAL DETAILS.
4. REFER TO CURTINS TRIAL PIT LOG TP102A FOR STRATA DETAILS.
5. TRIAL PIT UNDERTAKEN PERPENDICULAR TO VIADUCT PIER.

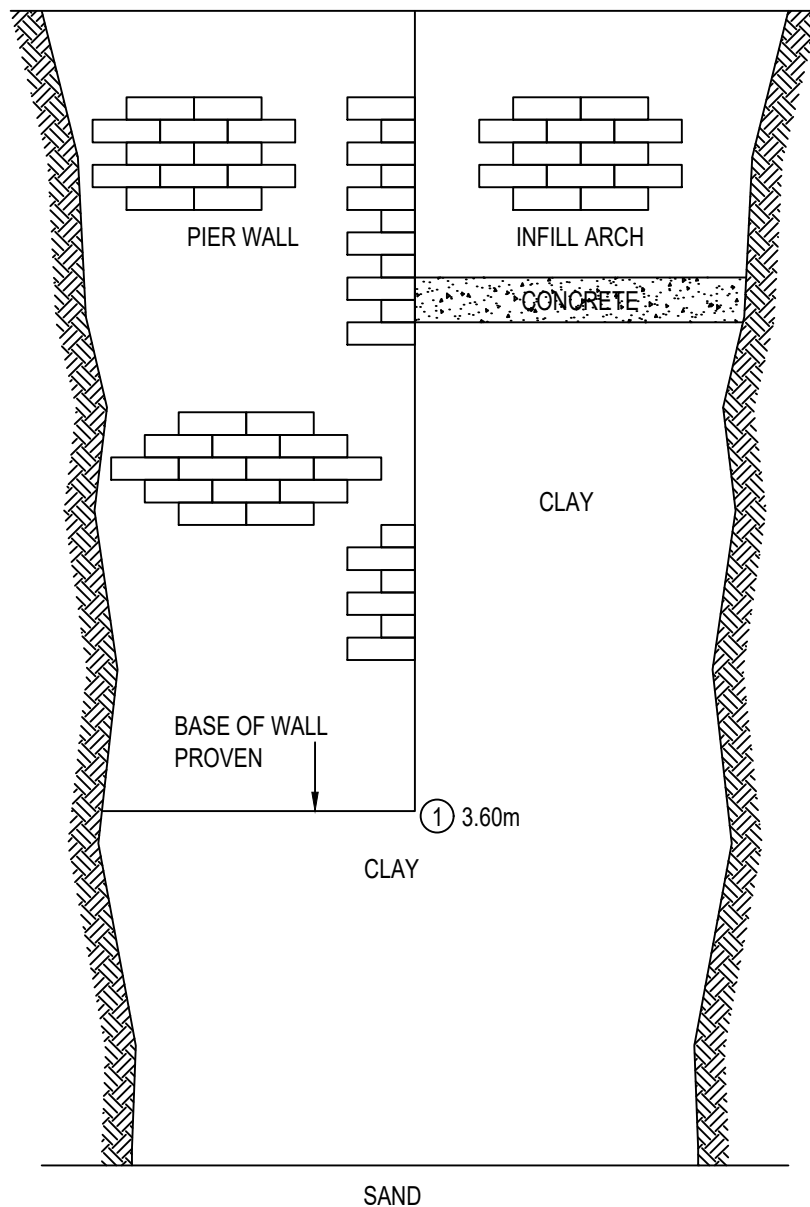
FACING SOUTH

1. NO FOUNDATIONS PROTRUDE WEST AT THE BASE OF THE VIADUCT PIER.
2. CONCRETE AT 1.45m bgl POTENTIALLY FOUNDATIONS OF BRICK INFILL. (ARCH).
3. REFER TO CURTINS TRIAL PIT LOG TP102A FOR STRATA DETAILS

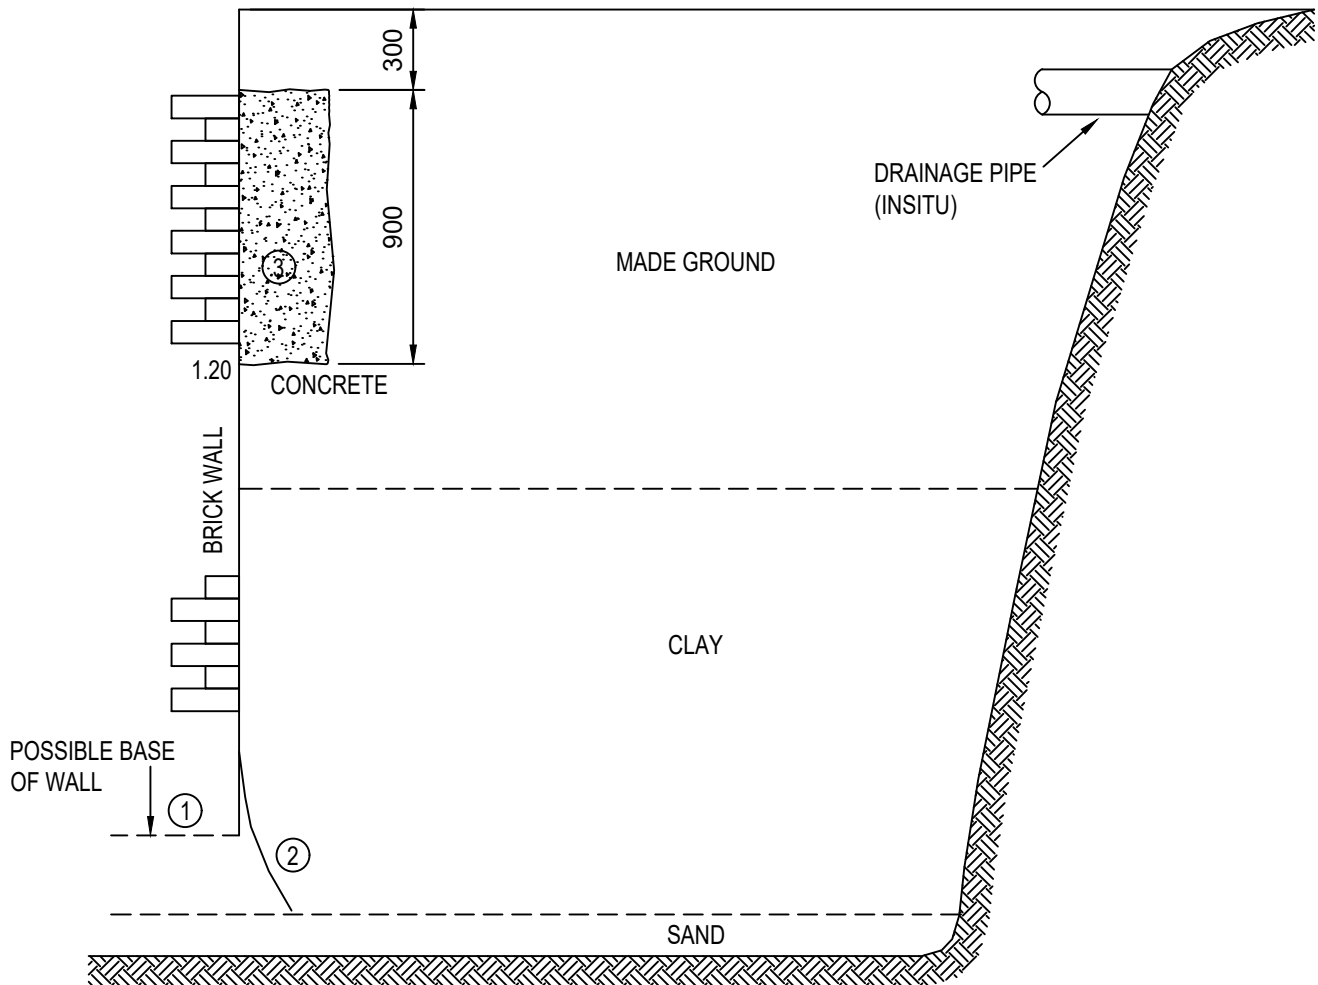
FACING WEST

1. BASE OF VIADUCT PIER NOT ENCOUNTERED IN THIS TRIAL PIT. STIFF CLAY ENCOUNTERED THROUGHOUT THE TRIAL PIT NOT PREVIOUSLY DISTURBED. INTERPRETTED THAT BASE OF WALL IS FOUND IN SIMILAR GROUND CONDITIONS AS TP102A, AND AS SUCH IS ASSUMED TO BEAR ONTO STIFF CLAY. NO EVIDENCE OF FOOTING PROTRUDING NORTH INTO TRIAL PIT TO 5.00 bgl.
2. DUE TO RESTRICTIONS ON SITE, IT WAS NOT POSSIBLE TO SAFELY EXCAVATE CLAY FROM BRICK WALL. THE EXCAVATOR COULD NOT BE MOVED BACK FROM THE PIT (NORTH) DUE TO ELEVATION CHANGE BEHIND IT.
3. SHALLOW CONCRETE NOT THOUGHT TO REPRESENT FOUNDATION. IT IS NOT CLEAR WHAT THE PURPOSE OF THE CONCRETE IS.
4. REFER TO CURTINS TRIAL PIT LOG TP103A FOR STRATA DETAILS.
5. TRIAL PIT UNDERTAKEN PERPENDICULAR TO BRICK PIER.

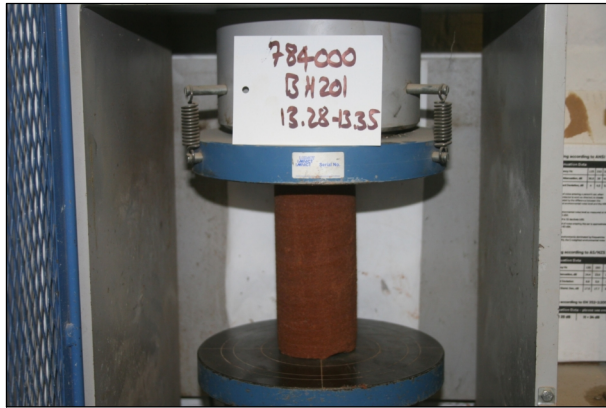
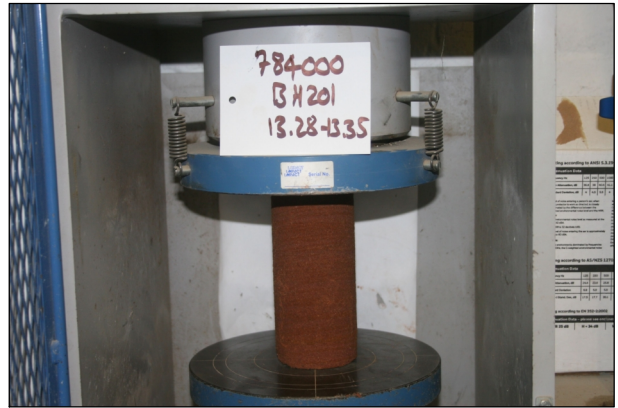
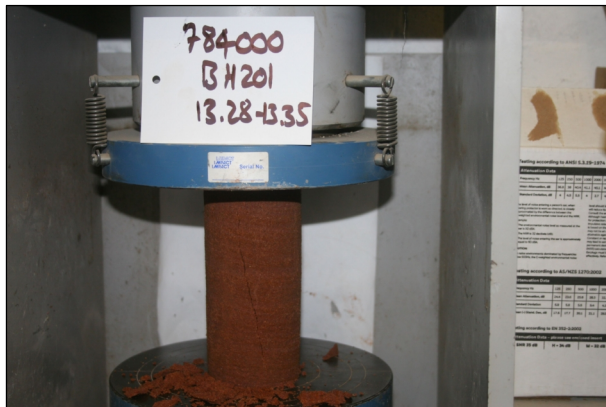
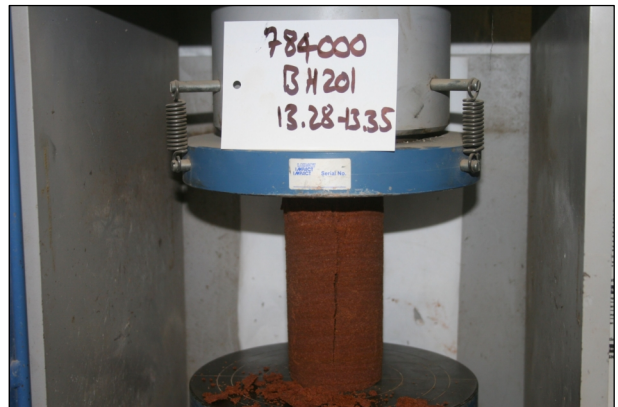
Sample tolerance checks: Straightness: **PASS**. Flatness: **PASS**. Perpendicularity: **PASS**.

Front view (pre-test)

Rear view (pre-test)

Front view (post-test)

Rear view (post-test)

Samples delivered from site to storage facility. Samples are stored in a frost free environment, at temperatures  $>4^{\circ}\text{C}$   
Compression machine: Impact CT340 2000kN Auto Compression Machine Serial No. CT340-22. SSL No. 011076

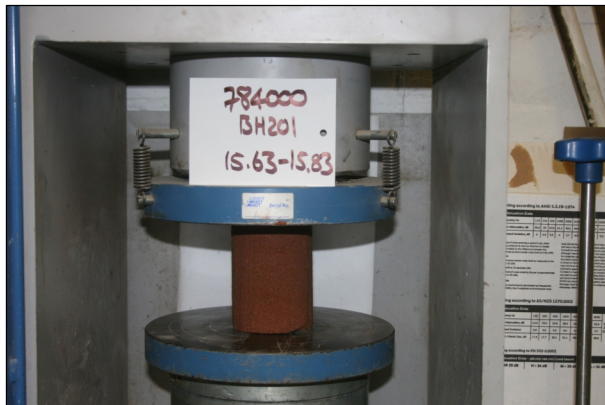
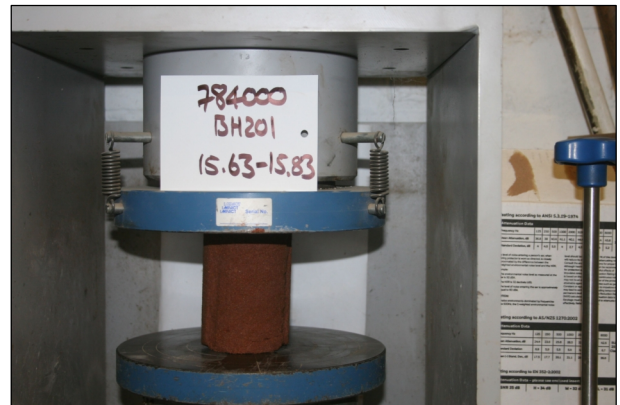
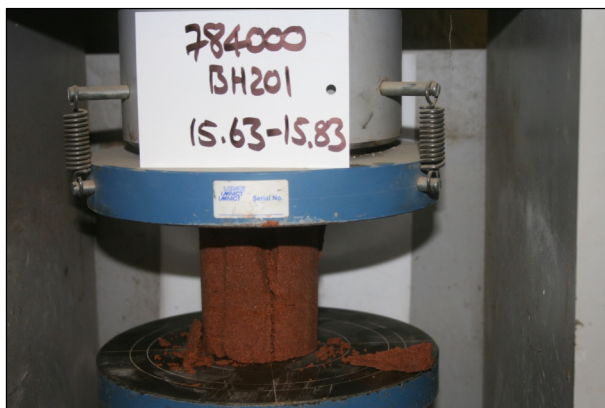
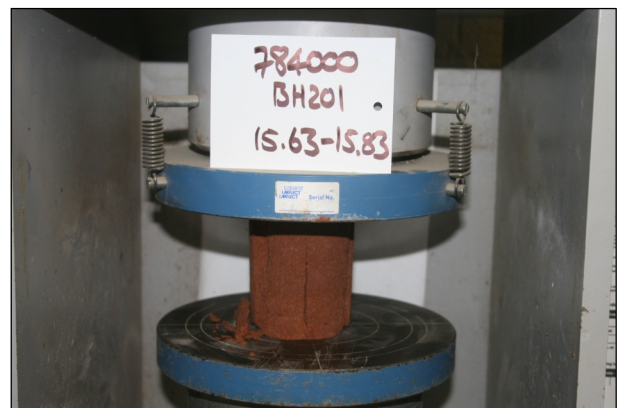
Sample tolerance checks: Straightness: **PASS**. Flatness: **PASS**. Perpendicularity: **FAIL**.

Front view (pre-test)

Rear view (pre-test)

Front view (post-test)

Rear view (post-test)

Samples delivered from site to storage facility. Samples are stored in a frost free environment, at temperatures  $>4^{\circ}\text{C}$   
Compression machine: Impact CT340 2000kN Auto Compression Machine Serial No. CT340-22. SSL No. 011076

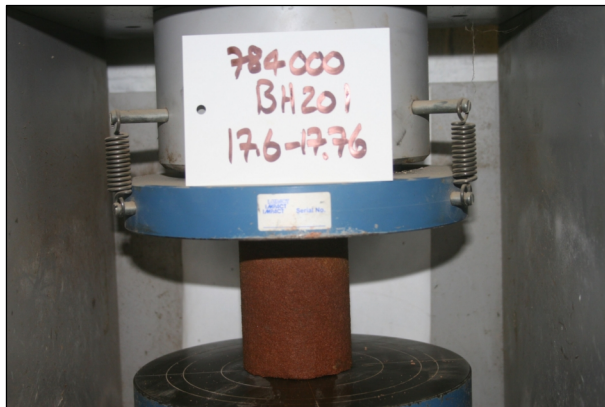
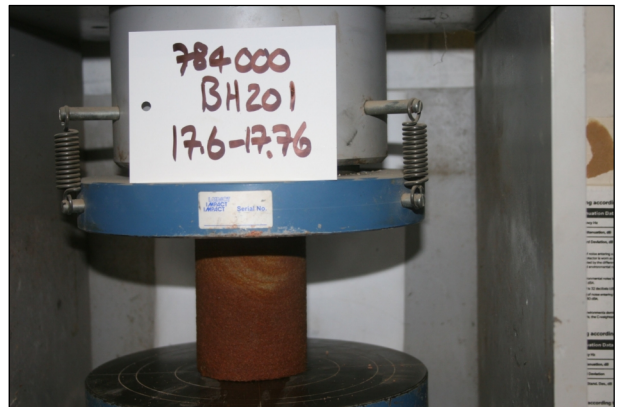
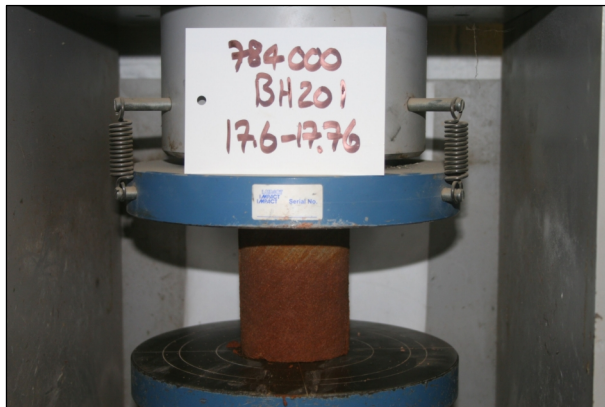
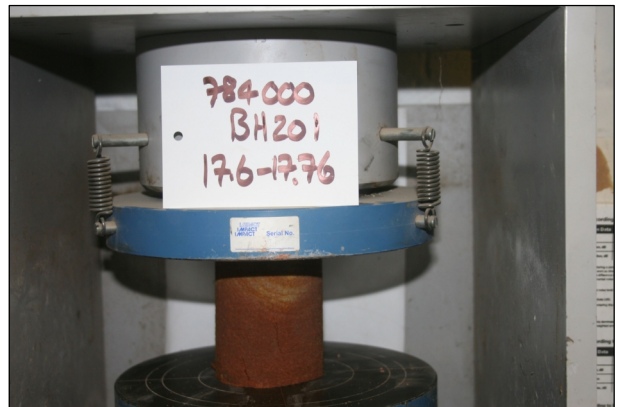
Sample tolerance checks: Straightness: **PASS**. Flatness: **PASS**. Perpendicularity: **FAIL**.

Front view (pre-test)

Rear view (pre-test)

Front view (post-test)

Rear view (post-test)

Samples delivered from site to storage facility. Samples are stored in a frost free environment, at temperatures  $>4^{\circ}\text{C}$   
Compression machine: Impact CT340 2000kN Auto Compression Machine Serial No. CT340-22. SSL No. 011076

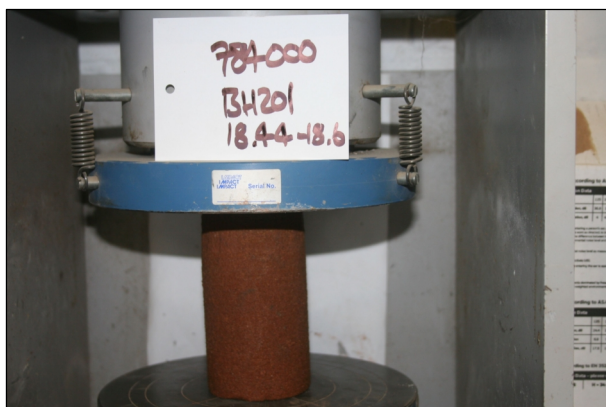
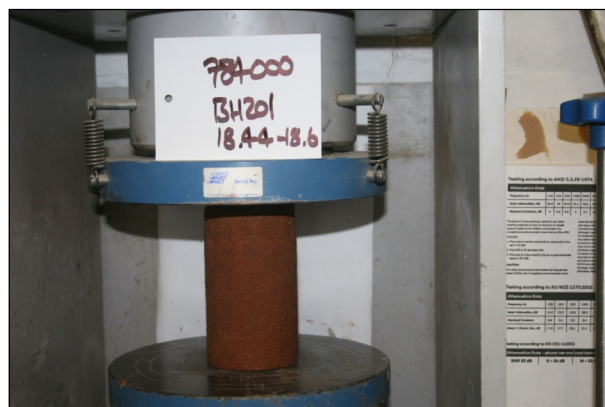
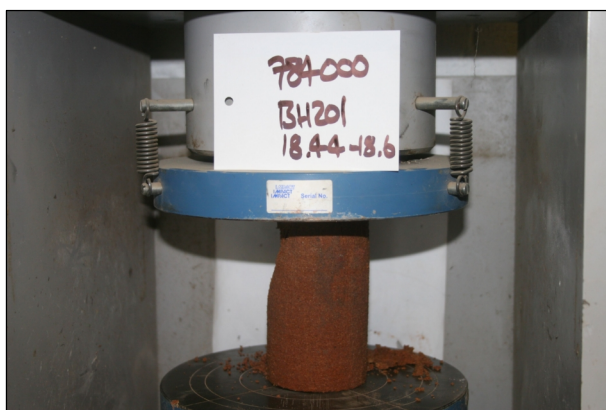
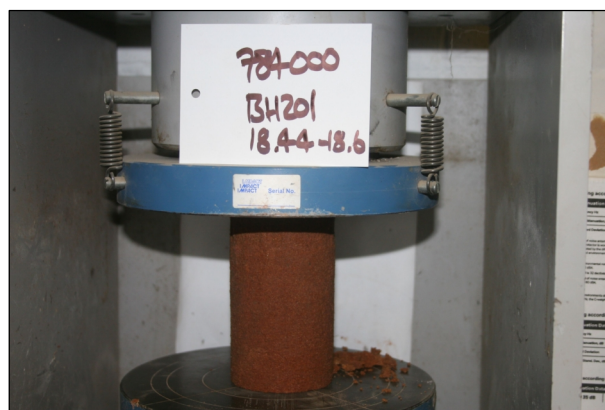
Sample tolerance checks: Straightness: **PASS**. Flatness: **PASS**. Perpendicularity: **PASS**.

Front view (pre-test)

Rear view (pre-test)

Front view (post-test)

Rear view (post-test)

Samples delivered from site to storage facility. Samples are stored in a frost free environment, at temperatures  $>4^{\circ}\text{C}$   
Compression machine: Impact CT340 2000kN Auto Compression Machine Serial No. CT340-22. SSL No. 011076

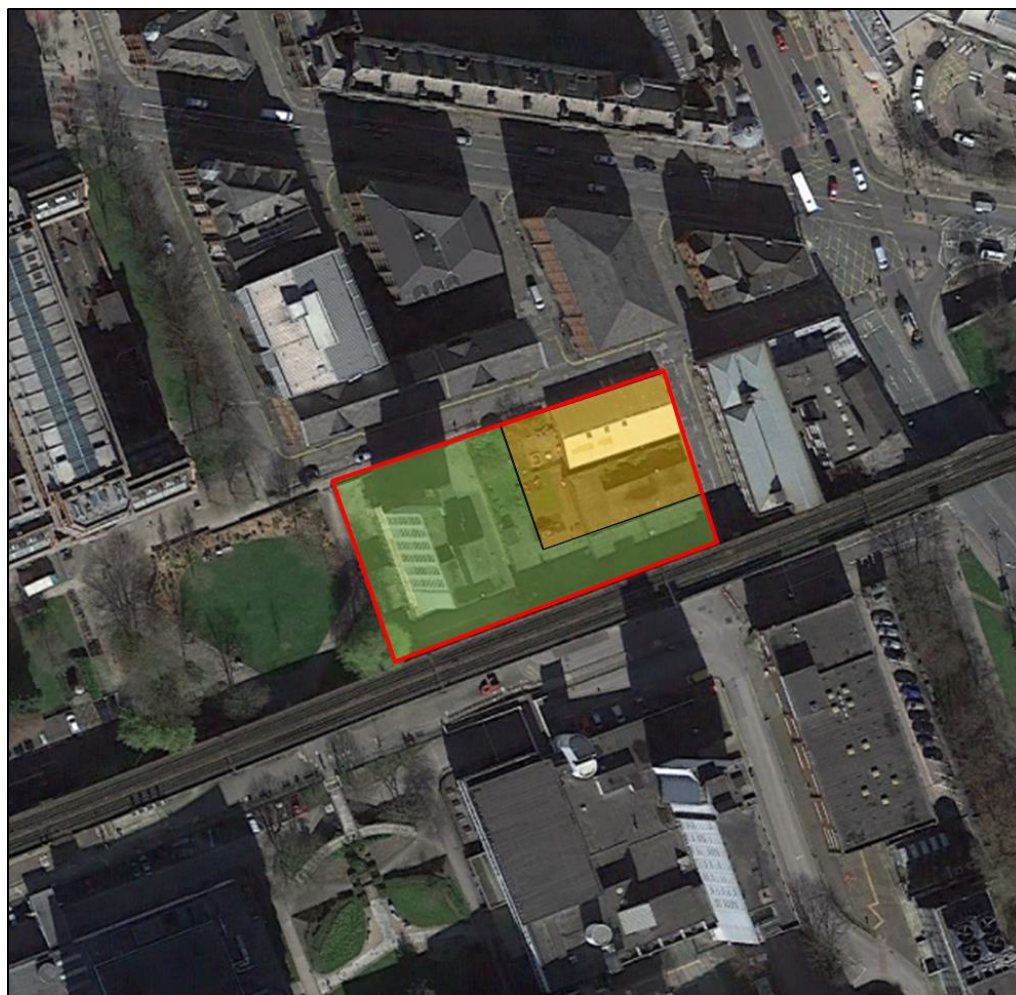
Risk Map

For indicative purposes – not to scale

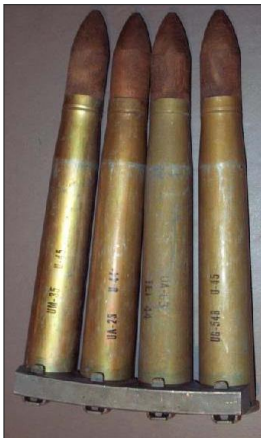
3in Unrotated Projectile (UP) Anti-Aircraft Rocket ("Z" Battery)

| Remarks | As a short range rocket-firing anti-aircraft weapon developed for the Royal Navy. It was used extensively by British ships during the early days of World War II. The UP was also used in ground-based single and 128-round launchers known as Z Batteries. Shell consists of a steel cylinder reduced in diameter at the base and threaded externally to screw into the shell ring of the rocket motor |
