# DAYTIME BAT SURVEY & NESTING BIRD SURVEY AT LAND OFF SWAN STREET, MANCHESTER

**JUNE 2020**

**RACHEL HACKING ECOLOGY**

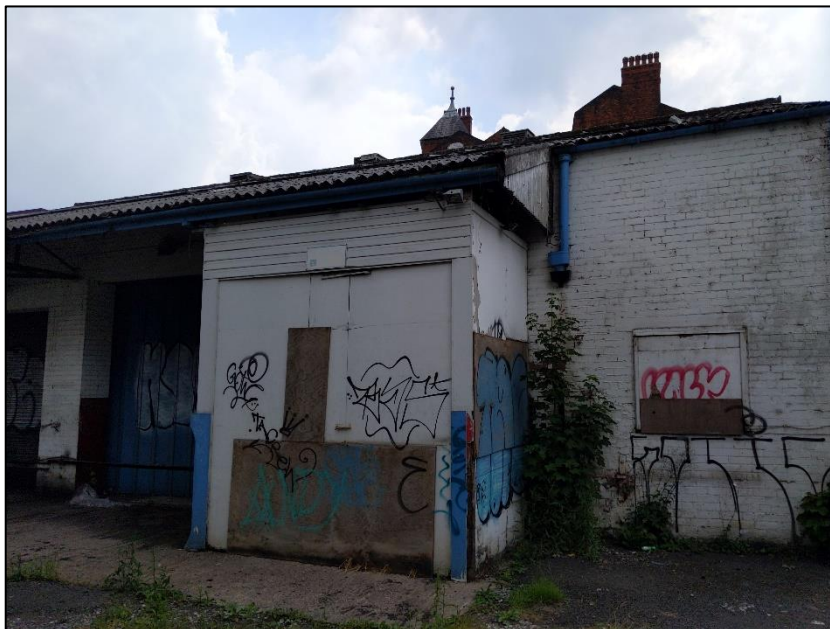
- 3.2 The external brickwork on is complete and intact, offering limited bat roosting opportunities behind or between the bricks (see Photographs 1 and 2). The metal doors are sealed to the brick. The cement roof is intact, offering limited scope for bats to roost behind. The cement panels are firmly attached to each other. The wooden window frames on the side elevation are sealed to the brickwork. The stone window lintels are complete and without gaps for bats to exploit.

Photograph 1 showing the front elevation of the structure

- 4.2 It is the opinion of the author of this report that the demolition can proceed without the need for further survey work (e.g. bat activity surveys) or bat mitigation due to the negligible potential of the buildings to support bats. However, if the work is delayed by longer than two years from the date of this survey, a further bat survey will be required to update the findings.

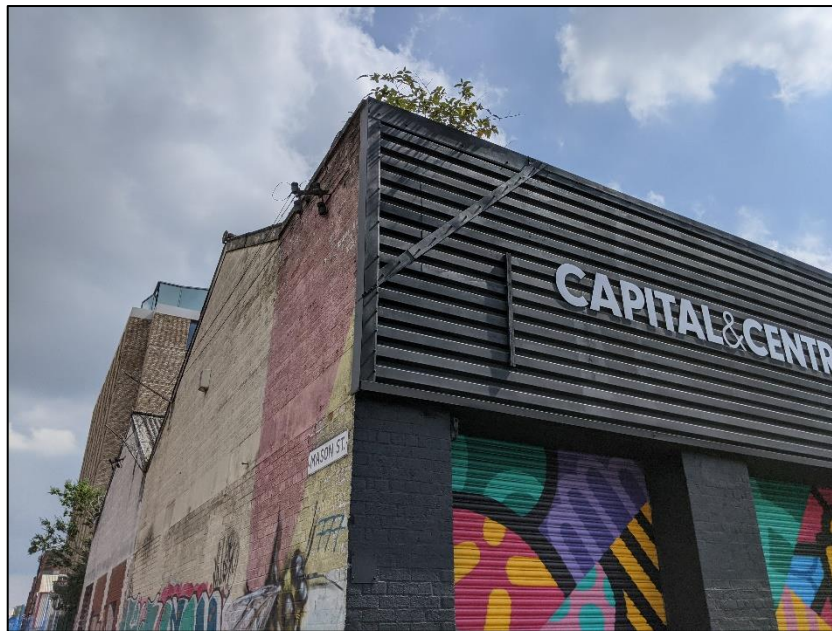
- 3.4 Building 2 is constructed from brick and has a pitched, cement roof (see Photographs 3 and 4). The external brickwork is complete, offering no suitable bat roosting opportunities. The roof is firmly attached to the brick walls, and all roofing panels are complete and intact. The metal shutters and wooden render on the front elevation are intact and sealed. Vegetation is penetrating the upper sections of the walls.

Photograph 3 showing the front and side elevations

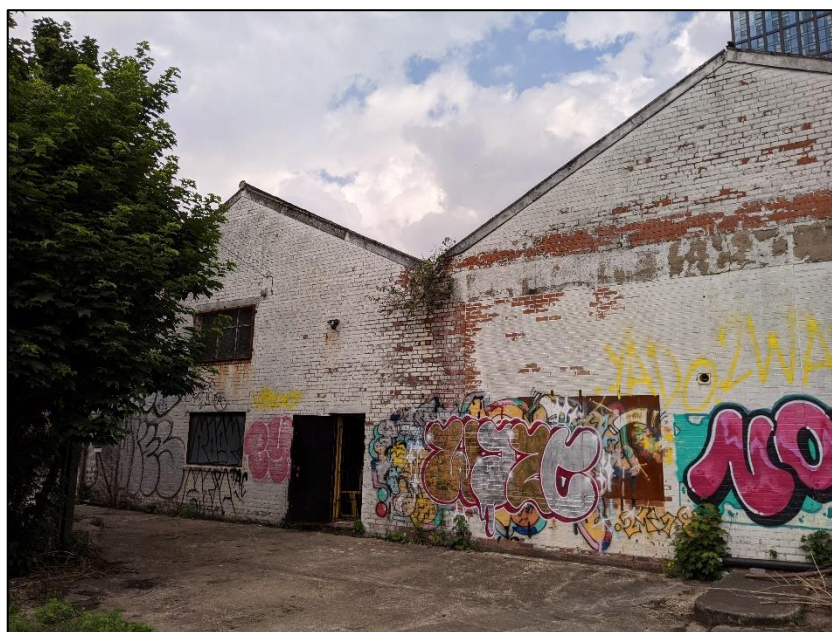
Photograph 4 showing the brickwork on the side elevations

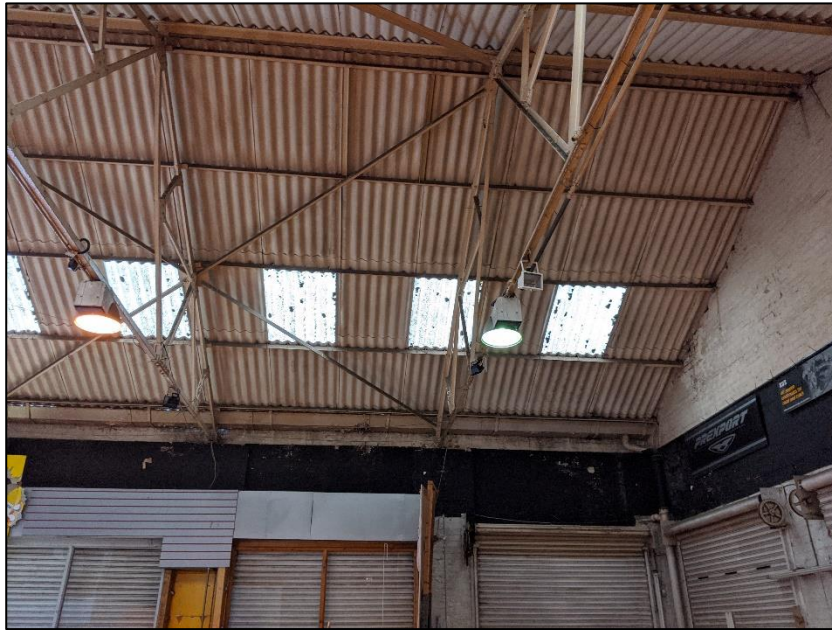
- 3.5 Internally, the structure large and open to the roof (see Photograph 5). No separate roof void exists. The interior is well-lit. The internal brickwork is complete, offering no suitable bat roosting cavities (see Photograph 6). No evidence of bat activity was found inside the building. The roof edges have been protected with wire mesh to prevent potential bird access. No signs of bird nesting were found inside Building 2.

**Photograph 5 showing the interior of Building 2**

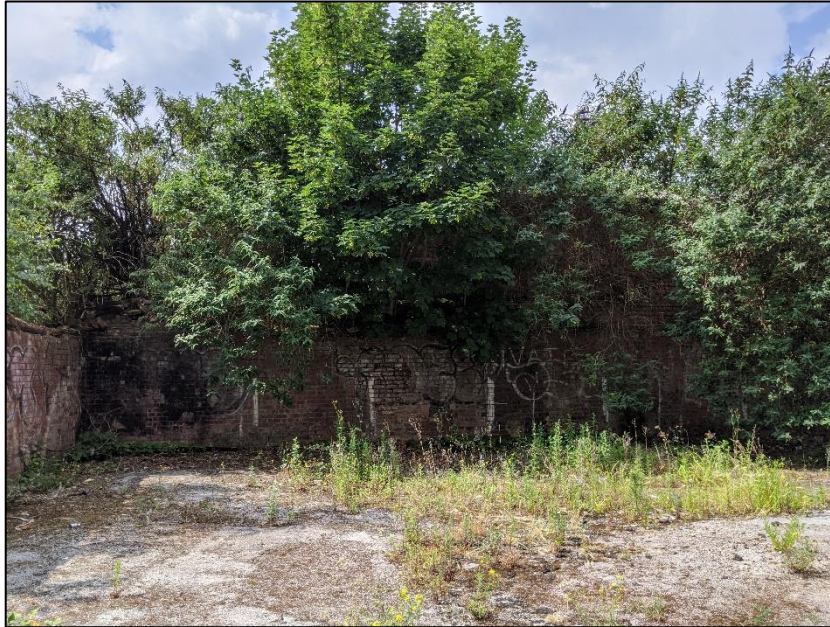
- 3.6 Parts of the site are overgrown with self-seeding shrubs and trees, including Butterfly Bush *Buddleia* sp. and Sycamore *Acer pseudoplatanus* (see Photographs 7 and 8). The vegetation was surveyed for nesting birds. No signs of bird nesting behaviour, such as adults carrying food or nesting material, was observed during the site visit.

**Photograph 7 showing the overgrown vegetation**

- 4.6 If a bird nest is found during demolition work, all work is to stop, and an Ecologist called for advice. A buffer zone of 4m should be erected around the nesting site, with no works undertaken in the buffer zone until the nest has been checked, and the chicks have fledged.

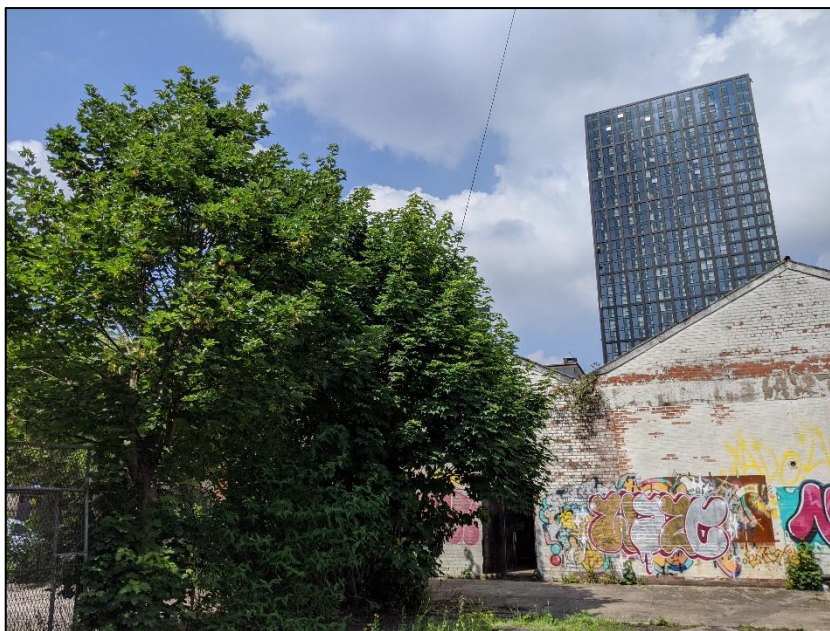
**Photograph 8 showing the self-seeded Sycamore trees**
