# Chandos Hall/Echo Street, Manchester

## Phase 2 Site Investigation

Curtins Ref: 065374-CUR-00-XX-RP-GE-002-V04

Client Name: IQ Student Accommodation

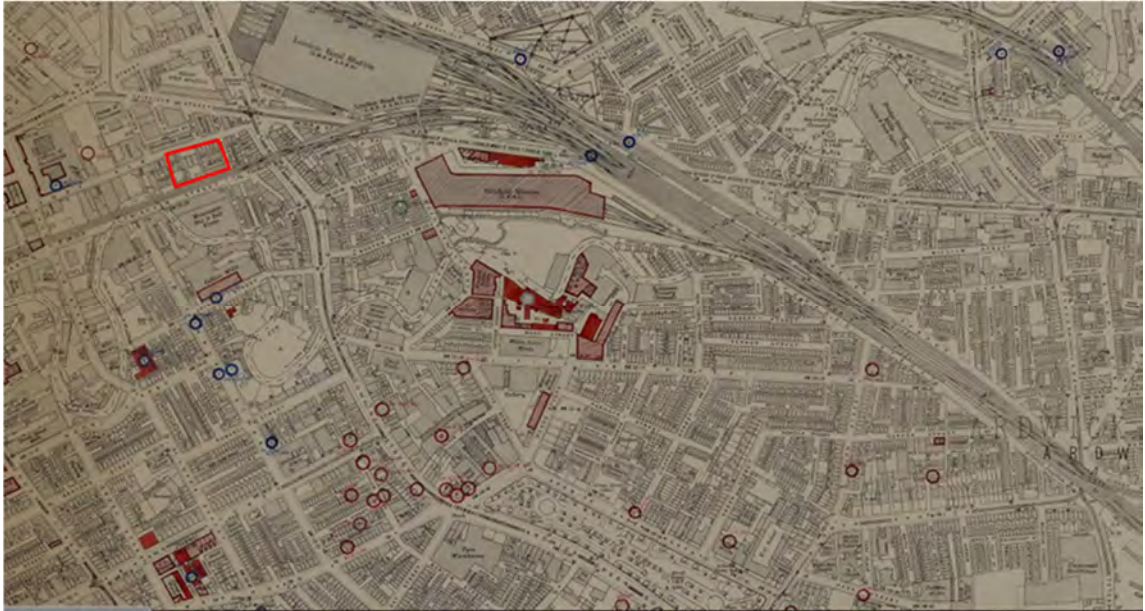
Historical mapping shows a wharf 110m and 200m northwest of the site. A review of available Manchester Bomb Damage mapping was also undertaken indicating bombing ruins (red shading), several fire bombs (red circles), high explosives (blue circles) ruins and damaged buildings (dashed shading) in the immediate surroundings of the site.

**Figure 2.6a** Map of bomb damage in Manchester from WWII. Site boundary identified in red.

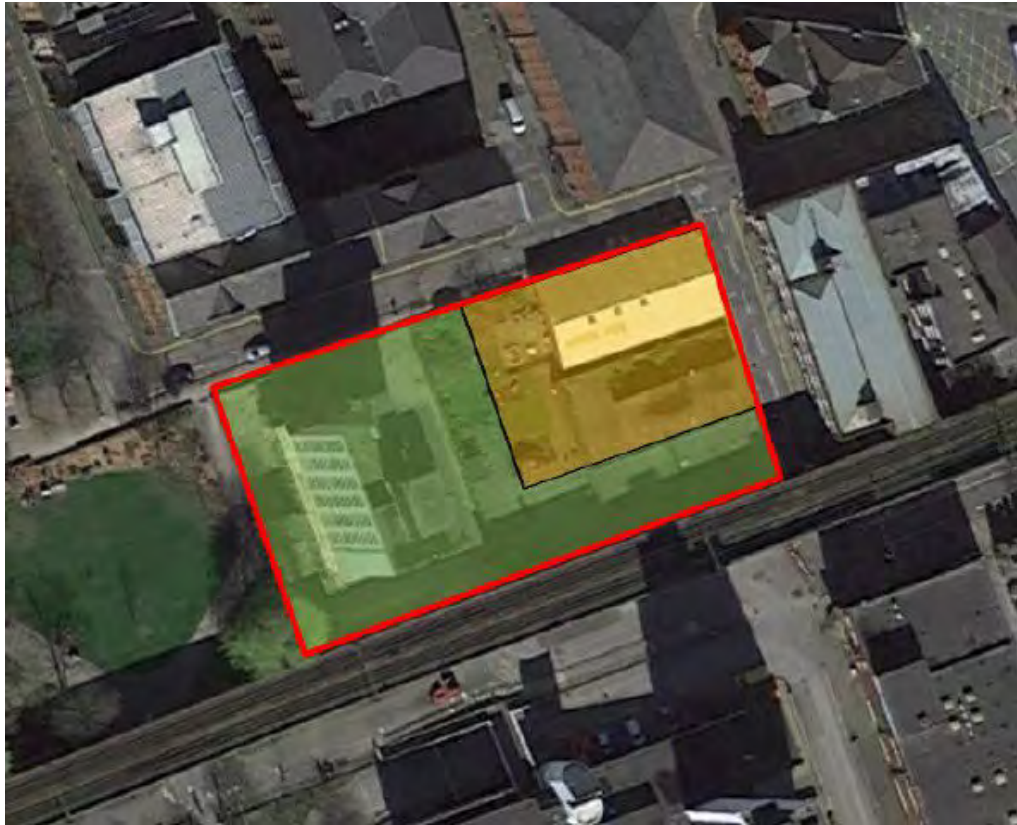
- An area of clearance is noted in the northeast corner of the site. It is thought possible that this was because of a bomb strike/fire damage. If rubble and debris was present in this area, there is a risk that evidence of UXO could easily have been overlooked. UXBs falling into 'bomb sites' was one of the most common scenarios for this going unnoticed and unrecorded.
- The rest of the site appears to have survived the war intact.

Given that most of the site appears to have survived the war, shows no signs of damage and likely accessed frequently, this part of the site has been given a **Low** Risk. The area within the northeast of the site is shown as cleared on post-war aerial photography. Given the poor quality of the record set for Manchester, it has not proved possible to prove that this clearance was not due to bombing. Thus, this area, with a small buffer to account for the 'J-curve' effect, has been given a **Medium** Risk. The zoned risk areas are shown in *Figure 2.6b* below.

**Figure 2.6b** Zoned UXO Risk Map. Medium risk areas = orange. Low risk areas = green.

As such the following risk mitigation measures are recommended to support the proposed investigation works at the Chandos Hall site:

1. **All Works** – Site Specific Unexploded Ordnance Awareness Briefings to all personnel conducting intrusive works.
2. **Medium Risk Areas:**
  - a. *Open Intrusive Works (trial pits, service pits, open excavations, shallow foundations etc.)* – UXO Specialist On-site Support and Site Specific Unexploded Ordnance Awareness Briefings to all personnel conducting intrusive works.
  - b. *Boreholes and Piled Foundations* - Intrusive Magnetometer Survey of all borehole and pile locations/clusters down to maximum bomb penetration depth.

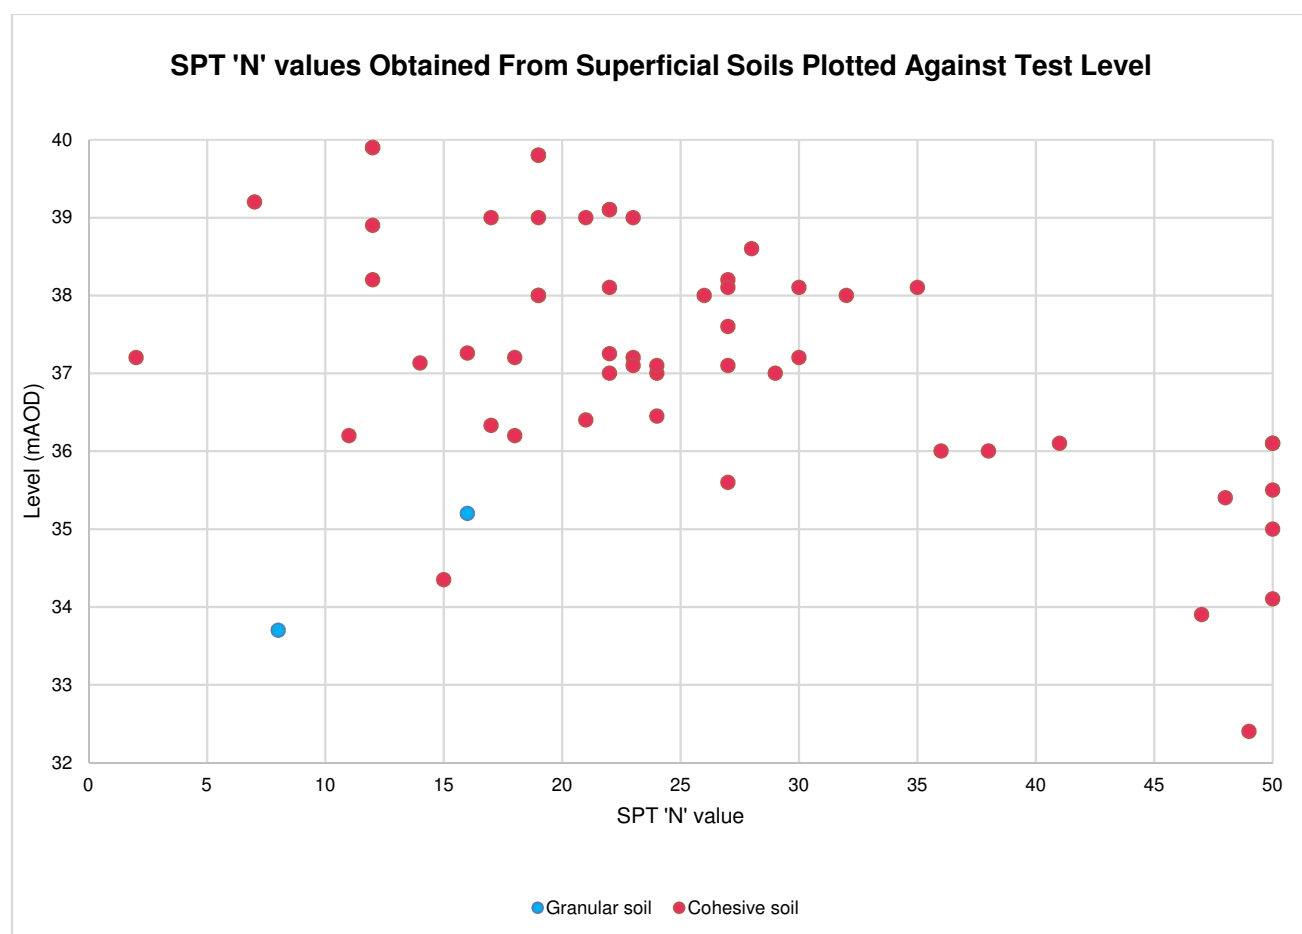
SPT 'N' Values in cohesive superficial soils generally increase with depth, though are generally variable, illustrated in *Figure 5.3*.

**Figure 5.3 – SPT 'N' Values vs Depth (values of >50 were recorded as 50).**

It should be noted that, as the SPT data is uncorrected, there may be some variation between the SPTs undertaken in the window sample boreholes compared to those undertaken in the cable percussive boreholes due to the different equipment used. Therefore, the characteristic 'N' values could equate to the lowest values recorded in each stratum; a characteristic SPT 'N' of 11 could be adopted for the cohesive and 26 for the granular superficial deposits, respectively. A review of  $N_{60}$  values confirm the lowest N values of 11 and 26 respectively, discounting locally soft deposits.

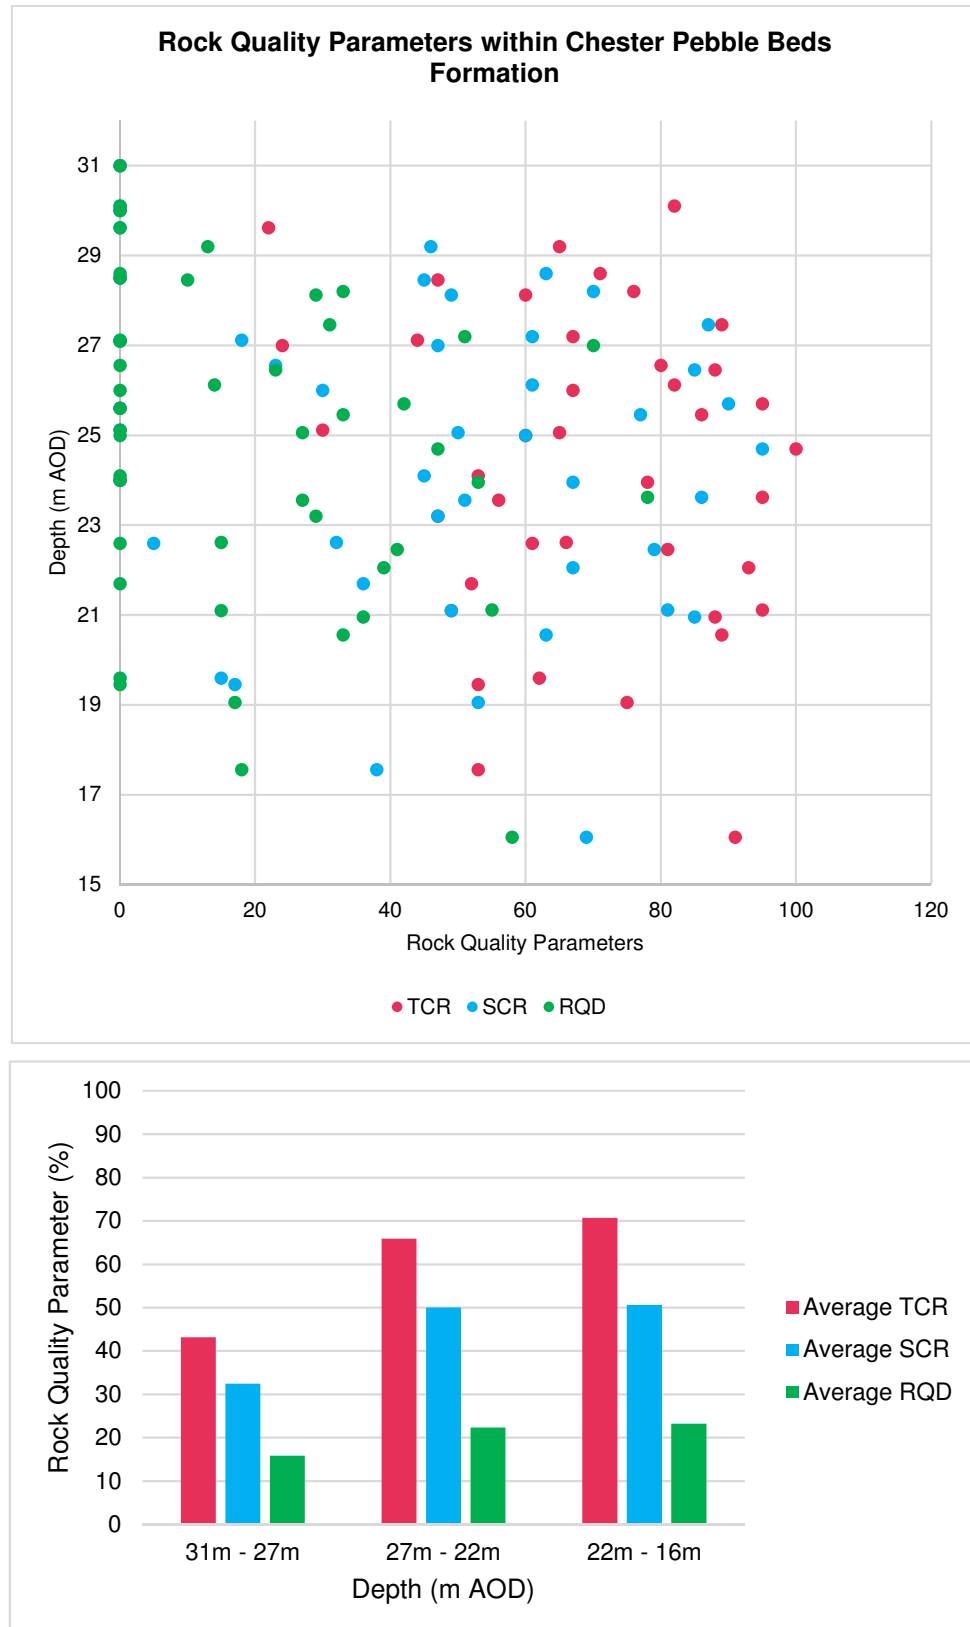
Rock Quality Designation (RQD) recorded in the cored samples ranged from 0% to 78%, averaging 19% across all of the rock core samples. This classifies the rock as being of very poor to poor rock mass quality. The RQD varies significantly between core runs. The total core recovery (TCR) ranged between 0% - 100% and the solid core recovery (SCR) ranged between 0% - 95%. The variability in the quality of the rock core samples recovered during this investigation is illustrated in *Figure 5.5a*.

**Figure 5.5a** – Summary of Rock Quality Parameters within Sandstone bedrock

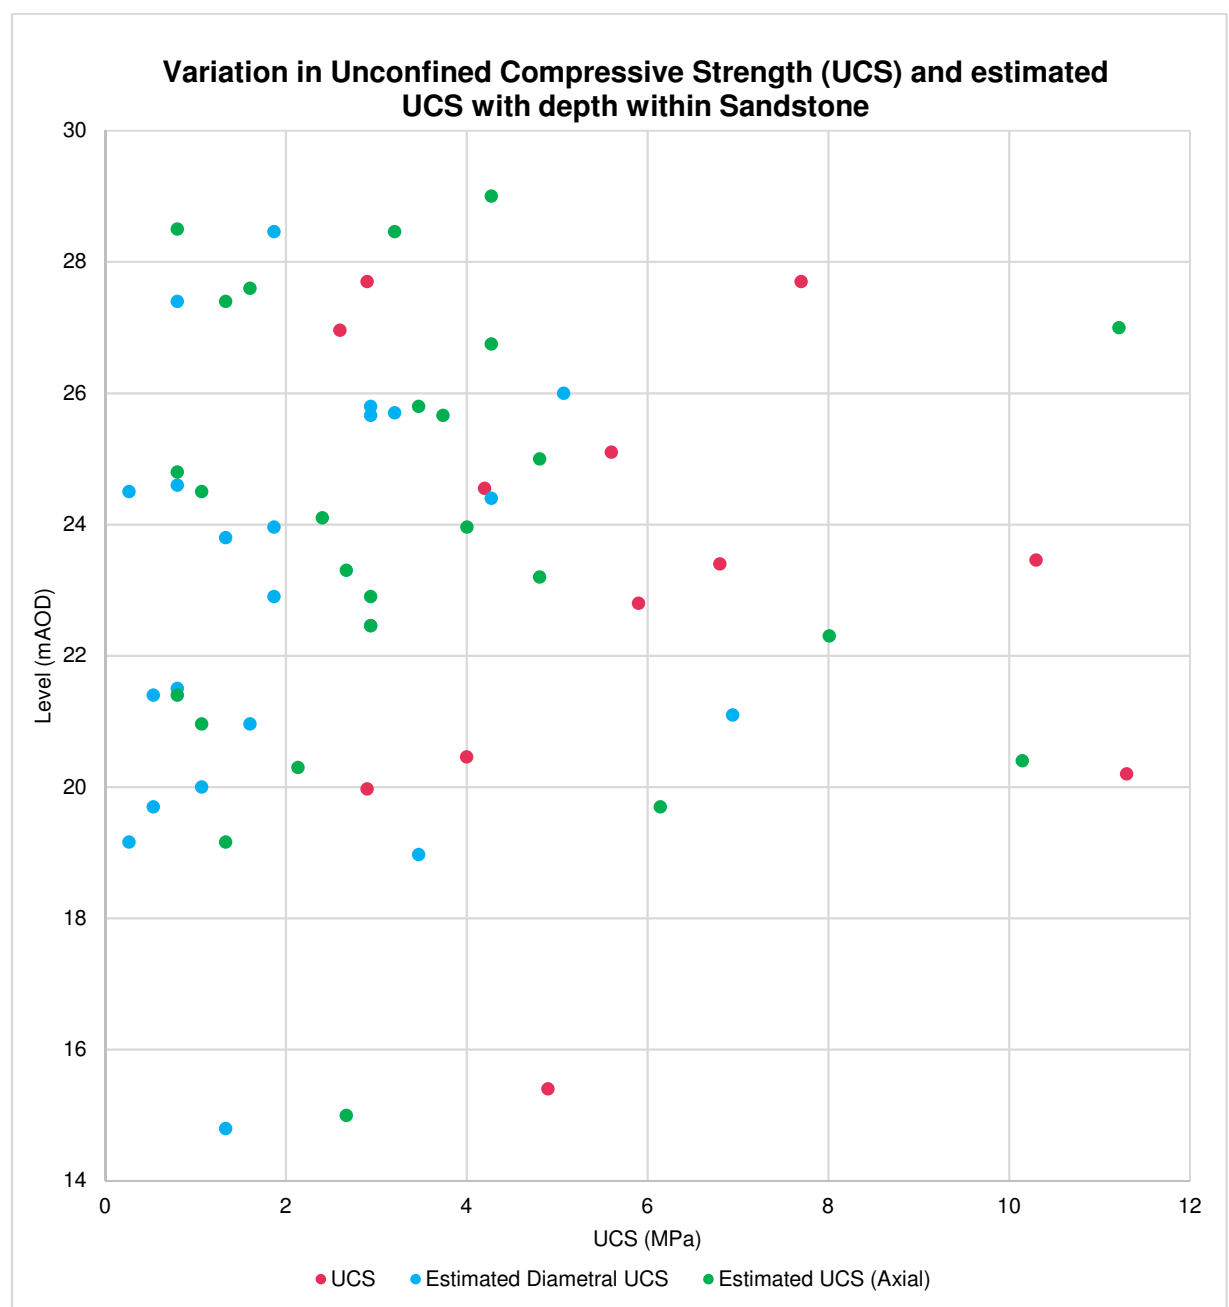
Figure 5.5b, summarises the UCS, estimated axial UCS and estimated diametral UCS test results against depth.

**Figure 5.5b – UCS and estimated UCS vs Depth within Sandstone.**

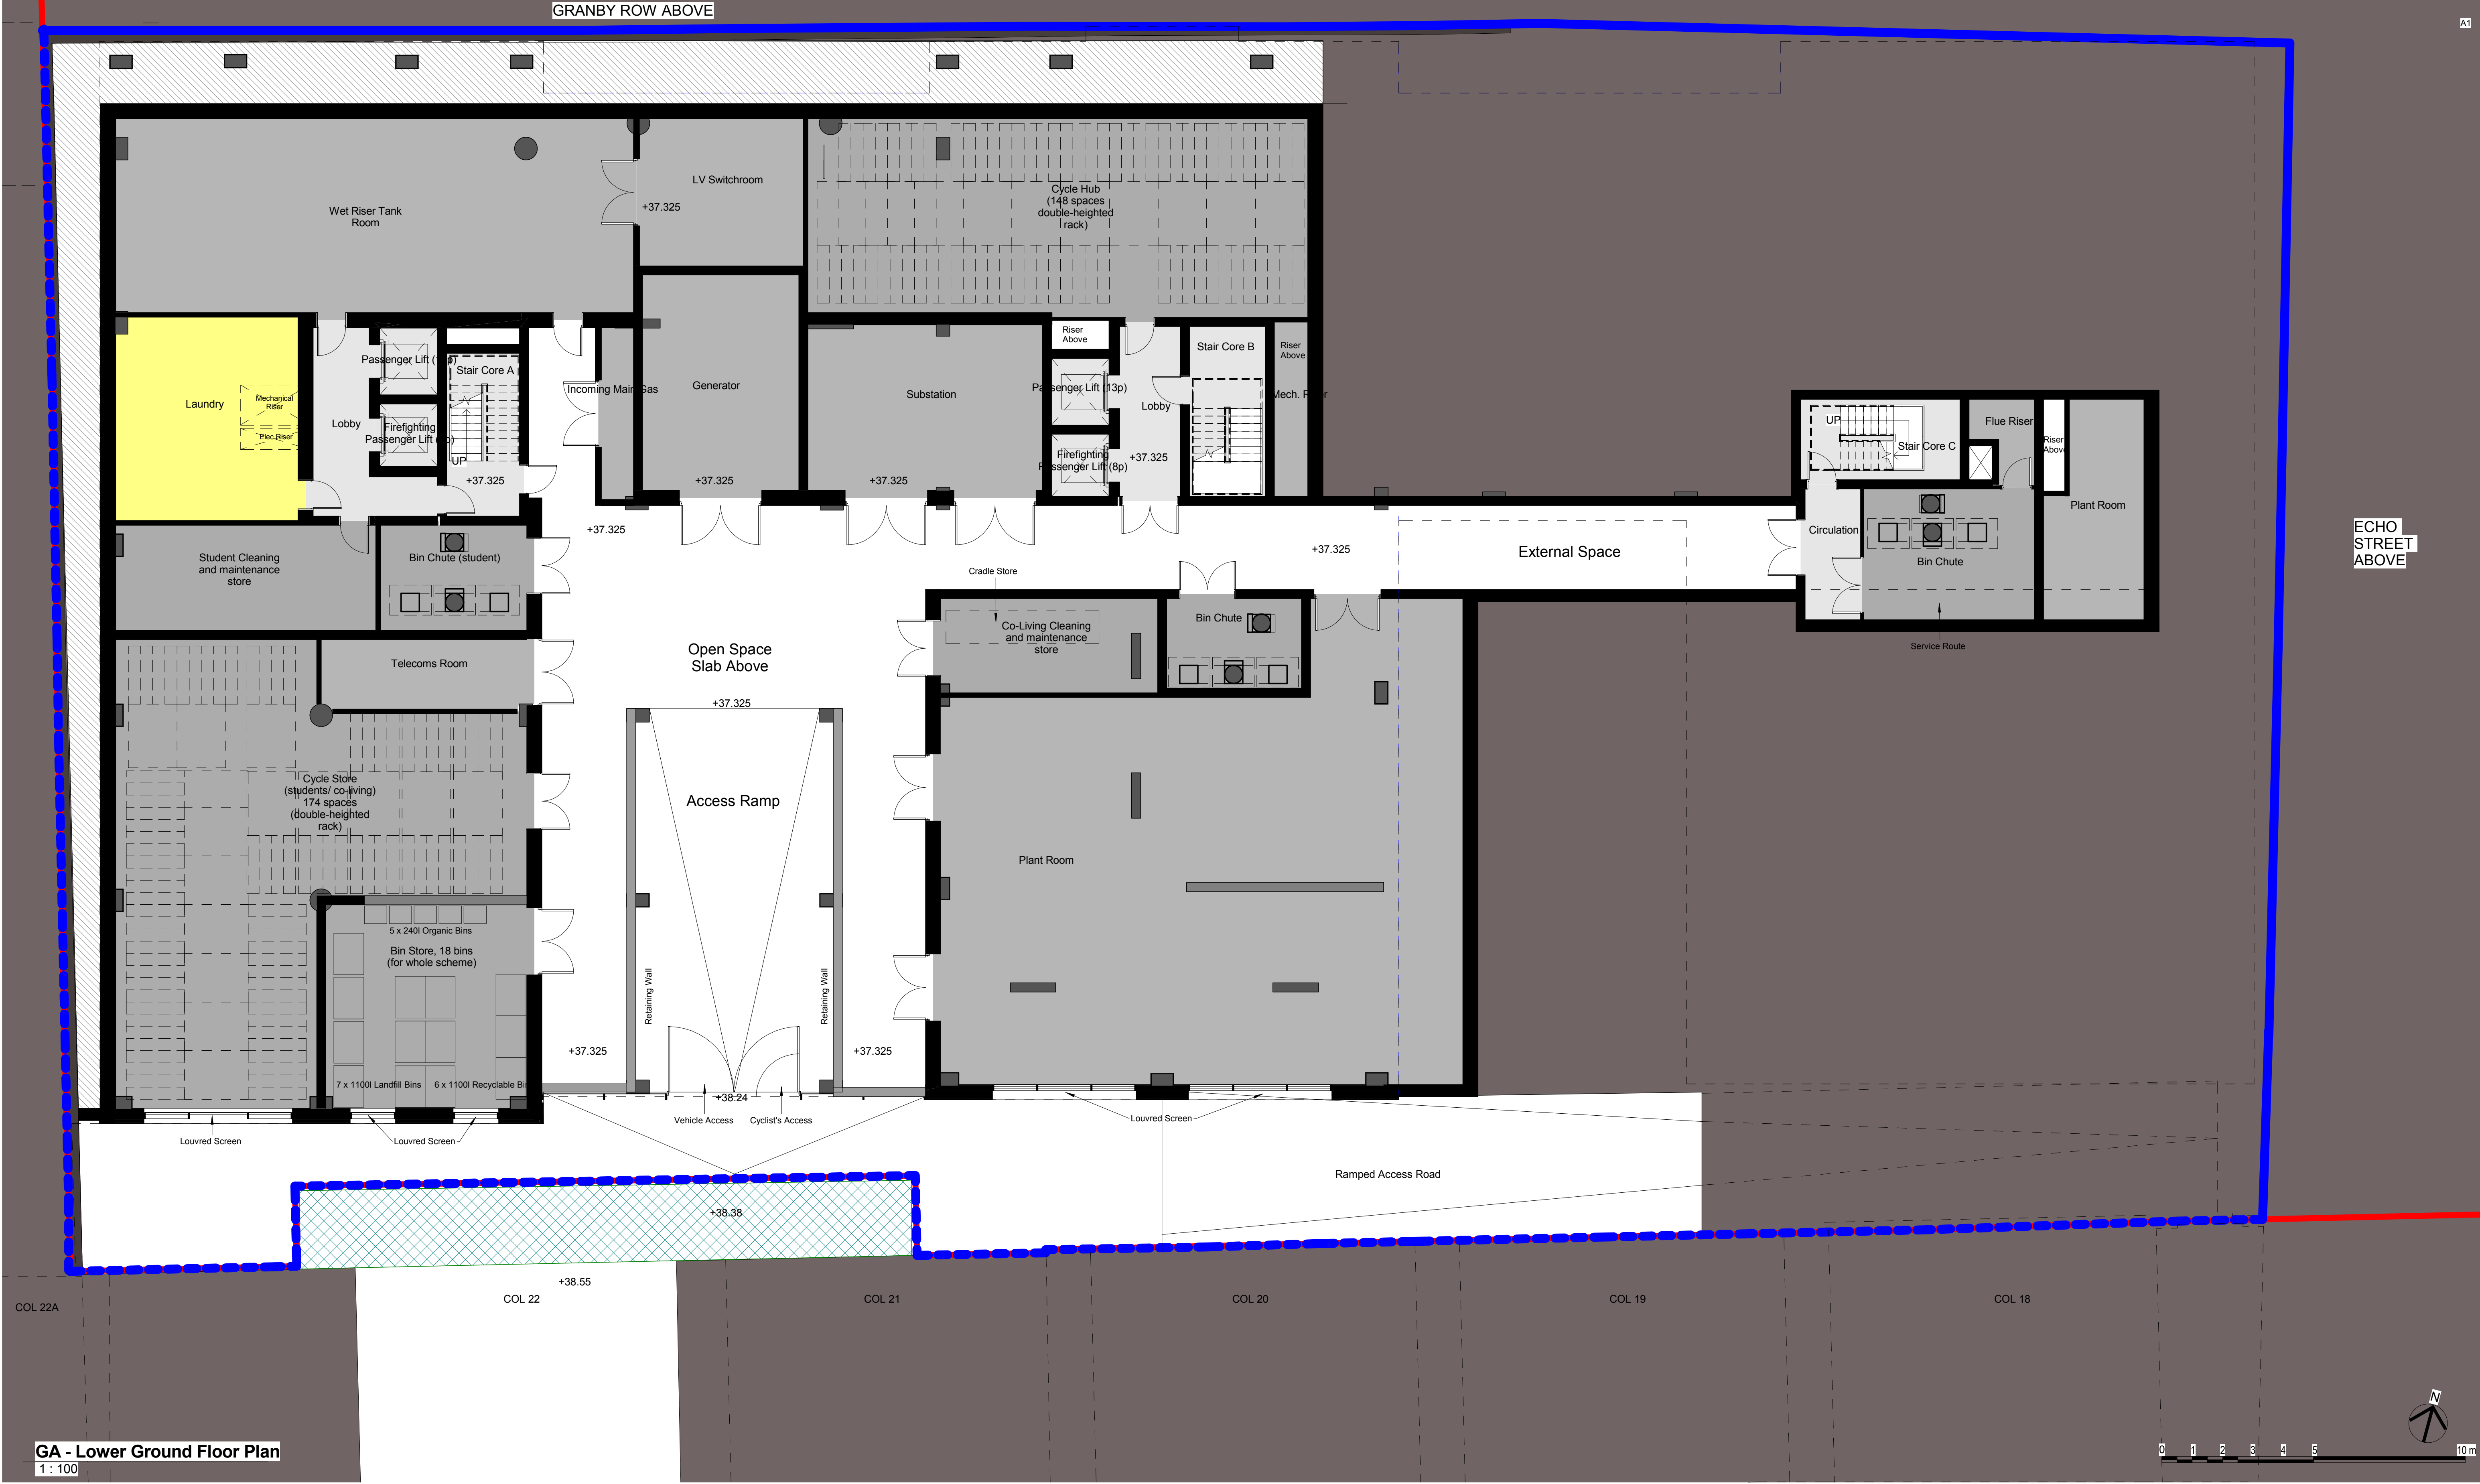
STATUS PURPOSE FOR ISSUE SR NO. DRAWING NO. REV.  
**S2 Planning 5426 5426 · SRA · XX · 00 · DR · A · 20-811 P03**

General Arrangement - Ground Floor Plan

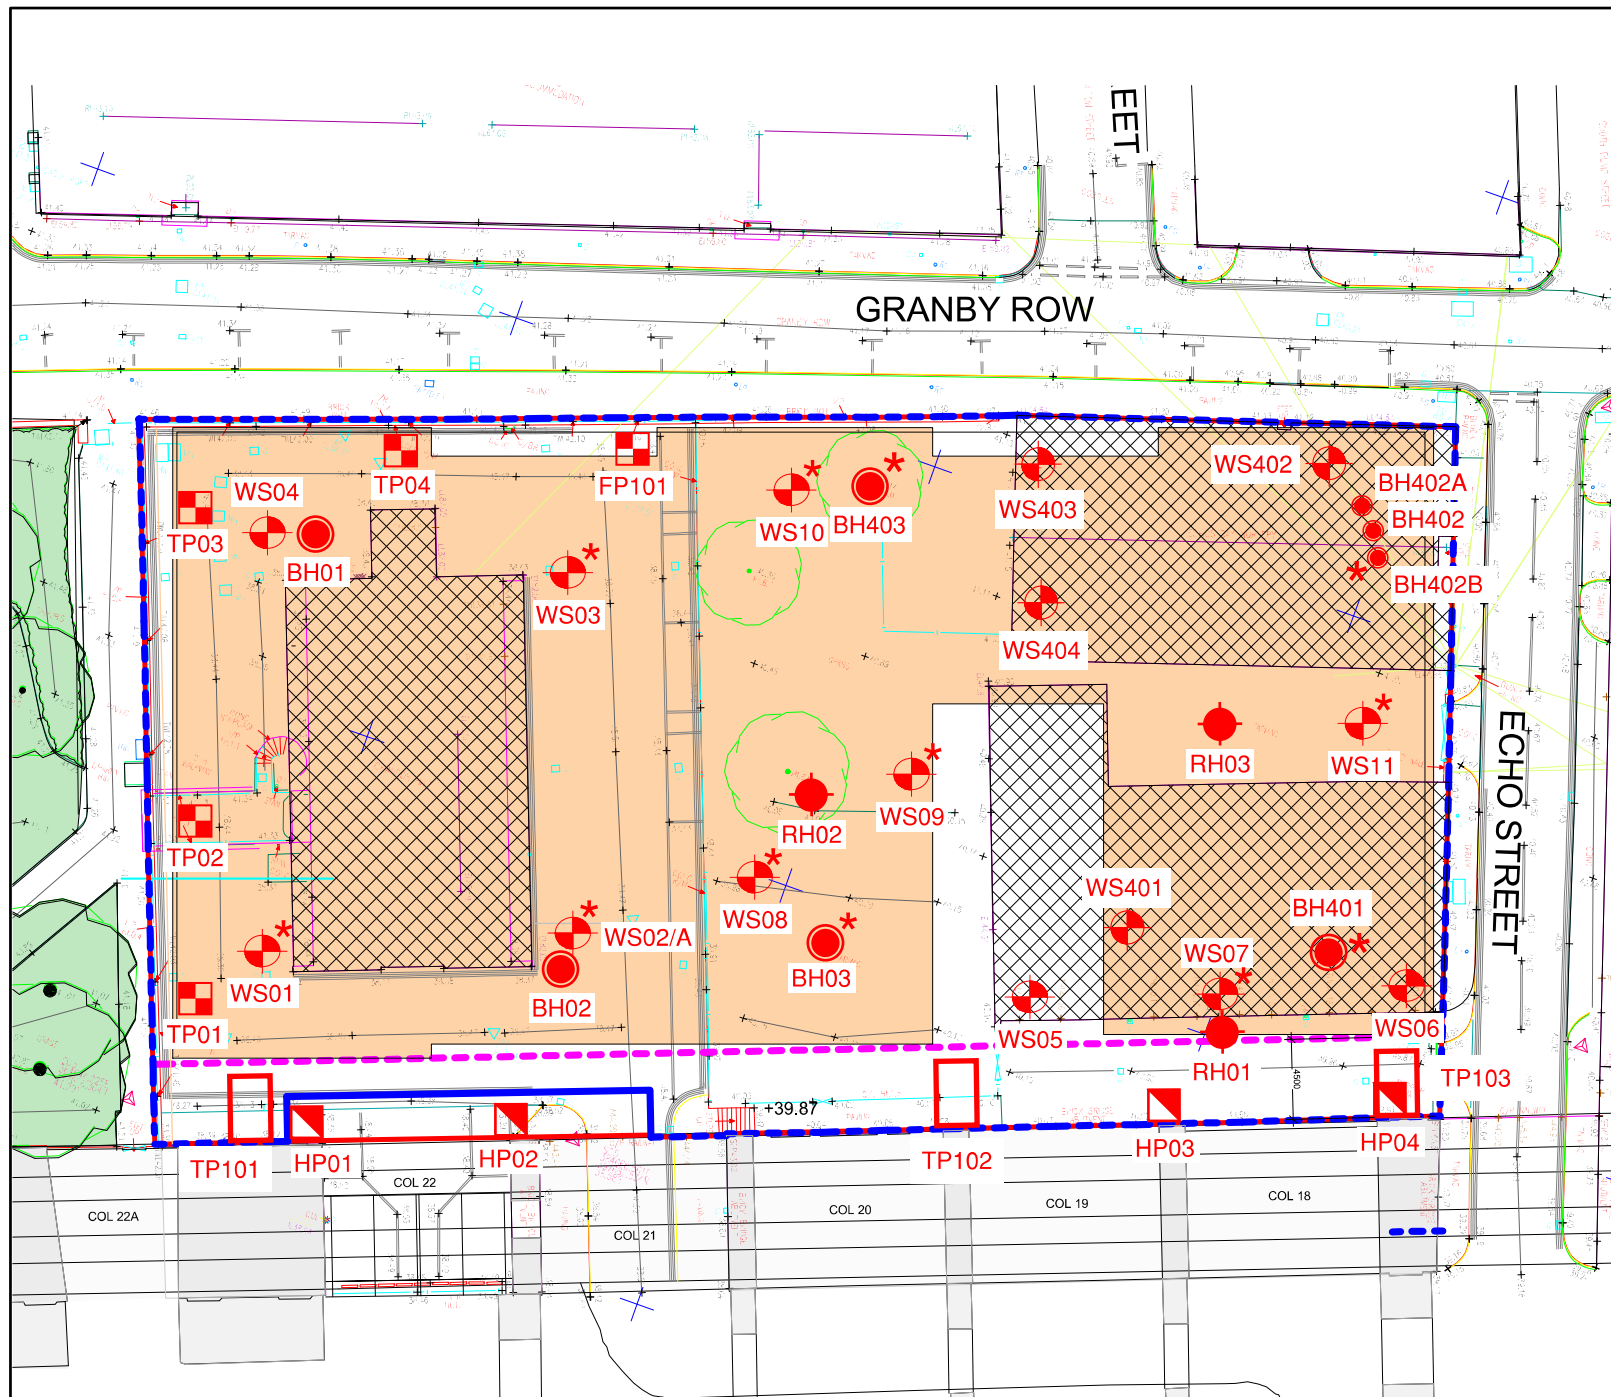
DRAWING NO.  
5426 - SRA-XX-B1-DR-A-20-810

# Stage 1, 2, 3 & 5 (completed)

- Window sample borehole location
- Cable percussive with rotary follow-on
- Machine excavated trial pits
- Hand excavated trial pits with hand-held window sample follow-on
- Micro-rotary borehole location
- Denotes the borehole is installed

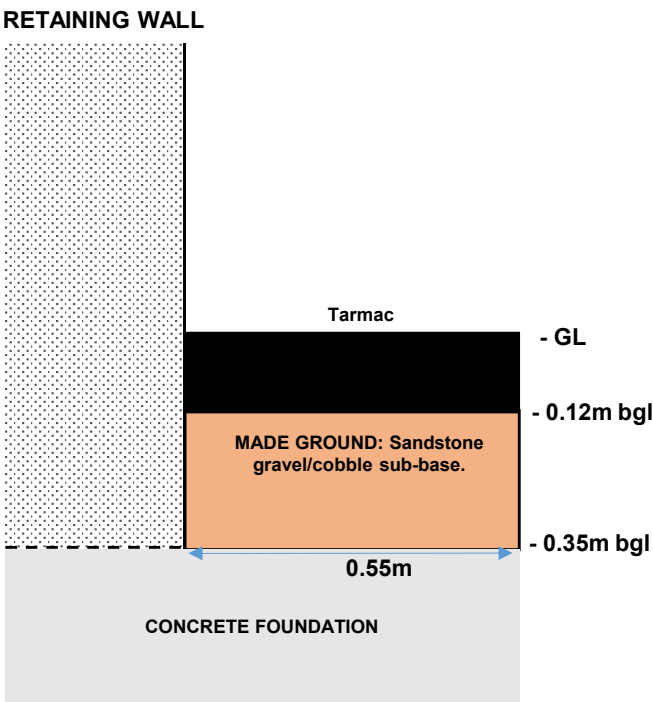
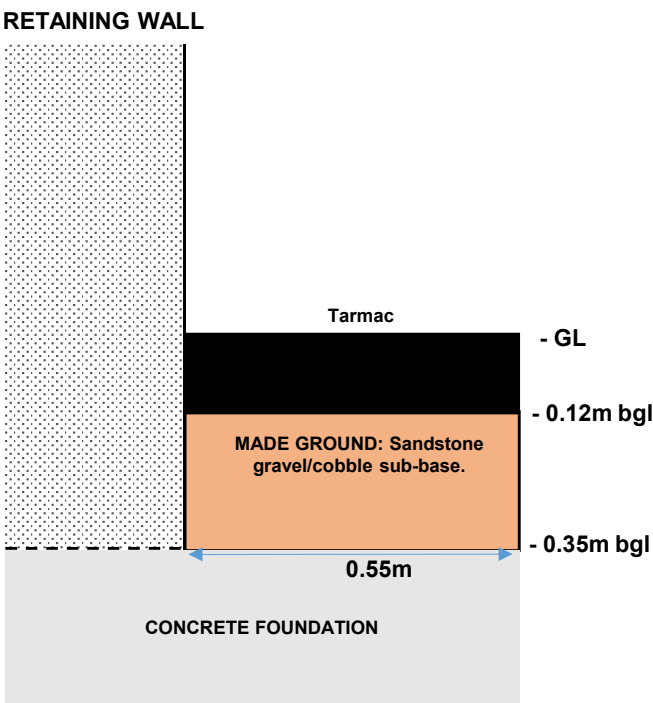
TP01- Identified Dimensions

Comments: Not to scale.  
Concrete foundation encountered but thickness not identified. Reference should be given to corresponding trial pit log for further strata details.

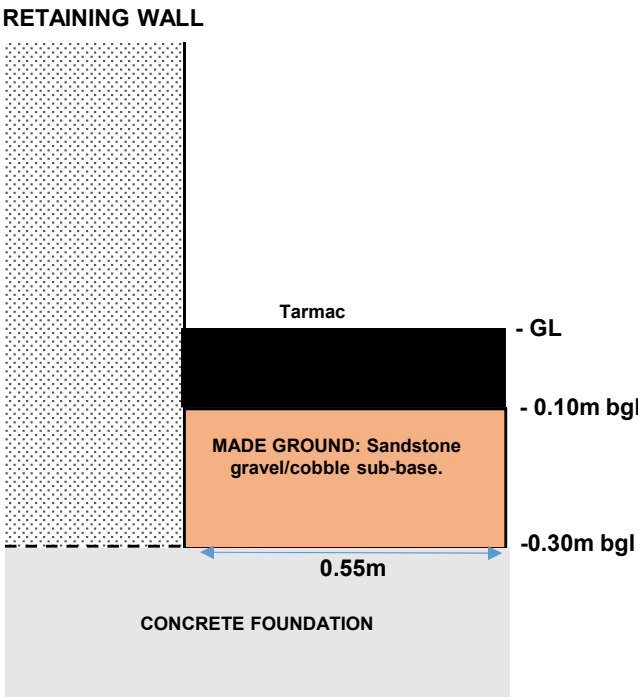
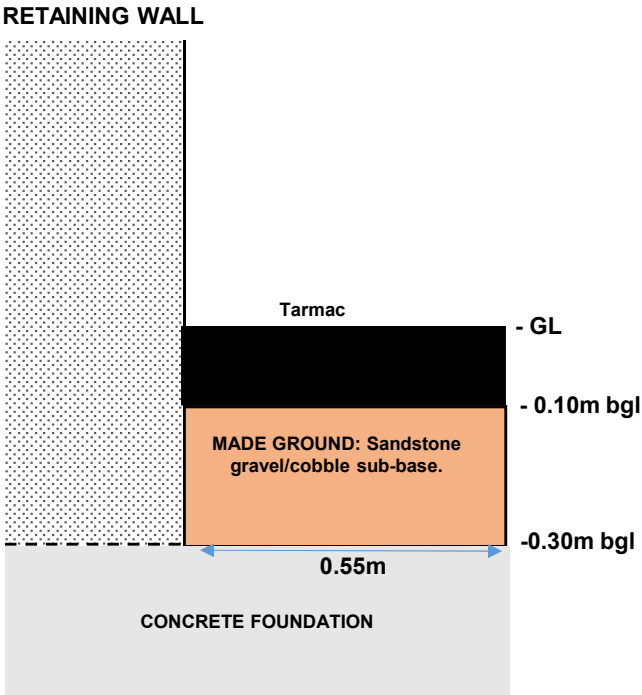
TP02- Identified Dimensions

Comments: Not to scale.  
Concrete foundation encountered but thickness not identified. Reference should be given to corresponding trial pit log for further strata details.

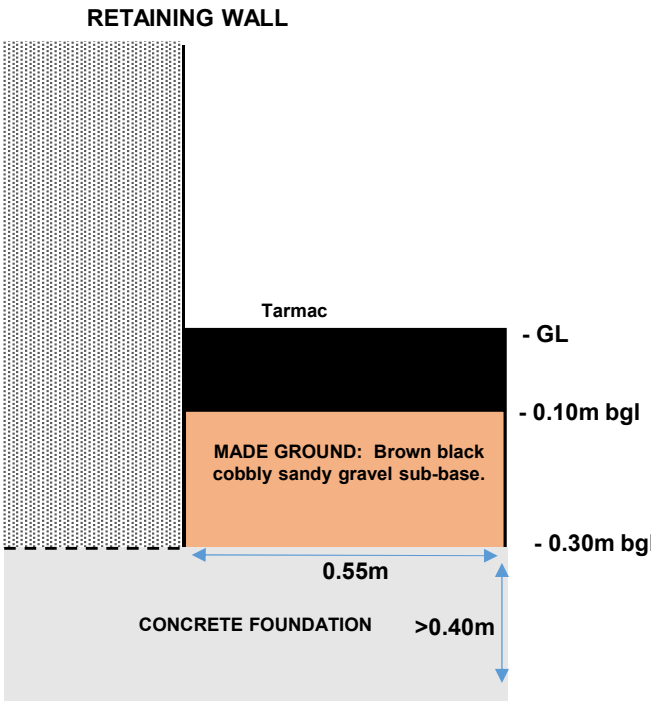
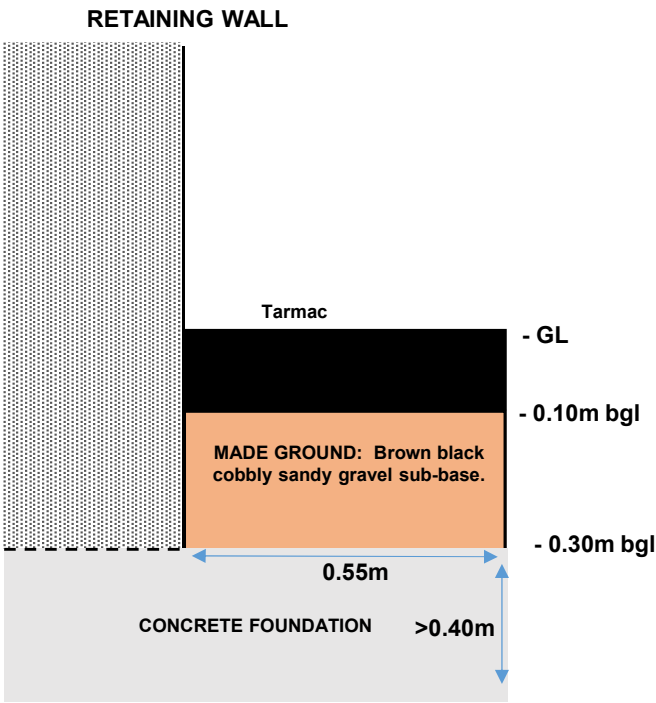
TP03- Identified Dimensions

Comments: Not to scale.  
Concrete foundation encountered but base not identified. Reference should be given to corresponding trial pit log for further strata details.

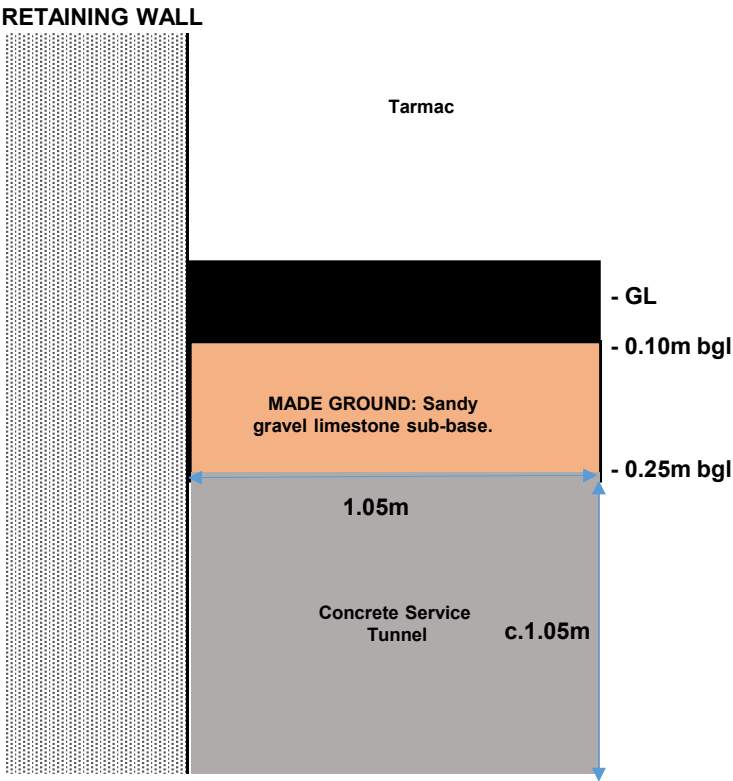
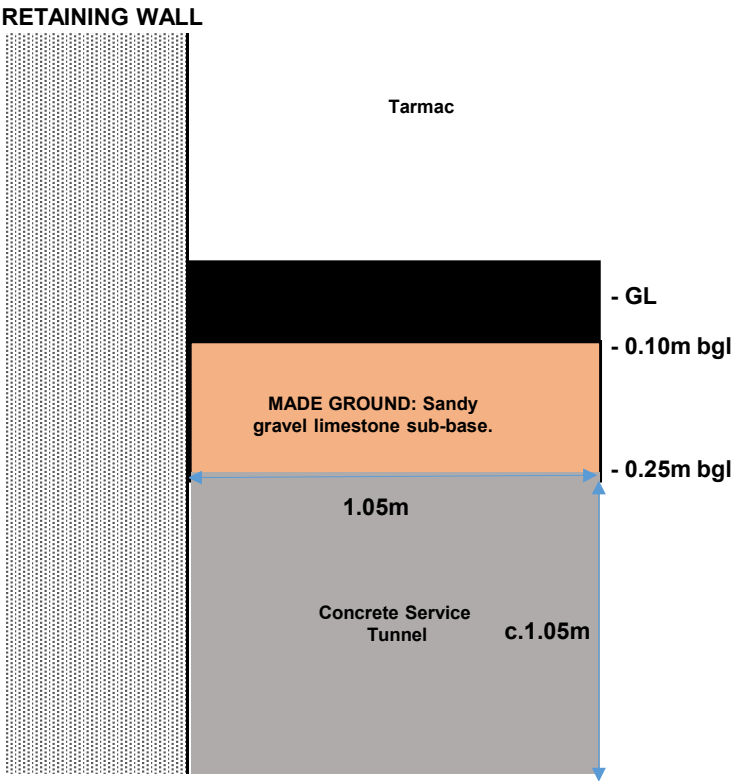
TP04- Identified Dimensions

Comments: Not to scale. Concrete service tunnel encountered, wall foundation not identified. Reference should be given to corresponding trial pit log for further strata details.

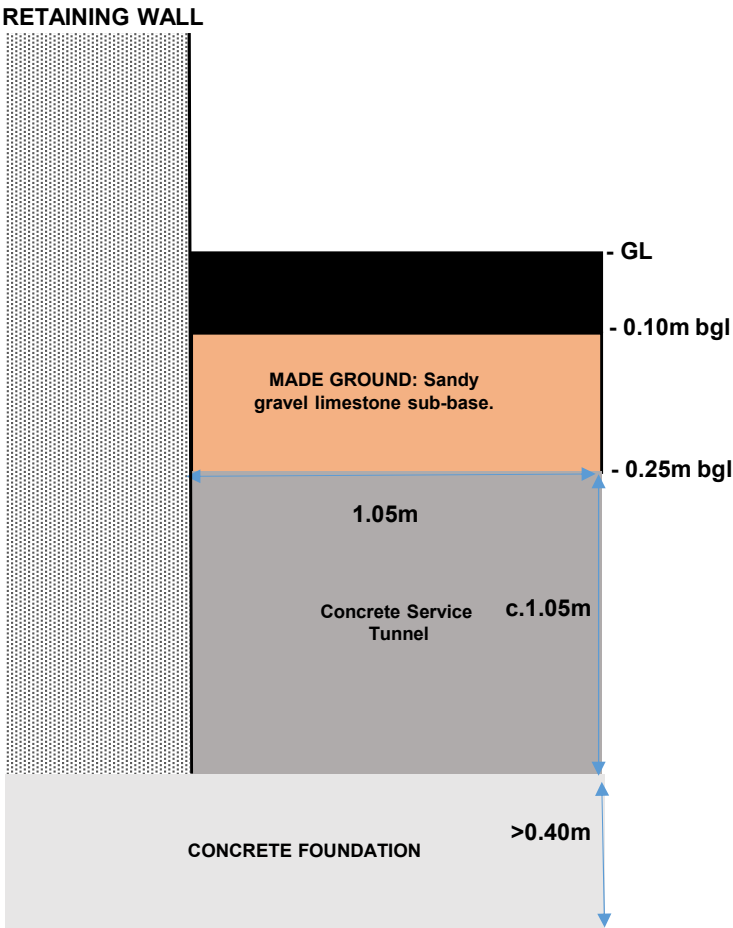
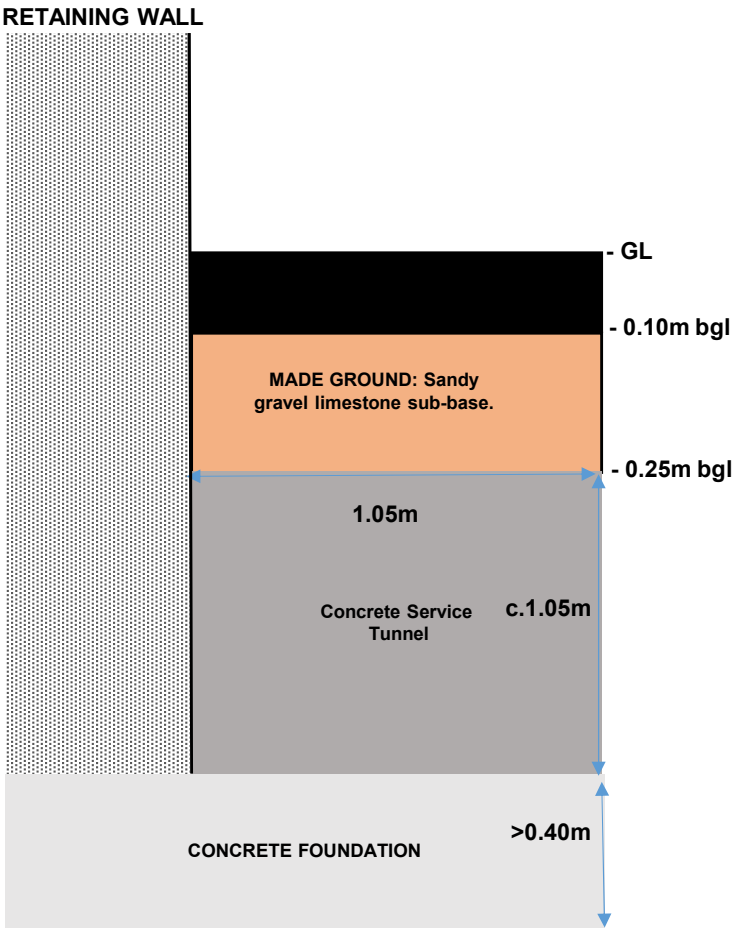
TP04- Estimated Potential Extent of Foundation

Comments: Not to scale. Drawing shows estimated potential extent of foundation based on available information, indicative only, foundation not proven during investigation.

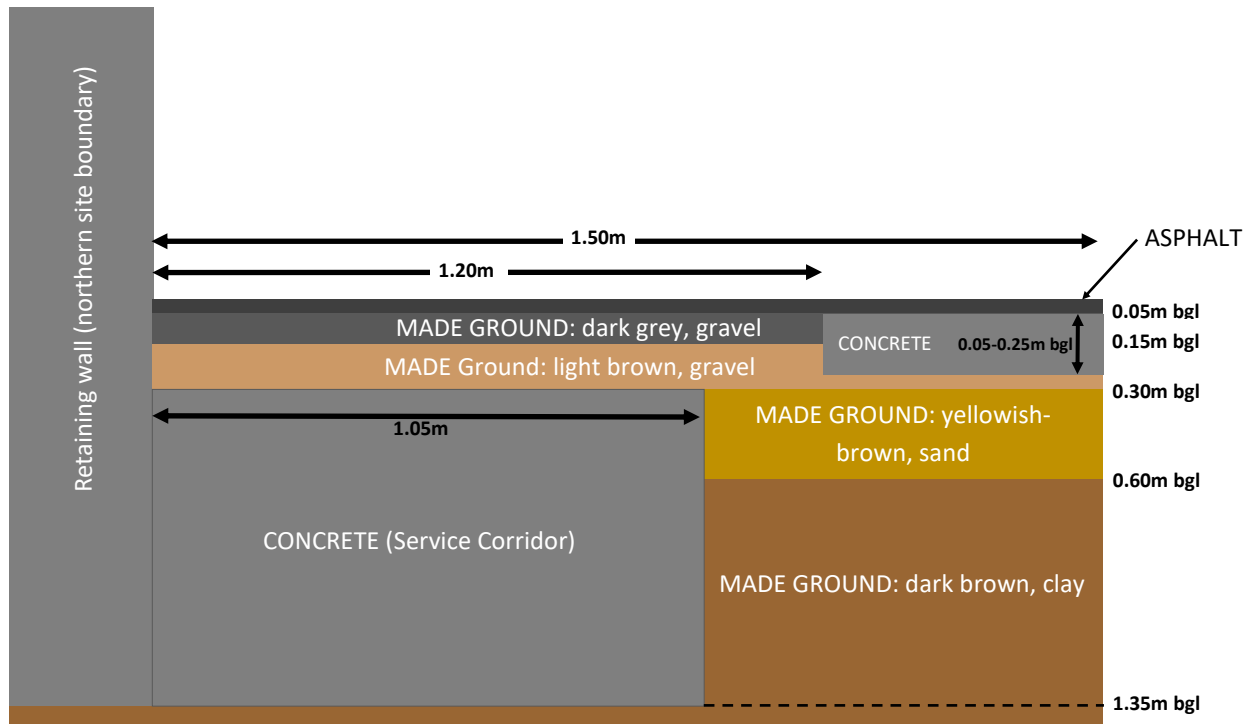
**FP101**

**Comments:** Not to scale. Reference should be given to corresponding trial pit log for further strata details. Trial pit edge stable.

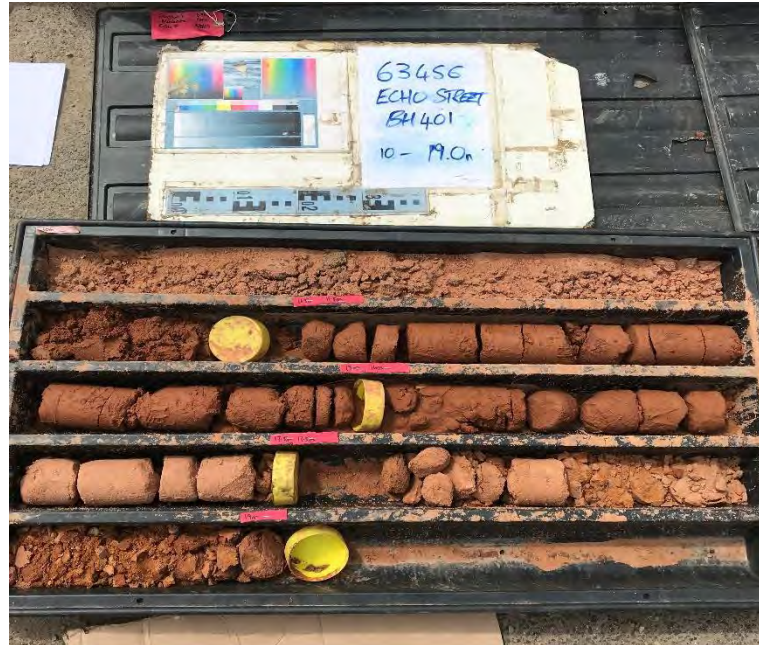
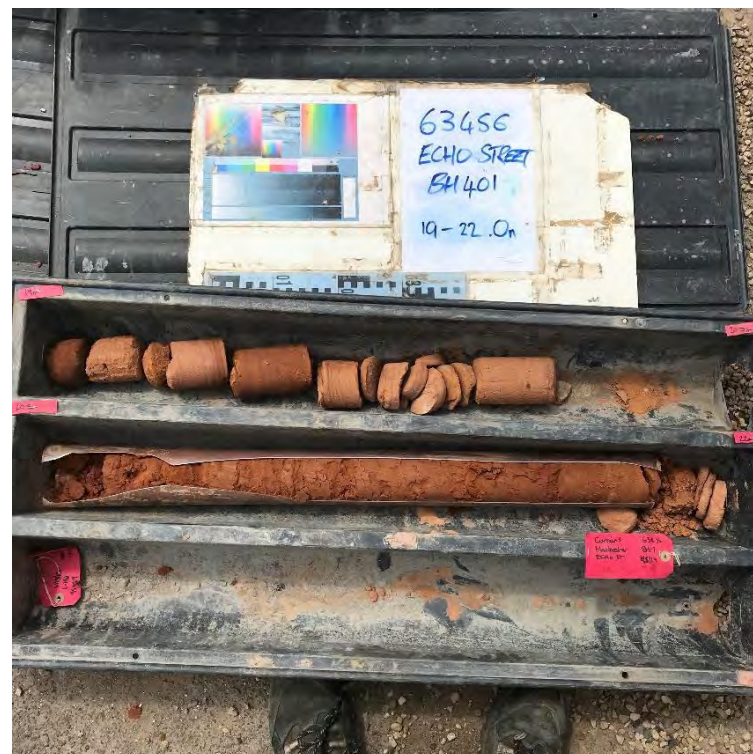
| <b>Client Name:</b><br>IQ Student<br>Accommodation | <b>Project Name:</b><br>Echo Street,<br>Manchester | <b>Project No:</b><br>065374.001 | <b>Borehole<br/>Location<br/>Reference:</b><br>BH401 | <b>Date Core<br/>Recovered:</b><br>30/05/2019 |

## Photographic Record of Rock Core

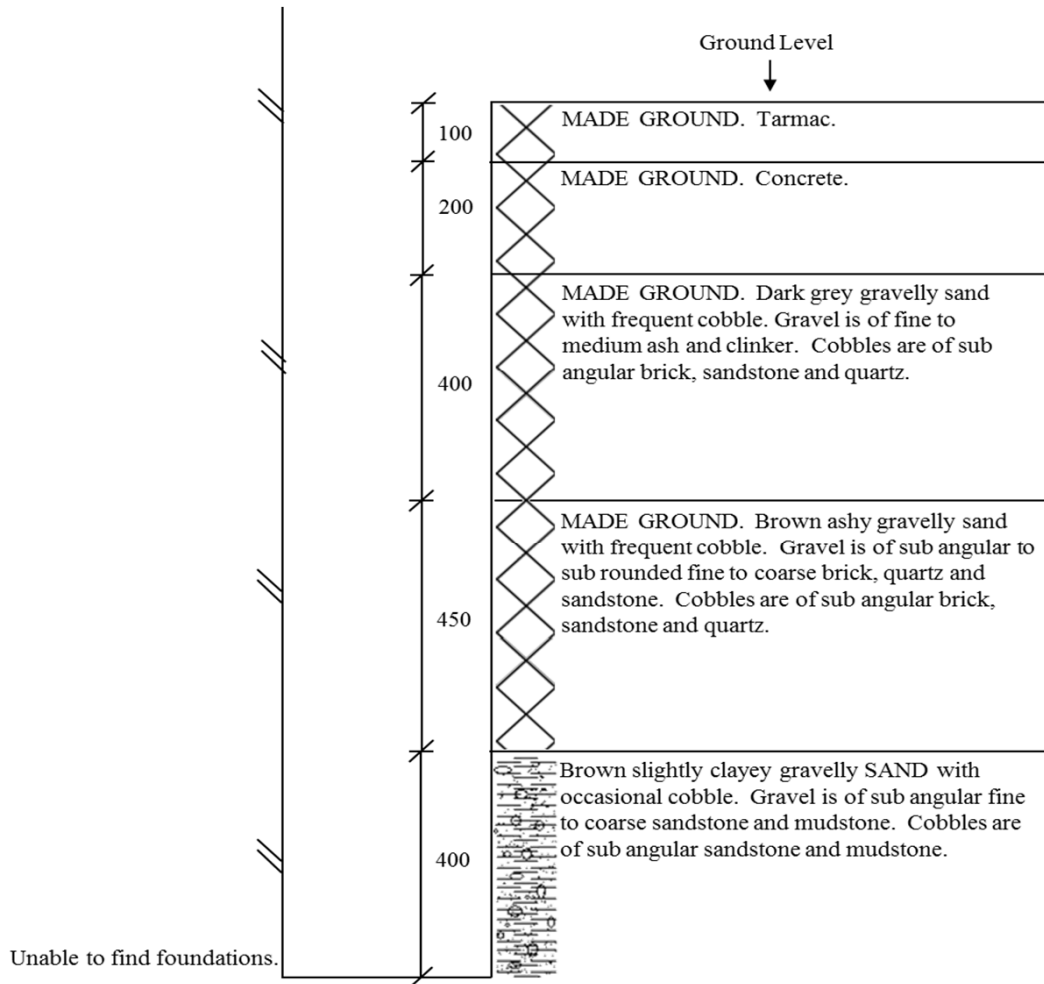
| <b>Trial Pit No: HP1</b> | | | |

For strata information below 1.55m, please refer to borehole HP1.

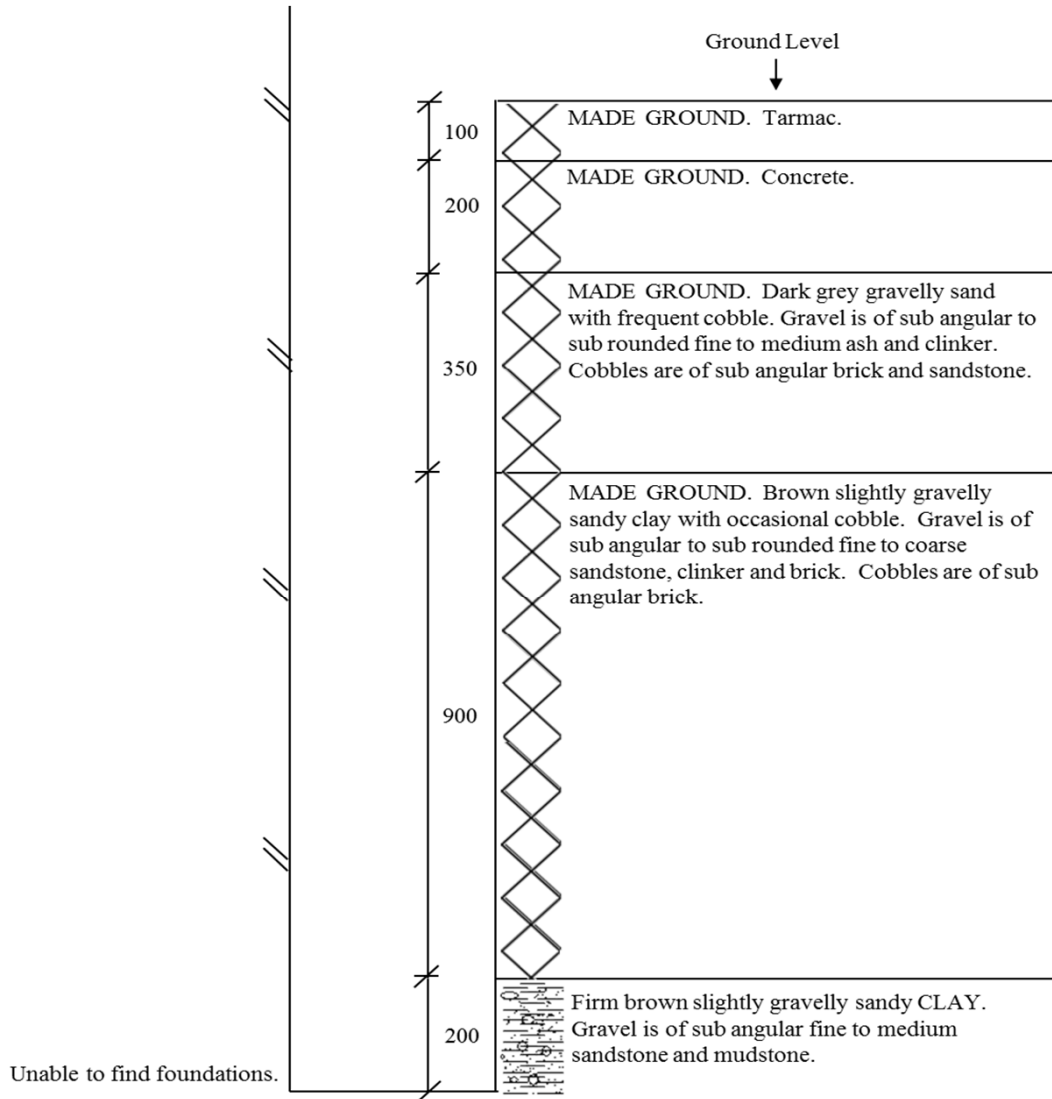
| <b>Trial Pit No: HP2</b> | | | |

For strata information below 1.75m, please refer to borehole HP2.

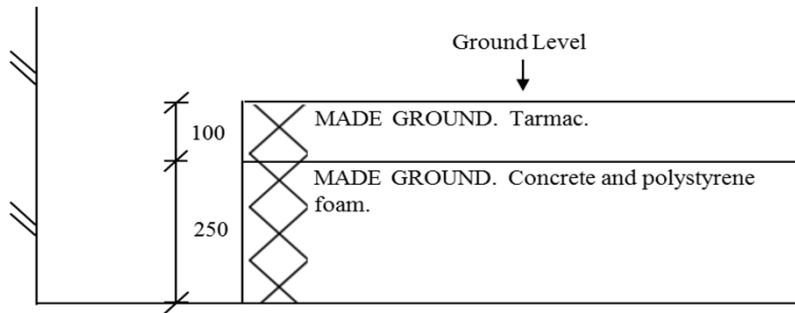
| <b>Trial Pit No: HP3</b> | | | |

HP3 terminated at 0.35m due to being unable to break through concrete.
