# Chandos Hall/Echo Street, Manchester

## Phase 2 Site Investigation

Curtins Ref: 065374-CUR-00-XX-RP-GE-002-V04

Client Name: IQ Student Accommodation

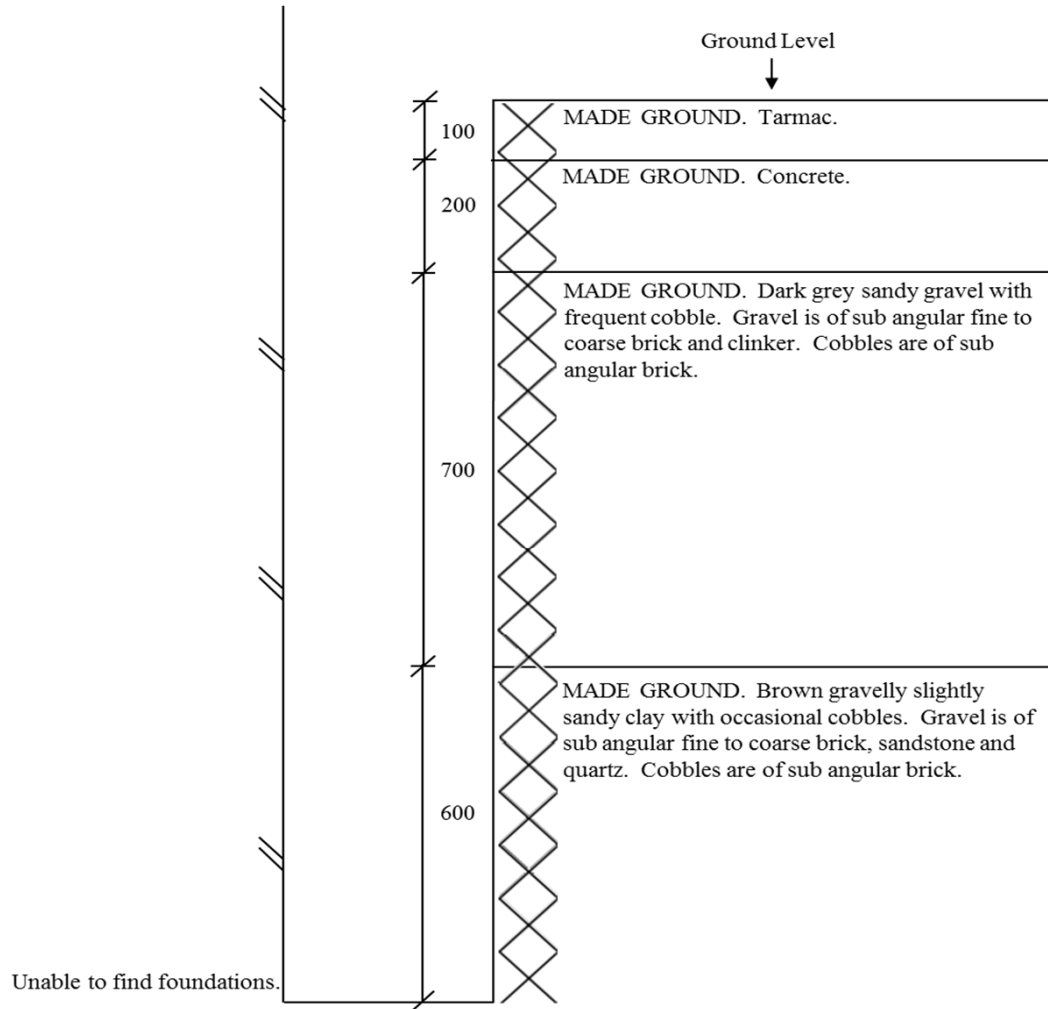
| <b>Trial Pit No: HP4</b> | | | |

For strata information below 1.6m, please refer to borehole HP4.

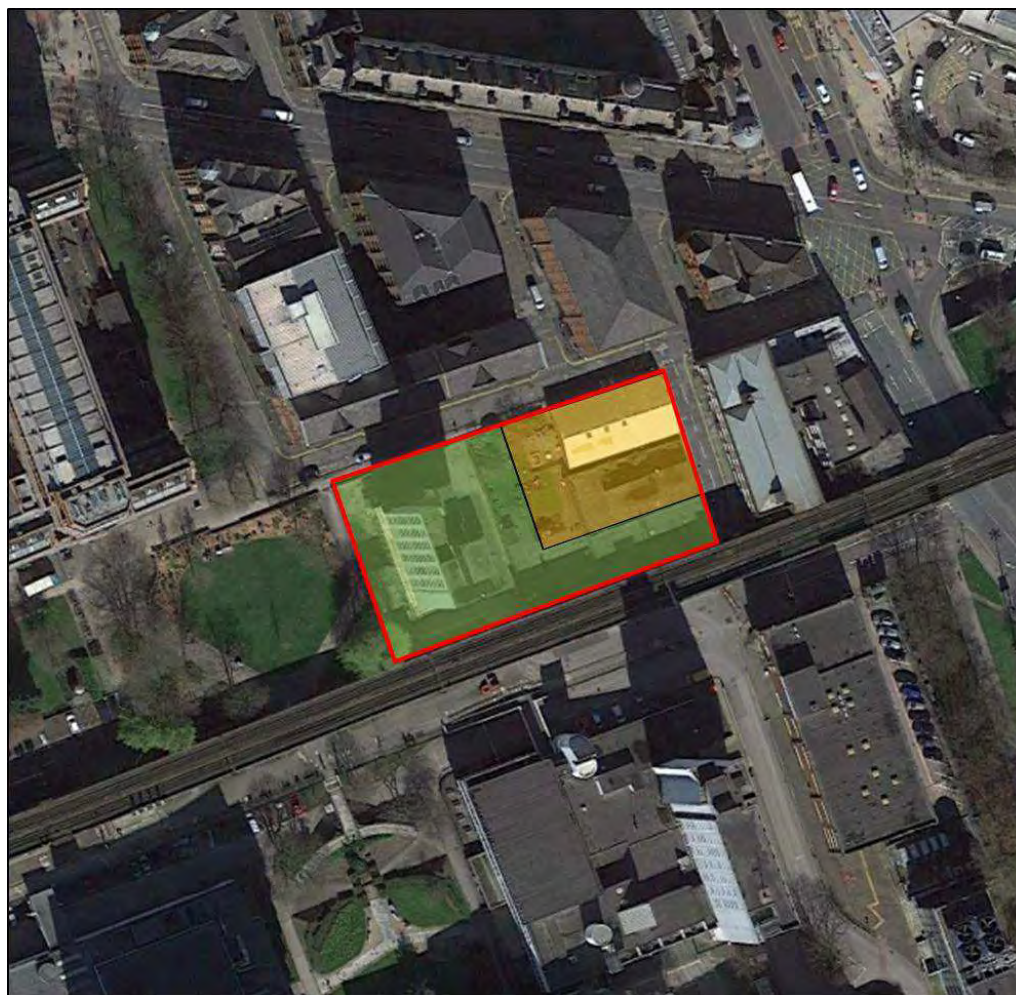
Risk Map

For indicative purposes – not to scale

Given that most of the site appears to have survived the war, shows no signs of damage and likely accessed frequently, this part of the site has been given a **Low** Risk. The area within the northeast of the site is shown as cleared on post-war aerial photography. Given the poor quality of the record set for Manchester, it has not proved possible to prove that this clearance was not due to bombing. Thus, this area, with a small buffer to account for the 'J-curve' effect, has been given a **Medium** Risk. The zoned risk areas are shown in *Figure 2.6b* below.

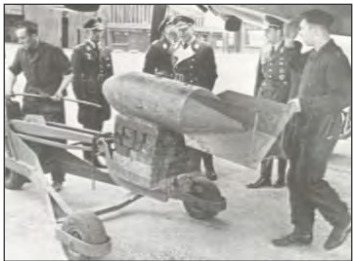
| Use | Against railway installations, embankments, flyovers, underpasses, large buildings and below-ground installations. |

SC250 bomb being loaded onto German bomber

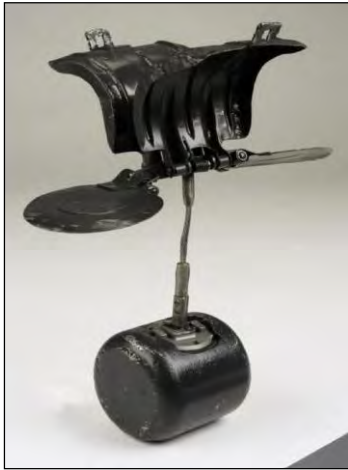
| Use | Designed as an anti-personnel/ fragmentation weapon. They were delivered by air, being dropped in containers of 23-144 sub-munitions that opened at a predetermined height, thus scattering the bombs. |
| Remarks | Very rare. First used against Ipswich in 1940, but were also dropped on Kingston upon Hull, Grimsby and Cleethorpes in June 1943, amongst various other targets in UK. As the bombs fell the outer case flicked open by springs which caused four light metal drogues with a protruding 5 inch steel cable to deploy in the form of a parachute & wind vane which armed the device as it span. |

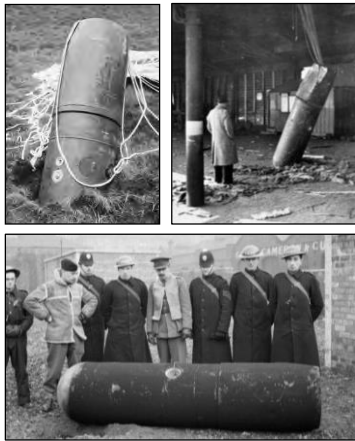
Parachute Mine (Luftmine B / LMB)

| Use | Against civilian, military and industrial targets. Used as blast bombs and designed to detonate above ground level to maximise damage to a wider area. |
| Remarks | Deployed a parachute when dropped in order to control its descent. Had the potential to destroy a whole street of housing in a 100m radius. |

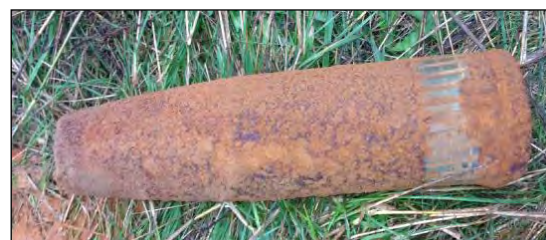
| Use | The 3.7in AA Mk 1-3 were the standard Heavy Anti-Aircraft guns of the British Army. |
| Ceiling | 30,000ft to 59,000ft |

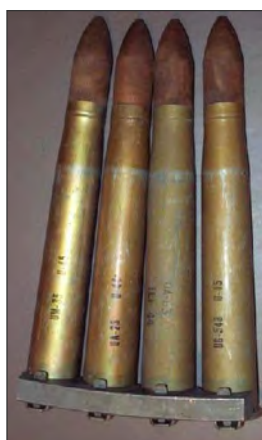
## 40mm Bofors Projectile

| Ceiling | 23,000ft (7000m ) |
| Remarks | Light quick fire high explosive anti-aircraft projectile. Each projectile fitted with small tracer element. If no target hit, shell would explode when tracer burnt out. Designed to engage aircraft flying below 2,000ft |

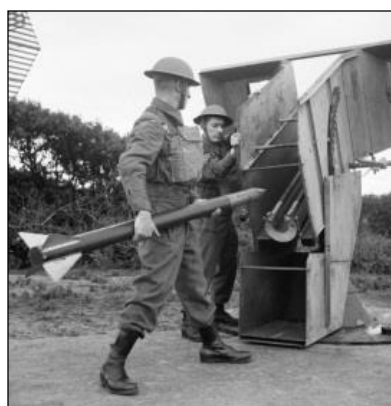
## 3in Unrotated Projectile (UP) Anti-Aircraft Rocket ("Z" Battery)

| HE Projectile Weight | 3.4kg (7.6lb) |
| Dimensions of projectile | 236 x 83mm (9.29 x 3.25in) |
| Remarks | As a short range rocket-firing anti-aircraft weapon developed for the Royal Navy. It was used extensively by British ships during the early days of World War II. The UP was also used in ground-based single and 128-round launchers known as Z Batteries. Shell consists of a steel cylinder reduced in diameter at the base and threaded externally to screw into the shell ring of the rocket motor |
