PROJECT TITLE  
**THG HIVE**

DRAWING TITLE  
**PRELIMINARY  
CUT FILL ASSESSMENT**

## **APPENDIX B - EXPLORATORY HOLE LOGSHEETS**

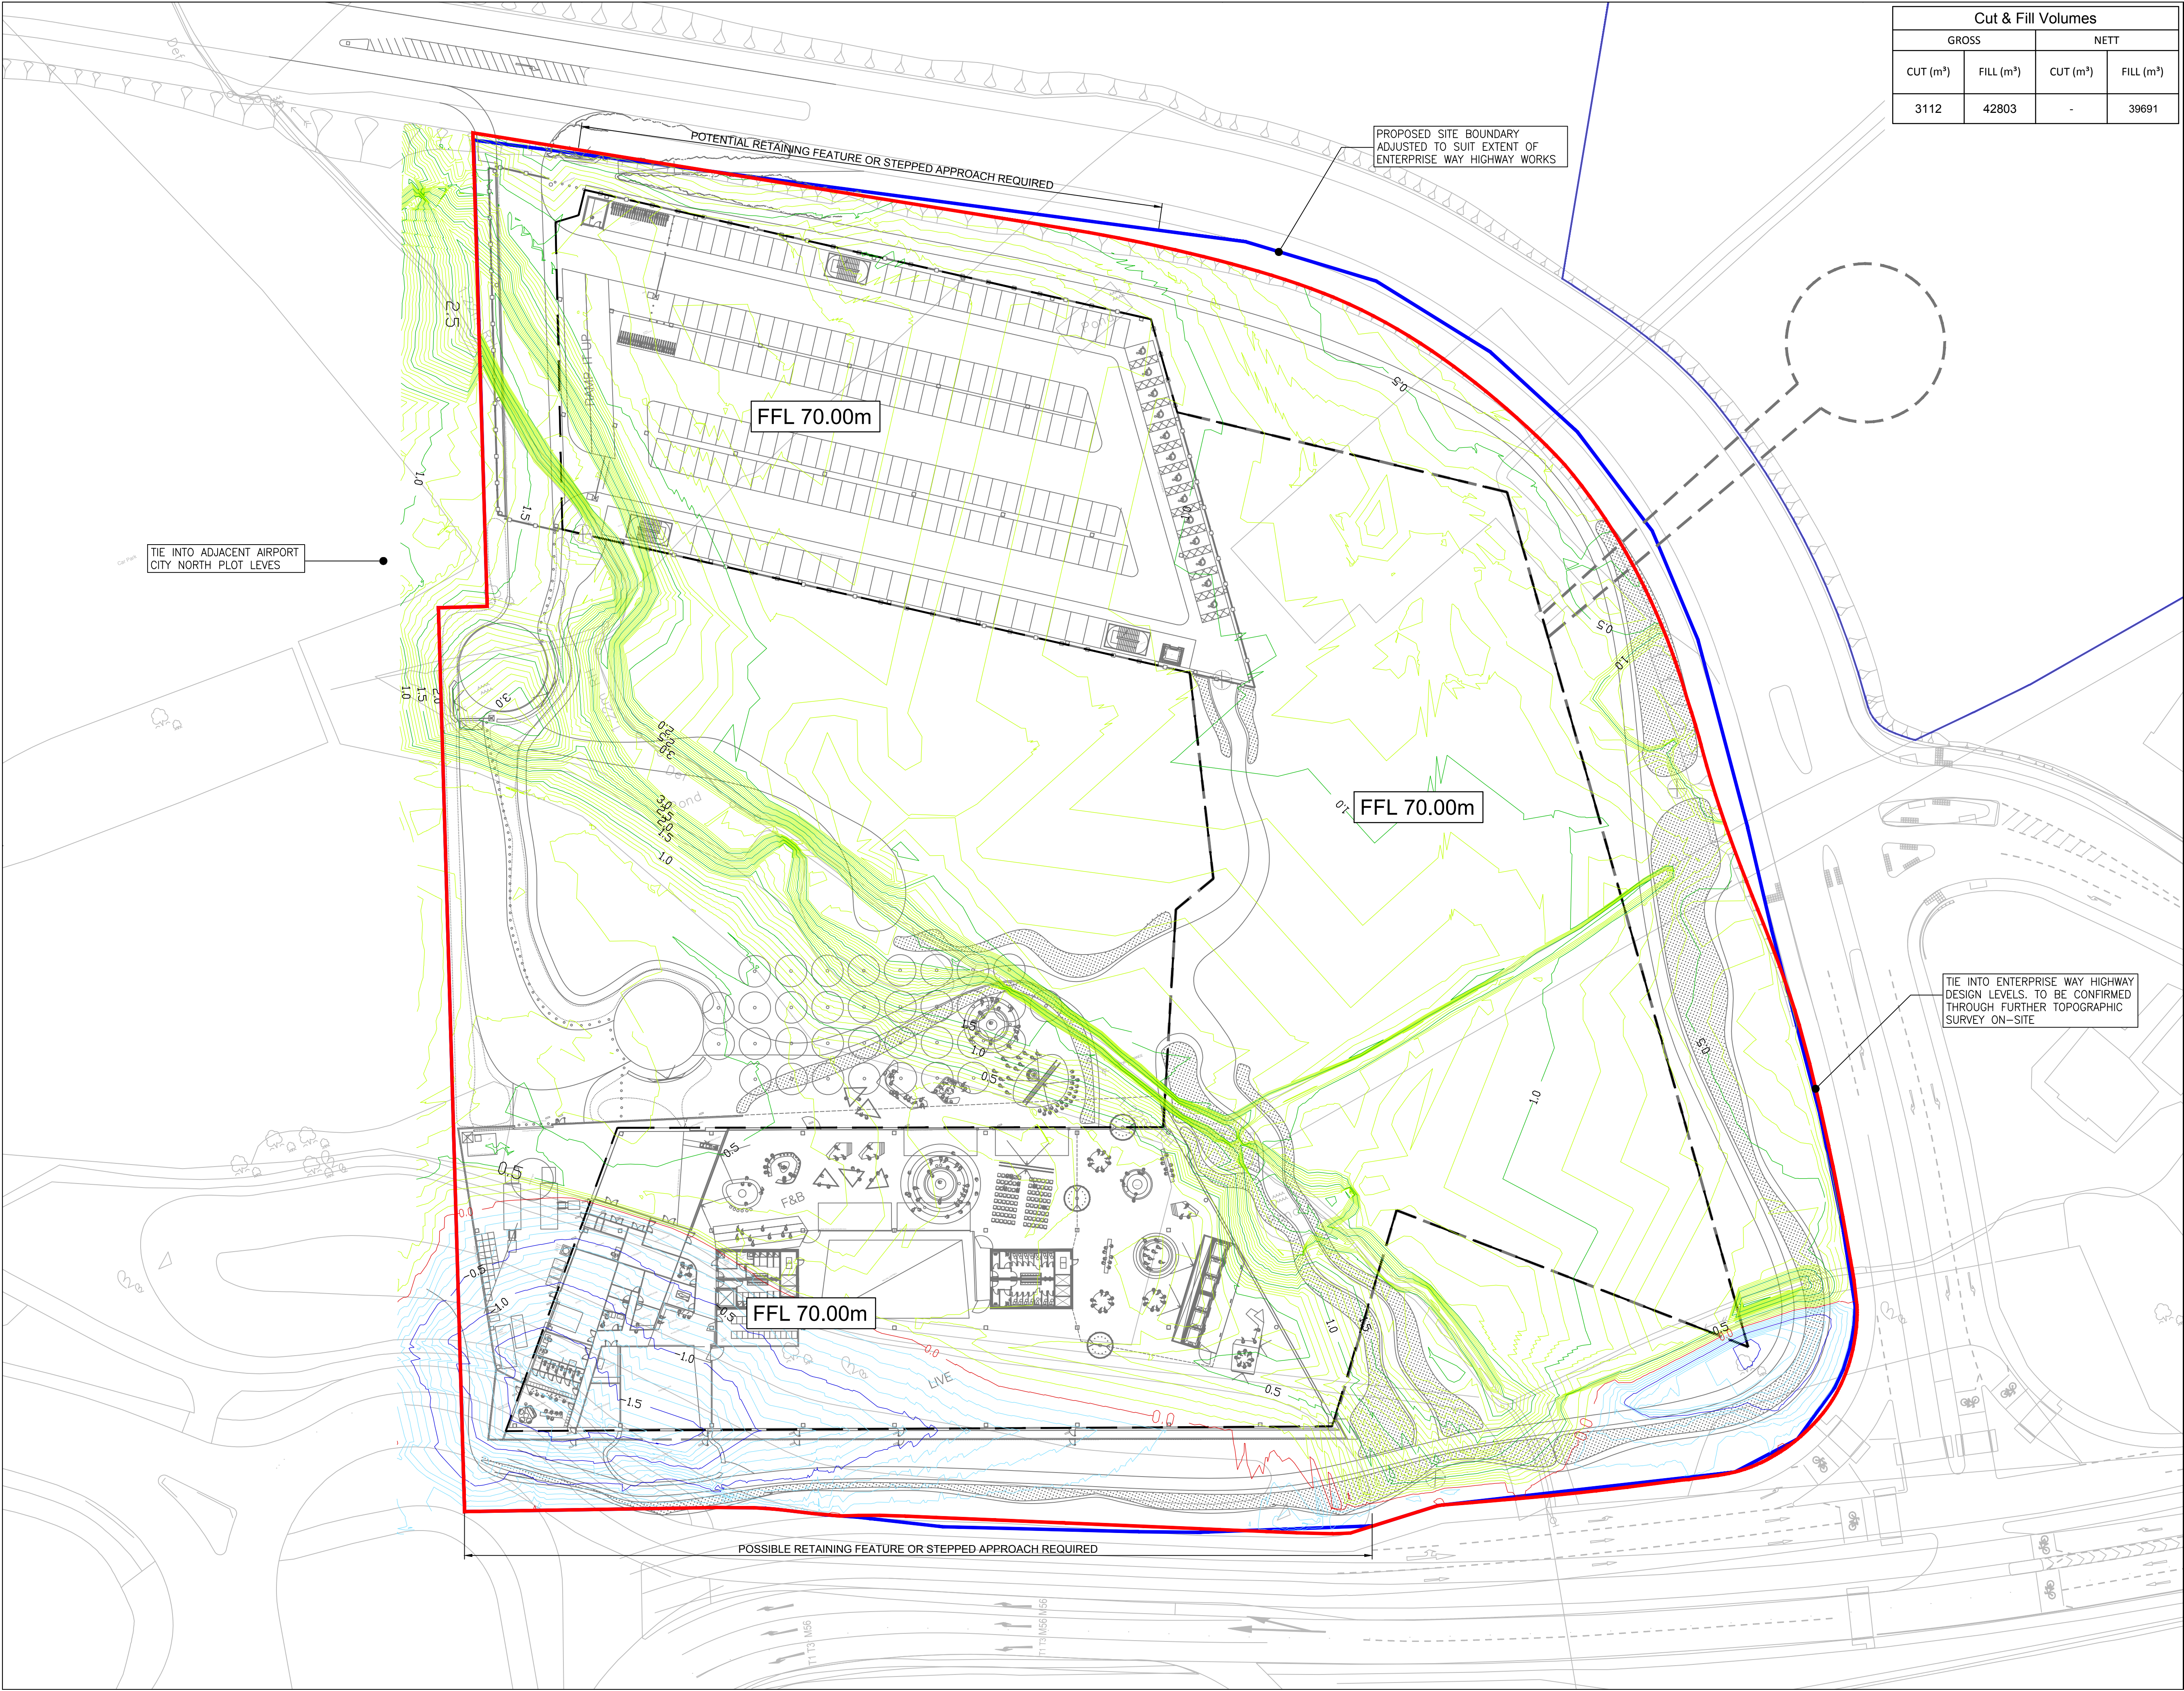
| PROJECT No.<br><b>3647</b> | DRAWING No.<br><b>CF03</b> | REV.<br><b>P1</b> |

| Cut & Fill Volumes | | | |
|---|---|---|---|
| 3112 | 42803 | - | 39691 |

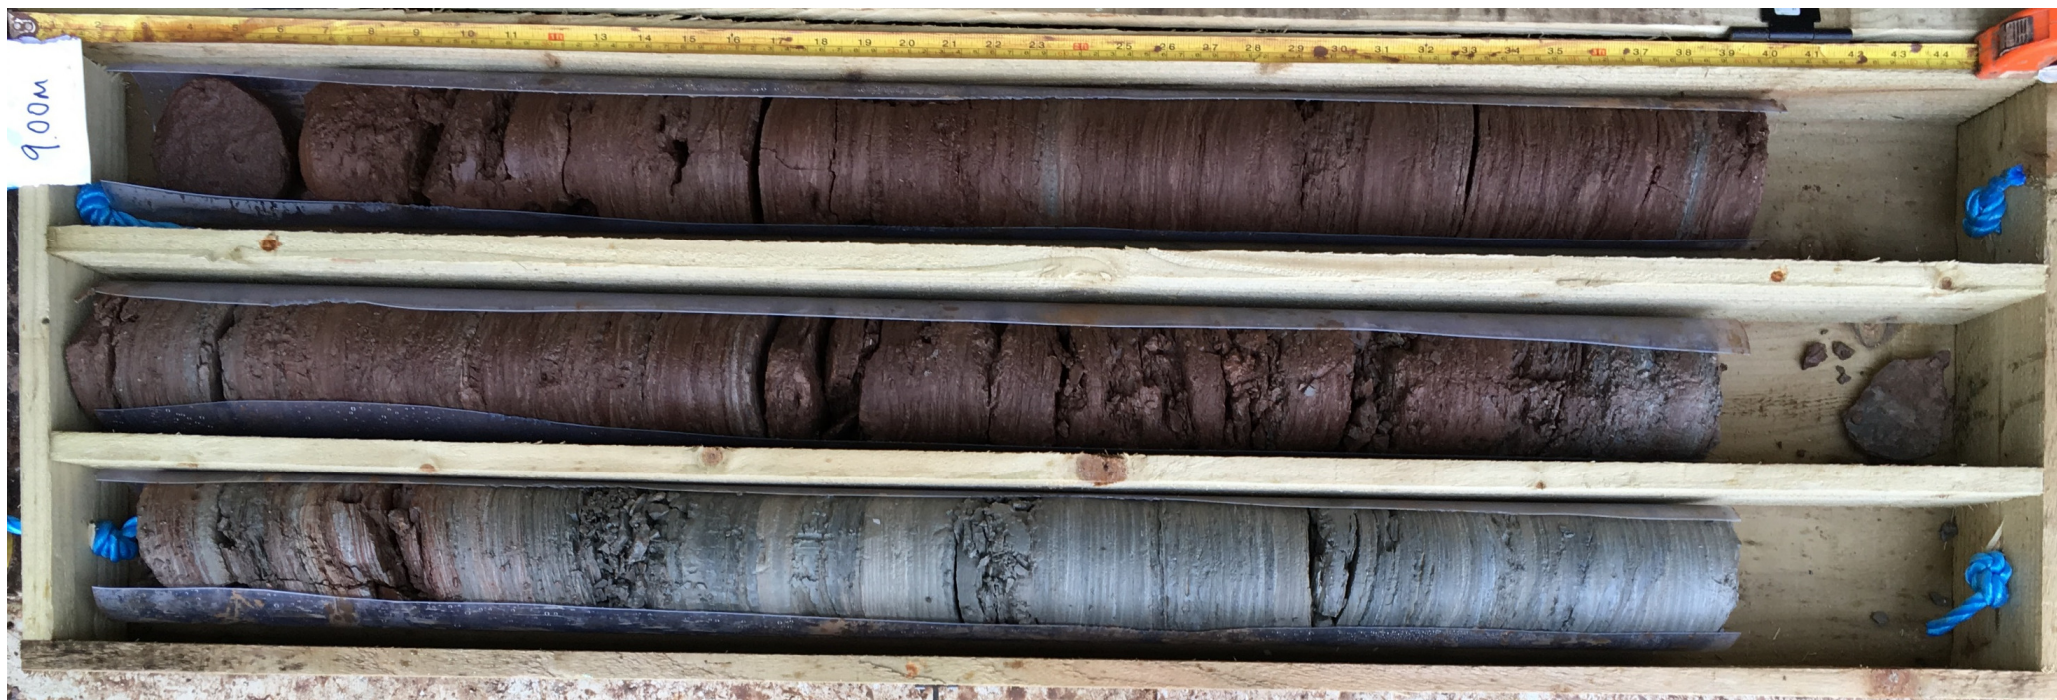
| | JOB NO | 3647 | SKETCH | BH101 | DRAWN BY |

| | PROJECT TITLE | The Hut Group, Hive | SKETCH TITLE | Rock Core Photos | ES |

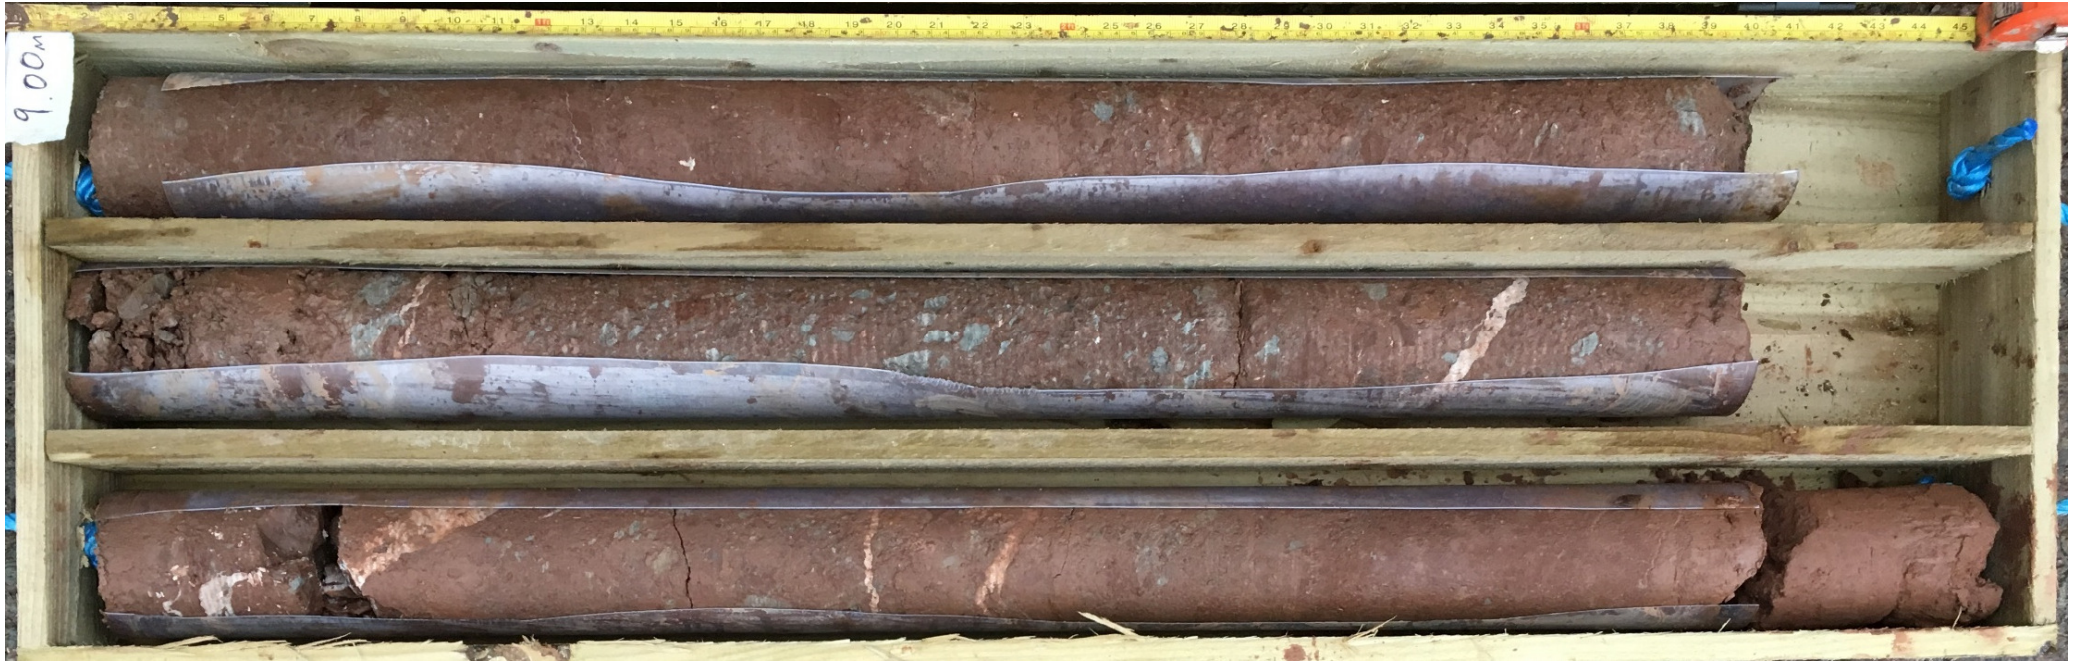
| | JOB NO | 3647 | SKETCH | BH102 | DRAWN BY |

| | PROJECT TITLE | The Hut Group, Hive | SKETCH TITLE | Rock Core Photos | ES |

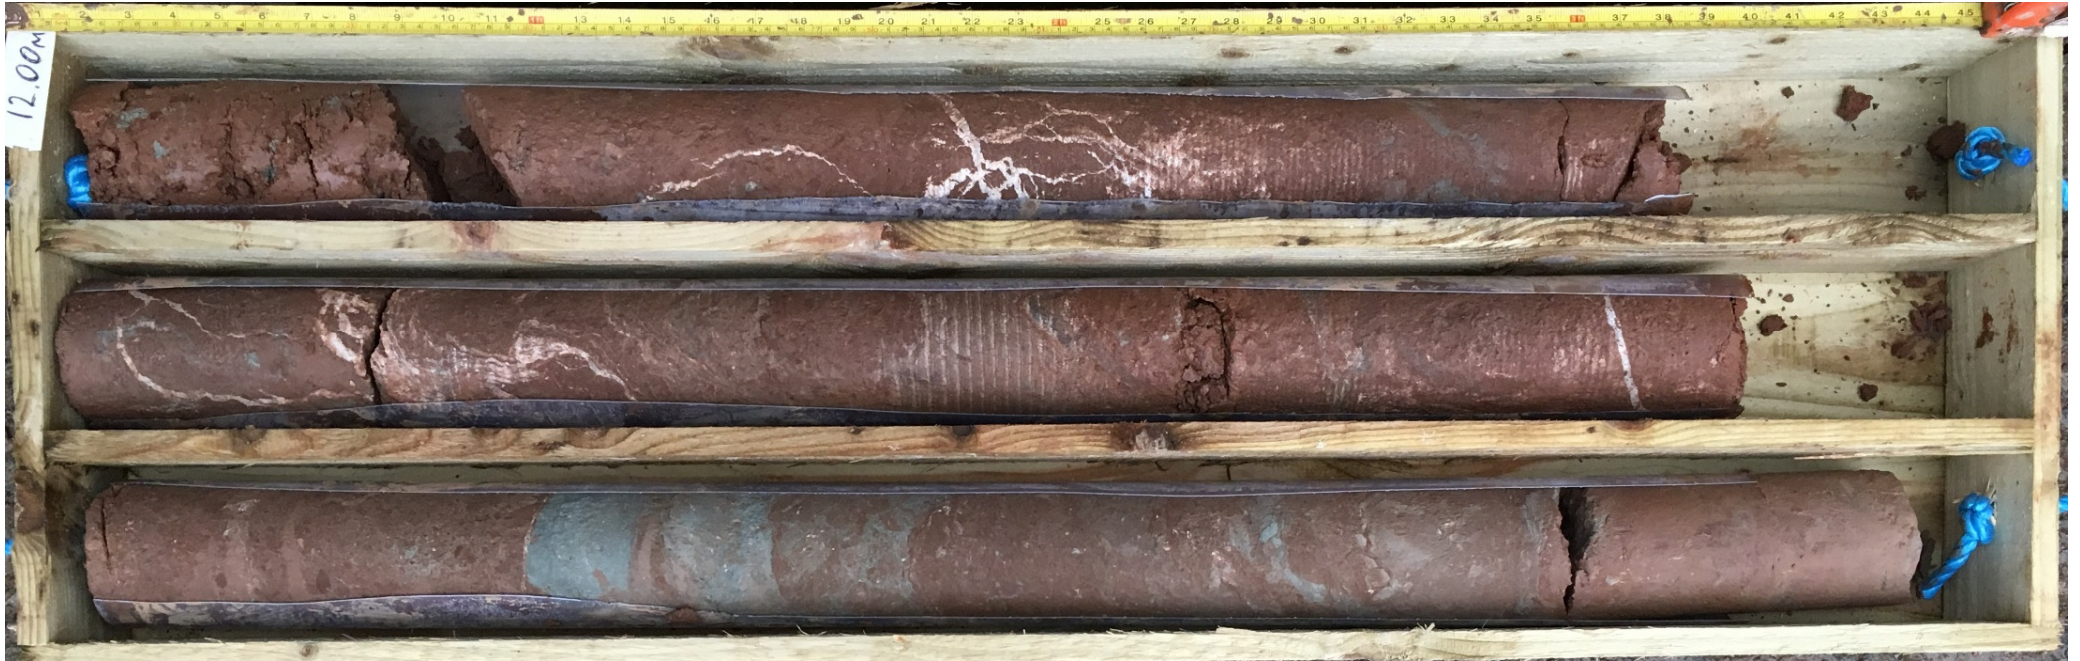
| | JOB NO | 3647 | SKETCH | BH102 | DRAWN BY |

| | PROJECT TITLE | The Hut Group, Hive | SKETCH TITLE | Rock Core Photos | ES |

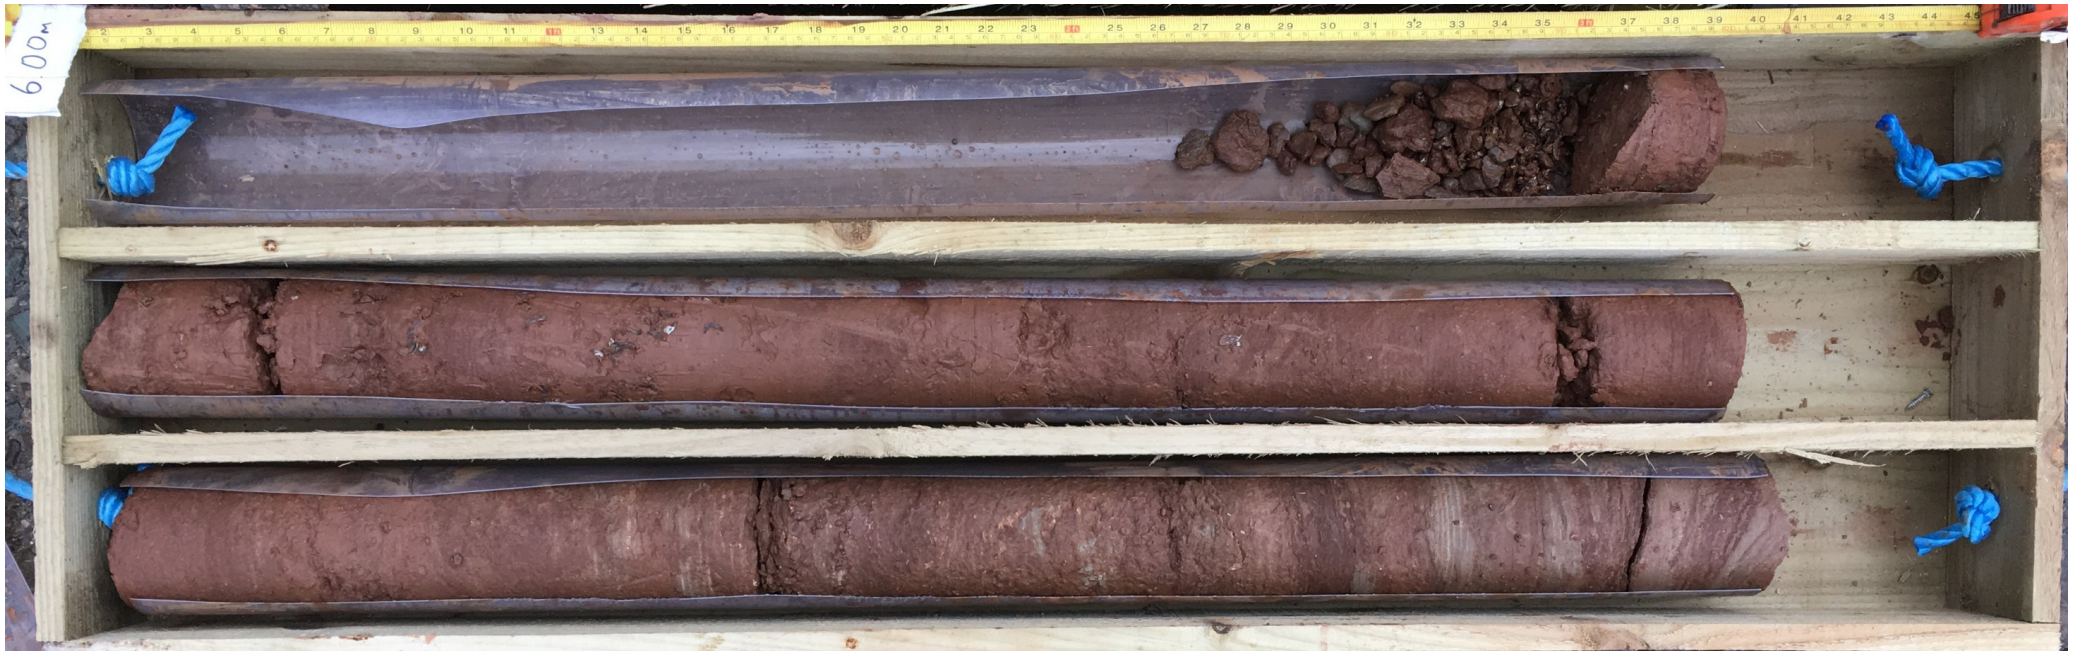
| | JOB NO | 3647 | SKETCH | BH103 | DRAWN BY |

| | PROJECT TITLE | The Hut Group, Hive | SKETCH TITLE | Rock Core Photos | ES |

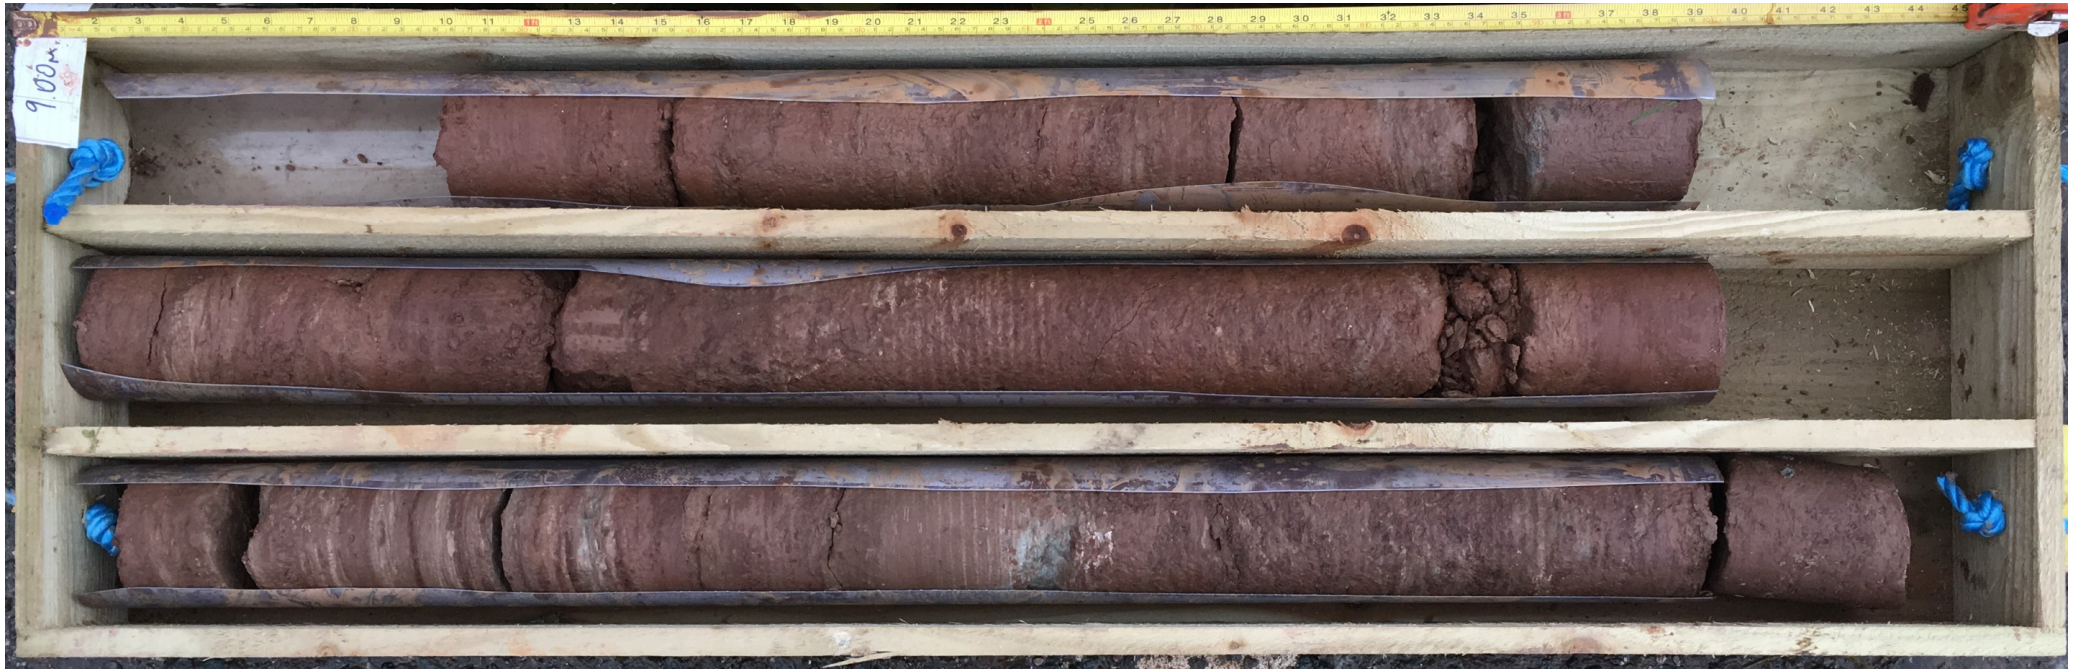
| | JOB NO | 3647 | SKETCH | BH103 | DRAWN BY<br>ES |

| | PROJECT TITLE | The Hut Group, Hive | SKETCH TITLE | Rock Core Photos | |
