| | PROJECT TITLE | The Hut Group, Hive | SKETCH TITLE | Rock Core Photos | ES |

# Percussion Drilling Log

| Project Name: THG HIVE, Airport City North | | Client: Airport City Partnerships | | Date: 06/11/2018 | |

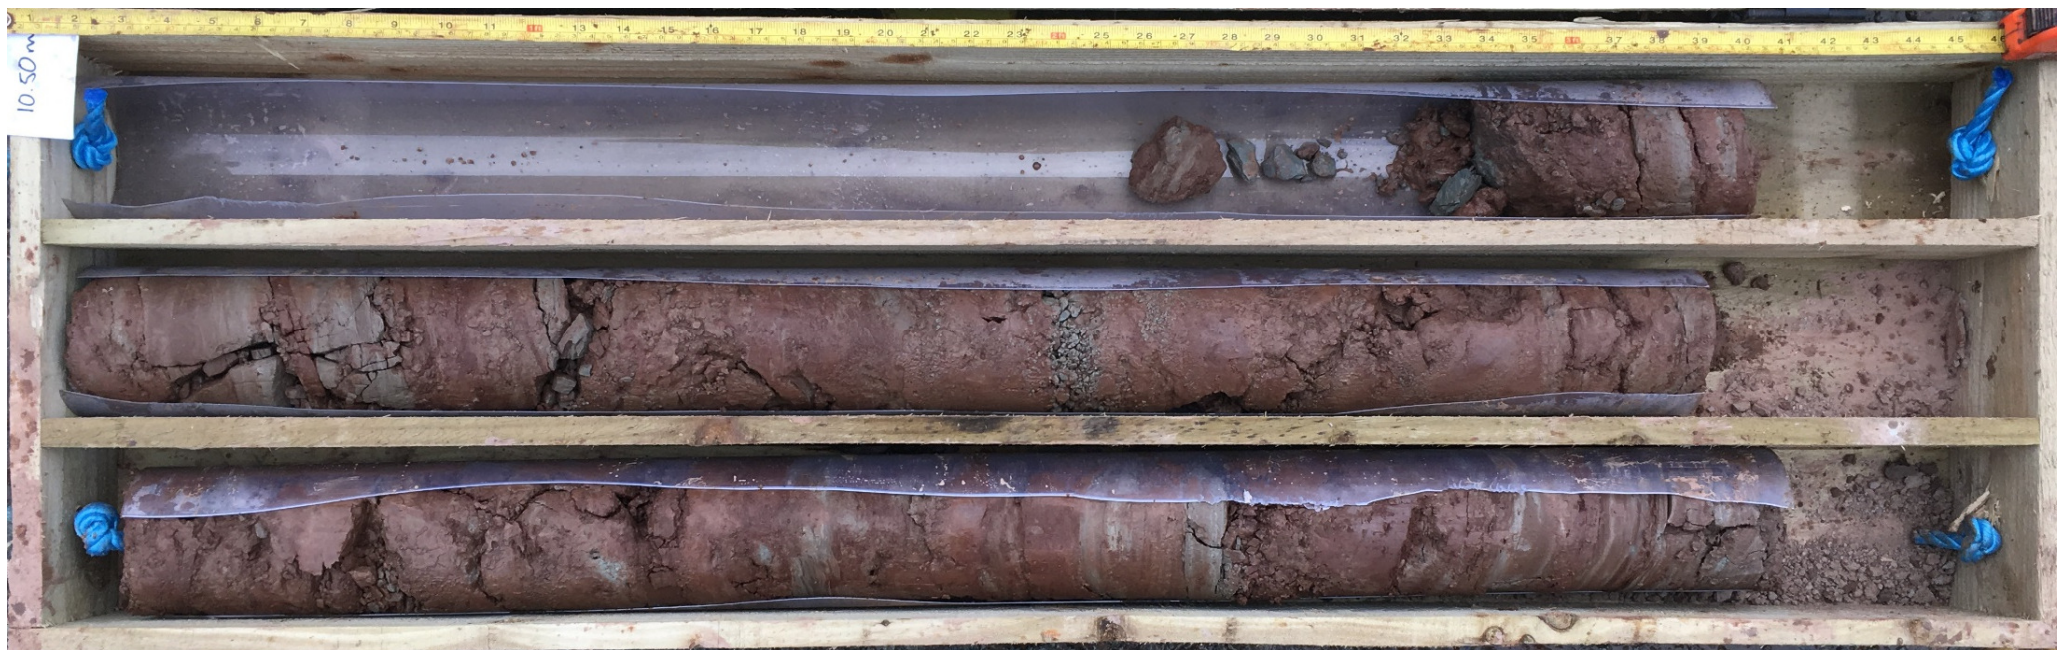
| | JOB NO | 3647 | SKETCH | BH104 | DRAWN BY |

| | PROJECT TITLE | The Hut Group, Hive | SKETCH TITLE | Rock Core Photos | ES |

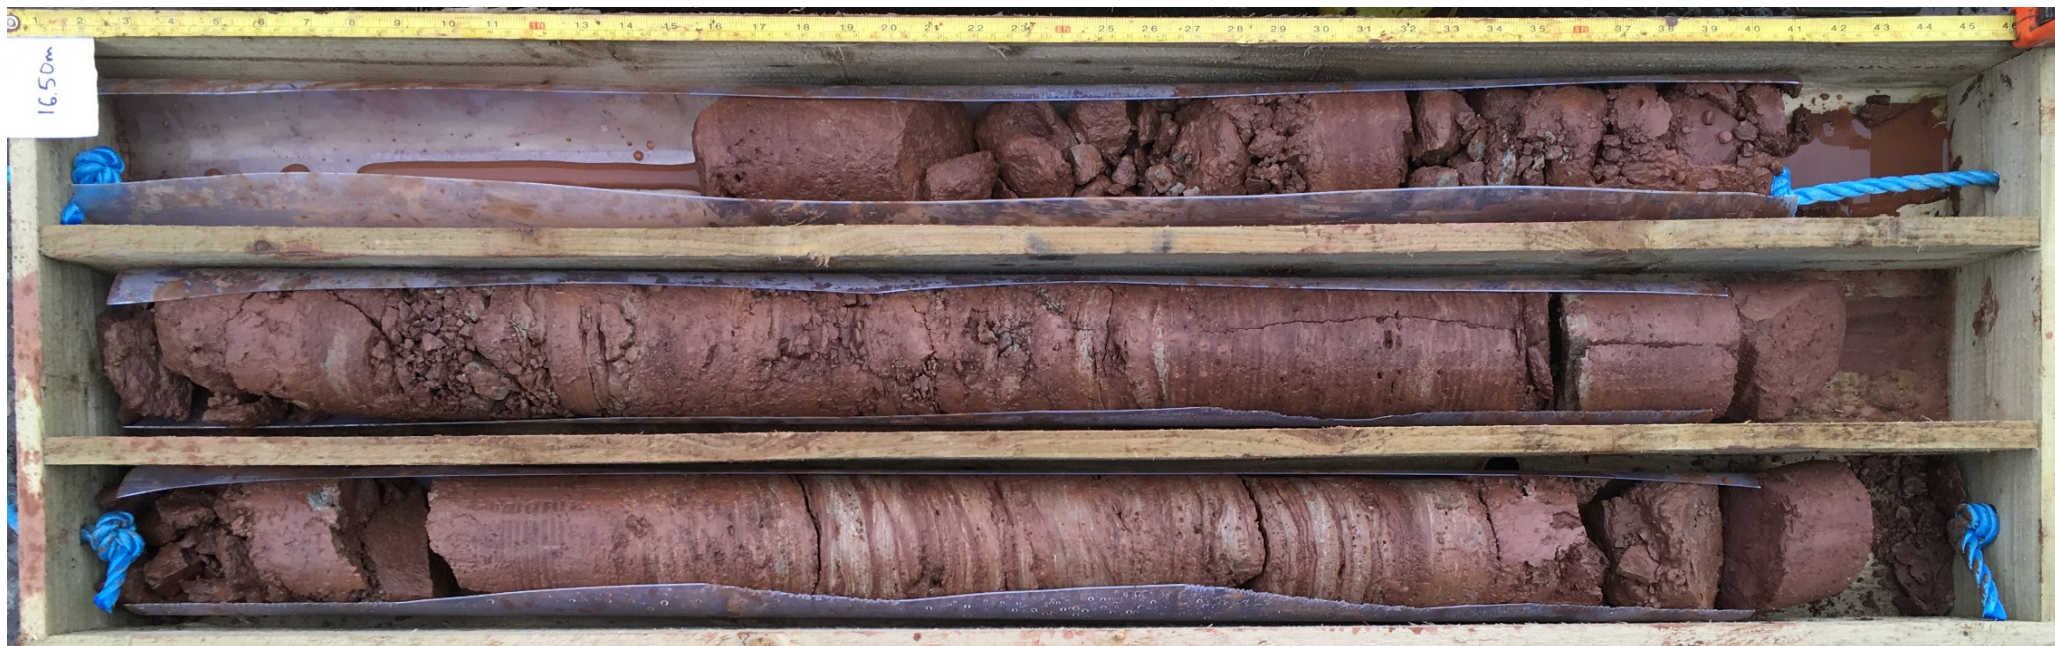
| | JOB NO | 3647 | SKETCH | BH104 | DRAWN BY |

| | PROJECT TITLE | The Hut Group, Hive | SKETCH TITLE | Rock Core Photos | ES |

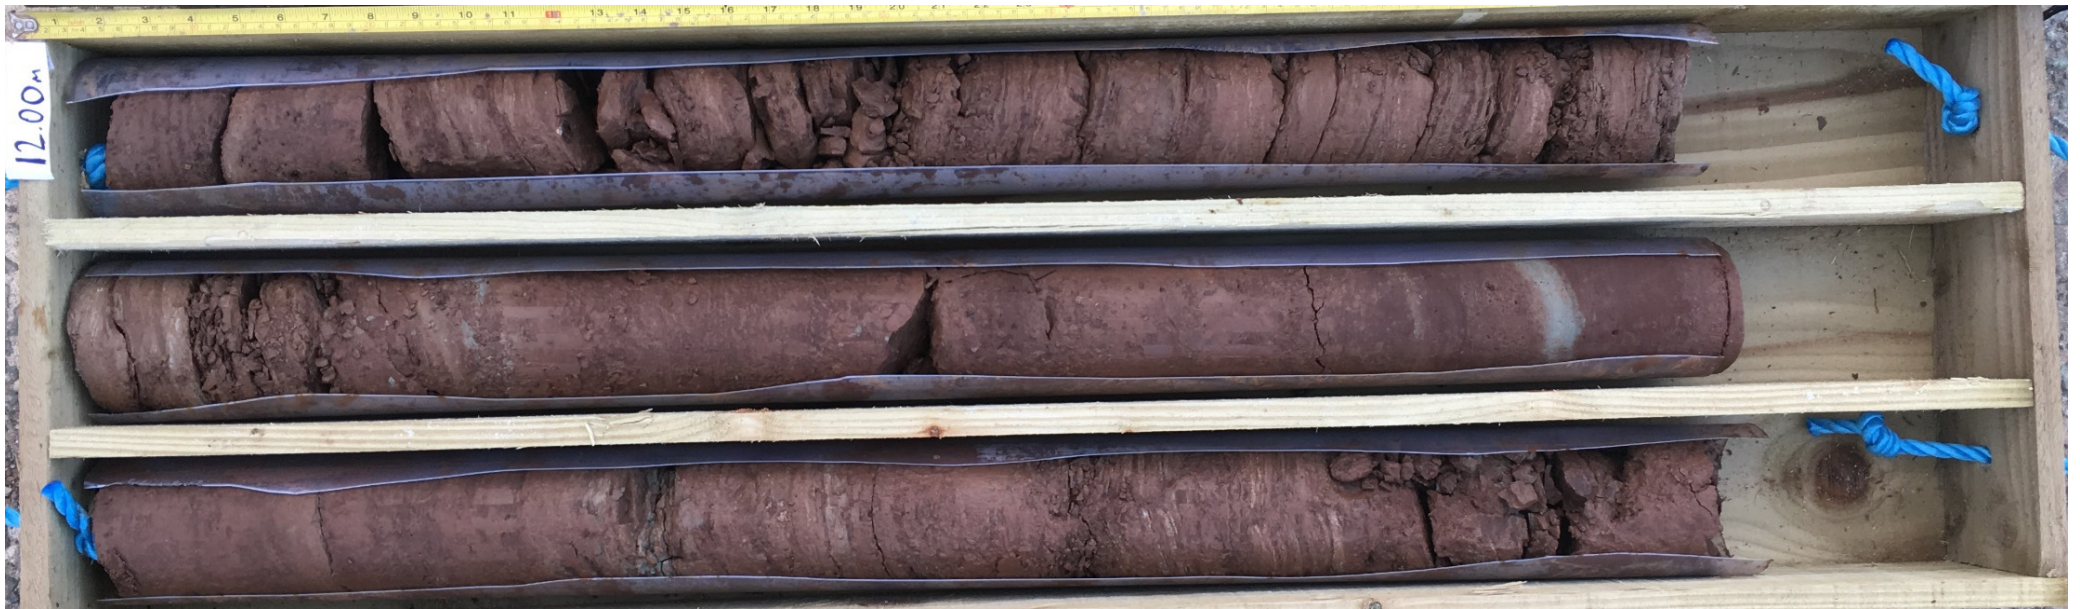
| | JOB NO | 3647 | SKETCH | BH105 | DRAWN BY |

| | PROJECT TITLE | The Hut Group, Hive | SKETCH TITLE | Rock Core Photos | ES |

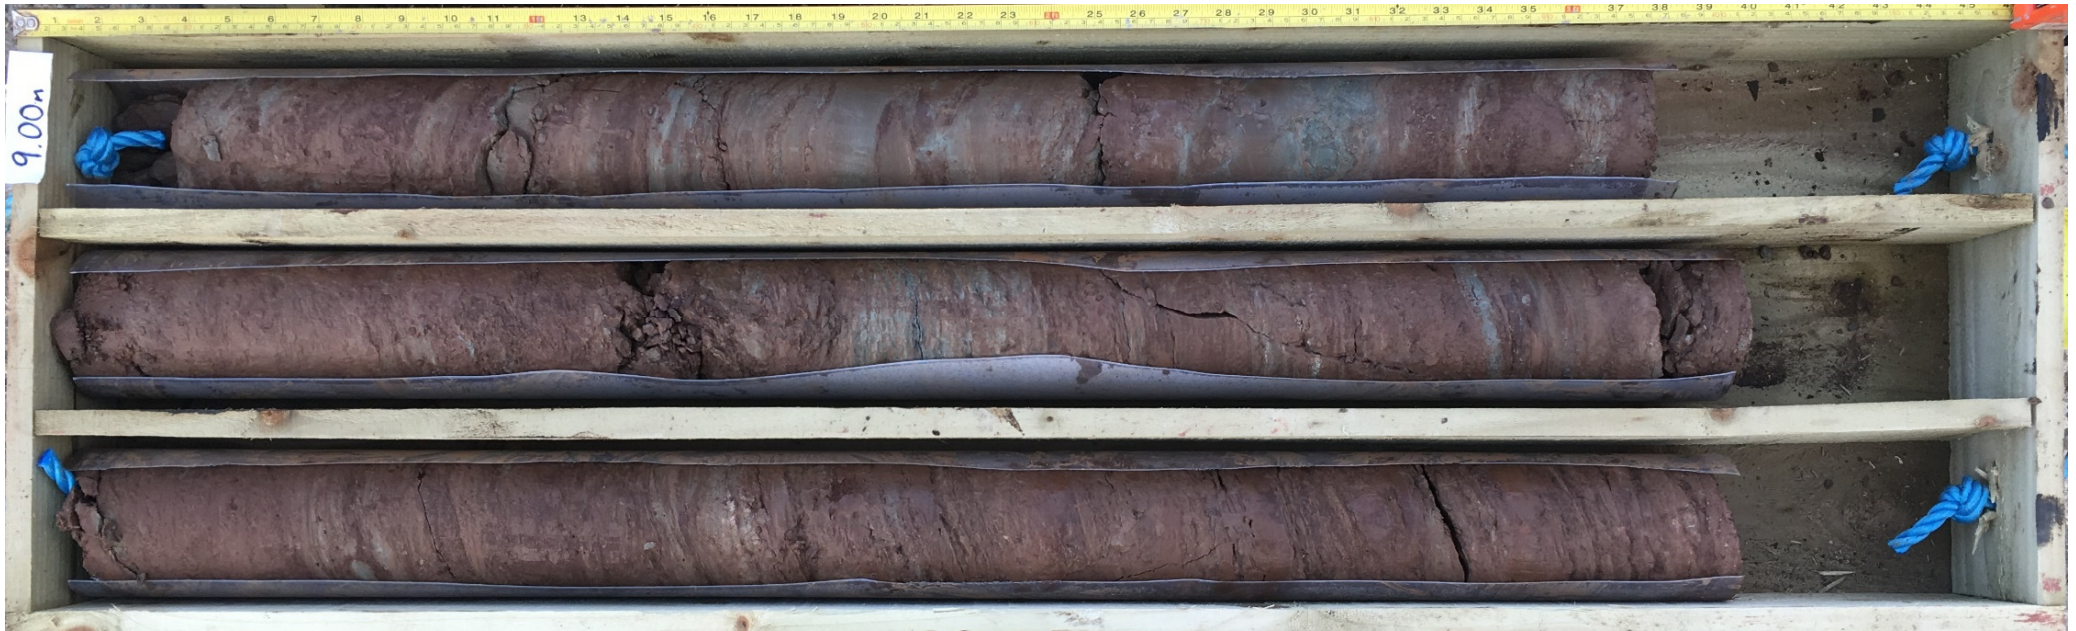
| | JOB NO | 3647 | SKETCH | BH105 | DRAWN BY |

| | PROJECT TITLE | The Hut Group, Hive | SKETCH TITLE | Rock Core Photos | ES |

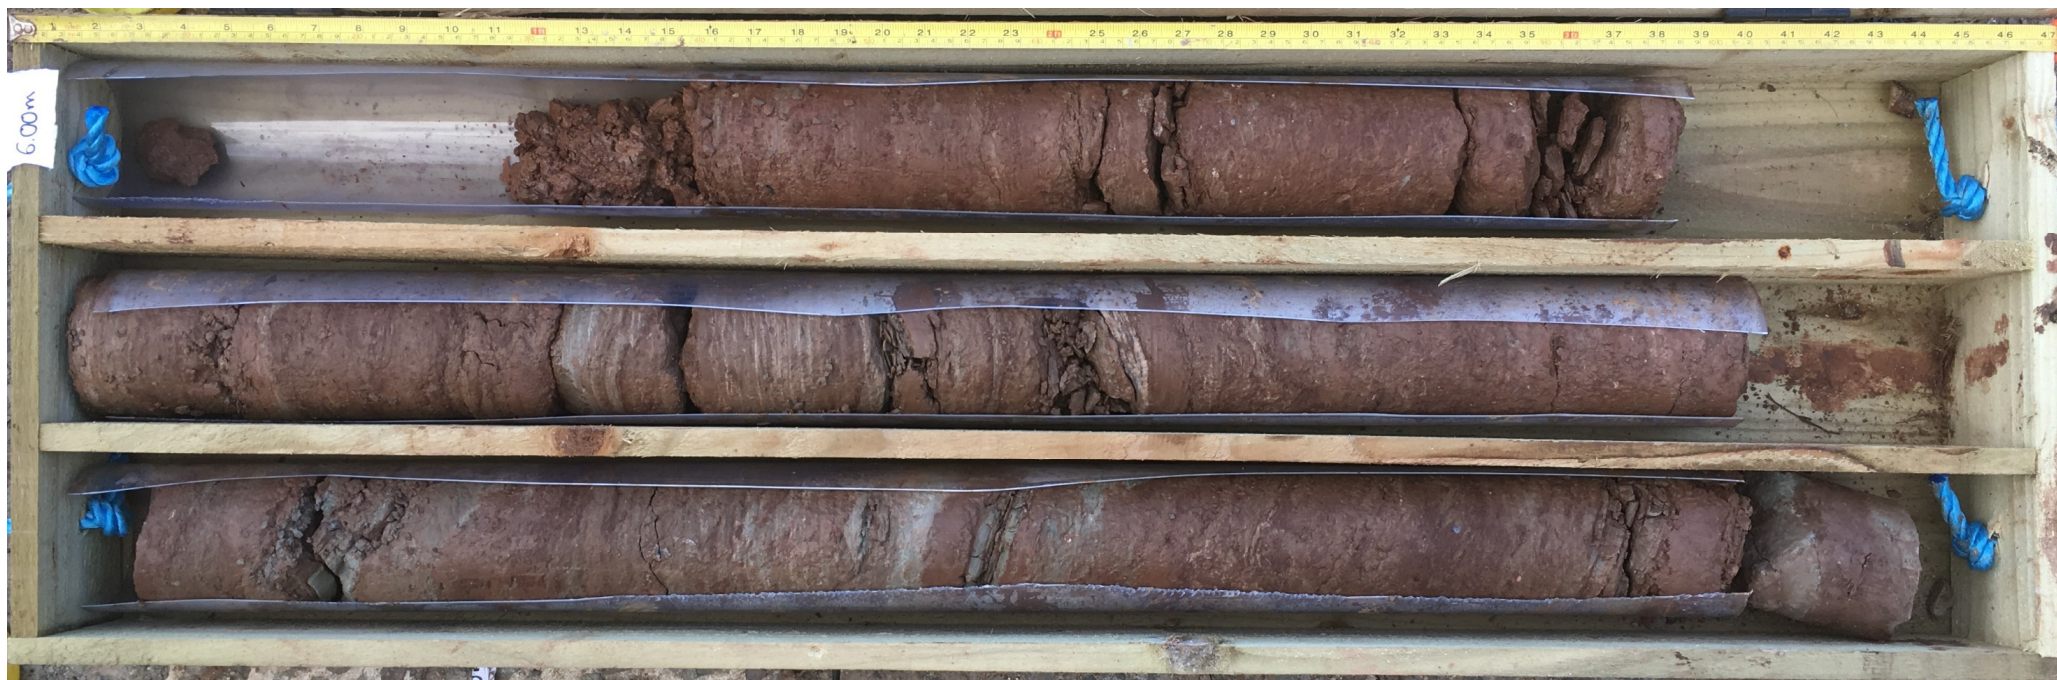
| | JOB NO | 3647 | SKETCH | BH106 | DRAWN BY |

| | PROJECT TITLE | The Hut Group, Hive | SKETCH TITLE | Rock Core Photos | ES |

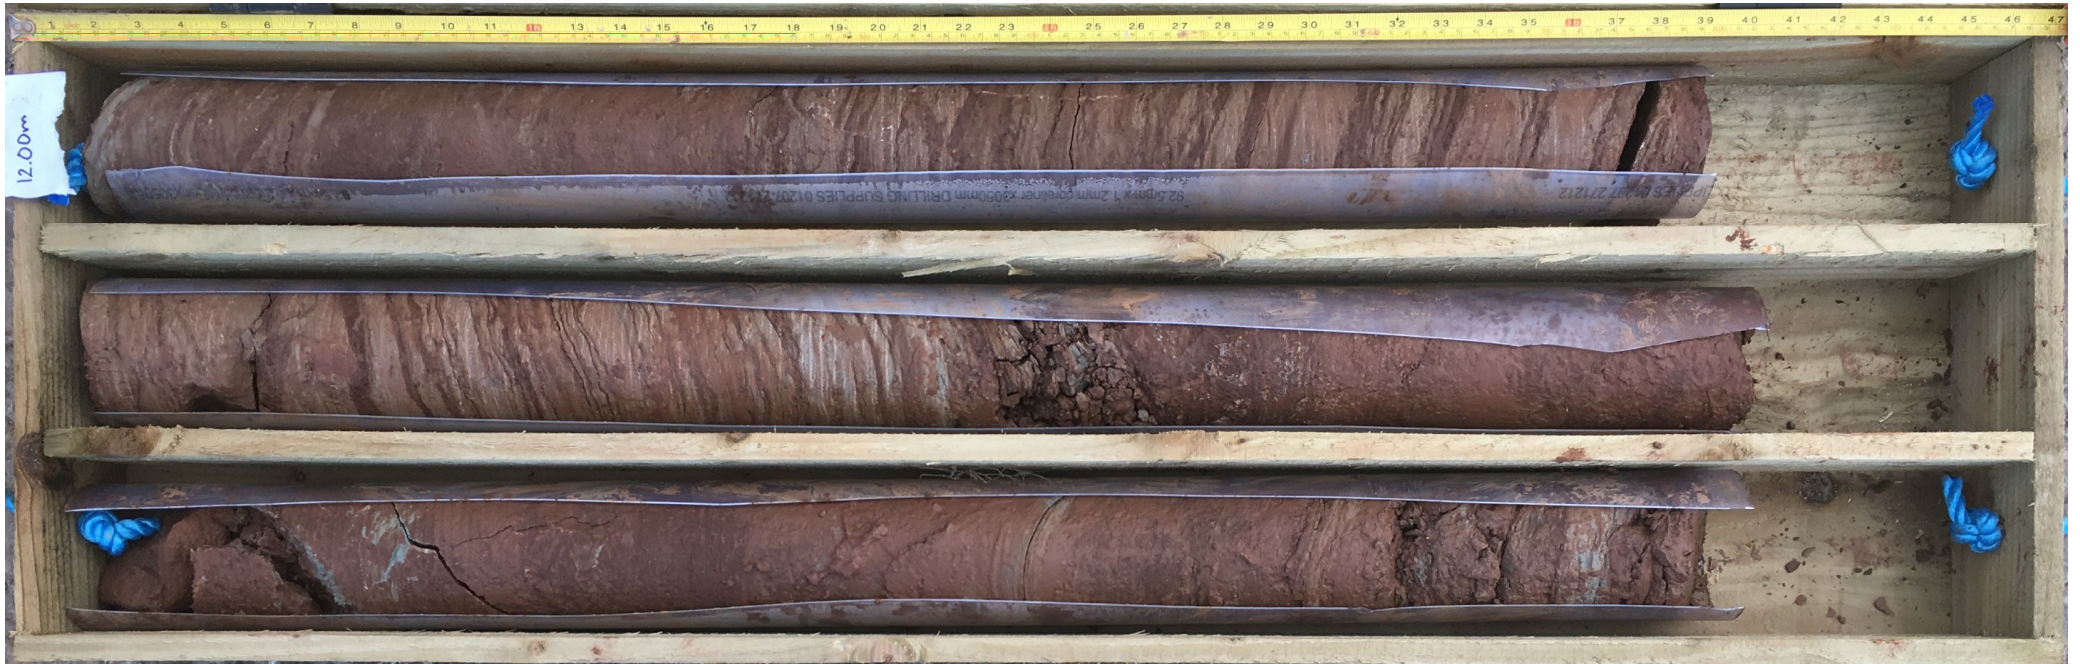
| | JOB NO | 3647 | SKETCH | BH106 | DRAWN BY |

| | PROJECT TITLE | The Hut Group, Hive | SKETCH TITLE | Rock Core Photos | ES |
