# Validation Completion Report

St Thomas, Hazelbottom

John Southworth Builders Ltd

| <b>Report Reference:</b> | <b>8243G-WML-00-XX-RP-G-0001</b> |

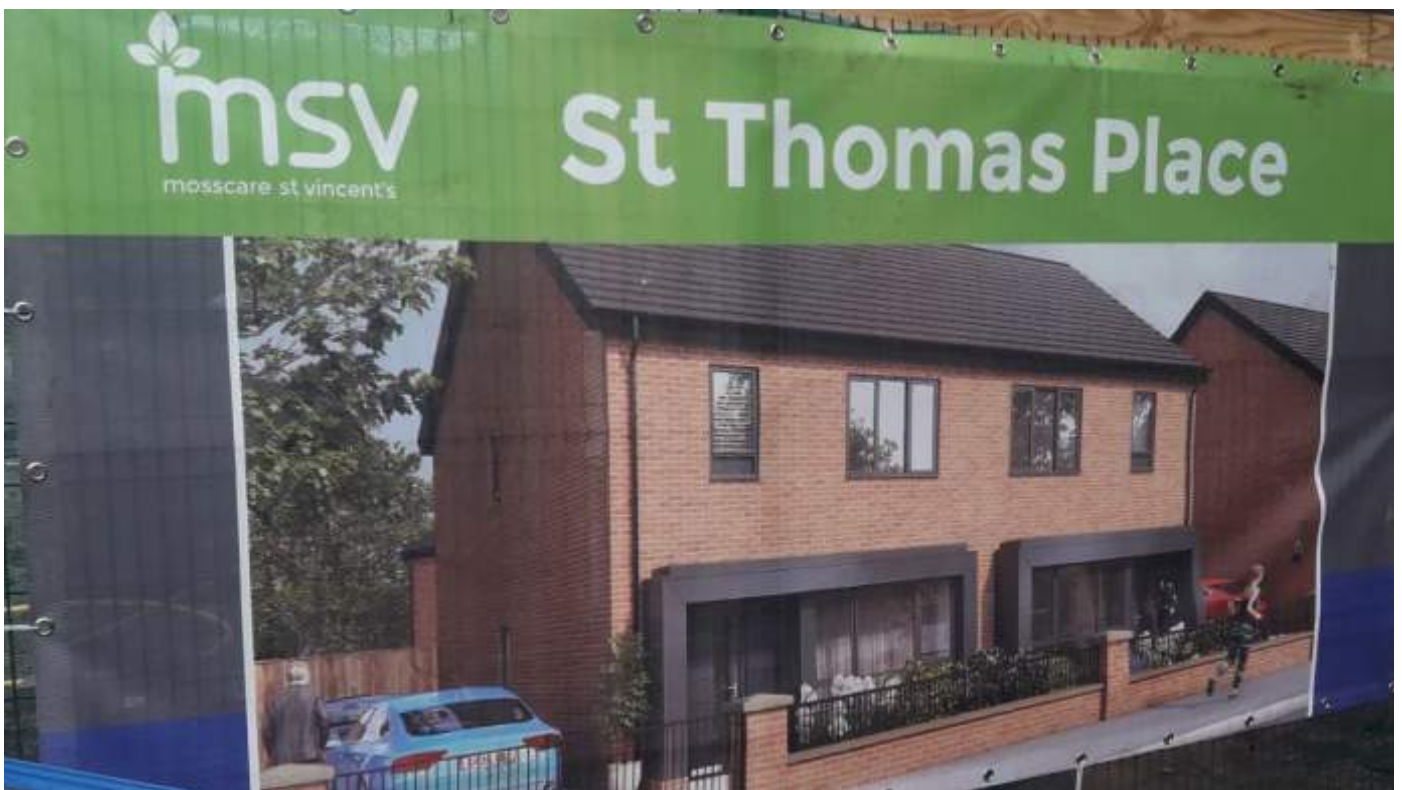
Record of Installation

Gas Barrier

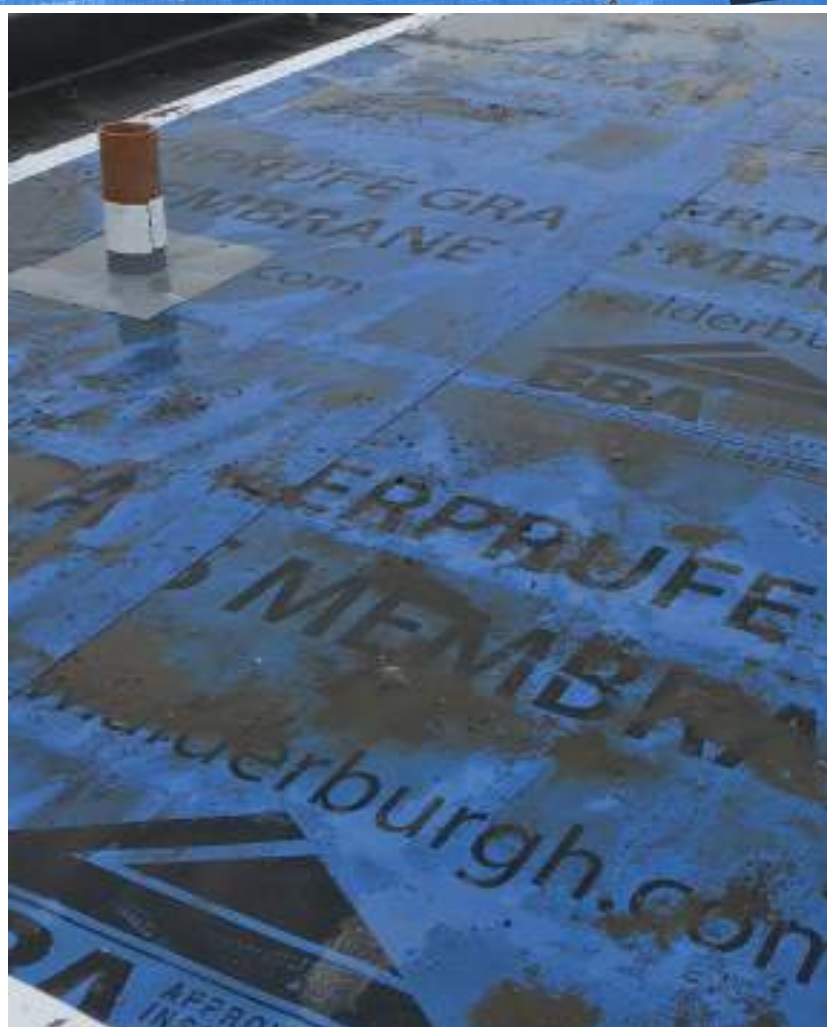
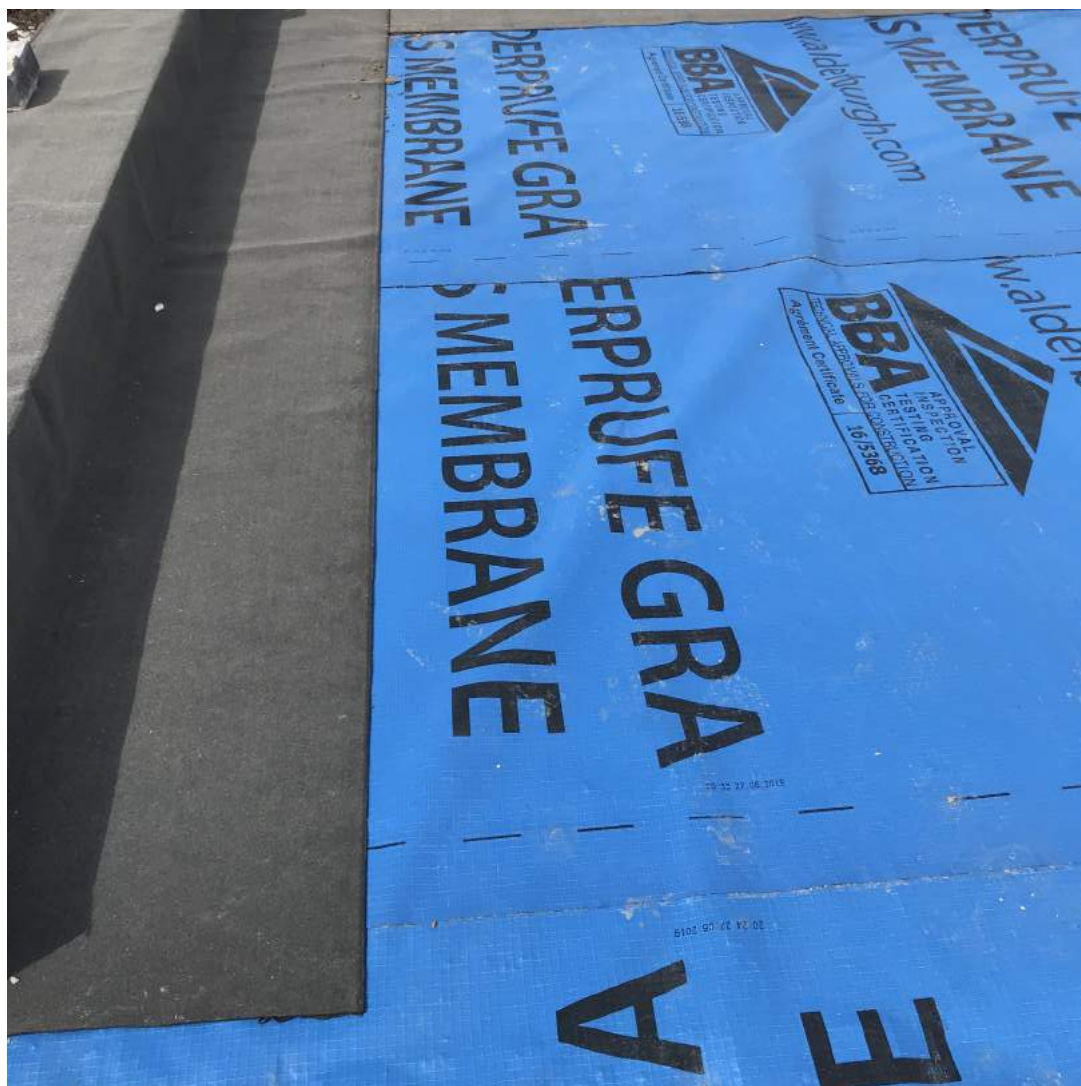
# **ALDERCOURSE GRA**

**Aldercourse GRA** is an aluminium cored high performance damp-proof course, to maintain the integrity of the gas barrier system in load-bearing locations. Used combination with all Alderprufe gas barriers it provides a continuous "through the wall to floor" junction.

**Aldercourse GRA** is a laminate of aluminium, high quality oxidised bitumen and hessian, surfaced with a light sand finish, and is compliant with **BS8485:2015** and **BS6398**. The aluminium layer provides an effective barrier to VOC as noted in **Ciria C748**. **Aldercourse GRA** can be heat-bonded to masonry, and in addition to gas barrier applications, it can also be used in cavity tray applications including parapet walls and beneath copings and cappings.

Any surface to which **Aldercourse GRA** will be heat bonded must be primed with one coat of **Tac Primer** at a rate of 0.1 to 0.3 litres per m<sup>2</sup> dependent on the porosity of the surface. The primer must be allowed to dry thoroughly before applying **Aldercourse GRA**.
