Our reference: 65347-CUR-00-XX-RP-GE-004-V01\_Tank Removal

27 September 2019

**Re: Echo Street, Manchester – Underground Storage Tank Removal Verification**

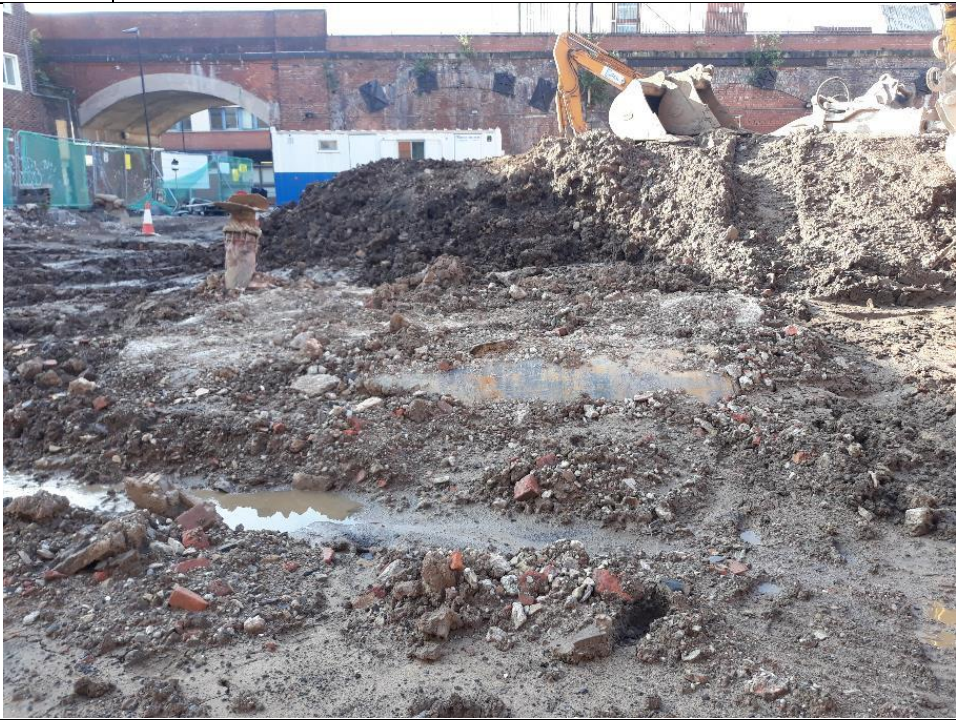
| <b>Photo No: 1</b> | <b>Description:</b> Tanks In-Situ |

The tanks were generally found to be in good condition, contained within a concrete bund. The bund base of the concrete strata was approximately 400mm to 500mm thick. The concrete base was situated on top of the natural clay strata.

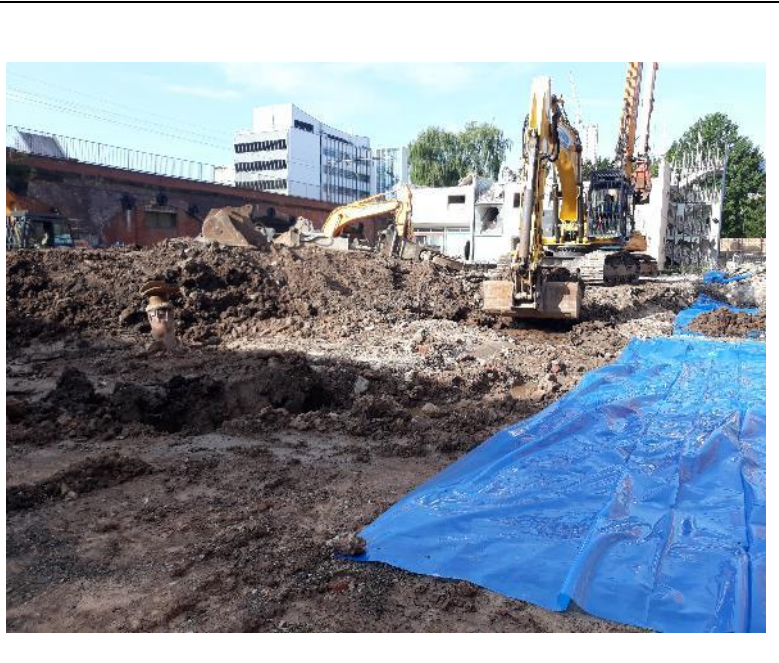
| <b>Photo No: 2 &amp; 3</b> | <b>Description:</b> Polythene laid out for emplacement of excavation arisings and tanks |

Once the tanks were removed were placed on polyethene membrane to protect the surrounding soils from leakages of any remaining liquids. No further leakages were observed. They were later put into skips for disposal.

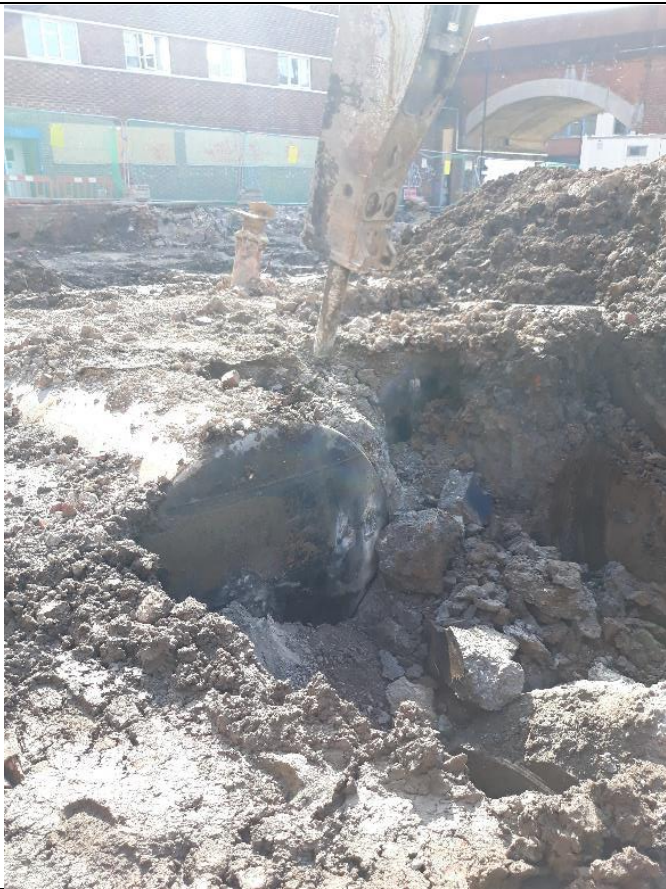
| <b>Photo No: 4</b> | <b>Description:</b> Removal of concrete bund to the side of the two tanks |

During removal of the tanks and concrete casing, a slight hydrocarbon odour and occasional black staining of the concrete was observed by the engineer.

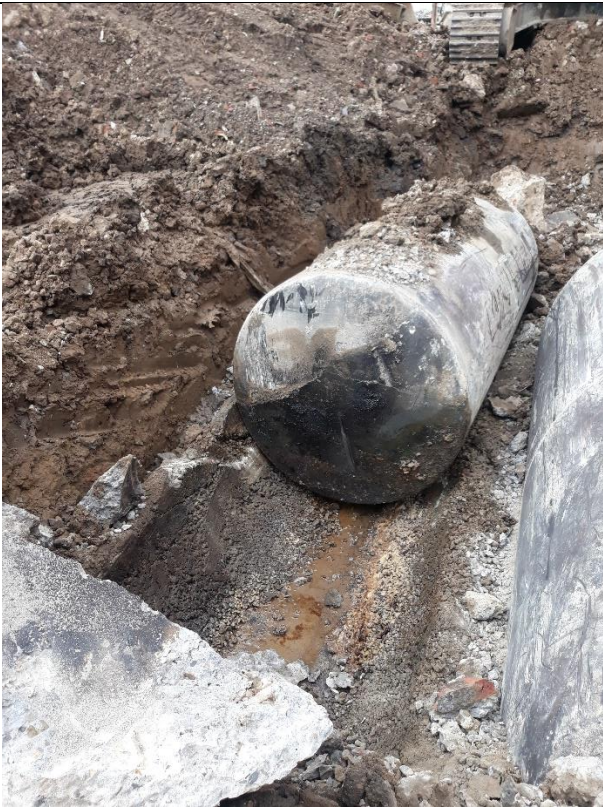
| <b>Photo No: 6</b> | <b>Description:</b> Slight sheen observed in water observed beneath Tank 1 |

On removal of Tank 1 a small volume of liquids with a slight sheen were observed, on top of the concrete base. The liquids were removed through use of a spill kit before the concrete was broken out.

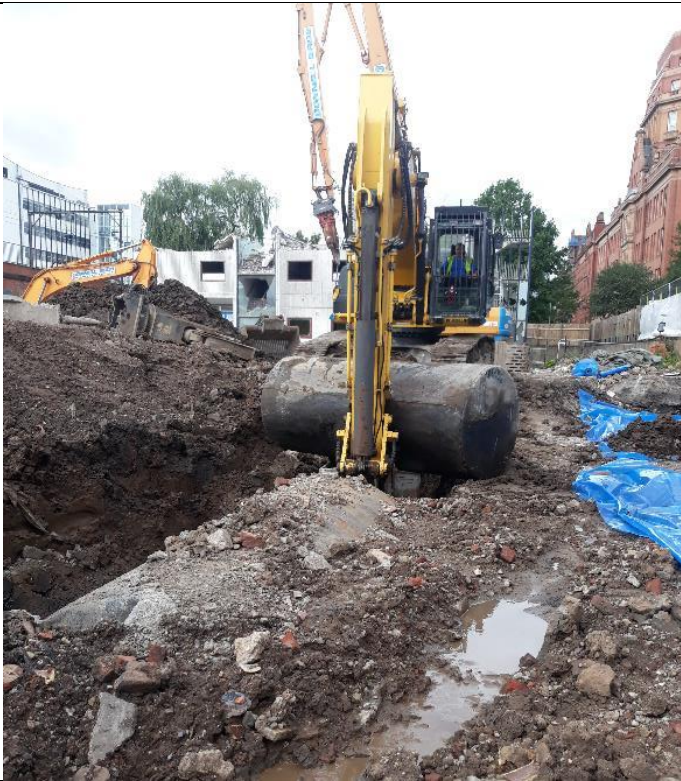
| <b>Photo No: 8</b> | <b>Description: Removal of Tank 1</b> |

Tank 1 was cylindrical in shape, circa 2.4m in length with a diameter of circa 1.5m with an approximate volume of 4.24m<sup>3</sup>.

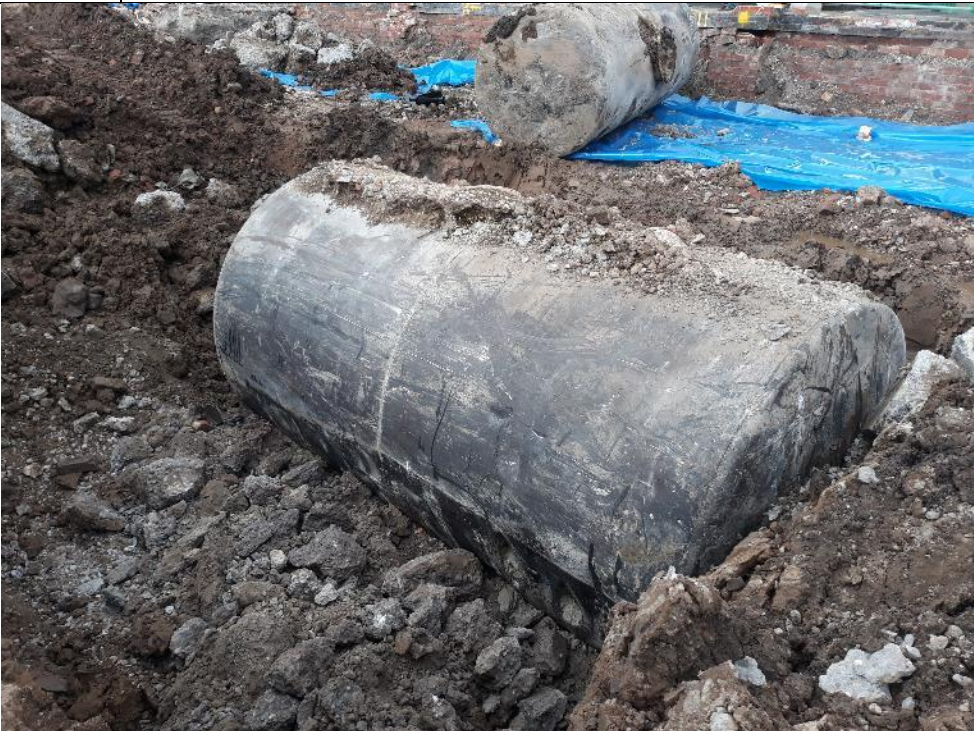
| <b>Photo No: 10</b> | <b>Description:</b> Tank 2 in-situ |

Tank 2 was cylindrical in shape, circa 3.5m in length with a diameter of circa 2.1m with an approximate volume of 12.12m<sup>3</sup>.

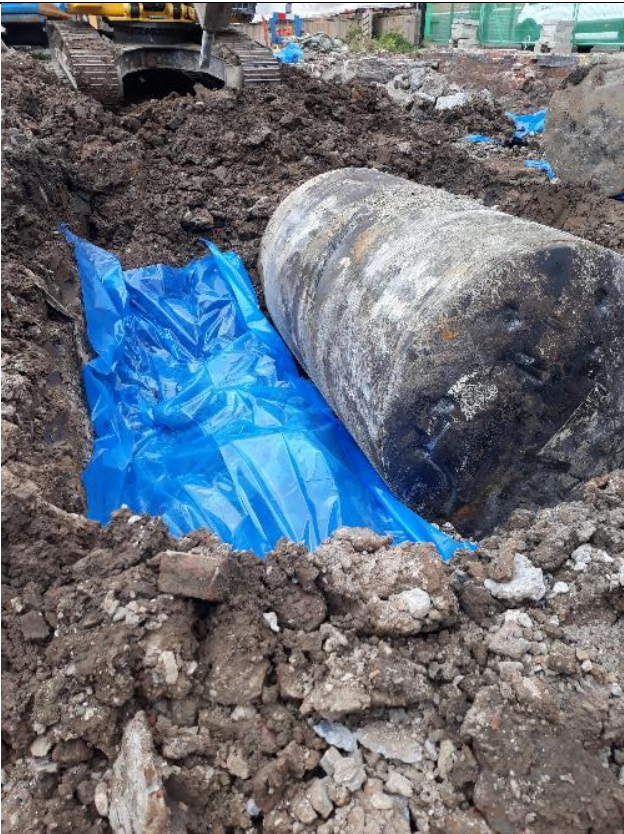
| <b>Photo No: 11</b> | <b>Description:</b> Polythene put in place prior to cutting Tank 2 |

Tank 2 was broken in situ due to its size to allow removal. A polythene membrane was placed underneath during this process to protect the surrounding soils from leakages of any remaining liquids. No leakages were observed.

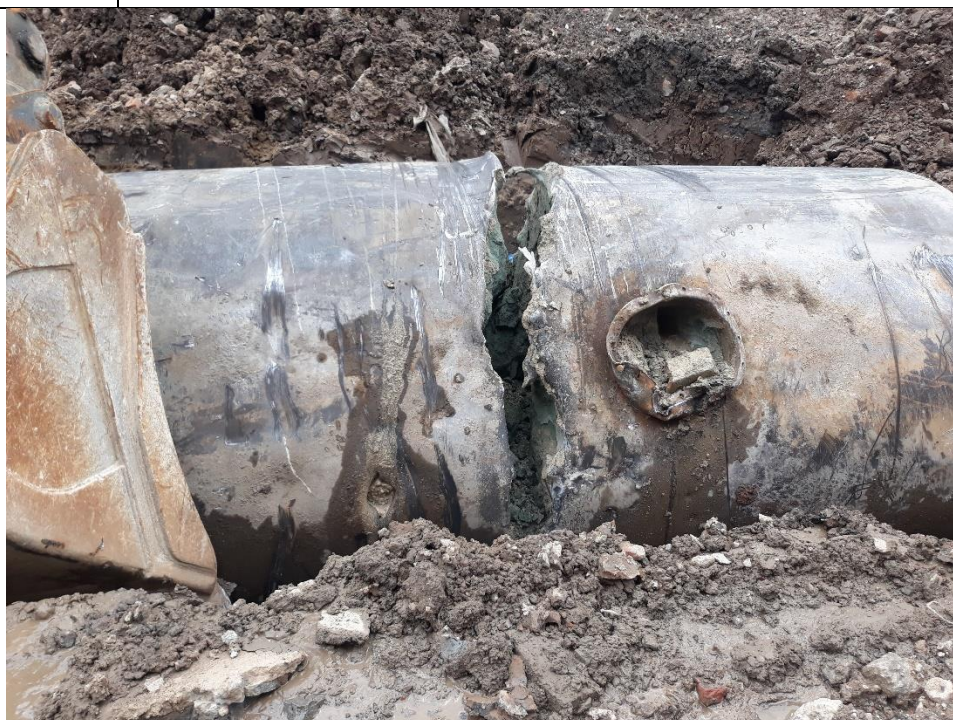
**Photo No: 12**

The tanks were filled with concrete and appeared to be in relatively good condition with limited evidence of significant historic leakages and spills. On removal of Tank 1 a small volume of liquids with a slight sheen were observed, on top of the concrete base. The liquids were removed through use of a spill kit before the concrete was broken out.

**Description:** Tank 2 broken in half exposing concrete used for decommissioning

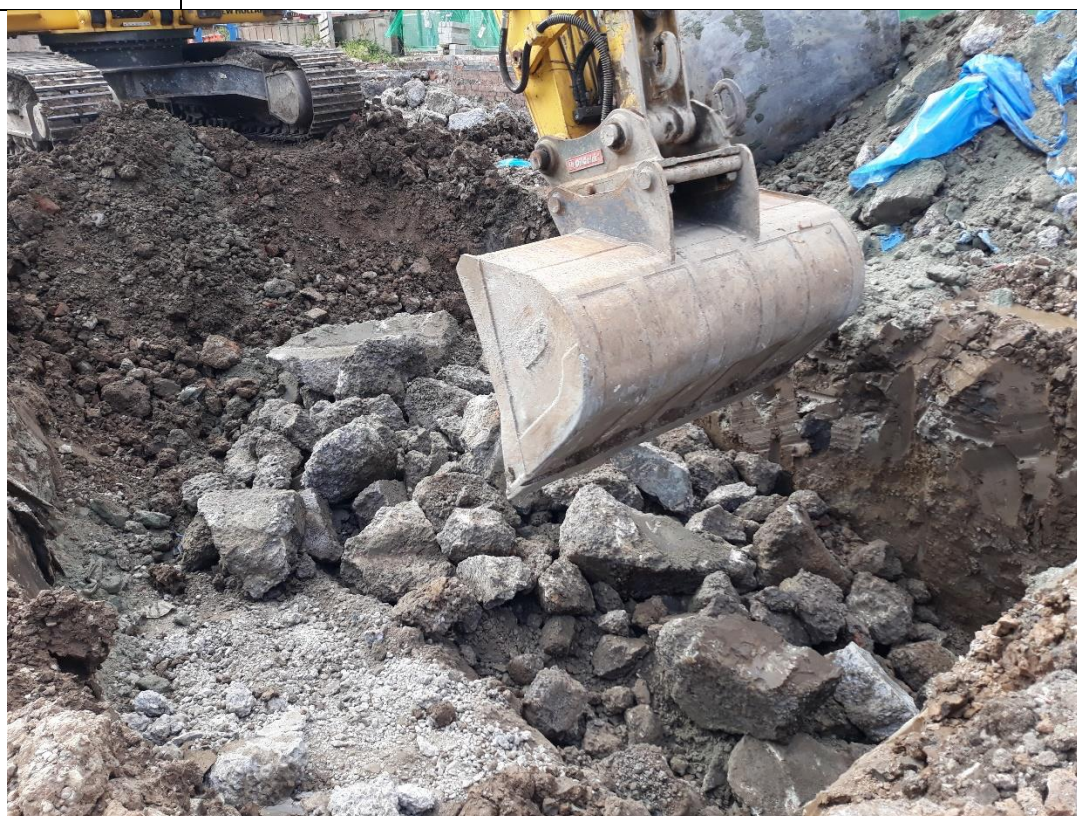
**Photo No: 13**

**Description:** Concrete base removed

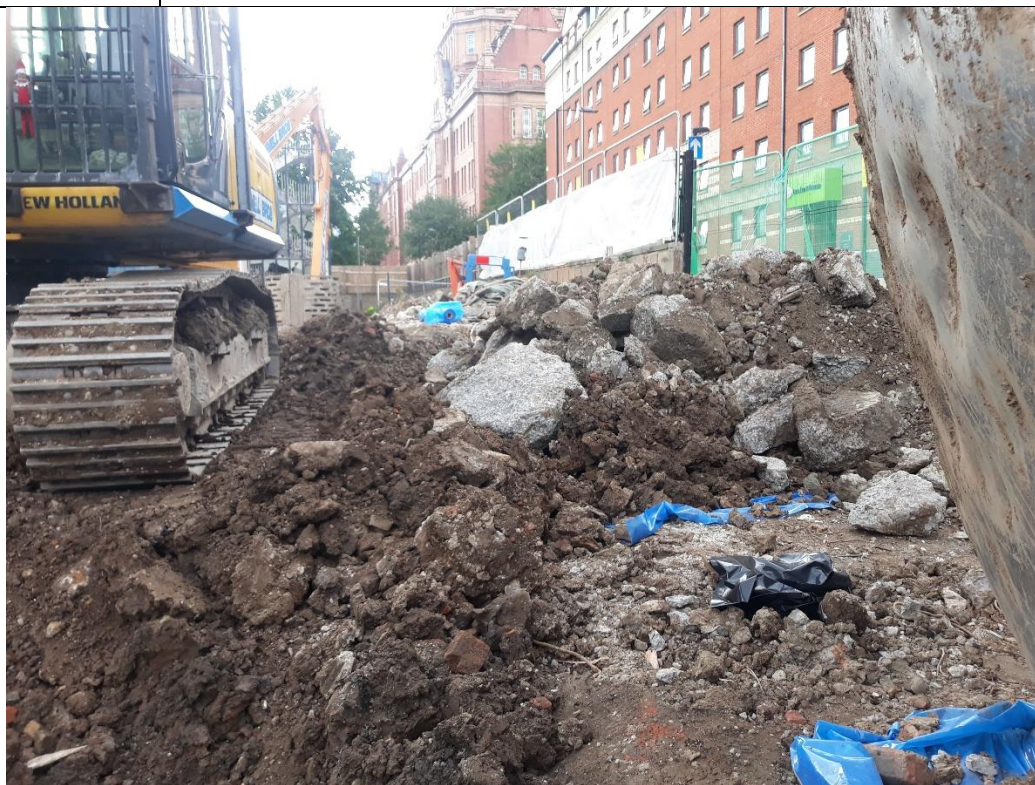
**Photo No: 15**

Soil samples SP01A – SP01C were collected from the stockpile of material that had been removed from around the tank to verify that the material was suitable for 'Commercial' use and be returned to the excavation or disposed of off-site. The locations of these samples are presented within *Attachment B*.

**Description:** Stockpiled material removed from around the tank (SP01)
