## Historic Building Investigation and Watching Brief

New Little Mill,  
Jersey Street,  
Ancoats,  
Manchester

**Document Type:** Historic Building Investigation and Watching Brief Report

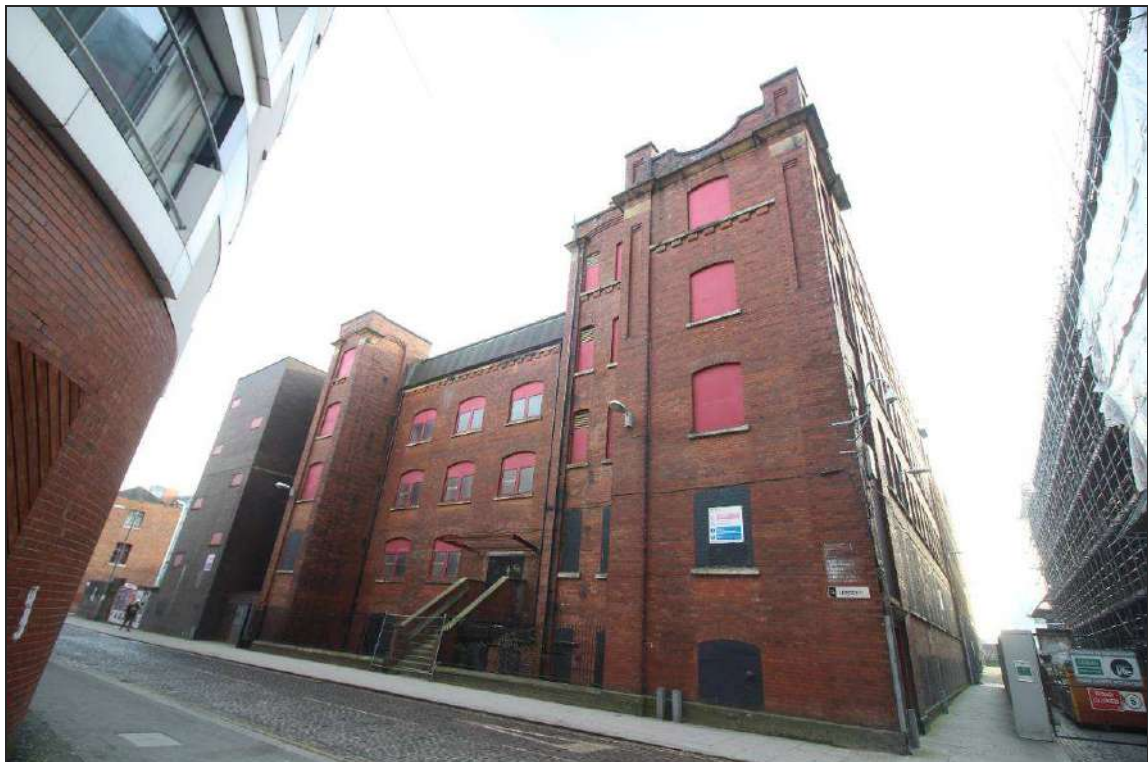
*Plate 12: General view of the north-western façade of New Little Mill*

**Northern façade:** this principal façade, fronting Jersey Street was constructed of machine-made brick, in three stretcher English Garden Wall bond (Fig 7; Plate 12). The elevation retained its original stair tower at the western end (Plates 12 and 13), which also incorporated a hoist and privy (Figs 2-6; Plates 5, 12 and 14), with a further tower in the centre of the façade, originally housing the electric motors that powered the mill (Plate 5). These projected from the façade, with protruding pilasters, recessed at sill level of the third floor (Plates 12 and 13). A later brown-brick stair tower had been erected at the eastern end of the façade (Plate 12).

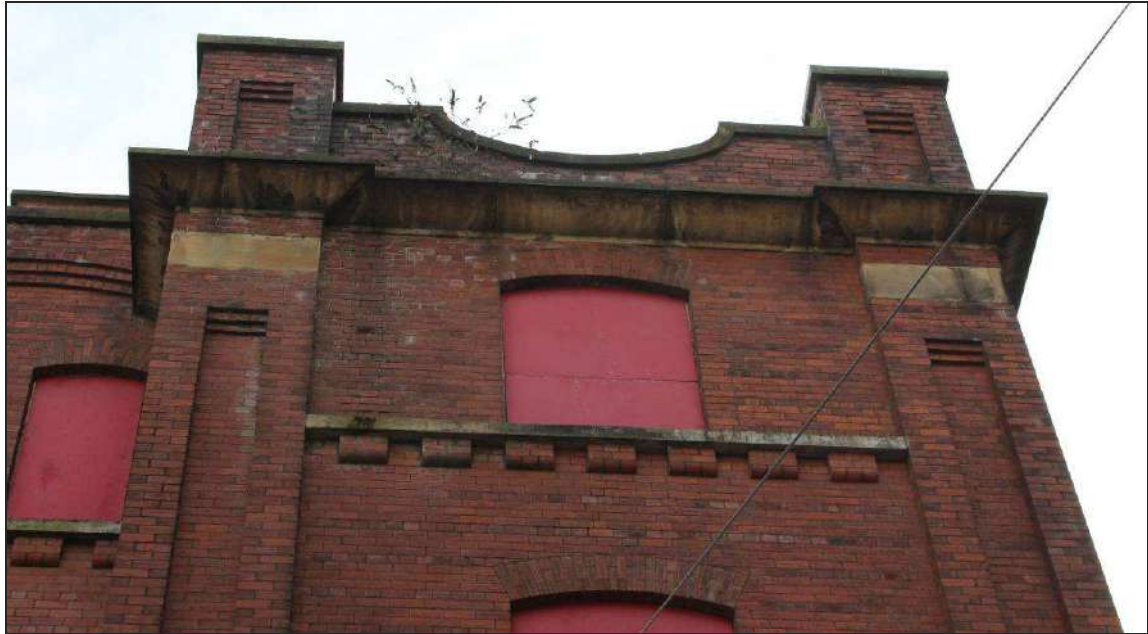
*Plate 13: Detail of upper stair tower*

The pilasters of the wider stair tower had narrow recess at second- and third-floor levels, each capped with tiered brickwork (Plate 13), and projected above the façade, where they had further panels (Plate 13). The parapet wall had a rounded scoop, again with oversailing sandstone capping, and representing a moderate architectural embellishment (Plate 13).

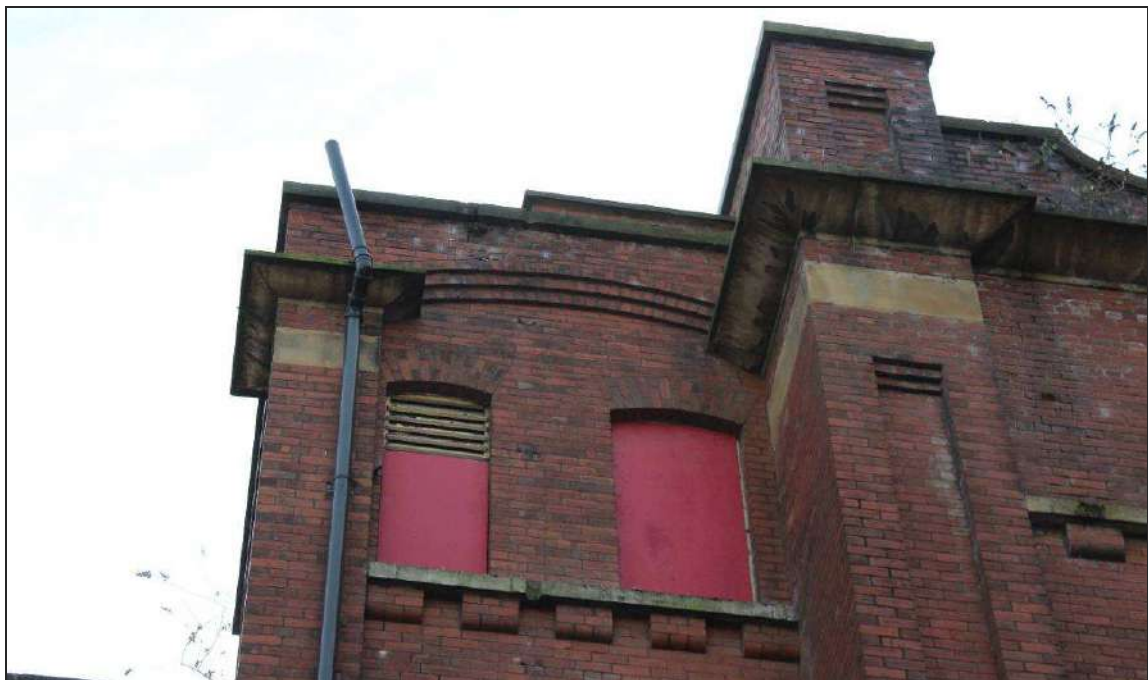
*Plate 14: Detail of upper hoist/privy tower*

Each of the exposed bays between the towers, had 7' (2.13m) wide windows, with gauged segmentally-arched lintels and projecting concrete sills (Plate 14). At lower ground-floor level, the sill of the window was formed by a three-course sandstone plinth that had a plain squared head. This did not extend across the central motor tower, and was not observed to the east, where it was obscure by later structures

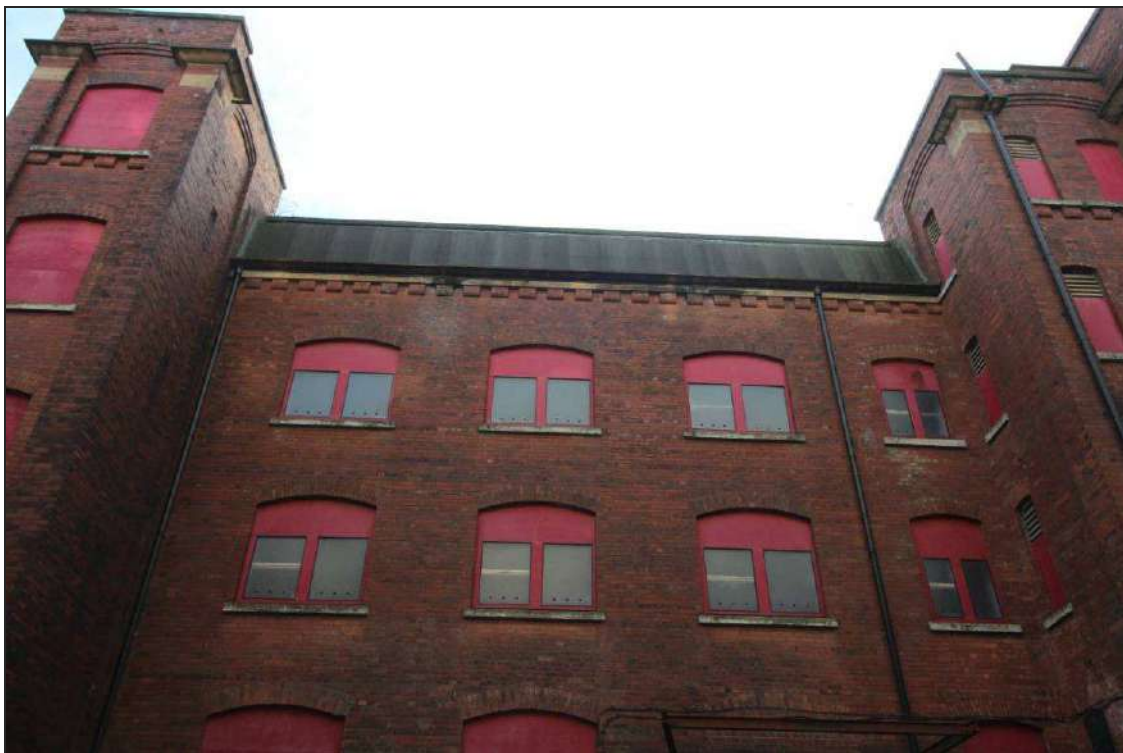
*Plate 15: Detail of the windows on the upper-floors and roof structure*

Above lower ground-floor level, each window was boarded with plywood sheeting housing a Perspex two-light opening (Plate 15). The narrower windows in the stair tower were fully boarded, as were those of the hoist tower and the central motor tower, all having similar arched lintels to the main façade, and with similar concrete sills, apart from at third-floor level, where it formed part of a continuous string band across the panel, carried on bull-nosed brick corbels (Plates 12, 13 and 14). Similar corbels form the head of the main façade (Plate 15), below a sandstone string band to the steeply-pitched northern bay of what was otherwise a flat roof (Plate 15). Although this was latterly covered with felt, it would have originally formed a fully-glazed band of steeply-pitched lights, affording high-quality light without shadows into the upper floor of the mill, utilising a similar roofing technique to that of the weaving sheds that became commonplace during the second half of the 19<sup>th</sup> century.

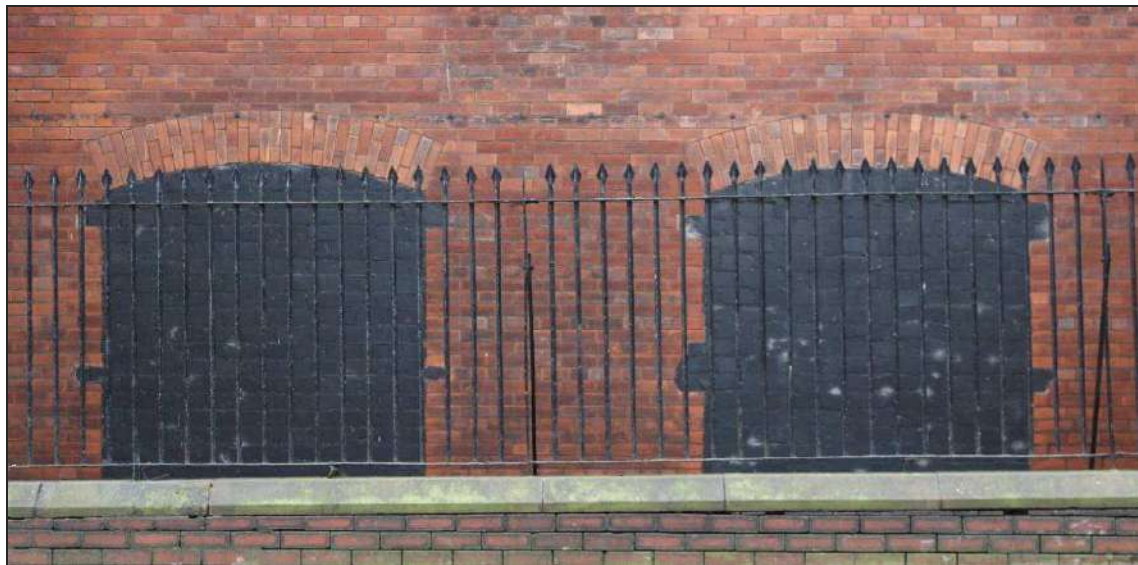
*Plate 16: Detail of the blocked windows of the lower ground floor*

All window apertures at lower ground-floor level, and at ground-floor level within the towers, were blocked with brick (Plates 12 and 16). The apertures of the two bays to the east of the hoist/privy tower were remodelled at lower ground-floor level, with a narrower window against the tower, and a wider window to the east, spanning the bay division. Both had flat lintels between rebuilt brick piers and a narrow timber canopy, (Plate 17), demonstrating that they represented remodelling of the original apertures.

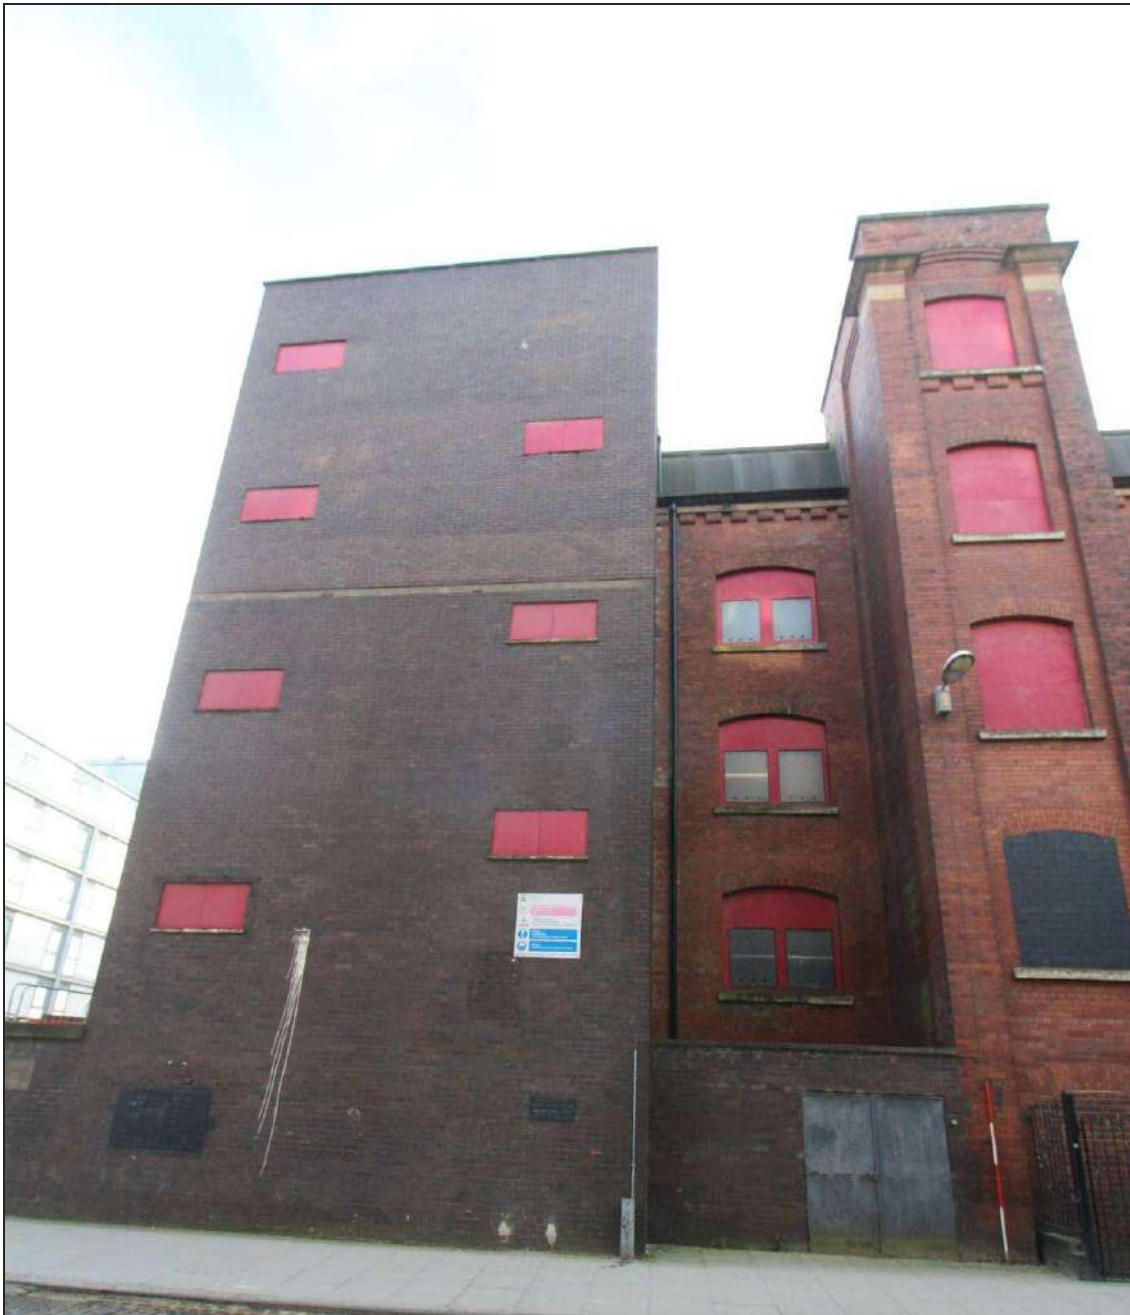
*Plate 19: Late stair tower and entrance at the eastern end of the northern façade*

Several further additions had been made to the northern façade, most noticeably being a large, almost two-bay wide stair tower placed at the eastern end of the wall (Figs 2-7; Plates 12 and 19). This was of a darker, brown brick construction, in stretcher bond with small horizontal windows, with projecting concrete sills corresponding to internal landing levels (Plate 19). As elsewhere, these were brick-blocked at the lower levels, and boarded above (Plate 19). A contemporary wall, of similar construction butted the motor tower, infilling the space to the new stair tower, which projected slightly further from the façade (Figs 2-7; Plate 19). This was of 8' (2.44m) height, and housed a double-doorway, latterly shuttered with steel plating, but which afforded access to a doorway in the west wall of the new tower at ground-floor level (Fig 2).

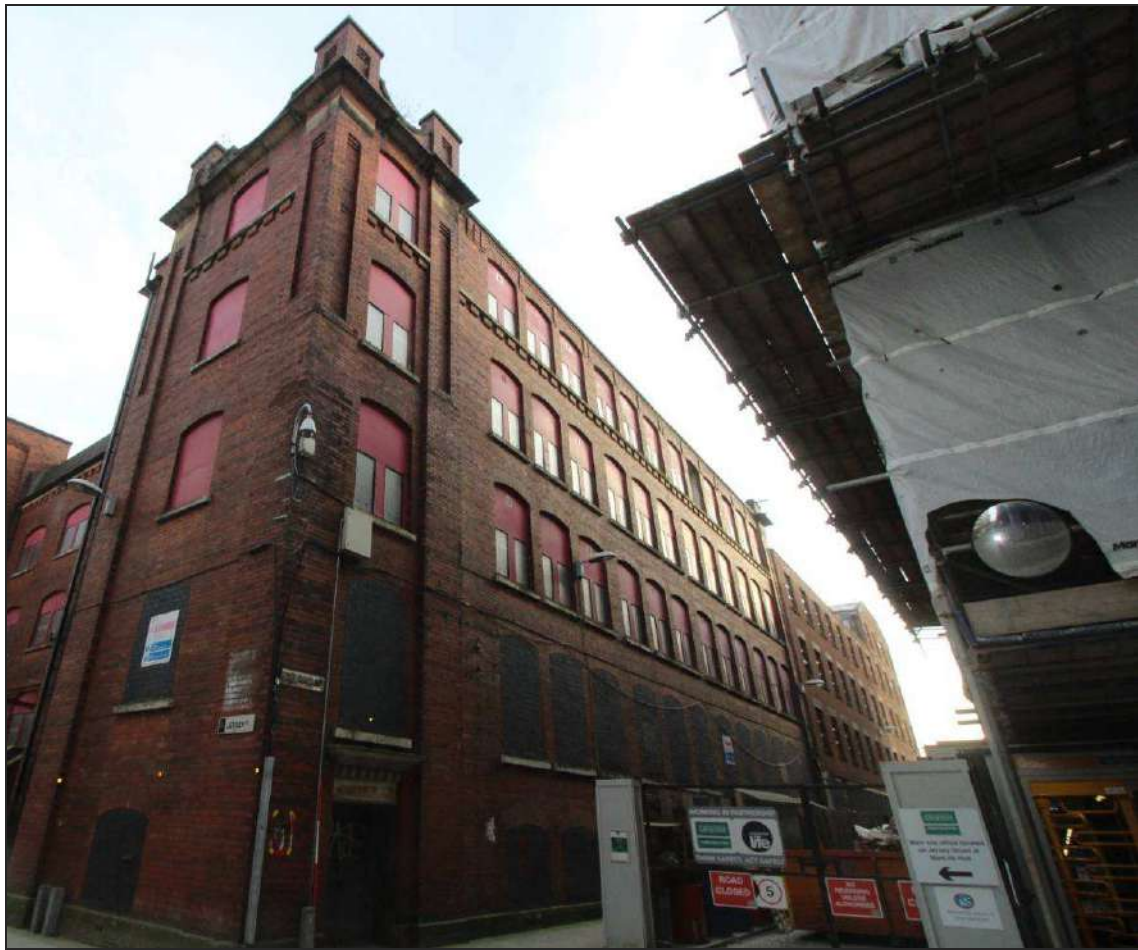
*Plate 20: General view of the south-western façade*

**Western façade:** the western façade fronted Bengal Street, and was of similar architectural decoration to the northern façade, constructed in a continuation of the three-stretcher English Garden Wall bond (Fig 8; Plate 20). The stair tower projected beyond the northern bay, and is narrower than on its northern face, but houses similar windows, although that at upper ground-floor level was a taller aperture, with the sill being placed lower than that within the northern façade. (Fig 8; Plate 20).

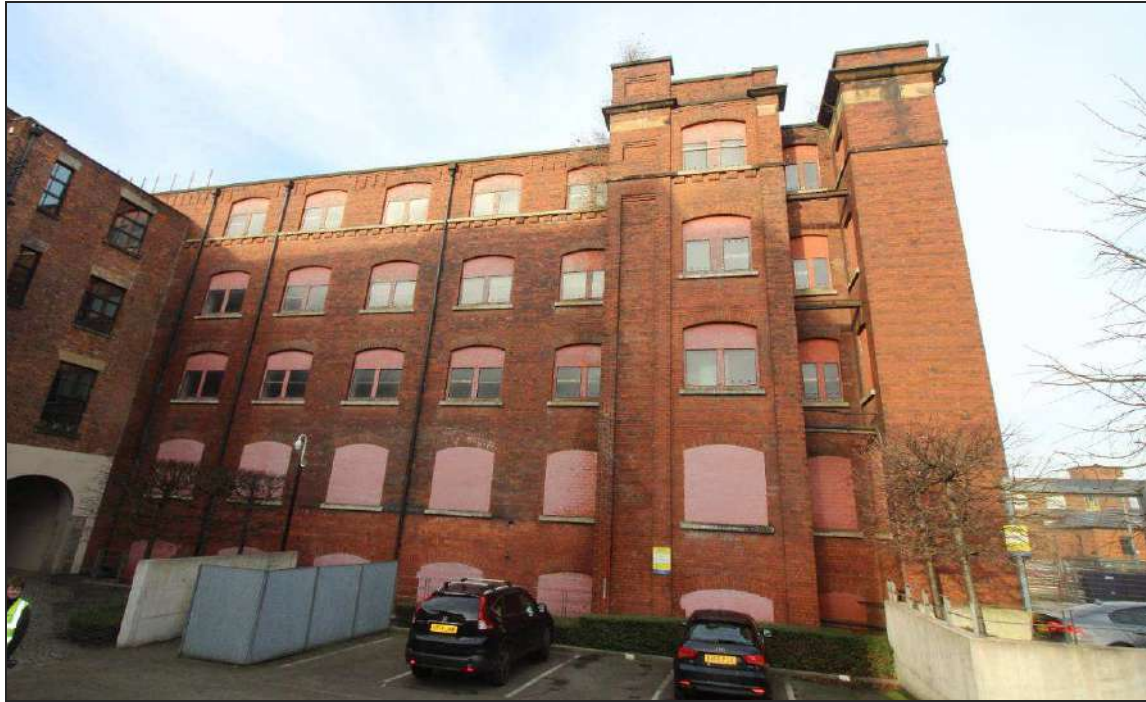
*Plate 23: General view of the southern façade*

**Southern façade:** the southern façade was also constructed with machine-made brick in a three-stretcher English Garden Wall bond. The three western bays were concealed behind the earlier Fireproof Mill to the south, and a privy tower projected slightly beyond the eastern bay (Fig 9; Plate 23), even though the original architects plans of 1908 had the privy tower placed on the east wall, rather than the south (Plate 5). A ventilation and humidifying tower was placed against the adjacent bay, almost immediately following the completion of the mill (Plates 9, 10, and 23), projecting to a similar extent to the privy tower (Figs 2-6, 9).

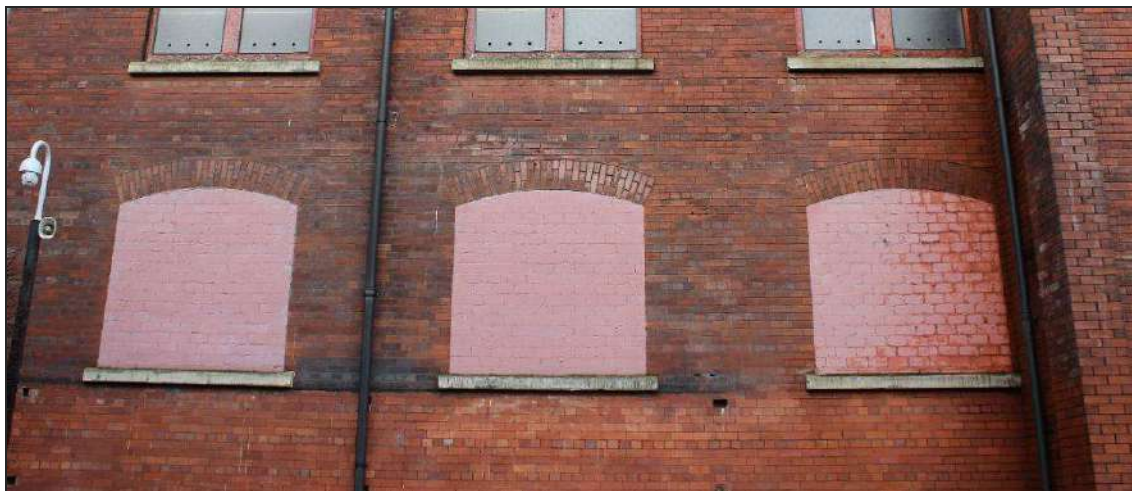
*Plate 24: Detail of blocked windows to the ground floor*

The window apertures in the intervening bays were as the northern façade, with blocking at lower and upper ground-floor level, and two-light Perspex pane within the upper floor timber boarding of the windows of the upper floors (Plates 23-25). The decoration of the upper floor sill and parapet were as on the western facade (Plate 25).

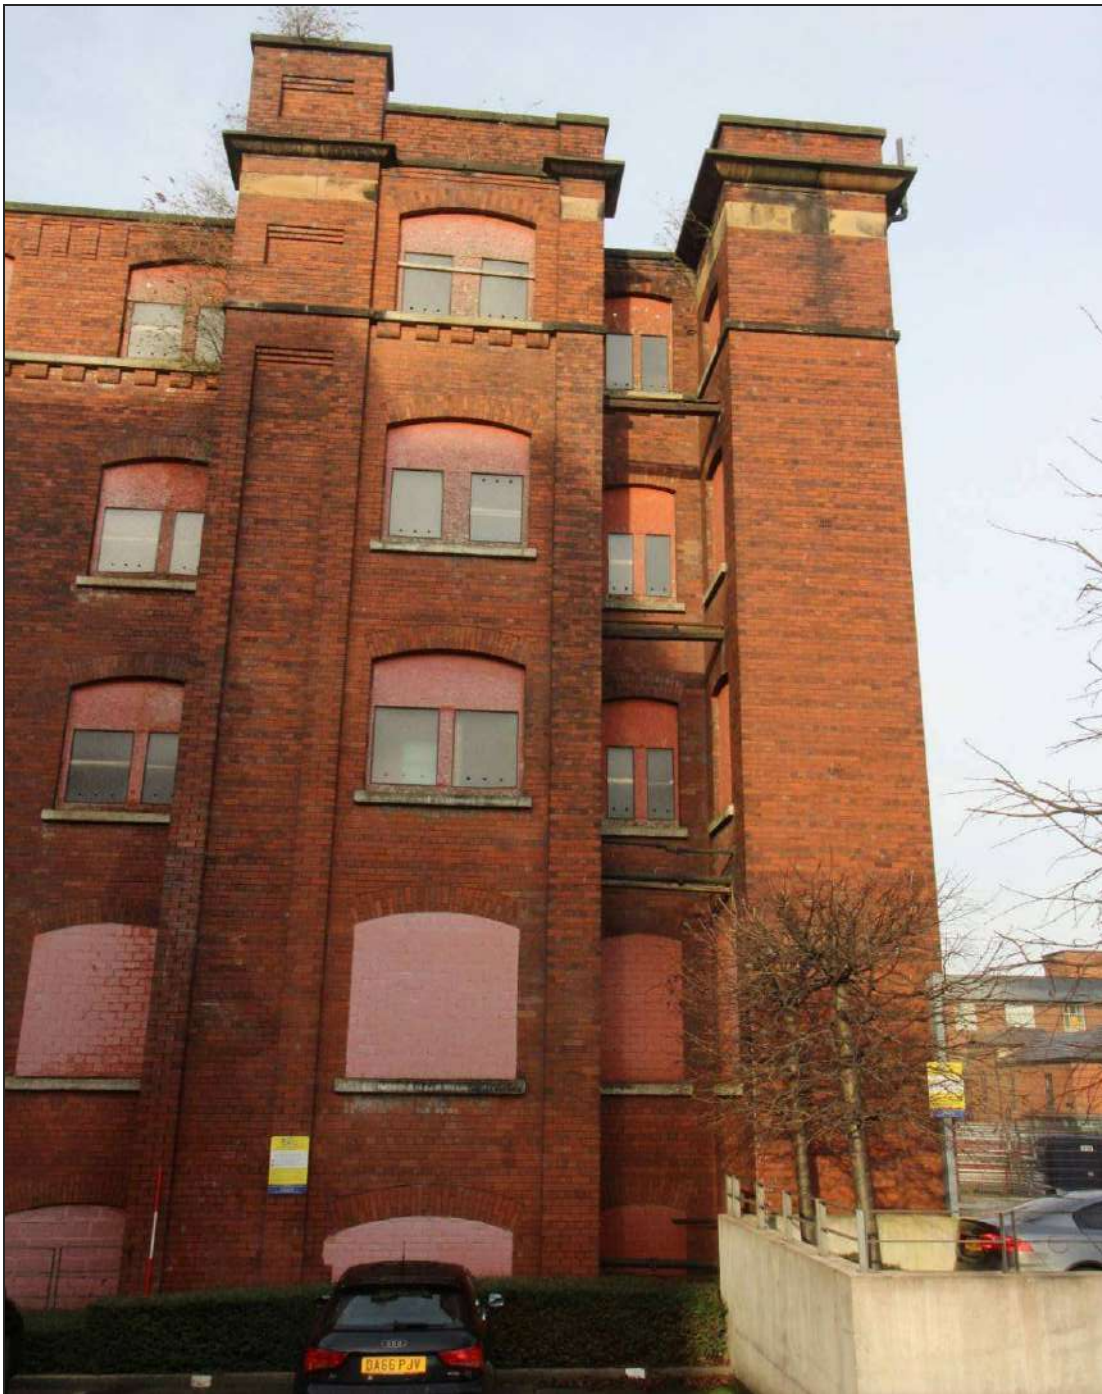
*Plate 27: General view of privy tower and later ventilation and humidification tower*

The privy tower at the eastern end of the façade had similar decoration to those of the northern elevation, but had windows in its eastern and western faces, rather than the southern, outward-facing side (Plates 23, 26, and 27). The third-floor level string band continued around the privy tower, but was not carried by brick corbels as with the other towers (Plates 23, 26, and 27). The narrow space in the eastern bay to the west of the privy tower housed narrow windows to each floor (Figs 2-6; Plates 23 and 27). These were of similar style to those elsewhere, but were of only 4' (1.22m) width.

A further tower was added to the southern façade almost immediately following the completion of the original construction. This was of the full width of the penultimate bay from the eastern end of the elevation (Figs 2-6; Plates 23 and 27), and externally comprised a bay with a window to each floor, matching those of the original façade (Plate 27), with a narrow flue on the western side. This had a recessed panel, matching the pilasters of the northern and western facades, with continuation of the decoration of the elevation and tower at third floor and parapet level (Plates 26 and 27). I-section steel beams tied this tower to the original privy tower to the east at first-, second- and third-floor level (Plate 27).

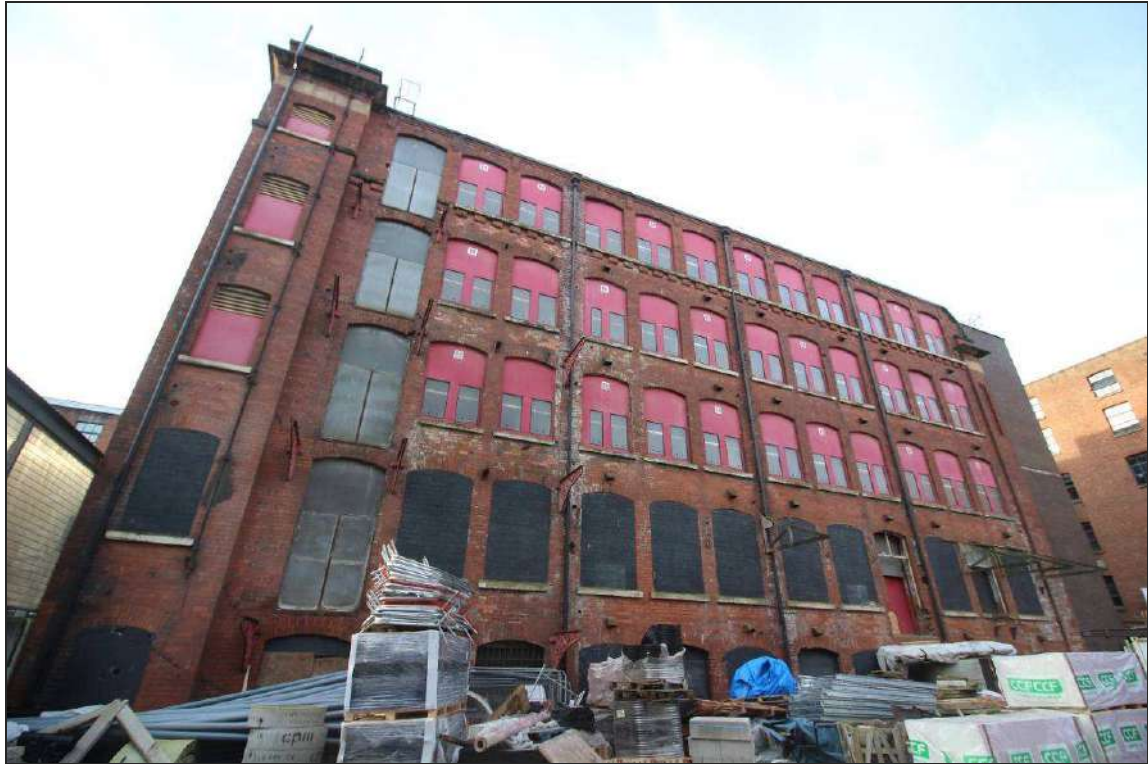
*Plate 28: General view of the north-east façade*

**Eastern façade:** the eastern façade was of four wide bays, with a privy tower projecting beyond its southern extent (Fig 10; Plate 28), and was similarly constructed in three-stretcher English Garden Wall bond (Plate 28). A late stair tower also butted the northern end of the façade, built with brown brick in stretcher bond.

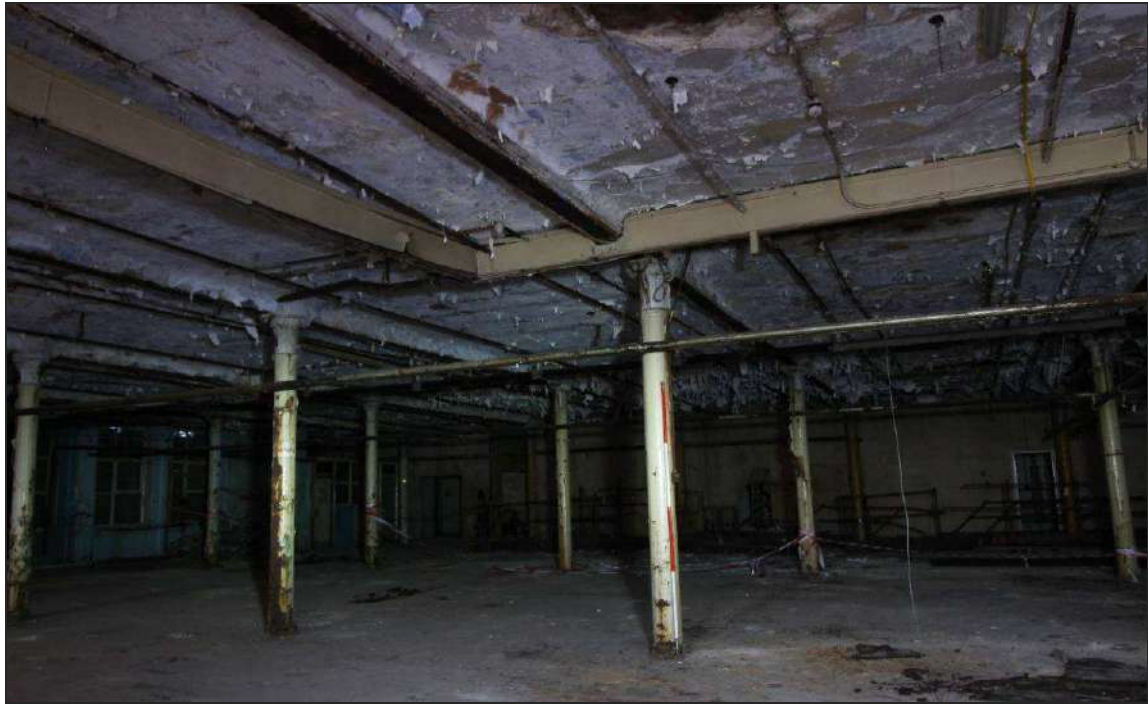
*Plate 32: General view of the ground floor, detailing the cast-iron column arrangement*

Internally, the mill comprised 10 x 4 bays, each divided by 9" (0.23m) diameter hollow cylindrical cast-iron columns, placed at 13' (3.96m) centres on the long axis of the mill, and carrying transverse I-section beams that supported the flat concrete ceilings (Figs 2-6; Plate 32). Each column had a double astragal to round head plate that incorporated a socket for the column above (Plate 33). The beams spanned between columns, carried on narrow brackets within the column casting supported by narrow flanges within the capital (Plate 33).

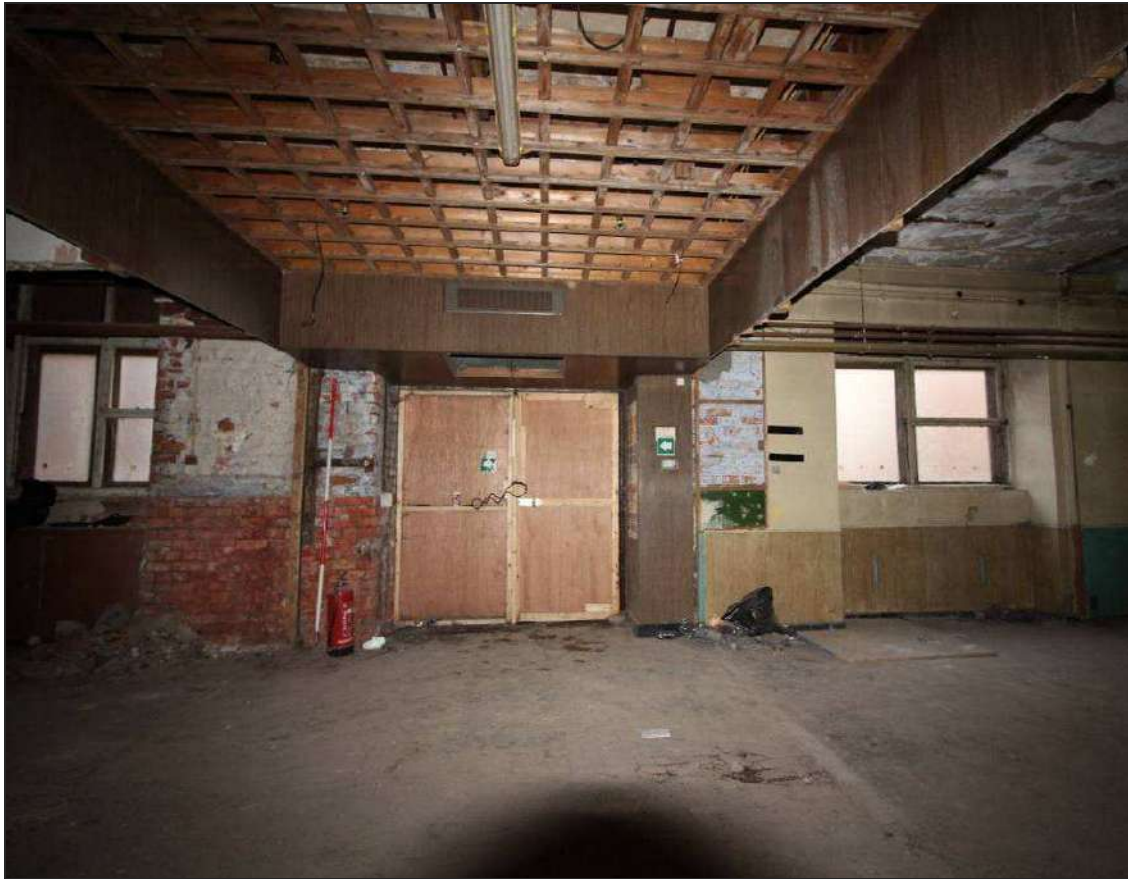
*Plate 34: Principal doorway into the mill in the northern wall, with ceiling of vestibule*

**Upper ground-floor level:** the principal entrance in the northern elevation, fronting Jersey Street, afforded access to the upper ground-floor level of the interior (Fig 2; Plate 34). Access would have been through large double doors, housed within a recessed opening with bull-nosed brick reveals (Plate 34). The original internal lintel was obscured by a modern timber panelled false ceiling, that has been inserted to create an entrance vestibule (Plate 34).

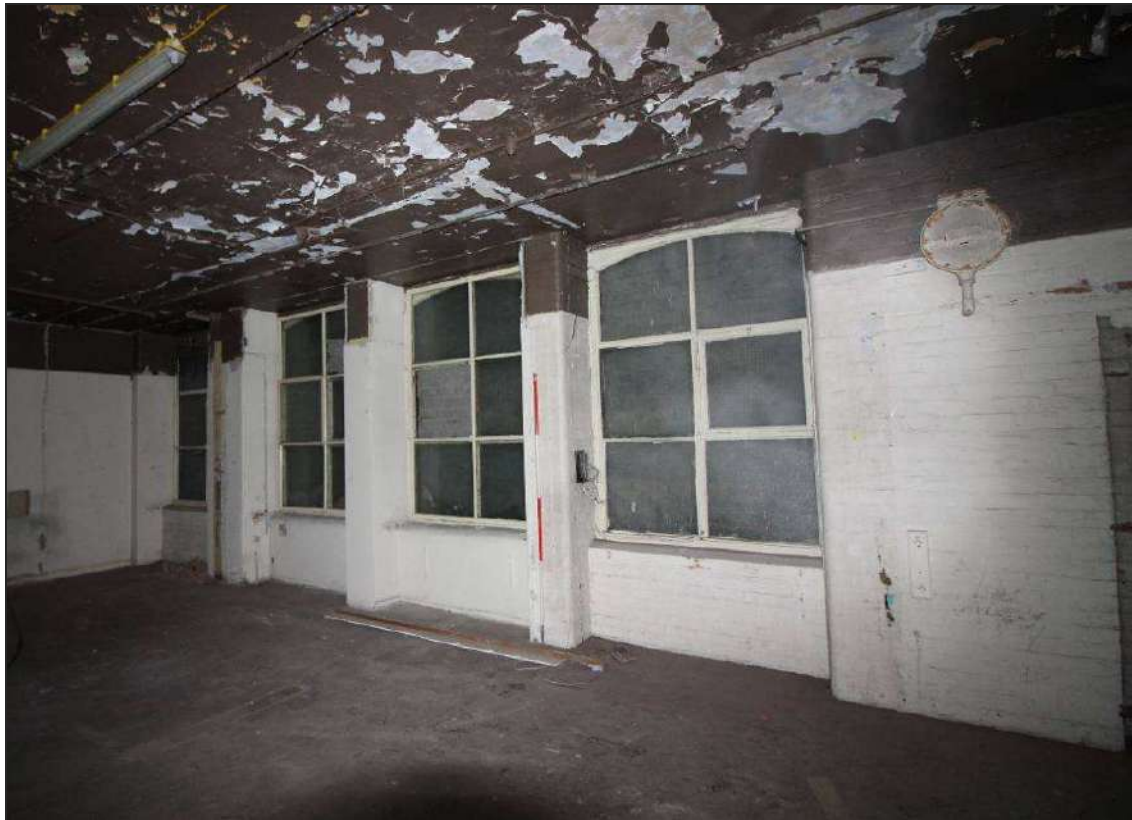
*Plate 35: Recessed windows in end wall of upper ground floor, with original timber window frames, late partition wall (left) and fire alarm valve (right)*

Each bay on the long elevation have full-height recessed window bays of 7'6" (2.28m) width, with bull-nosed brick piers of 5'5" (1.65m) width carrying the ends of the I-section steel ceiling beams between (Fig 2). In the end walls of the mill, the window bays were again recessed, but with narrower piers within each bay, between wider examples at each bay division (Fig; Plate 35). Most windows retained six-light timber frames of three rows of two large lights, with a tilt opening to one side of the central row (Plate 35). The majority of the glazing had been removed, but some windows did retain obscured glass panes (Plate 35).

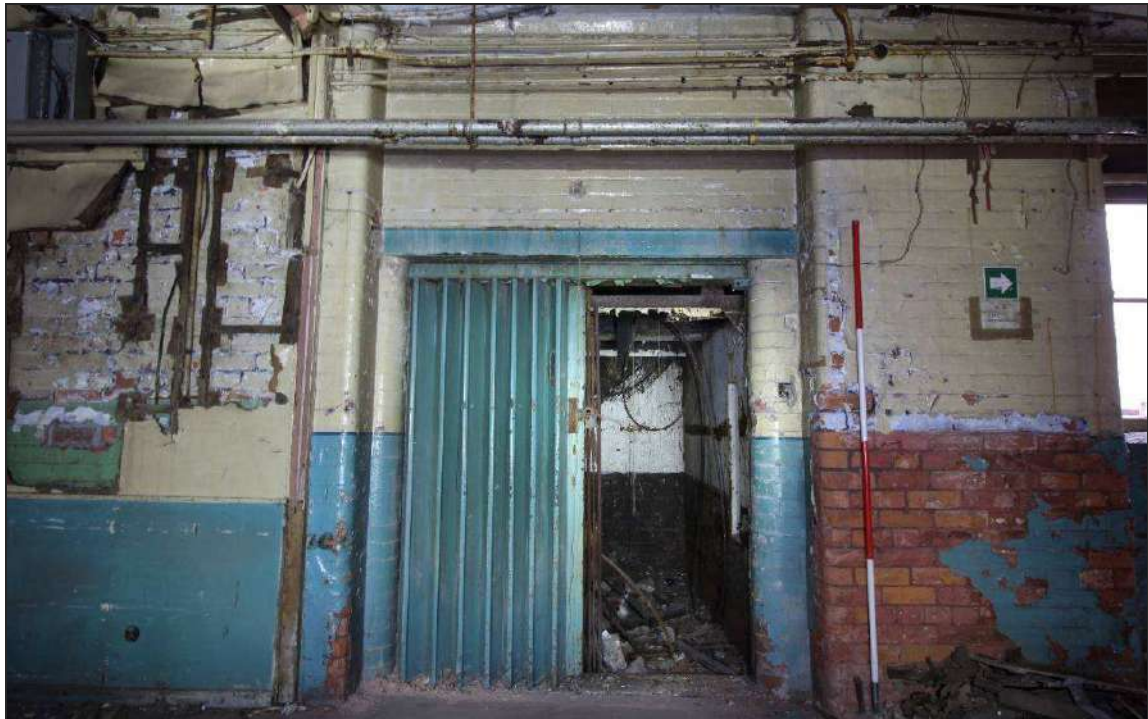
*Plate 36: The doorway of the former motor tower at upper ground floor level*

The motor tower within the north elevation was set within a blind recess, with bull-nosed brick reveals, and with an I-section steel lintel and concertina sliding door affording access into an inserted hoist/lift (Plate 36). The tower was constructed to house electric motors that powered line shafting to each floor, but its remodelling into a hoist shaft following the removal of the motors removed any evidence for the motor housings, or the placement of the belt drives for line shafting. The hoist was locally manufactured in Ancoats by Etchells, Congdon, & Muir Ltd, with the cage being rated at 20 cwt.

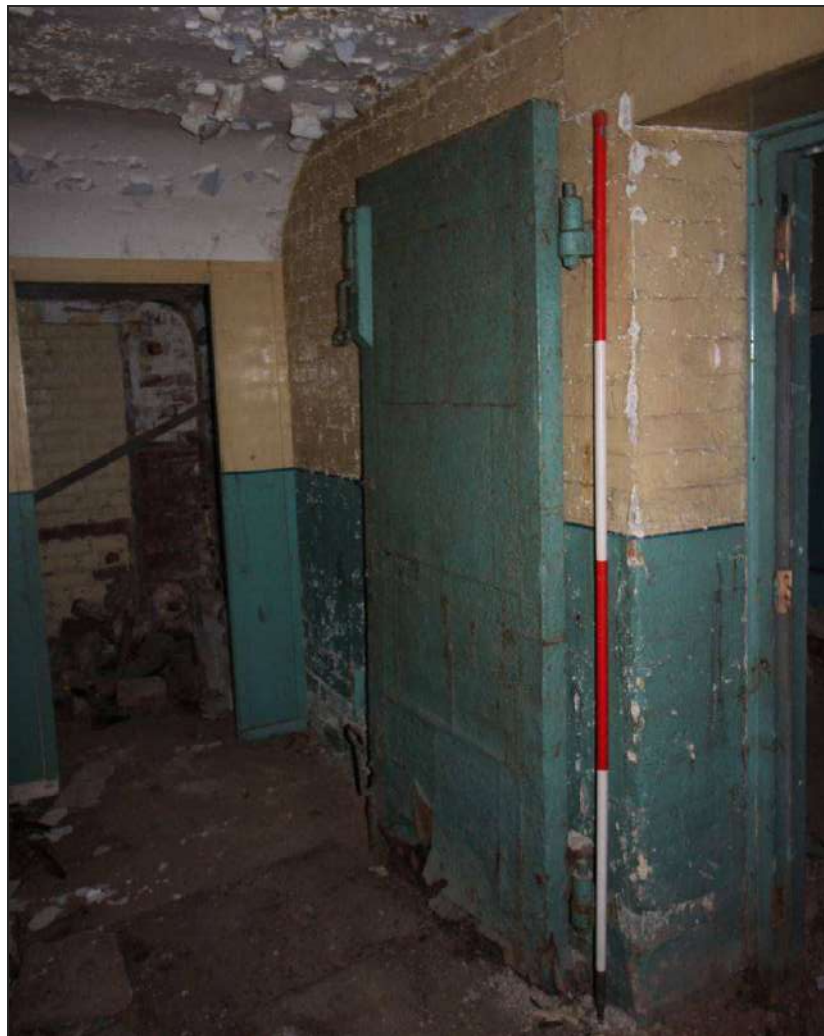
*Plate 38: Vestibule at base of north-west stair tower with door into basement and room*

The stair in the north-west corner of the basement comprised a half-turn concrete stair around a brick stair wall (Figs 2-6). A small store room was formed with timber partitions below the rear of the stairs (Fig 3; Plate 38 ), with a relatively large vestibule at basement level having a large fireproof door into the main mill, hung on two large pintels, rather than being a sliding door as seen on the floors above (Plate 38). The lowest flight of stairs also led directly to a tunnel beneath Bengal Street, affording access to the basement of New Mill, within the main Murrays' Mills complex (Fig 3; Plate 39). This passage also appears to have had a substantial fireproof door at its entrance, although only a single strap hinge survived *in-situ* (Plate 40). The 5'2" (1.57m) wide tunnel was contemporary with the construction of the original Little Mill in 1818, and had an arched ceiling, with its crown 7' (2.13m) above the extant concrete floor (Plate 39). The western 5'6" (1.68m) had been rebuilt in machine made brick below a flat iron-sheet ceiling (Plate 41), and butted the outer edge of the external wall face of New Little Mill, suggesting that the tunnels had to be rebuilt at its eastern end following the fire that destroyed the original Little Mill. The tunnel was blocked latterly at its western end, into the basement of New Mill (Plate 42), with the passage having been somewhat compromised by the insertion of a water pipe across it (Plates 41 and 42), although this is not the water main shown on the plan of 1926 (Plate 11).

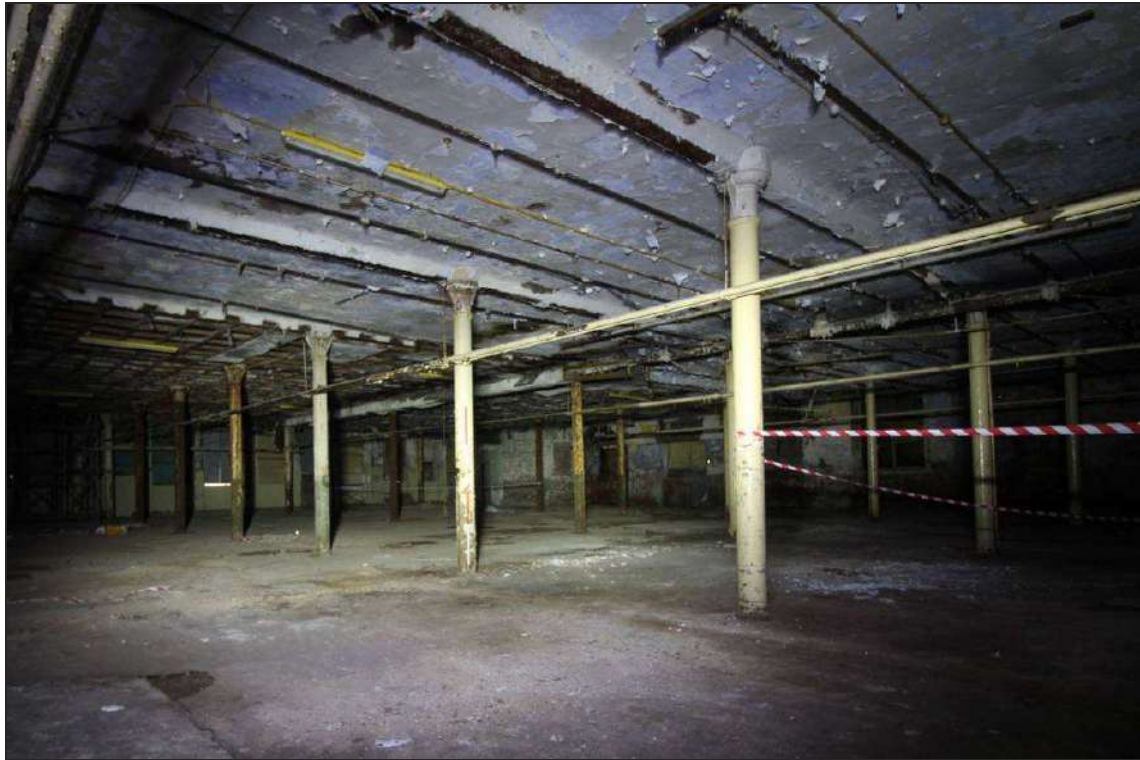
*Plate 43: General view of the lower ground floor*

The basement was similar in layout to the floors above, but was taller to accommodate preparatory working, as opposed to the spinning that was undertaken on the floors above (Plates 6 and 43).

Despite the taller height of the ceiling, the columns were of similar 9" (0.23m) diameter, even though wider columns in basements of broadly contemporary mills were common. The space was less divided than on the upper ground floor, revealing more of the concrete rendered floor, and painted brick walls and ceiling (Plate 43). As with the floor level above, many of the window apertures retained six-light frames of similar style

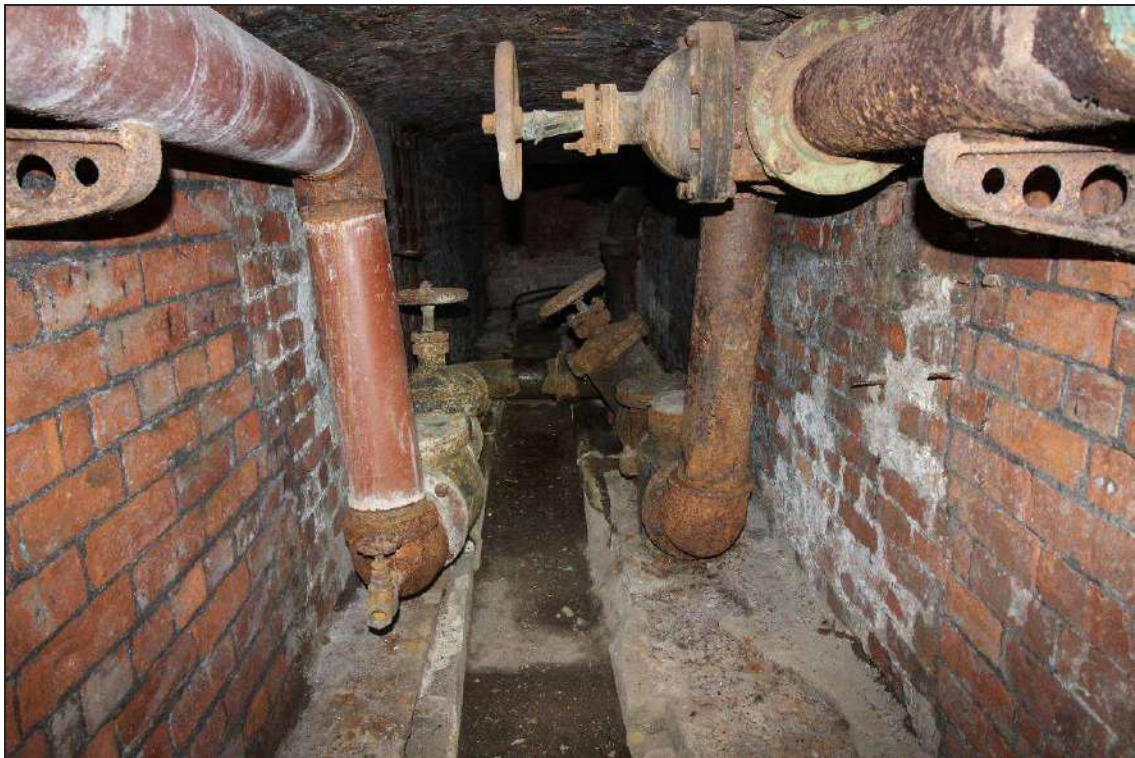
*Plate 45: General view of the service tunnel, detailing the channel within the floor*

A second tunnel below Bengal Street, connecting the basement of Little Mill to the basement of New Mill within the Murrays' Mills main complex, was constructed as a ducting tunnel, rather than for pedestrian access, and was used latterly for pipework between the two mills. It is not shown on mapping until 1851, but its placement on the approximate centre-line of New Mill (Plate 3) suggests that it may have been used to house a drive shaft between New Mill and Little Mill, and is thus more likely to have formed part of the original construction.

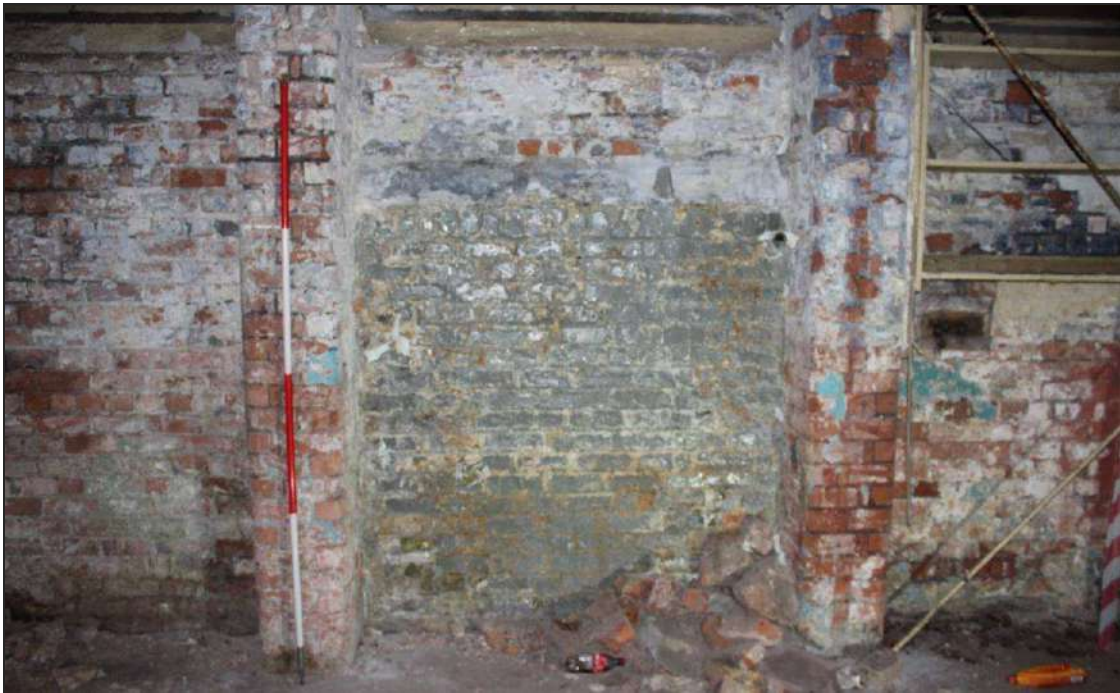
*Plate 51: Blocked entrance into the southern tunnel below Bengal Street*

A third tunnel, situated three-bays to the south of the small shafting tunnel, had been blocked, flush with the face of the internal west wall. This originally afforded access into the northern end of the Bengal Street Block, or Wing Mill of the Murrays' complex predating an engine house attached to the southern side of the end of New Mill, which powered a rope race (Miller and Wild 2007). Entry into the tunnel had been through a 5'6" (1.67m) high doorway with a concrete lintel, and was of full-bay width, utilising the brick piers of the bay as its jambs (Plate 51). The blocking of the entrance comprised grey machine-made brick, suggesting a date in the latter part of the 20<sup>th</sup> century.

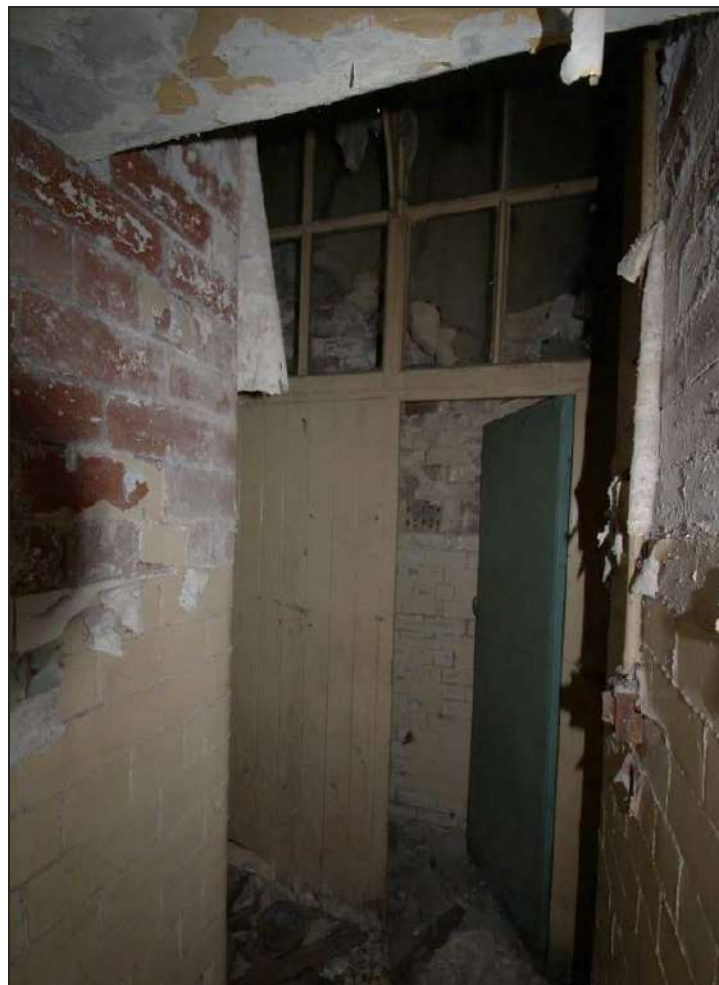
*Plate 52: Timber partition within basement privy*

An original privy tower of 7' x 5'6" (2.13 x 1.67m) internal dimensions was placed at the eastern end of the south wall. It retained a single stall, formed of tongue-and-grooved timber partitions, which appear original, separating the flushing toilet (replaced latterly with a modern ceramic bowl) from a washbasin that was placed beneath the window to the immediate north (Fig 3). The partition had a continuous glazing band of two rows above door lintel height, including a vent opening window (Plate 52).
