## Historic Building Investigation and Watching Brief

New Little Mill,  
Jersey Street,  
Ancoats,  
Manchester

**Document Type:** Historic Building Investigation and Watching Brief Report

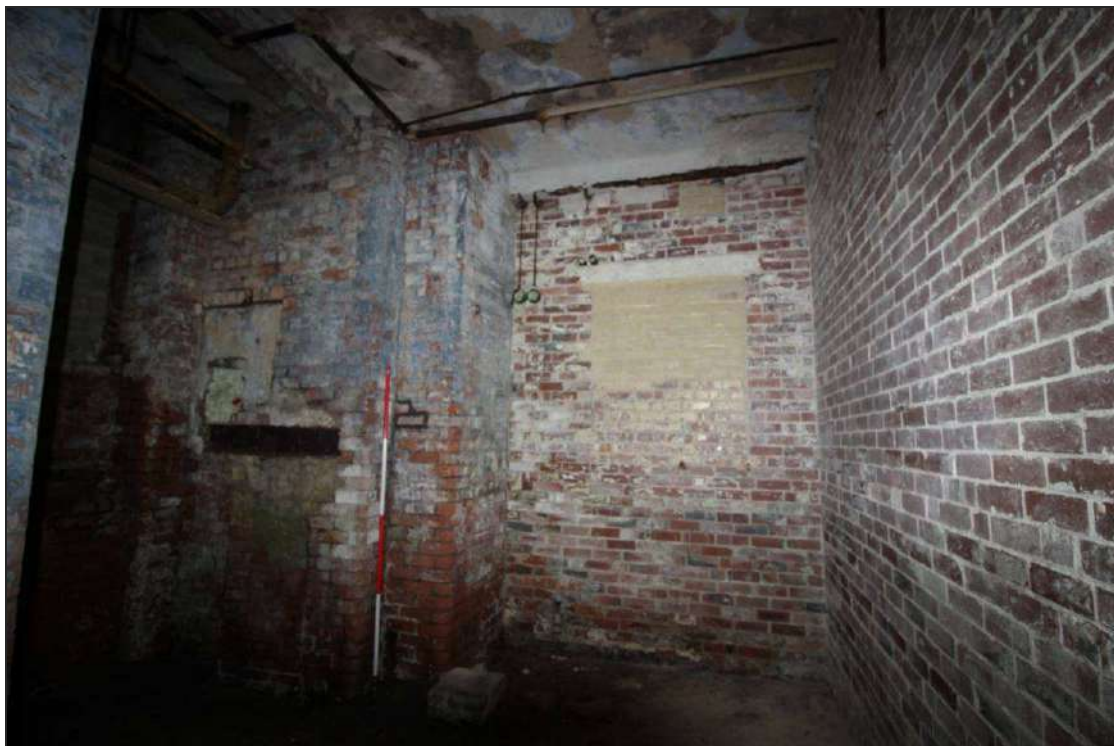
*Plate 54: Detail of the blocked window within the south-west wall of the inserted room*

To the west of the original privy tower, a narrow window formed an original aperture within the end bay of the mill (Fig 3). The adjacent bay was remodelled shortly after the completion of the present structure, with the addition of an 18'6" (5.64m) wide tower, that span marginally wider than the adjacent bay. Not only does this project beyond the southern façade of the structure, but also included a room of 15'4" (4.67m) width that projected 8'9" (2.67m) into the open-plan basement (Plate 53). This was of full-brick thickness construction, in stretcher bond, and had a doorway towards the eastern end of its north wall. This had a concrete lintel and a concrete threshold step up into the room. The door has been removed but the timber door frame survived. Both the east and west walls of this room also had high-level windows into the basement, with concrete lintels and sills, but these were blocked with machine-made brick.

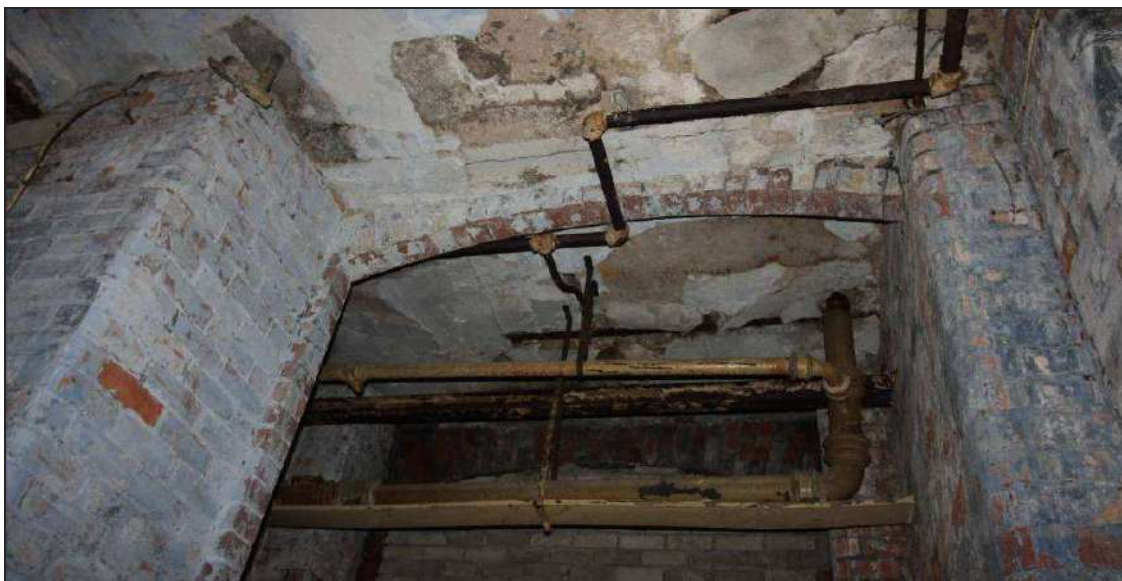
*Plate 55: Remains of the segmental arch head of the earlier window within the basement*

The eastern part of the projecting tower was open into the internal room at basement level, whilst the western part was enclosed to form a flue relating to the humidification and ventilation system that was housed within the tower (Fig 3). The segmentally-arched head of the original window in this bay of the mill had been retained within the ceiling of the new tower, with the window itself having been removed to form the open-plan access into the extension (Plate 55). The window aperture within the south wall of the later tower had bull-nosed brick reveals below a segmentally-arched lintel and a chamfered sandstone sill (Plate 56). This was blocked subsequently in two phases, the first comprising machine-made brick to a height of 2'2" (0.66m), and finally being completely blocked with modern grey brick in stretcher bond (Plate 56).

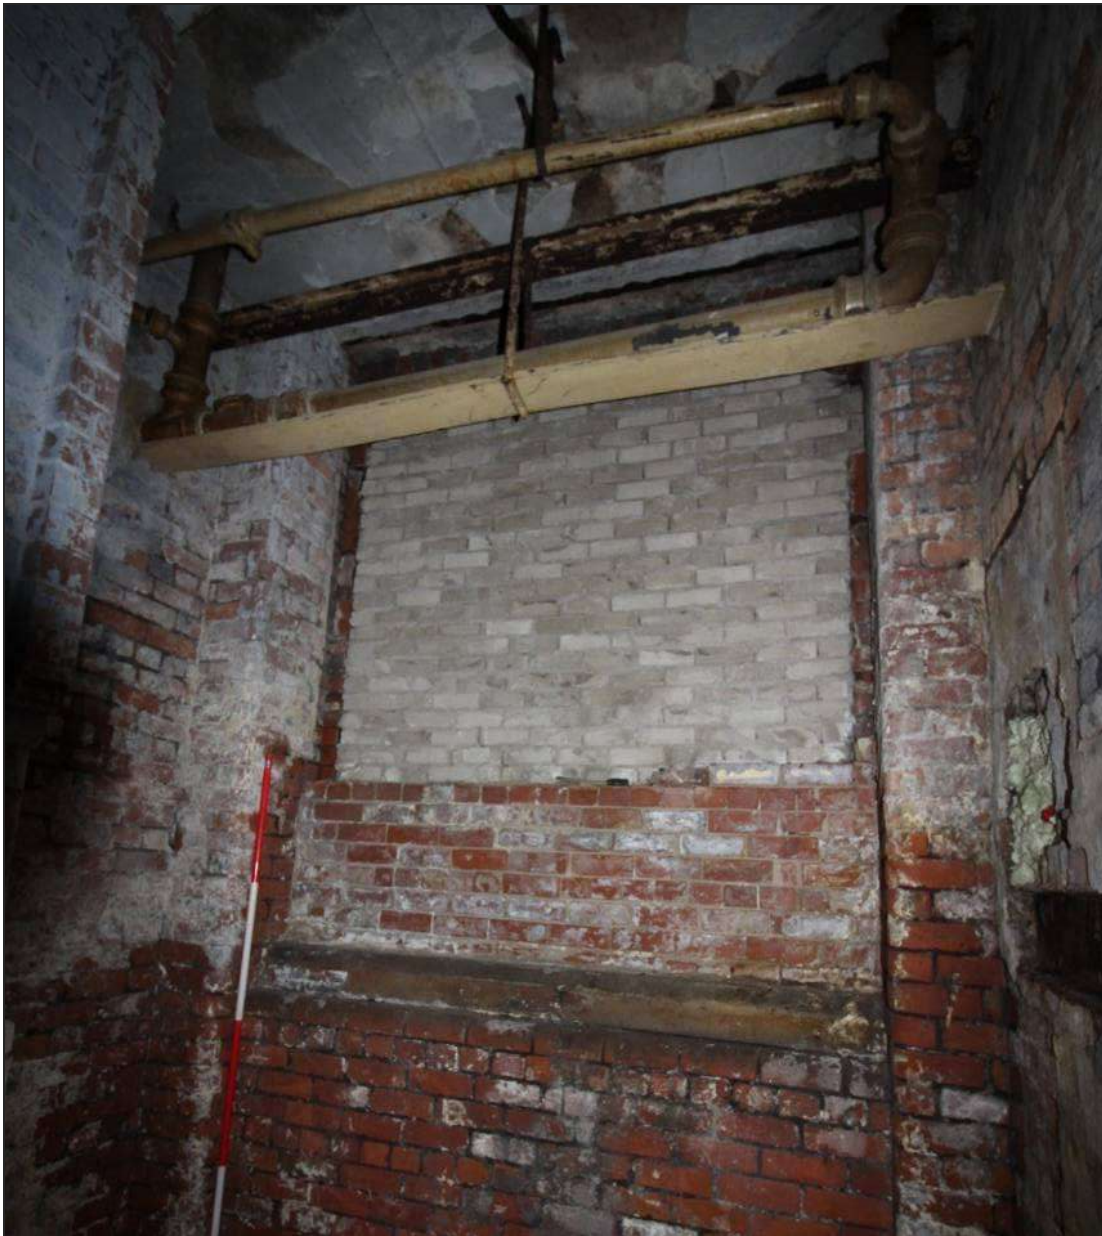
*Plate 56: Blocked window in the south wall of the secondary tower*

A blocked flue leading into the base of a chimney was situated within the west wall of the tower, below an I-section steel lintel of 7½" (0.19m) thickness, and placed 5' (1.52m) above floor level (Plate 57). This was blocked subsequently, with machine-made brick laid in stretcher bond (Plate 57). A second, narrow aperture into the flue was placed directly above the lintel of the lower aperture, and was similarly blocked below a lintel of edge-set brick above an iron bar (Plate 57). The eastern face of the chimney within the secondary tower also housed the western end of a flat steel beam, placed across the entire room at approximately 3m above floor height (Plates 55-57). This was supported at its mid-point by a strap into the concrete ceiling, which appears to have lifted the centre of the beam slightly (Plate 56). The beam appears to have formed protection for a series of reducing water pipes that form part of the humidification system, and that would likely have been connected to a boiler placed within the vestibule within, or immediately to the north of the base of the tower. Further pipes linked into this system passed through the east wall of the vestibule within the basement, and formed a network of heating pipes, which survived extant throughout the basement, running in pairs down either side of each column row (Plates 43 and 56).

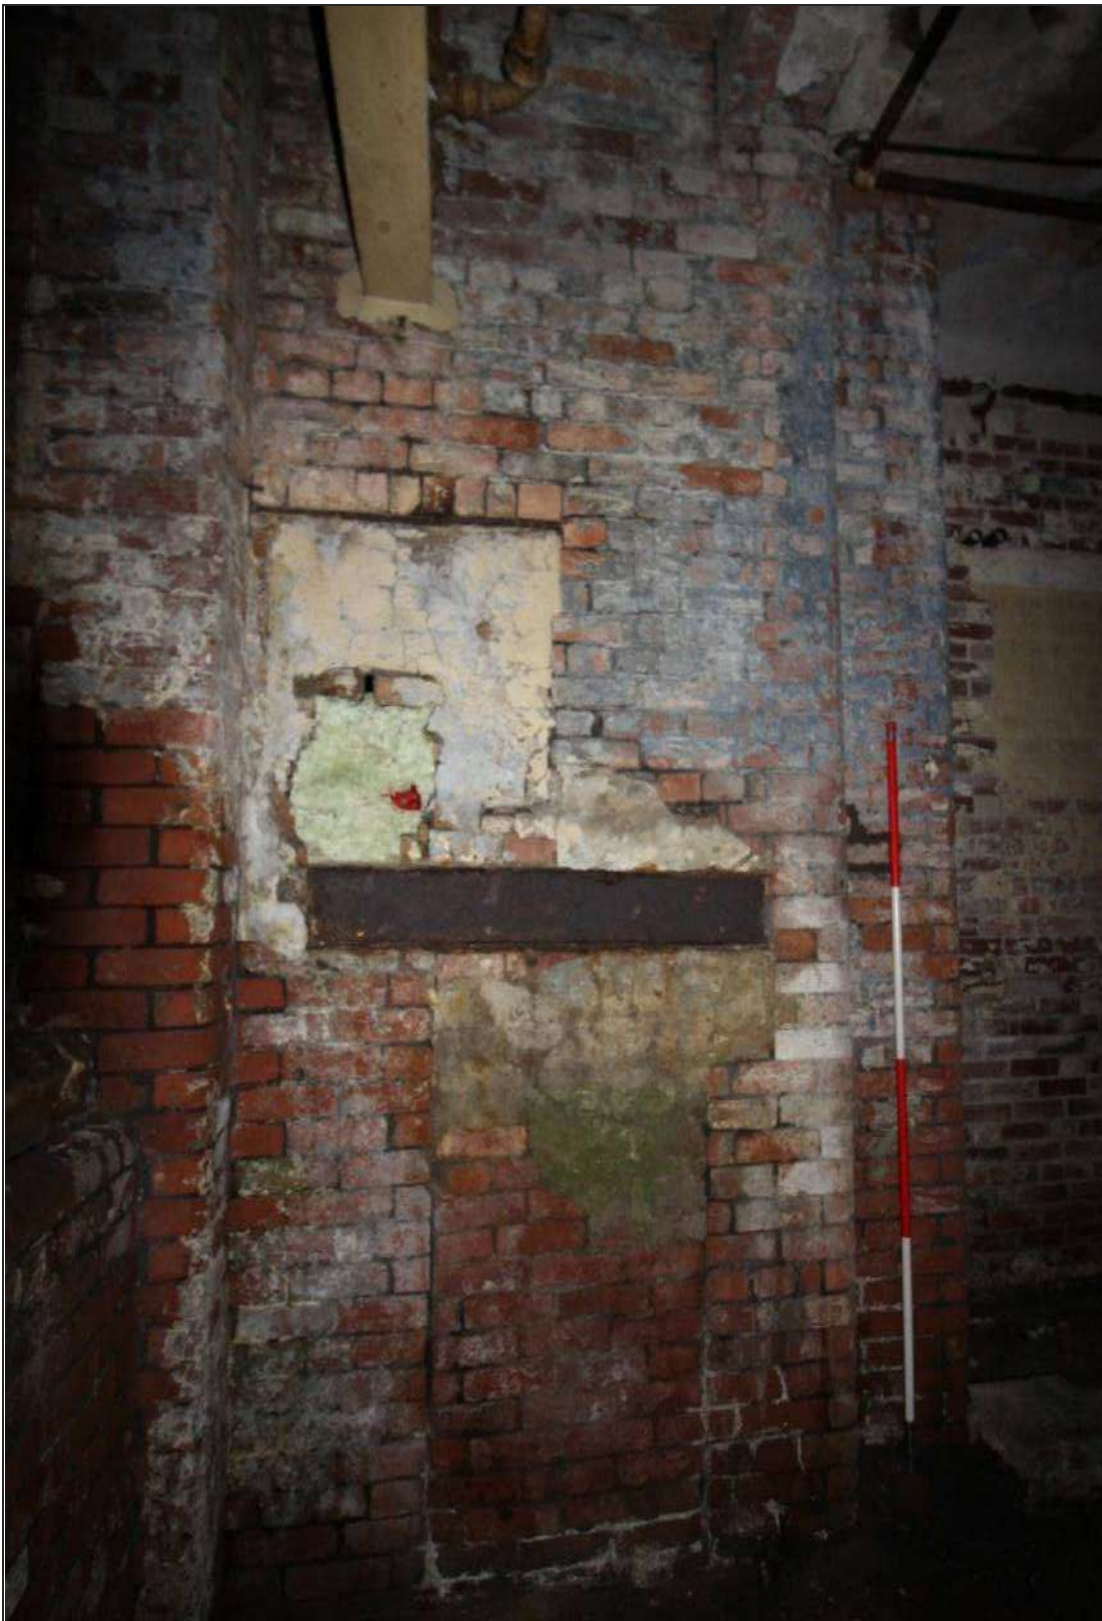
*Plate 57: Two blocked flues leading into the chimney*

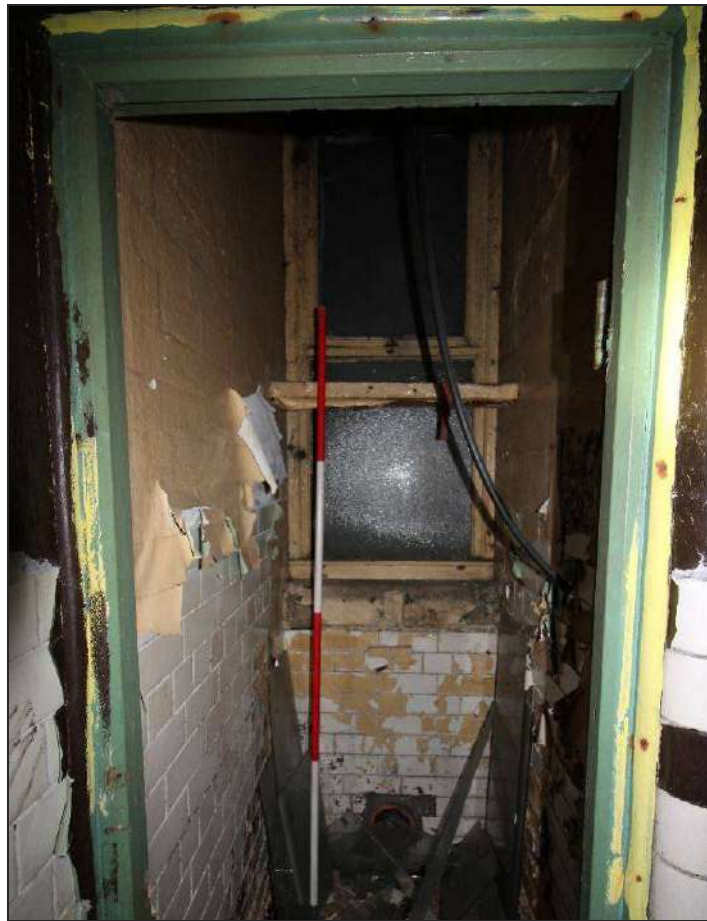
*Plate 59: Base of original privy tower*

No access was possible into the base of the motor tower, which was later remodelled to house a lift. The original hoist tower to the west was blocked at all floor levels. To the east of this original hoist tower and the main entrance, the base of what formed a privy tower on the floors above formed a narrow passage (Fig 3). This appears to have retained a privy at its northern end, the door frame and white-glazed tiling surviving *in-situ* (Plate 59), but with a short flight of four concrete steps on the eastern side of the passage affording access into a small room that infilled the external area to the main entrance steps (Fig 3). This latterly housed two modern toilet cubicles (Plate 60), and had a modern grey brick blocked window in the north wall (Fig 3), suggesting that it was added to the building to provide additional toilets, presumably for female employees.

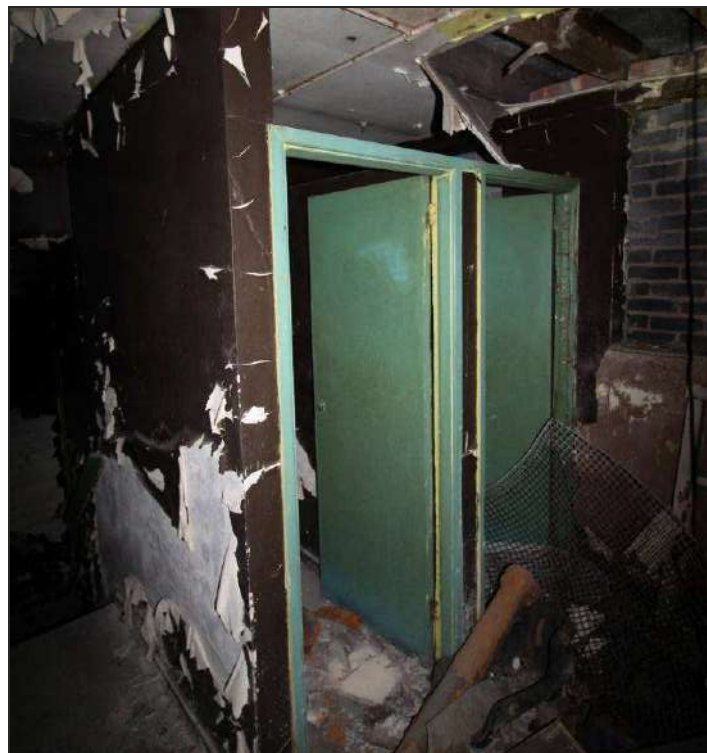
*Plate 60: Stalls within extension between privy tower and entrance steps*

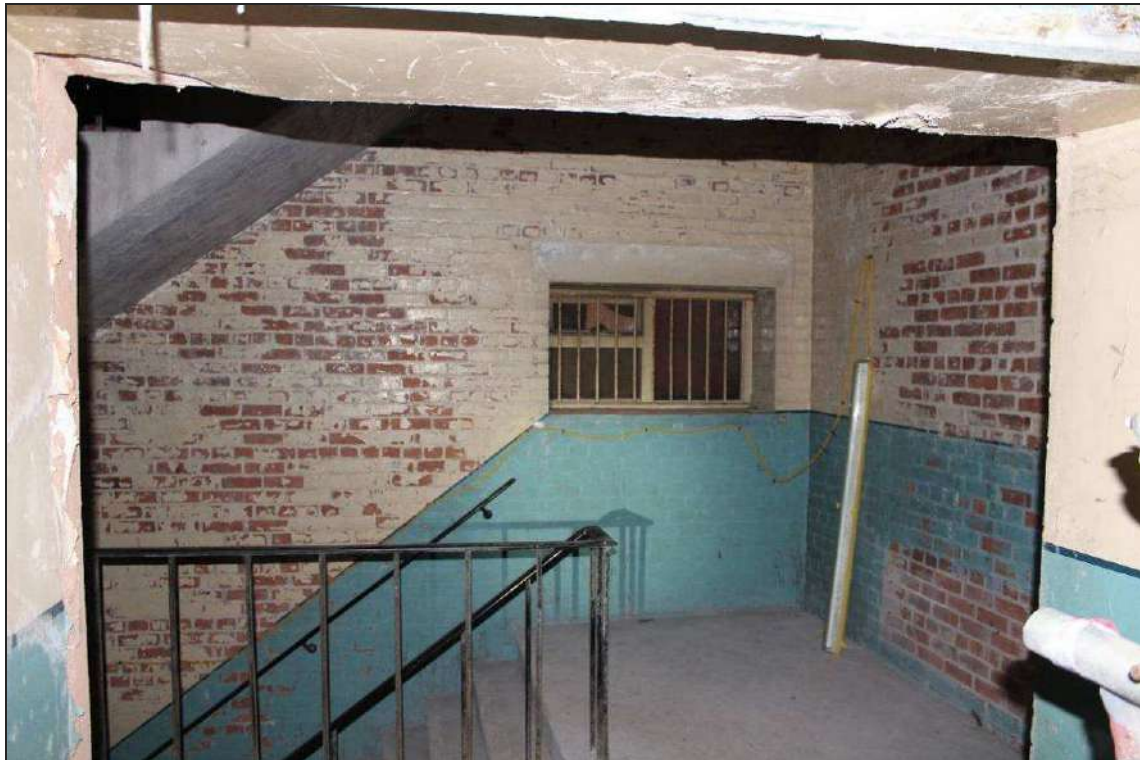
*Plate 61: First-floor landing of the later stair tower*

At the eastern end of the northern façade an additional tower placed against the original structure represented a late 20<sup>th</sup>-century stair tower (Figs 2-6). The stairs within the tower were of a closed stringer type with concrete rendered risers and treads with a modern steel round handrail bolted to the external wall. The handrail on the open side was supported by slender painted steel balusters, bolted to each step. At each landing a small, horizontal rectangular window with a flush concrete lintel and a flat internal sill afforded some natural light, and comprised a three-light timber-framed window with steel security bars (Plate 61).

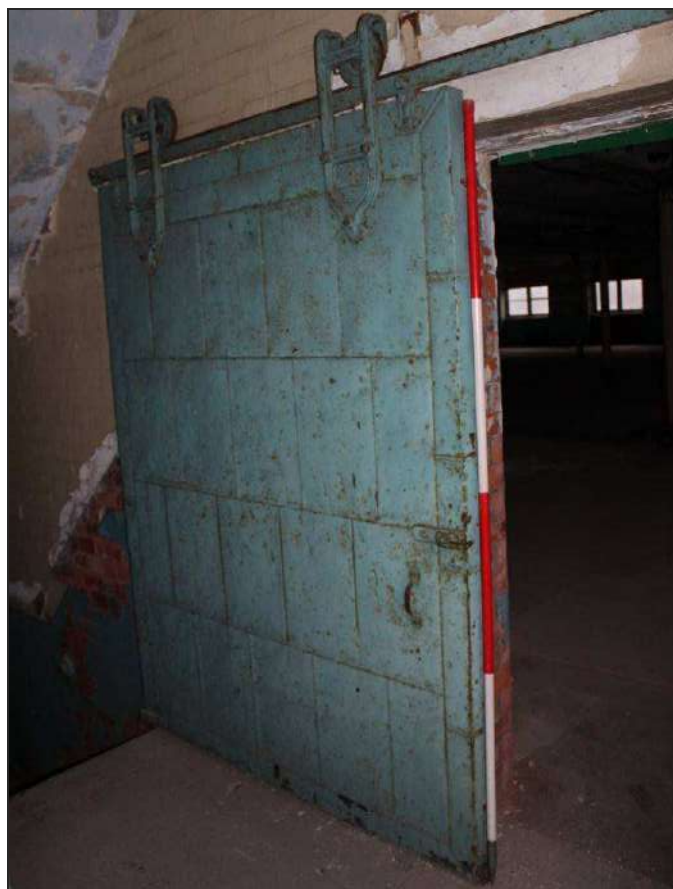
*Plate 63: Detail of fireproof sliding door*

Original access to the upper floors was afforded by the tower at the western end of the northern façade, housing a half-turn concrete stair (Figs 2-6; Plate 62). Scars on the adjacent brick wall suggest that these represent replacements of an earlier stair, presumably of brick and sandstone construction. Each landing was well-lit with windows in the east wall, and larger windows in the north wall lighting both the landing and the outer flight of steps between floors (Figs 2-6). Each floor also retained a sliding external door with fireproof cladding (Plates 62 and 63), each having relatively ornate brackets to the rail rollers (Plate 63), but none retaining maker's plates. The doors themselves were timber with iron sheets riveted over the surface to afford the fireproof protection (Plates 62 and 63).

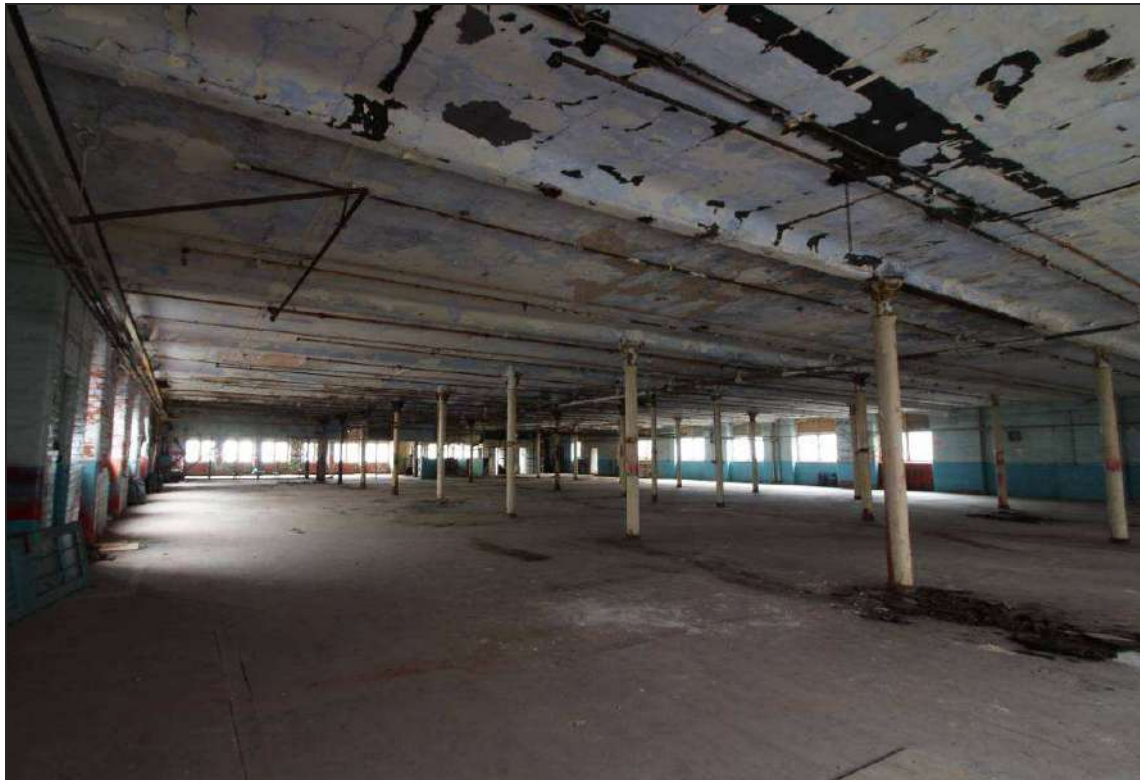
*Plate 64: General view of the first floor, looking east*

The first floor was completely open plan (Fig 4) and had painted brick walls, a concrete rendered timber floor, and a concrete ceiling of flat-arched vaulting between rendered I-section steel beams (Plate 64). Each beam span comprised three beams of 24' (7.32m), jointed above a 9" (0.23m) diameter hollow cylindrical cast-iron columns with astragals below flanged capitals with round head plates with projecting rectangular lugs (Plate 65). These carried the flat section of the base of each I-beam, the end of which was bifurcated to form a rounded clasp around the foot of the column above, which was socketed into the head of that below, forming a continuous interlocking column through the full building (Plate 65). No evidence was visible for how the bifurcated ends of adjacent beams were jointed together, suggesting that they were bolted with a plate level with the top of the I-section beam, above visible ceiling level (Plate 65).

Two-rows of cast-iron eye-brackets were bolted into the ceiling within the sixth and seventh bays from the western end of this floor. Each row ran in the same direction, with those in the seventh bay aligned immediately to the south of the centre-line of the motor tower (Plate 67), strongly suggesting that they related to line shaft hangers associated with power transfer to the floor. Pipes relating to the humidification system were also placed longitudinally down the length of the floor (Fig 4), but were attached at a higher level than those on the floors below (Plate 64).

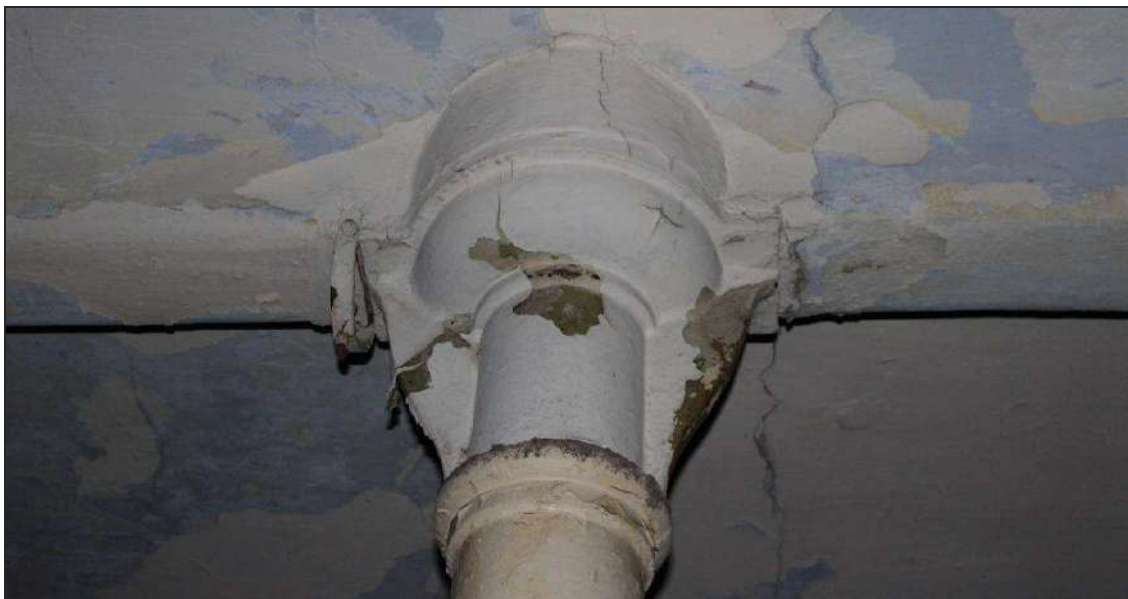
*Plate 65: Detail of column capital*

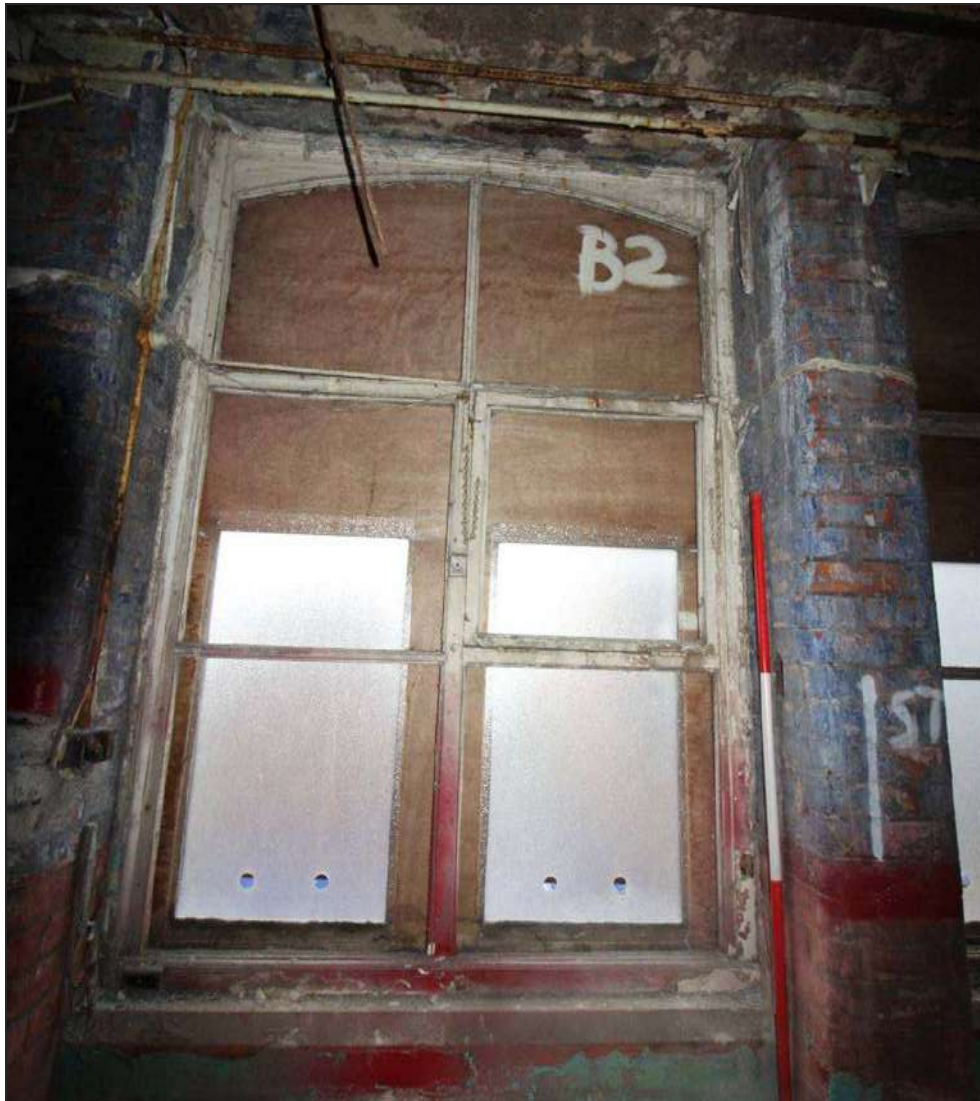
*Plate 66: Detail of window*

Each bay housed a floor to ceiling recessed window aperture within each wall, measuring 7'6" (2.23m) wide, between 5'5" (1.66m) wide brick piers. Each housed a six-light timber-framed window, divided in three rows of two lights (Plate 66). The central row comprised centre-hung hopper-style tilt openings (Plate 66), and although the majority of the glazing had been removed, some windows retained obscured glass panes.

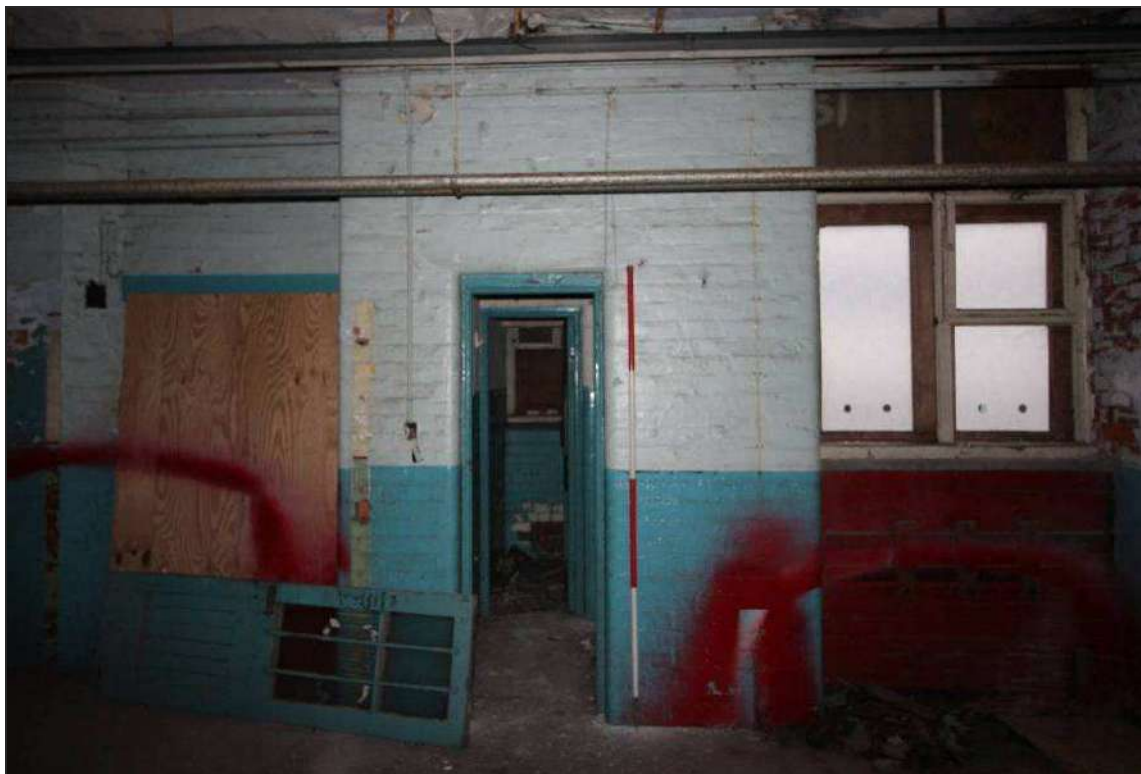
*Plate 68: Doorway into original privy tower with blocked hoist to left*

The hoist tower adjacent to the stairs at the north-west corner of the mill was blocked, and the adjacent privy had been removed, although the room remained open (Plate 68). As at basement level the walls were of glazed brick, with channel-section metal beams spanning the six-light timber-framed window to house the toilet cistern (Plate 69). The entrance into the privy was rebated into the wall thickness on its eastern side (Fig 4), where it had a narrow two-light window, the upper of which had a tilt vent opening. A basin would have been placed below the window within the reveal, with a sign for 'drinking water' being attached to the base of the window frame, demonstrating that the water was piped from the main.

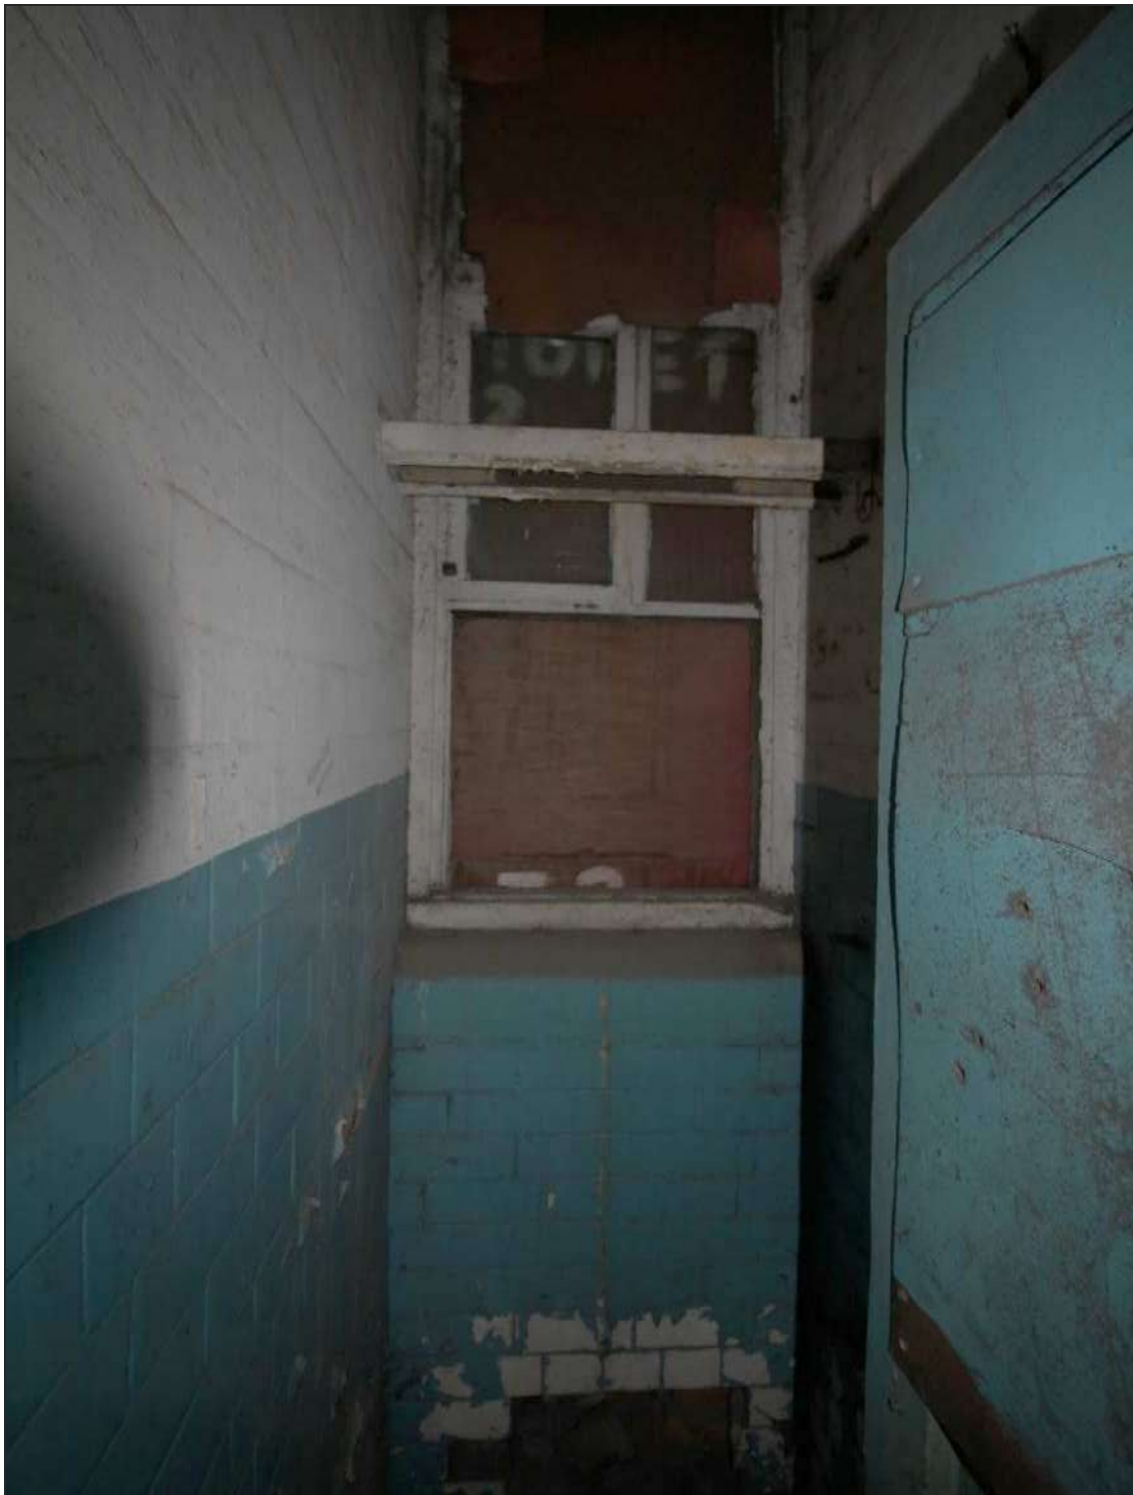
*Plate 69: The blocked window and cistern rails within the northern privy tower on the first floor*

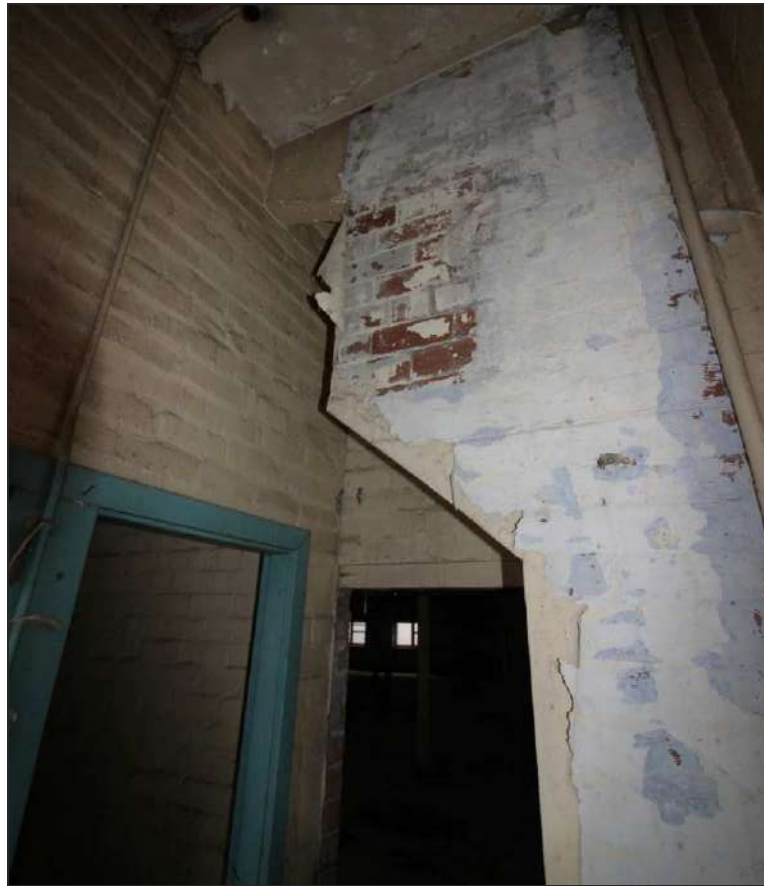
*Plate 71: Cutaway east jamb of original window with cubicle wall respecting original lintel arch*

The later adjacent humidification and ventilation tower had also been remodelled into a privy tower at this level, and was also entered through a narrow doorway with bull-nosed brick reveals and a chamfered, flush rectangular lintel. Part of the eastern jamb of the original window aperture was cut away to ease access into a vestibule that housed a low washbasin and box-shuttered pipework (Plate 71), with two brick-built cubicles placed transversely across the tower, backing onto the enclosed chimney of the former ventilation system (Fig 4; Plate 72). The brick partition of the cubicles was erected around the external, single-skin arched lintel of the original window aperture (Plate 73).

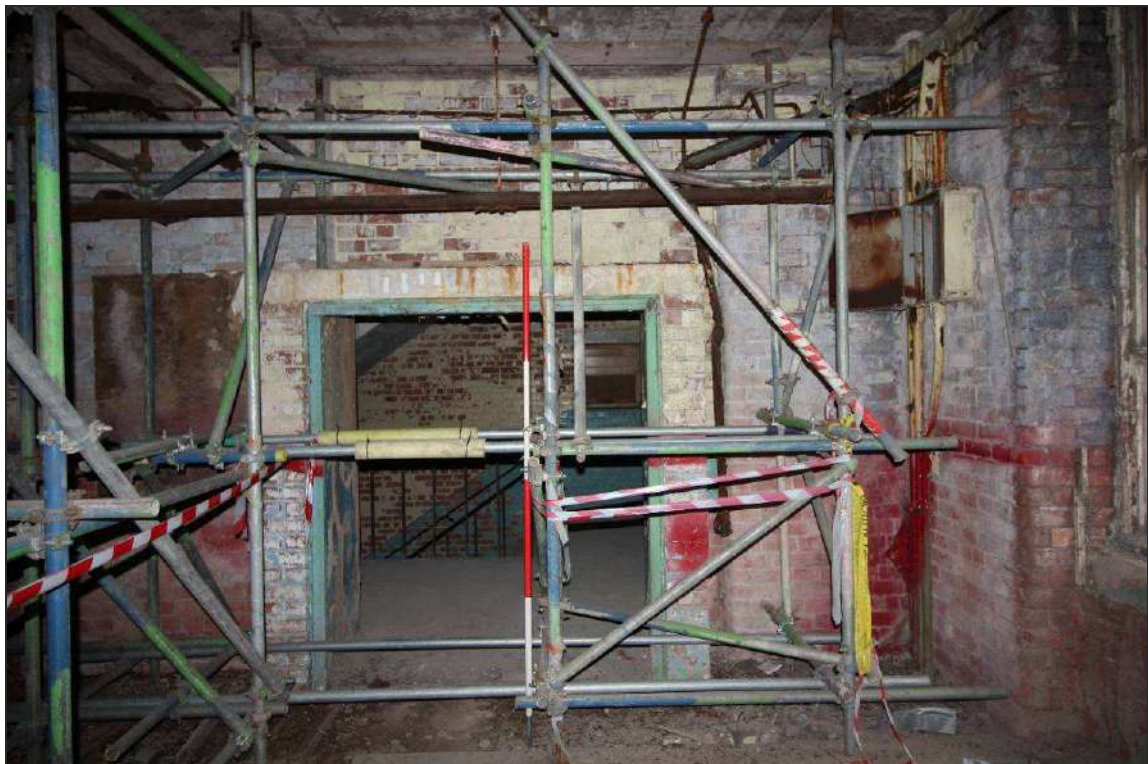
*Plate 74: Doorway into the late stair tower at first-floor level*

The motor tower was boarded at this level, but access was maintained to the late stair tower at the northern end of the elevation (Plate 74). Immediately adjacent to the tower, at the northern end of the east wall, a pair of fuse boxes appeared to represent a relatively late replacement of earlier boxes placed within the wide pier of the bay division to the south (Fig 4). These retained original ducting, but the fuse arrays within had been removed upon replacement.

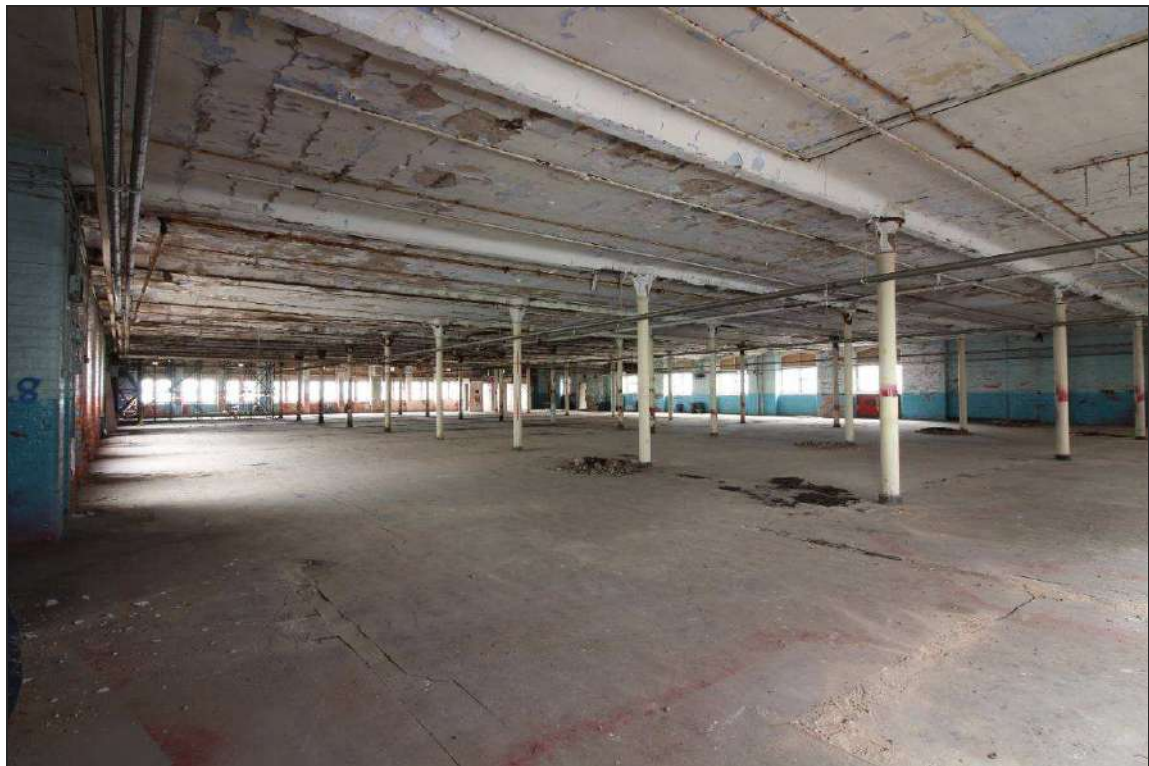
*Plate 75: General view of the second floor*

The layout of this floor was similar to that of the first floor, comprising a rendered timber floor, painted brick walls and a vaulted ceiling (Plate 75), carried on columns as below (Plate 76). The pipes of the humidification system survived almost entirely intact (Plates 75-78). An area of damaged ceiling revealed that the concrete floor was attached to a diamond-shaped steel mesh, itself attached to the underside of slender I-section steel ceiling joists. These were placed on approximately 2' (0.61m) centres and were carried on L-section brackets riveted into the rib of the I-section ceiling beams (Plate 77).

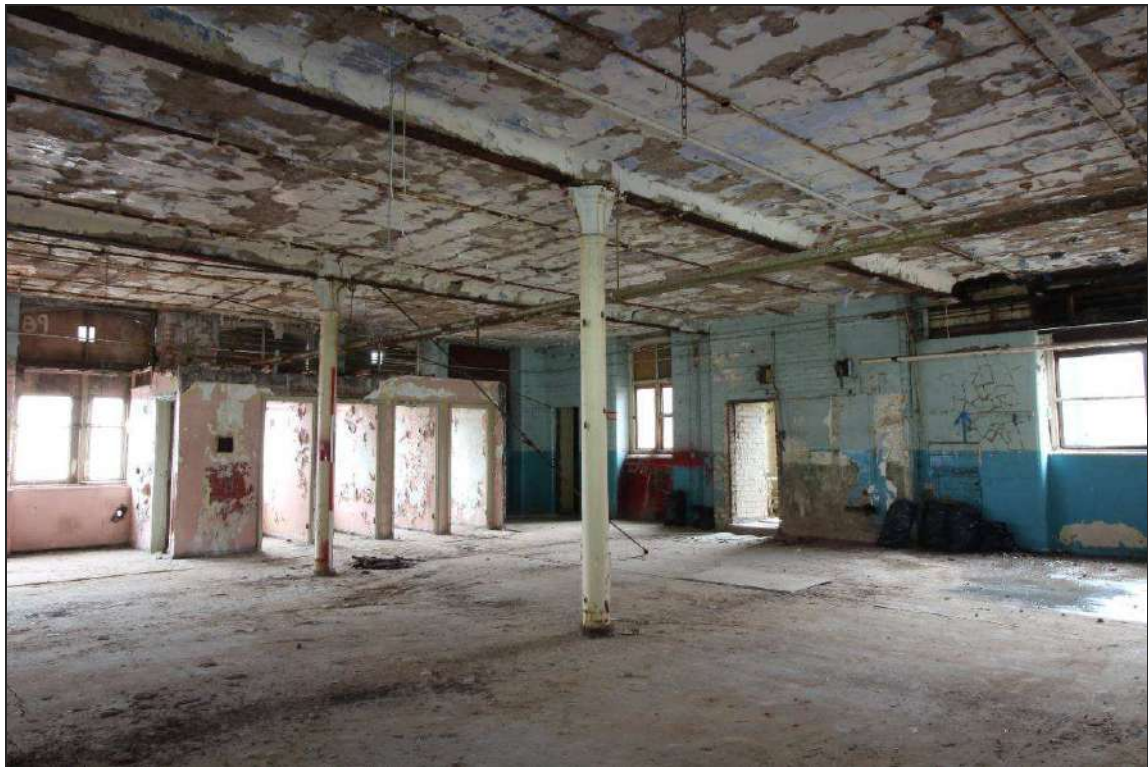
*Plate 76: Detail of the columns on the second-floor*

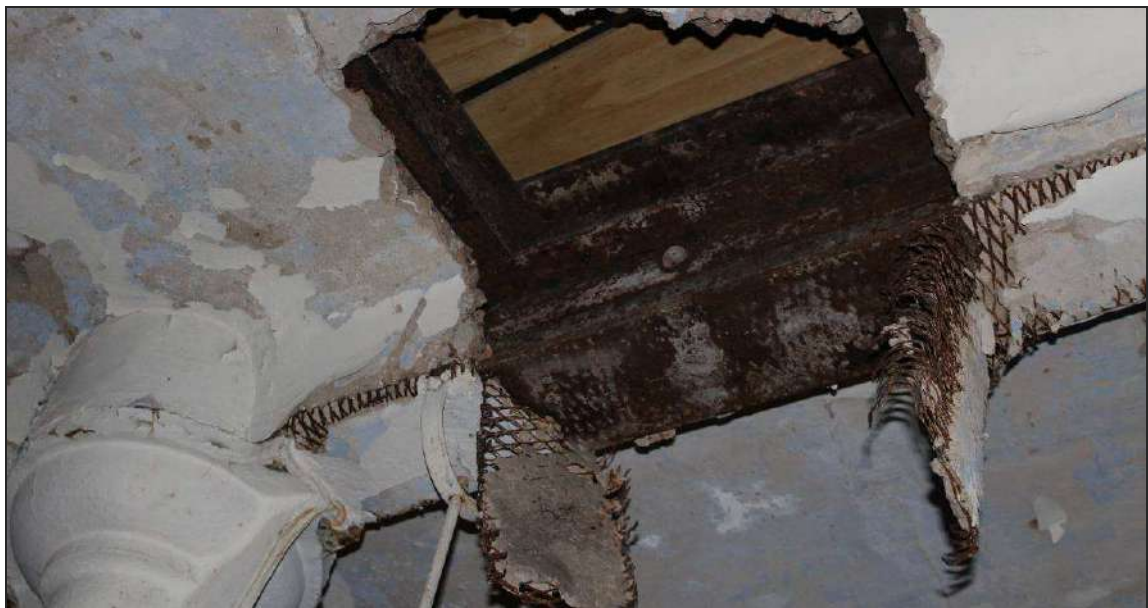
*Plate 77: Detail of concrete and I-beam ceiling construction*

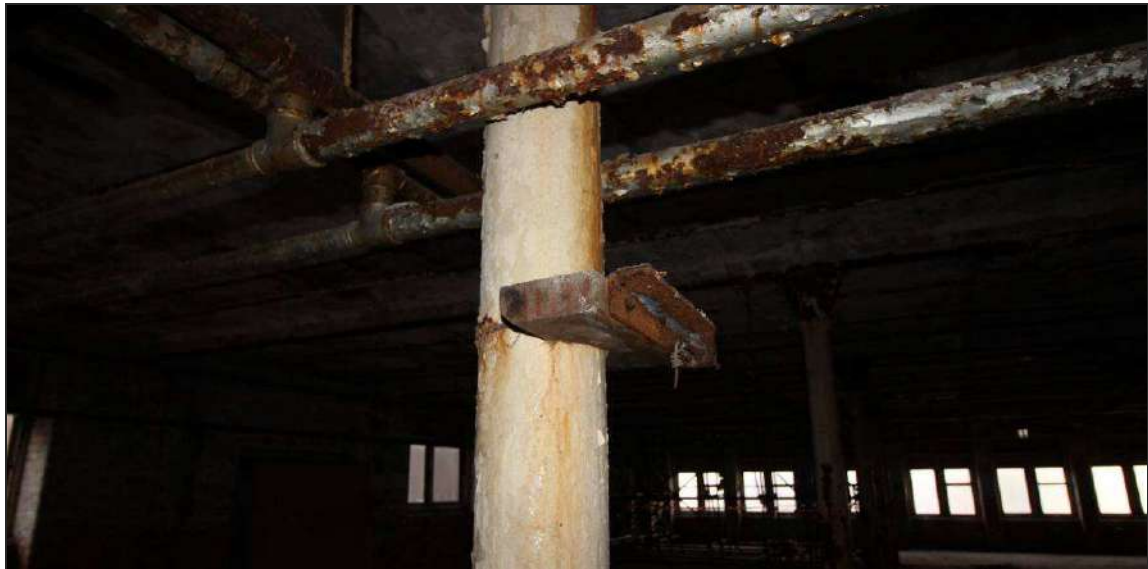
*Plate 78: Detail of an attached bracket to the north-west column*

Two columns at the north-western end have later brackets attached at a height of 1.87m above floor level. These comprised small timber battens, moulded to the diameter of the column and strapped in place by a 1" (25mm) wide steel band (Plate 78). A 2" (0.05m) L-section steel angle bracket was subsequently bolted to the outer face of each timber. A stop had been welded to one edge of the bracket, with a steel pin welded into the centre. Several early electrical fuse boxes and switches are situated around the main compartment of this level.

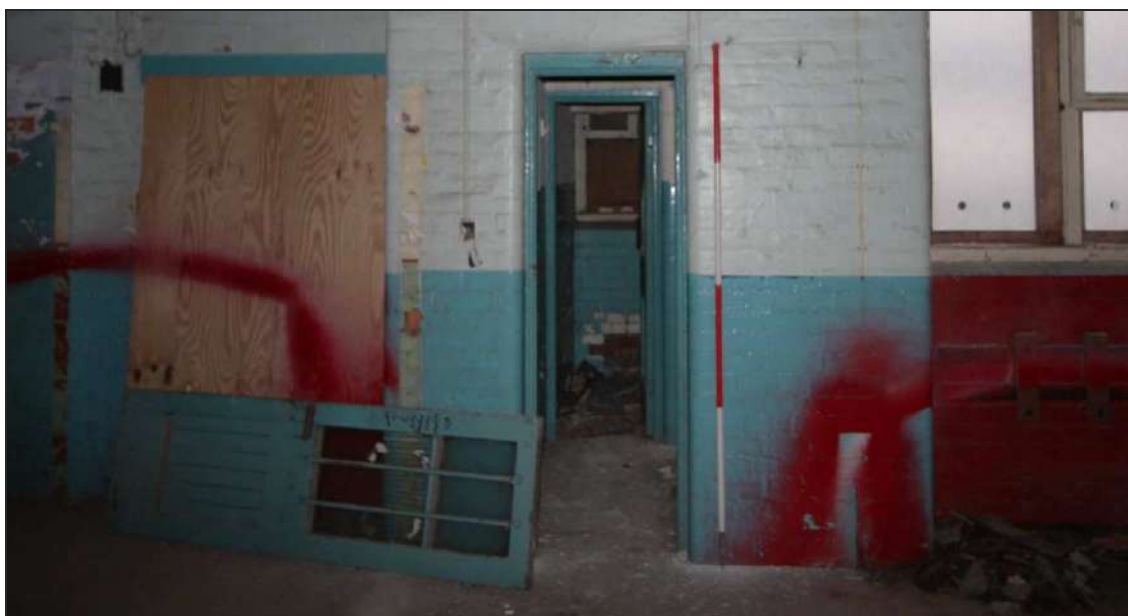
*Plate 79: Northern privy and blocked hoist tower, with original doorway lying nearby*

The original privy towers were as the floor below. A ledged and braced timber door was placed against the wall adjacent to the entrance of the north privy tower, and presumably represented the door for the privy tower. It had a tongue and groove timber board panel below the middle rail, and two rows of three glazed panels above (Plate 79). The glazing was of obscured glass separated by simple chamfered timber mullions and transoms. The later ventilation and humidification tower was similarly remodelled to the floor below, having brick cubicles for privies. The entrance into the tower had a more pronounced rebuilt eastern jamb (Plate 80), with the timber framing of what was presumably an air vent also visible within the blocking of the original window aperture (Plate 80). The vestibule of the tower was also better preserved than that below, retaining two cast-iron pedestals for washbasins along with planked shuttering for a cupboard shuttering pipework along the south wall (Plate 81).

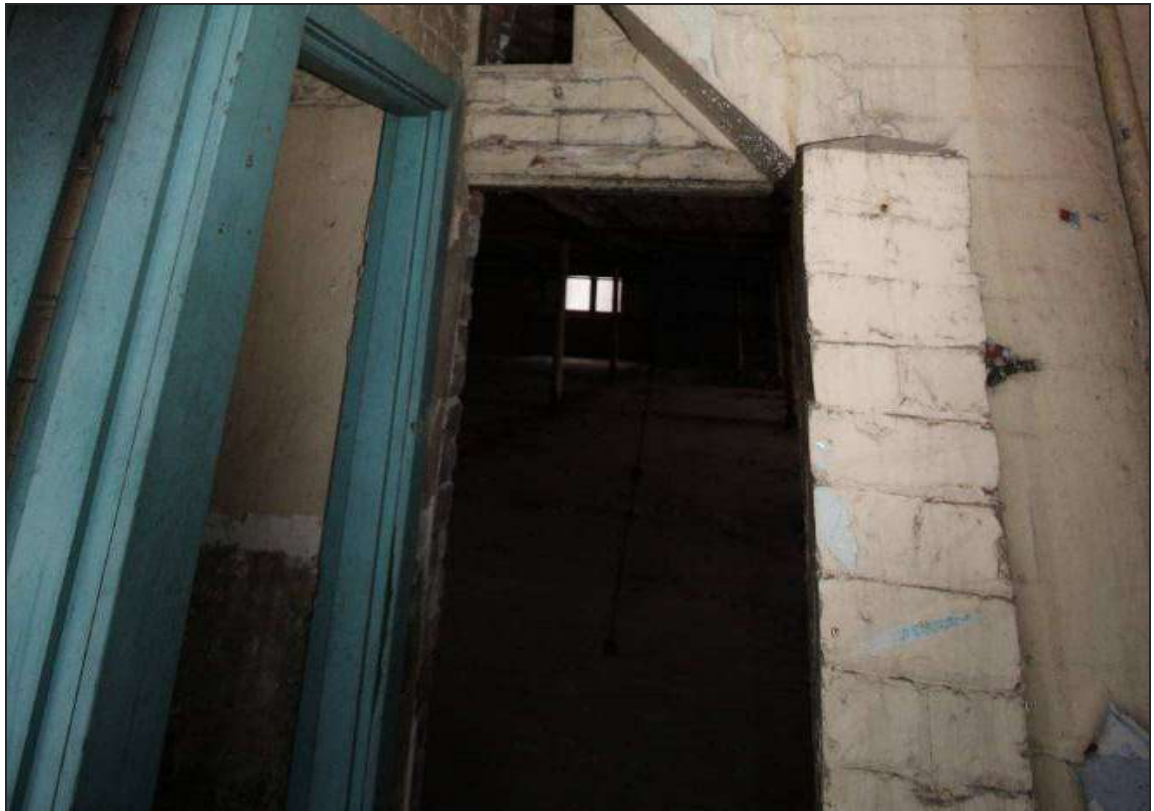
*Plate 80: Detail of the remodelled entrance into ventilation and humidification tower*
