## Historic Building Investigation and Watching Brief

New Little Mill,  
Jersey Street,  
Ancoats,  
Manchester

**Document Type:** Historic Building Investigation and Watching Brief Report

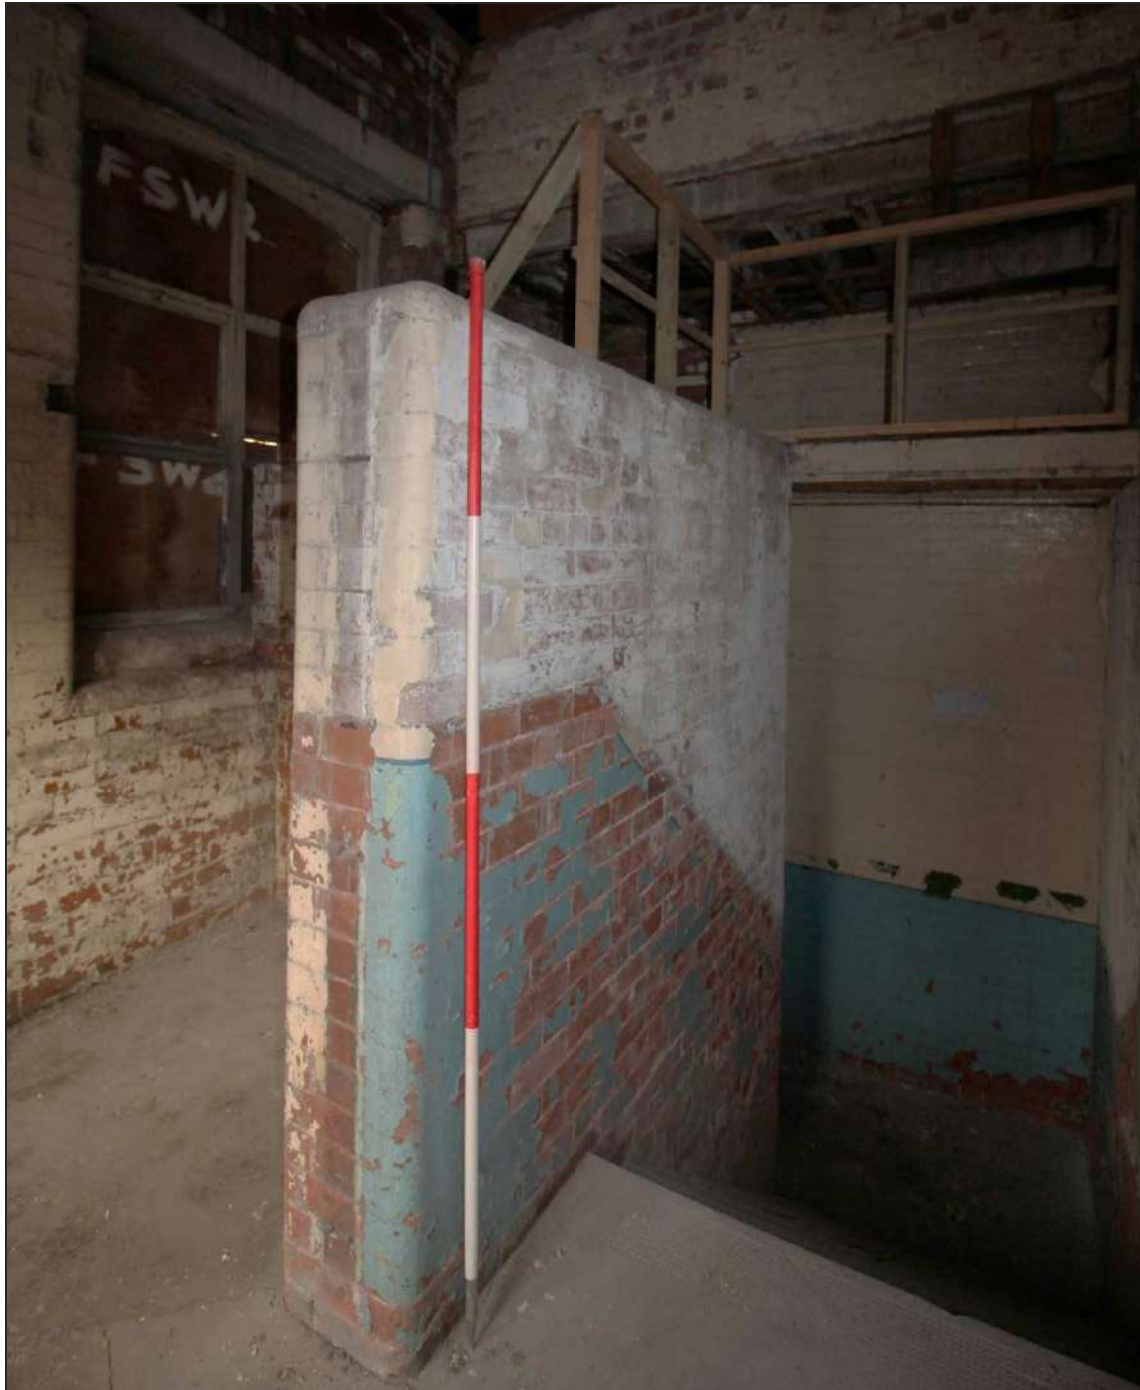
*Plate 82: The third-floor landing of the original stair tower*

Entry into the third floor of the mill was similarly afforded by the two stairs towers against the north wall (Fig 6). The top landing of the original stairwell had a concrete rendered floor, painted brick walls and a suspended rendered ceiling. The landing was lit by two window apertures within the north and west walls (Fig 6; Plate 82). Each aperture had bull-nosed brick reveals, replaced concrete lintels and an internal sill of bull-nosed brick. Each retained a six-light timber-framed window, the glazing having been removed and boarded externally (Plate 82).

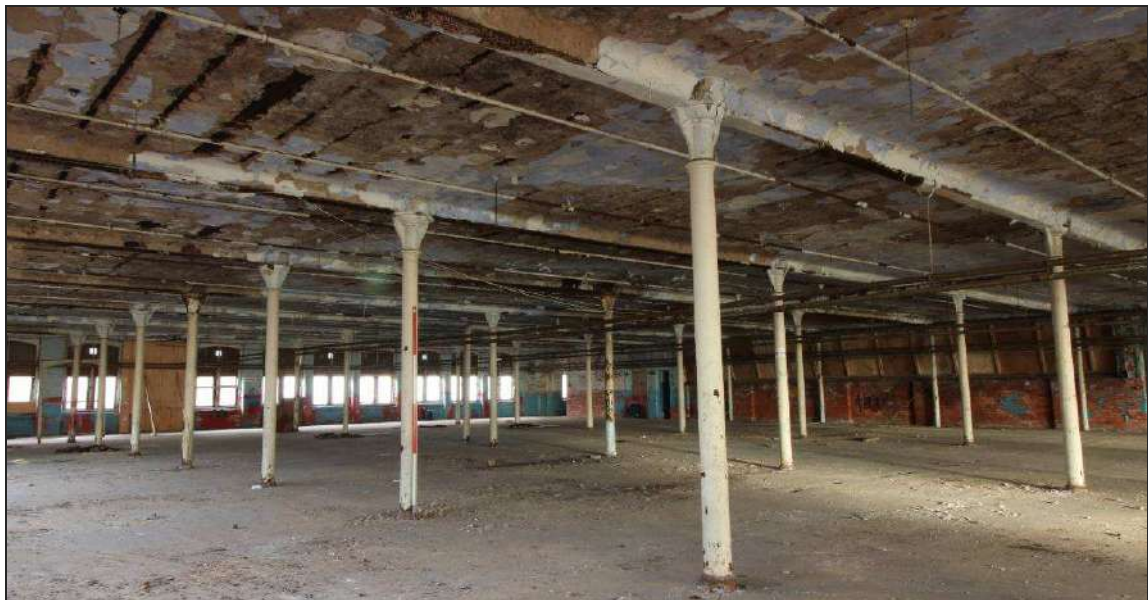
*Plate 81: General view of the third-floor*

The third floor represented the upper floor of the building, and had a similar layout to those of the lower levels, comprising a rendered timber floor, painted brick walls and a flat concrete ceiling (Fig 6; Plate 83). Despite representing the upper members of the vertical columns from basement level, the column and ceiling arrangement was similar to that on the floors below, with the top of the capital presumably infilled with concrete, rather than housing the foot of an additional column above.

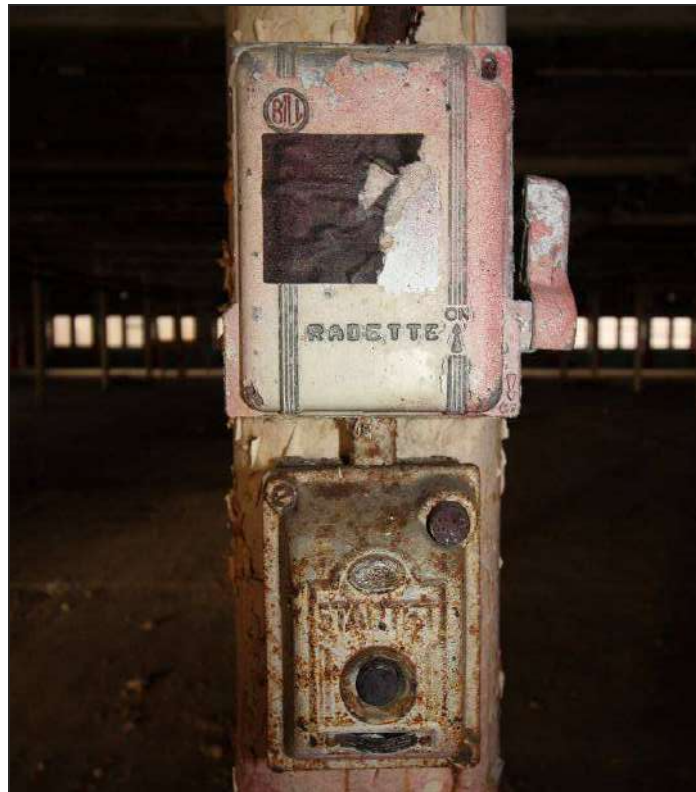
*Plate 84: Detail of the electrical switch boxes mounted on a third-floor column*

One of the columns retains a 'Bill Radette' 500V switchfuse, above a 500V 'Startet' on/off switch (Plate 84). Radette switch fuses were manufactured by Bill Switchgear of Aston, Birmingham, between 1950 and 1970 ([collection.sciencemuseumgroup.org.uk](http://collection.sciencemuseumgroup.org.uk)), whilst the Startet switch may have related to an industrial sewing machine, probably relating to use of the mill following the cessation of spinning in the early post-WWII period. Humidification pipes were again well preserved (Plate 83), as were the smaller pipes of the sprinkler system, the vertical pipe of which had a curved 90° joint just below ceiling level (Plate 85)

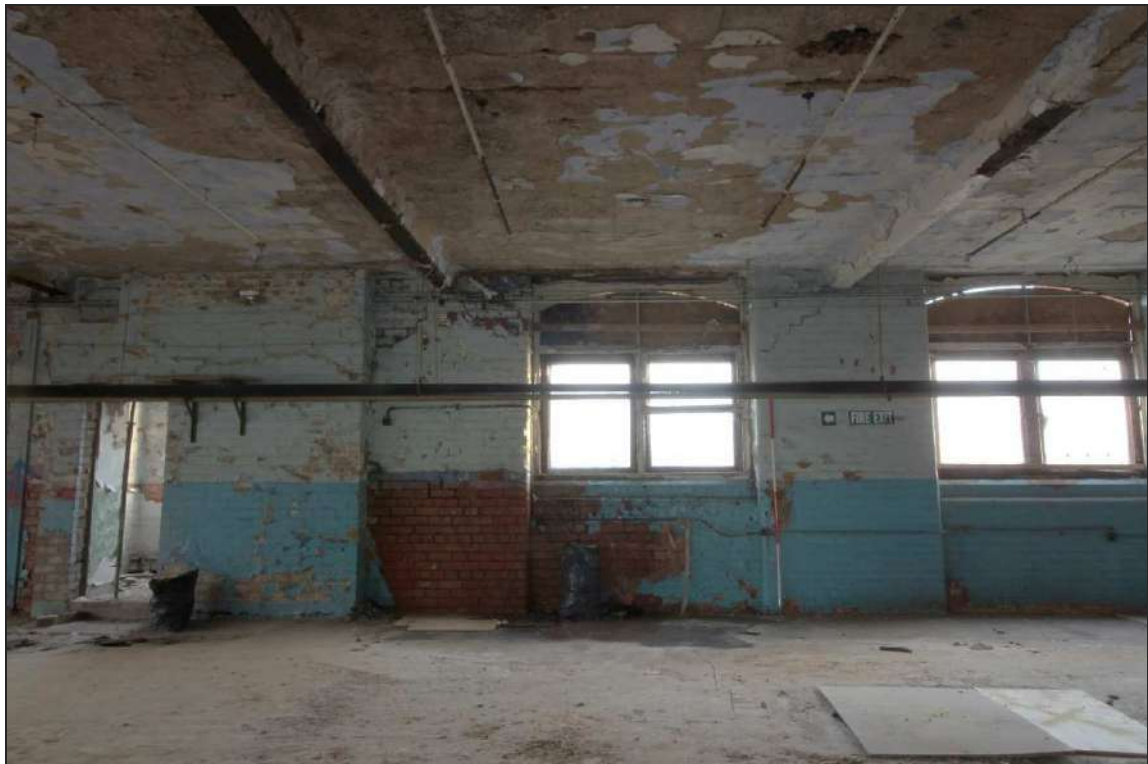
*Plate 86: Windows on the third-floor, and remodelled entrance into later privies*

Whilst the south, east, and west walls were of similar construction to the floors below, and housed similar windows (Plate 86), a significant difference to the floors below was the construction of the north wall at this upper level. It comprised a brick wall to a height of 4'6" (1.37m), capped with an angled concrete sill to a sloping continuous glazing band, interrupted only by the motor tower (Plate 87). Whilst the window frames had been removed, and replaced with plywood shuttering (Plate 87), the unusual window construction could still be identified, with the upper part of each frame having been attached to a longitudinal I-section steel rail that formed the window lintel. Columns were placed at each bay division, not only carrying the end of the ceiling beams as below, but supporting the joint between the longitudinal beams of the window lintel (Plate 88). All members were bolted onto the headplate of the column, which differed to those elsewhere, having a flange only on the inner, southern face (Plate 88), and demonstrating an attention to detail within the construction of the building that was undertaken with high aesthetic regard.

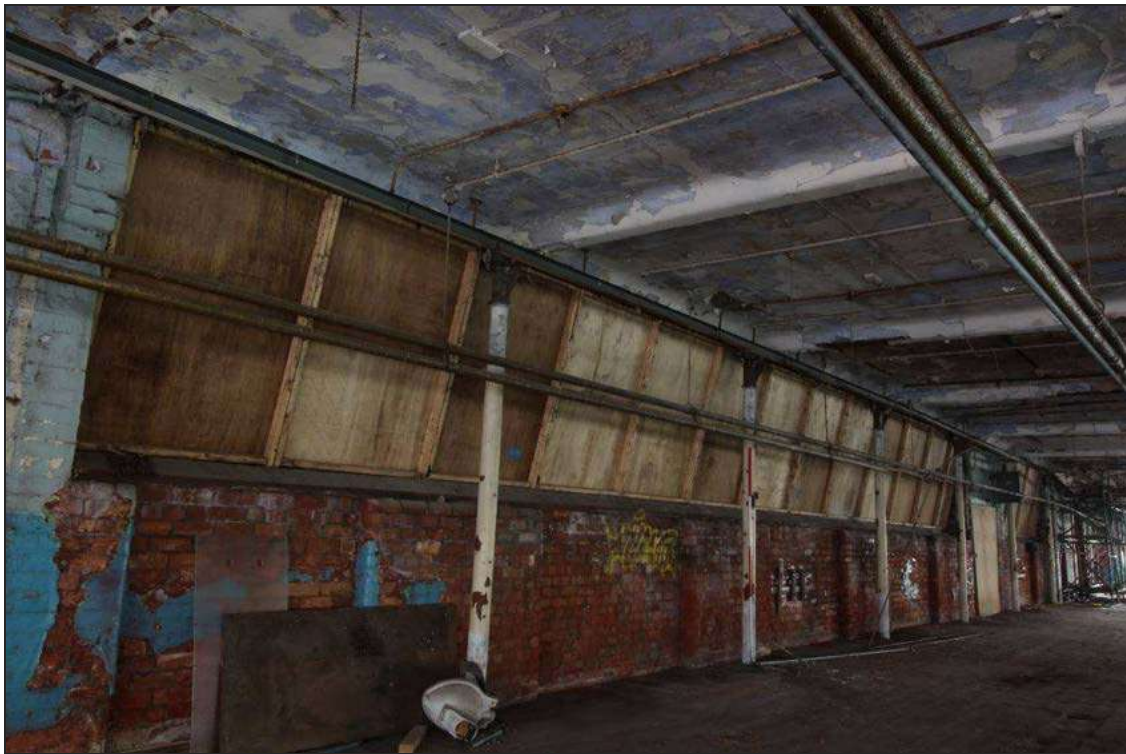
*Plate 87: Glazing band within the north wall of the third-floor, with columns at each bay division*

The glazing band on the upper floor of the mill is an unusual feature for a spinning mill, and derives from the tradition of northern light asymmetrical roofs found in single-storey weaving sheds from the mid-19<sup>th</sup> century. Whilst most early 20<sup>th</sup>-century large spinning mills were much taller than the surrounding structures, typically being of four to six storeys in height, New Little Mill was relatively short, and the glazing band may have been introduced to maximise the best quality light from the north, which would not cast shadows, but which would have been reduced by the buildings opposite into normal vertical windows.

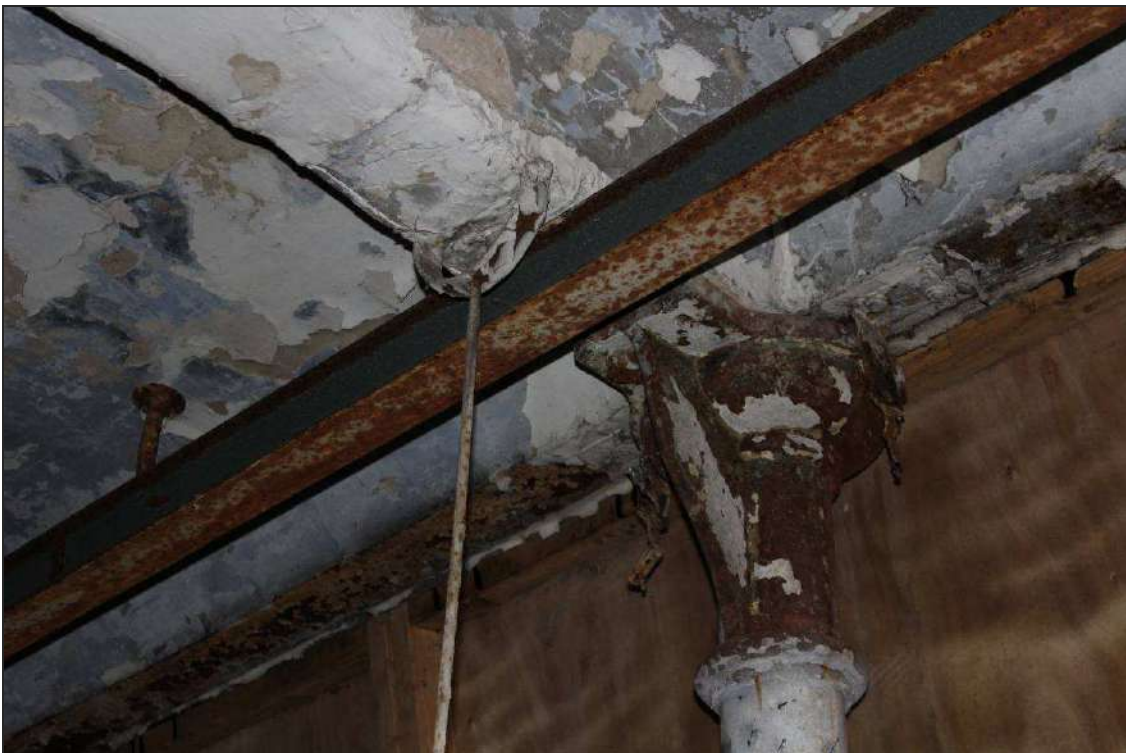
*Plate 88: Detail of column capital and beam jointing by north wall of upper floor*

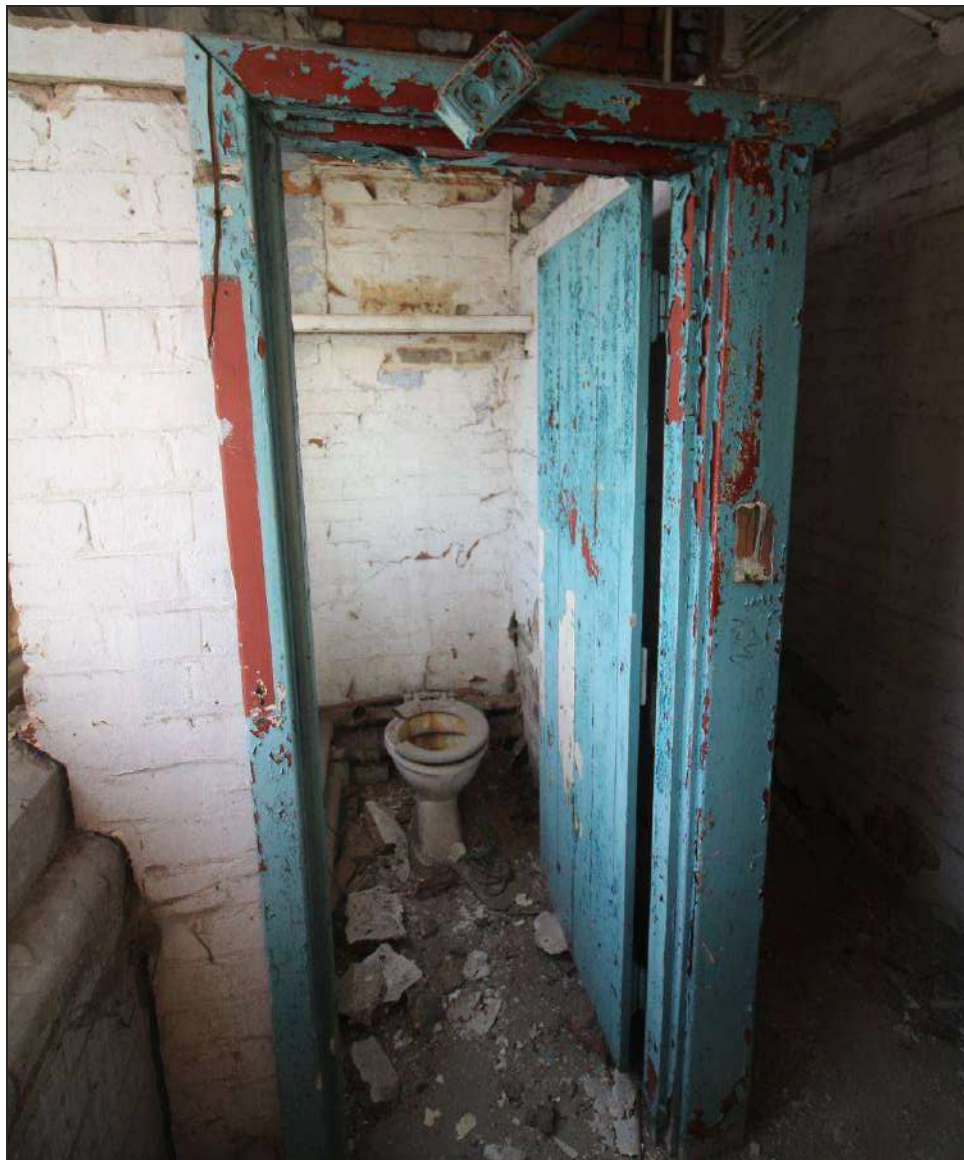
*Plate 89: Toilet cubicle with wall scar for cistern within the later privy on the third floor*

As with the floors below, the ventilation and humidification tower had been remodelled into privies with brick partitions. The layout differed slightly at this floor level, with a thick concrete floor within the tower having a step up from the main mill (Plate 86). It is probable that this floor related to machinery relating to the upper level of the humidification and ventilation system, rather than the privies. As on the floors below, some sanitary ware survived, and is of mid-20<sup>th</sup>-century date, as does timber planking to carry a raised cistern, the scar for which could be seen within the peeling paintwork to the rear (Plate 89). Door frames and a planked batten door also survived (Plate 89), with the extant six-light window in the south elevation being divided into two by the brick partition wall forming the front of the privies, again as on the floors below (Figs 2-6).

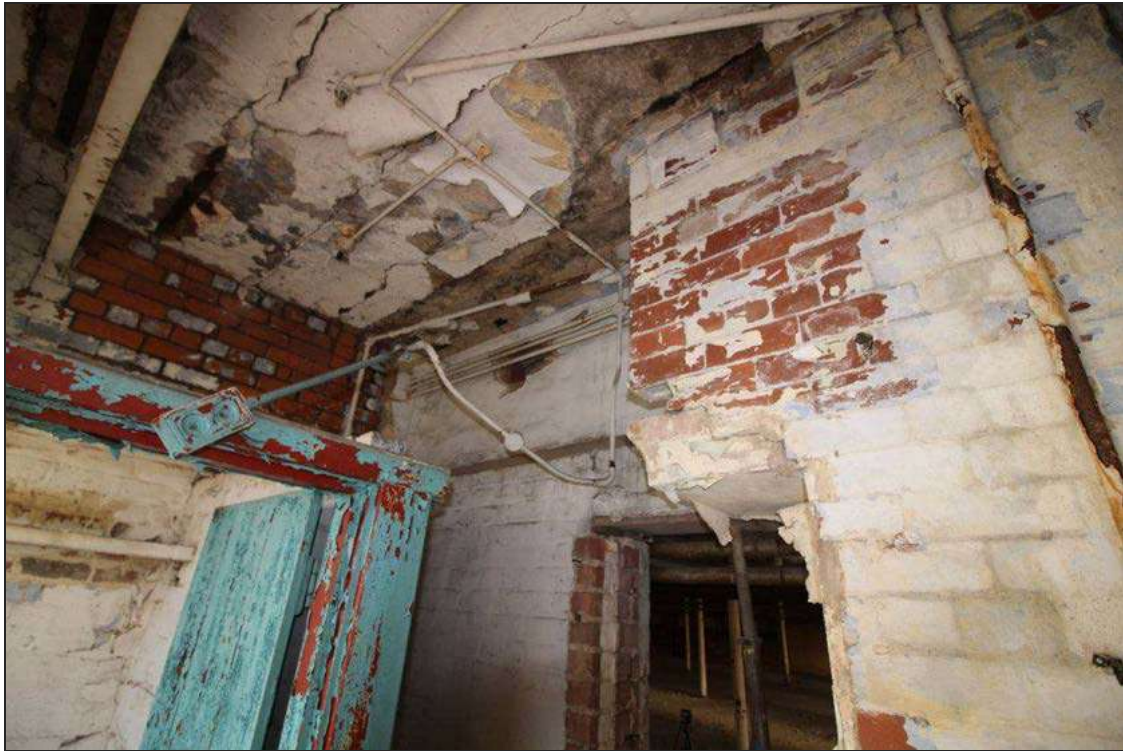
*Plate 90: Detail of the removed external lintel arch of the original window aperture*

Another slight difference to the floors below is that the segmentally-arched head of the original external window lintel had been removed (Plate 90), unlike on the lower floors, probably because there was no need to retain strength in the wall above, which terminated immediately above, with the original parapet having also been removed.

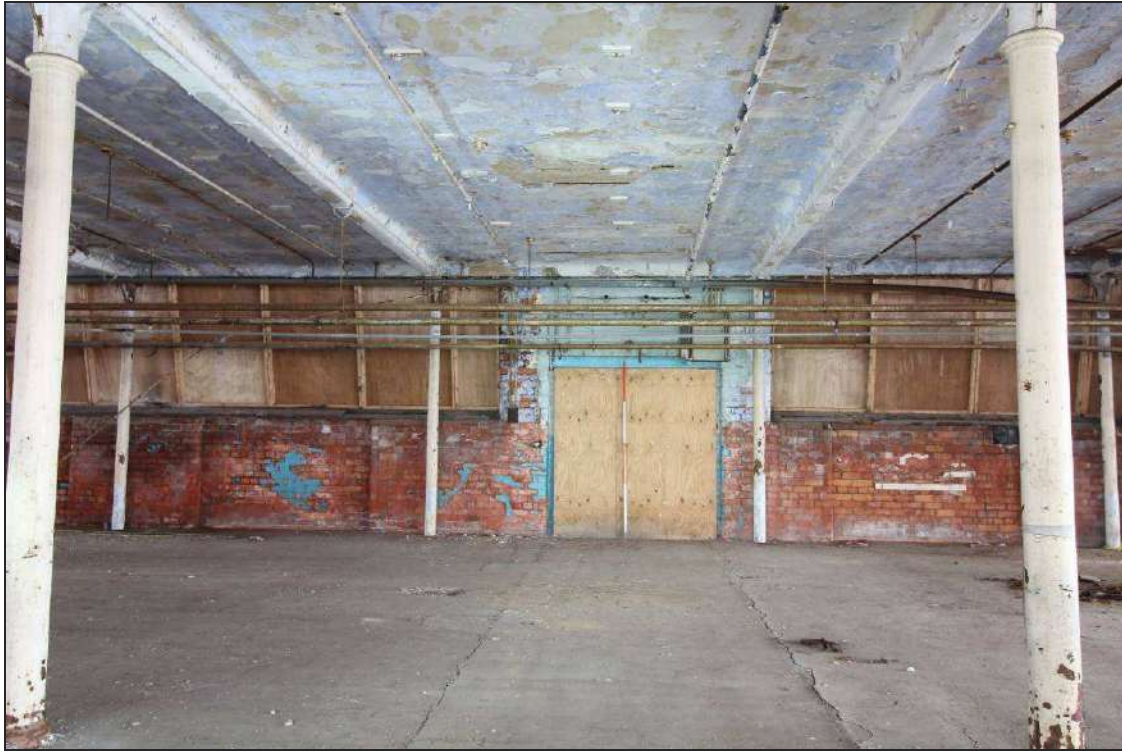
*Plate 91: Blocked doorway of the motor tower, with scars for possible power transfer brackets in the ceiling*

The original motor tower continued to this level, although its entrance was blocked, affording no access to the later hoist headgear (Plate 91). The opening was less obscured than below, showing the bull-nosed brick reveals to the original aperture, which had been reduced in height with an inserted I-section steel lintel (Plate 91). Within the adjacent bay of the main mill, scars on the ceiling and in the bay to the south were similar to those on the first floor (Plate 67), suggesting a similar arrangement for power transfer from the motor tower into the mill.

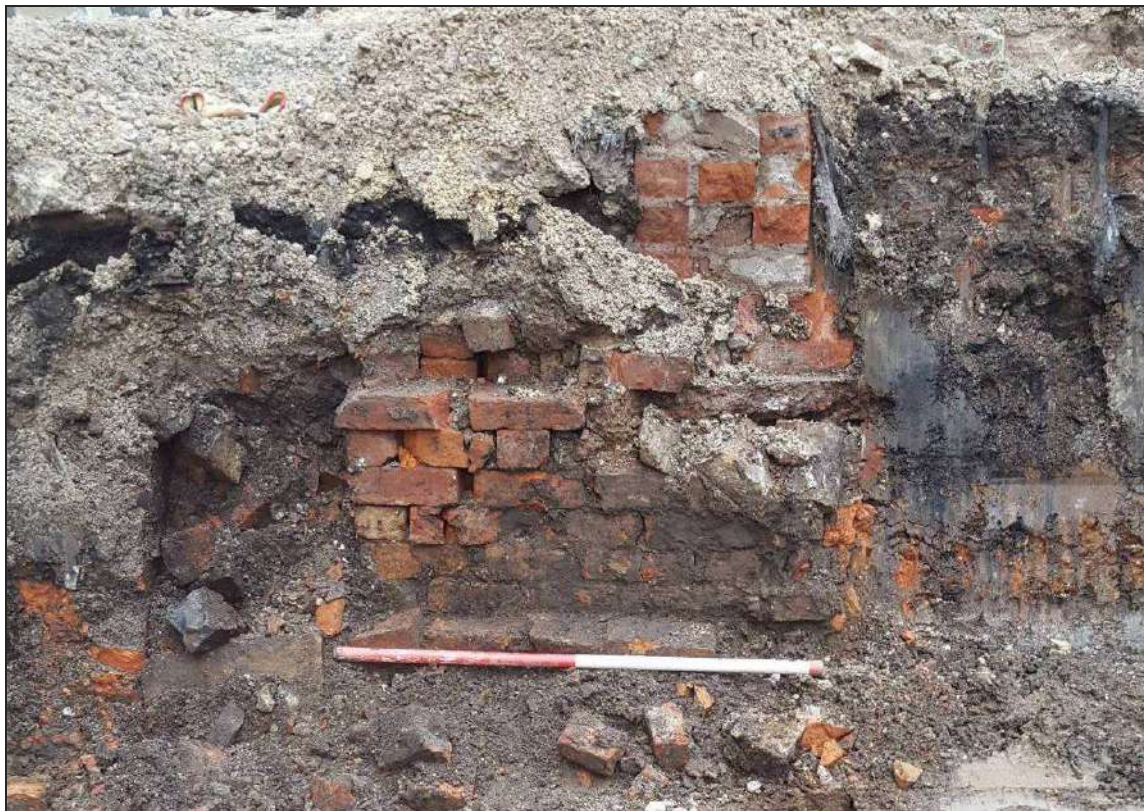
Plate 93: The excavated remains of wall **004**, with later wall **005** above

The earliest structural remains revealed during the watching brief comprised the fragmentary remains of several brick walls (**003**, **004**, **006**, **009**, **010**, **011**, **013**, **017**, **018**, **019**, **020** and **021**). Walls **003** and **006**, together with the remnants of a brick floor (**004**) were exposed at the northern end of the trench, and are likely to have represented the vestiges of the foundations for early 19<sup>th</sup>-century buildings situated to the rear of the Bee Hive pub on Jersey Street.

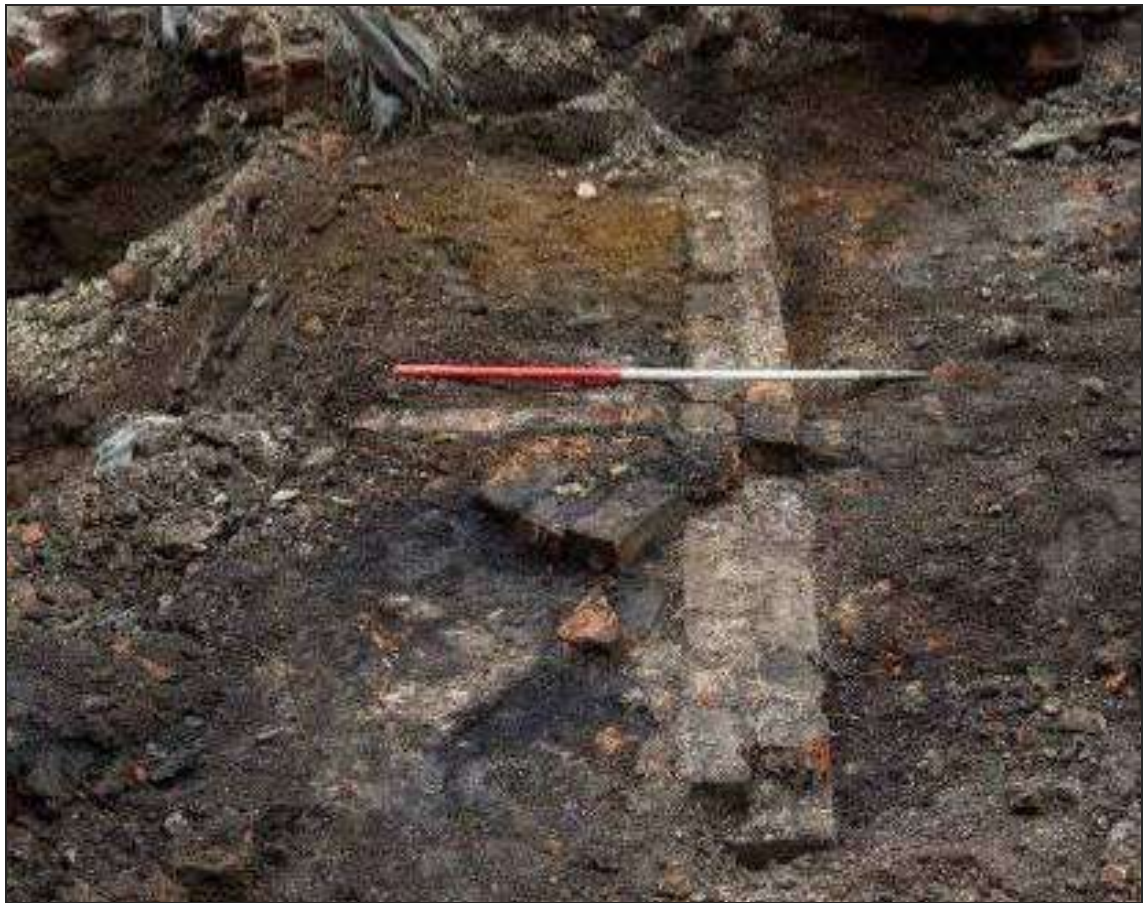
*Plate 95: The excavated remains of wall **018***

The fragmentary remains of several walls revealed in the southern part of the trench are likely to have represented further remains of the buildings to the rear of the Bee Hive pub on Jersey Street. Walls **018**, **019**, and **021** all comprised hand-made bricks bonded with lime-based mortar, consistent with an early 19<sup>th</sup>-century construction date. Wall **018** was two courses wide and was aligned north/south (Plate 95), whilst walls **019** and **021** were three-courses wide, aligned east/west, and probably formed the rear wall of a building. A short section of another two-course wide wall (**017**), again constructed of hand-made bricks, abutted wall **018** and almost certainly represented an internal partition. The absence of any intact surfaces suggests that the buildings had been demolished to below floor level, and that the surviving walls represented the foundation courses.

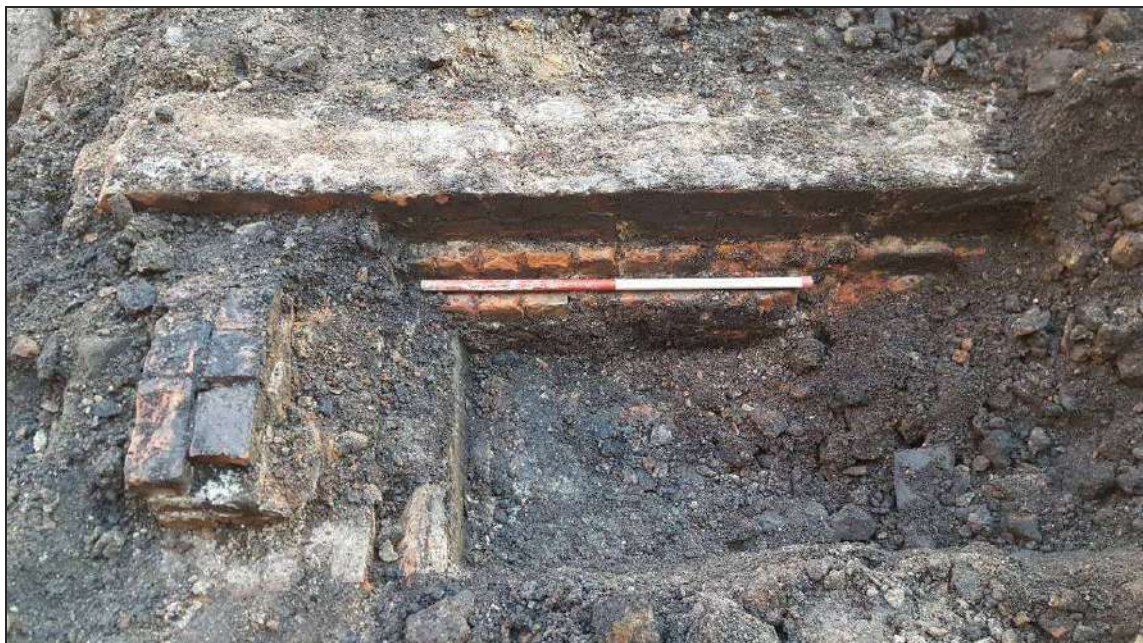
*Plate 96: The remains of walls **010** and **011**, with later wall **012** above*

Other short sections of probable early 19<sup>th</sup>-century walls (**010**, **011**, and **013**) were exposed in the central part of the trench. Walls **010** and **011** formed a short L-shaped structure (Plate 96), which possibly represented the vestiges of a fireplace, although this could not be determined with confidence. Wall **013** comprised a pillar of hand-made bricks that measured 0.5 x 0.5m, but was isolated from any other structural remains.

Wall **005** was aligned north/south across the centre of the site, and similarly comprised machine-made bricks bonded with cement, indicative of a 20<sup>th</sup>-century construction date (Plate 93). This wall, together with walls **012** and **016**, were three-courses wide and of little archaeological interest (Plate 96).

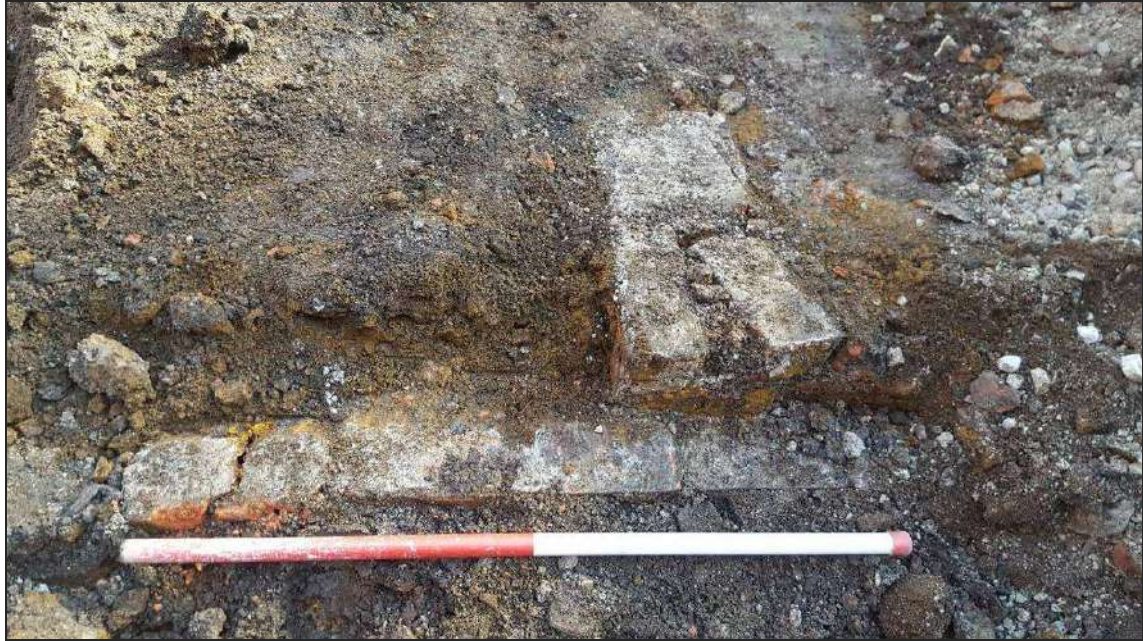
*Plate 97: The remains of walls **014** and **015***

A second phase of development on the site was represented by the remains of four walls (**007**, **008**, **014** and **015**). Wall **007** comprised a two-course wall of hand-made brick bonded with lime-based mortar that was aligned east/west in the northern part of the trench. Walls **014** and **015** similarly comprised hand-made bricks, and formed an L-shaped structure (Plate 97).

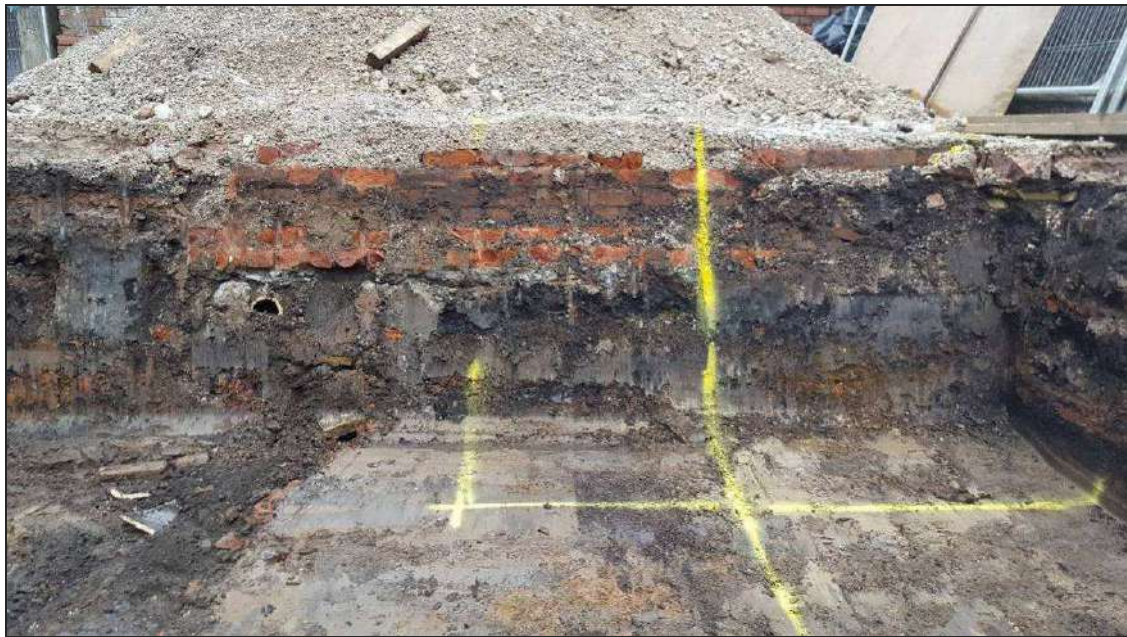
*Plate 98: Wall **002** exposed in the north section of the excavated trench*

The latest phase of development on the site was represented by walls **001**, **002**, **005**, **012** and **016**. Wall **001** formed a boundary to the site along Jersey Street and Radium Street, and comprised machine-made bricks bonded with cement-based mortar, indicative of a 20<sup>th</sup>-century construction date. The fabric of wall **002**, revealed in the north section of the excavated trench, similarly comprised machine-made bricks and was almost certainly of the same date as wall **001** (Plate 98). This appeared to have cut through wall **003**.
