# Television Baseline Survey Report

Mulbury New Cross (Goulden Street, Oldham Road and Bendix Street)

Mulbury Homes Limited

November, 2019

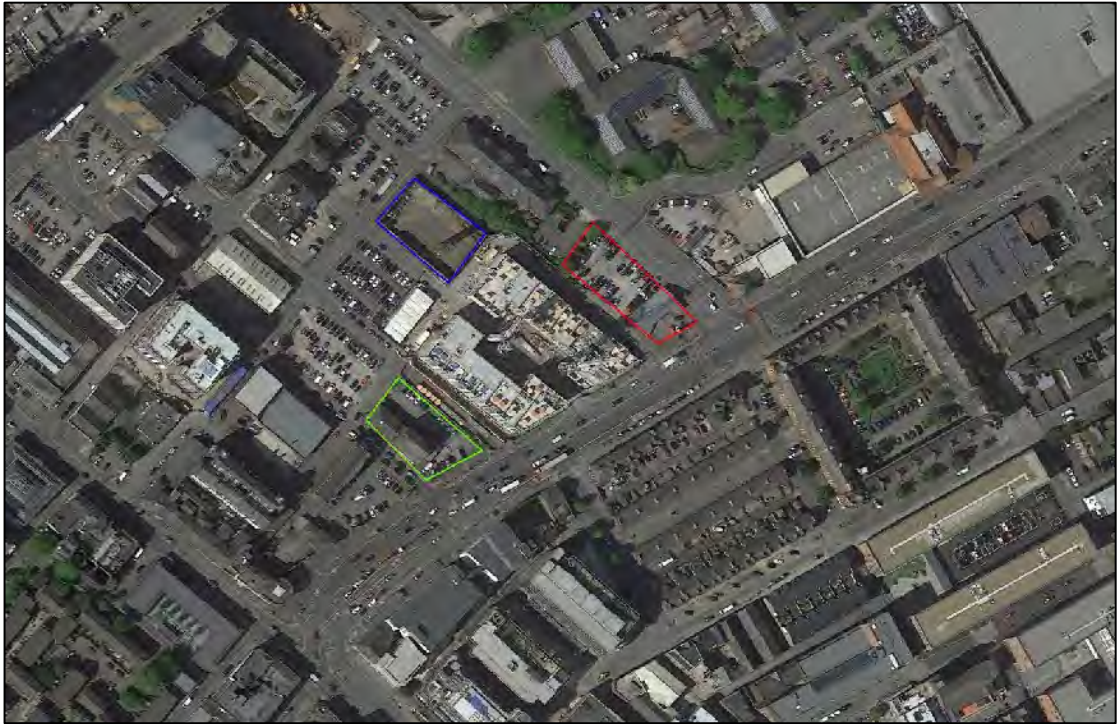
Figure 4 Site boundaries – aerial image

The Site boundaries are shown in Figure 4<sup>2</sup> below.

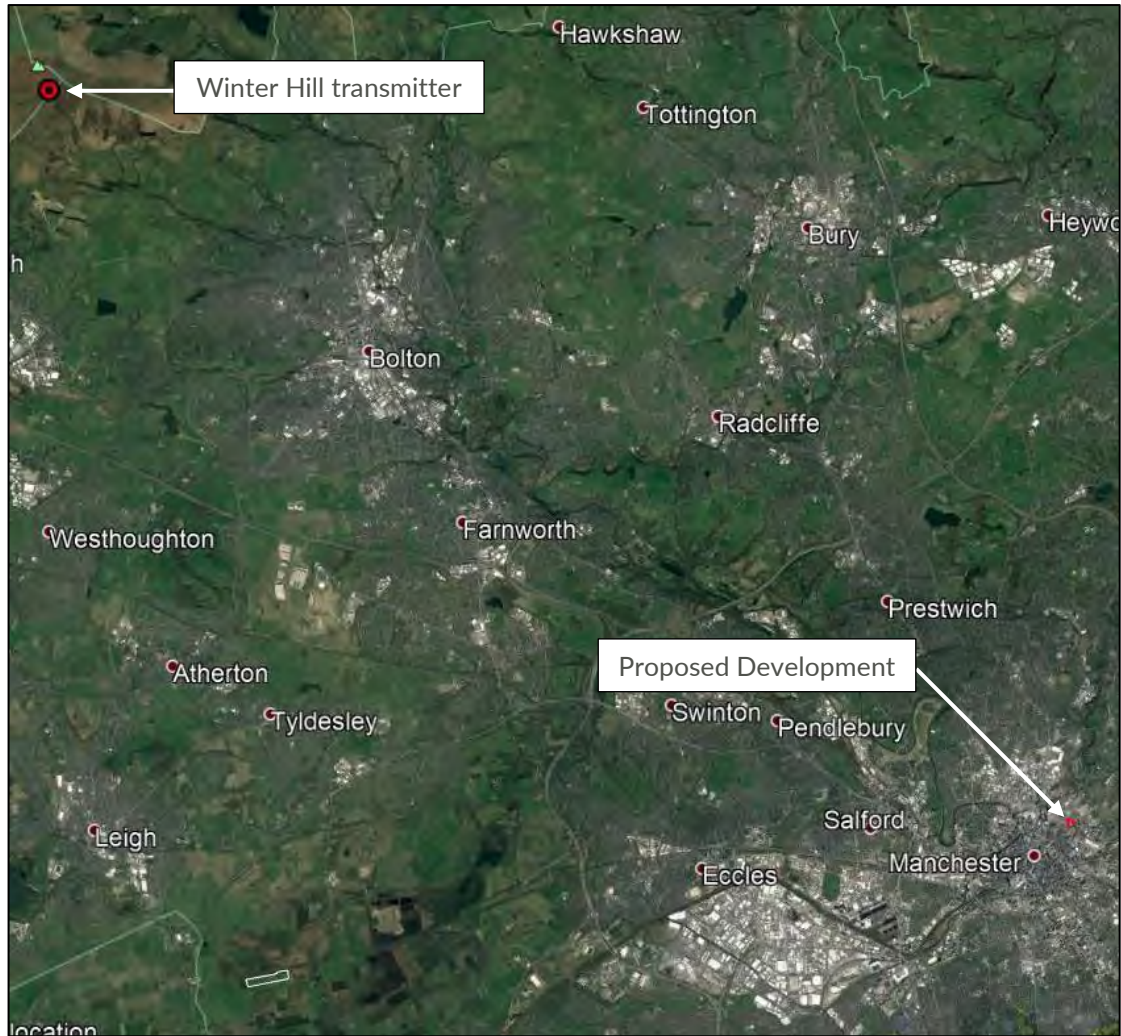
Figure 5 Television transmitter and Proposed Development relative location

Winter Hill is one of the UK's main television transmitters located approximately 24.4km northwest of the Proposed Development (published coordinates SD66051446). The main digital services provided are shown in Table 1 below.

The location of the Winter Hill transmitter relative to the Proposed Development is shown in Figure 5<sup>4</sup> below.

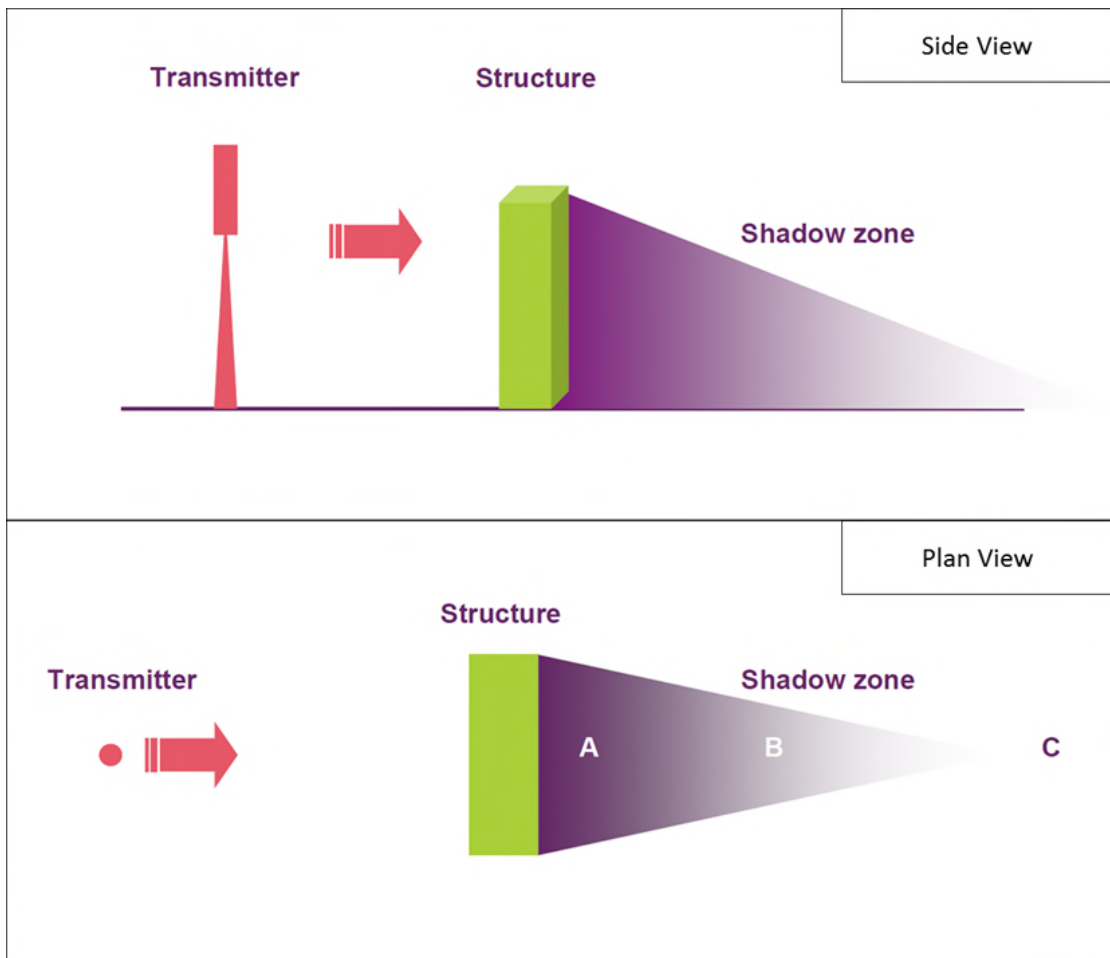
Figure 6 Diffraction Loss Zones

*"In general, there will be three 'zones' behind the structure:*

*Zone A - close behind the structure (typically a few tens of metres) there may be a large reduction in signal level with a possible complete loss of reception*

*Zone B - further away (typically a few hundred metres) the signal reduction is less severe and the shadow will be smaller as diffraction effects partially fill in the shadow. Depending on the size of the structure, some locations could still lose reception completely*

*Zone C - some distance away (1-5km) the shadow will effectively have disappeared."*

The zones mentioned are illustrated in Figure 6<sup>5</sup> on the following page, taken from Section 3.2 of an Ofcom paper<sup>6</sup> regarding the impact of buildings on broadcast signals.

In the case of the shadow zone, this has been modelled as having straight sides in order to be conservative. In actuality due to diffraction effects the zone would have a more triangular shape as shown in Figure 6 in the previous section.

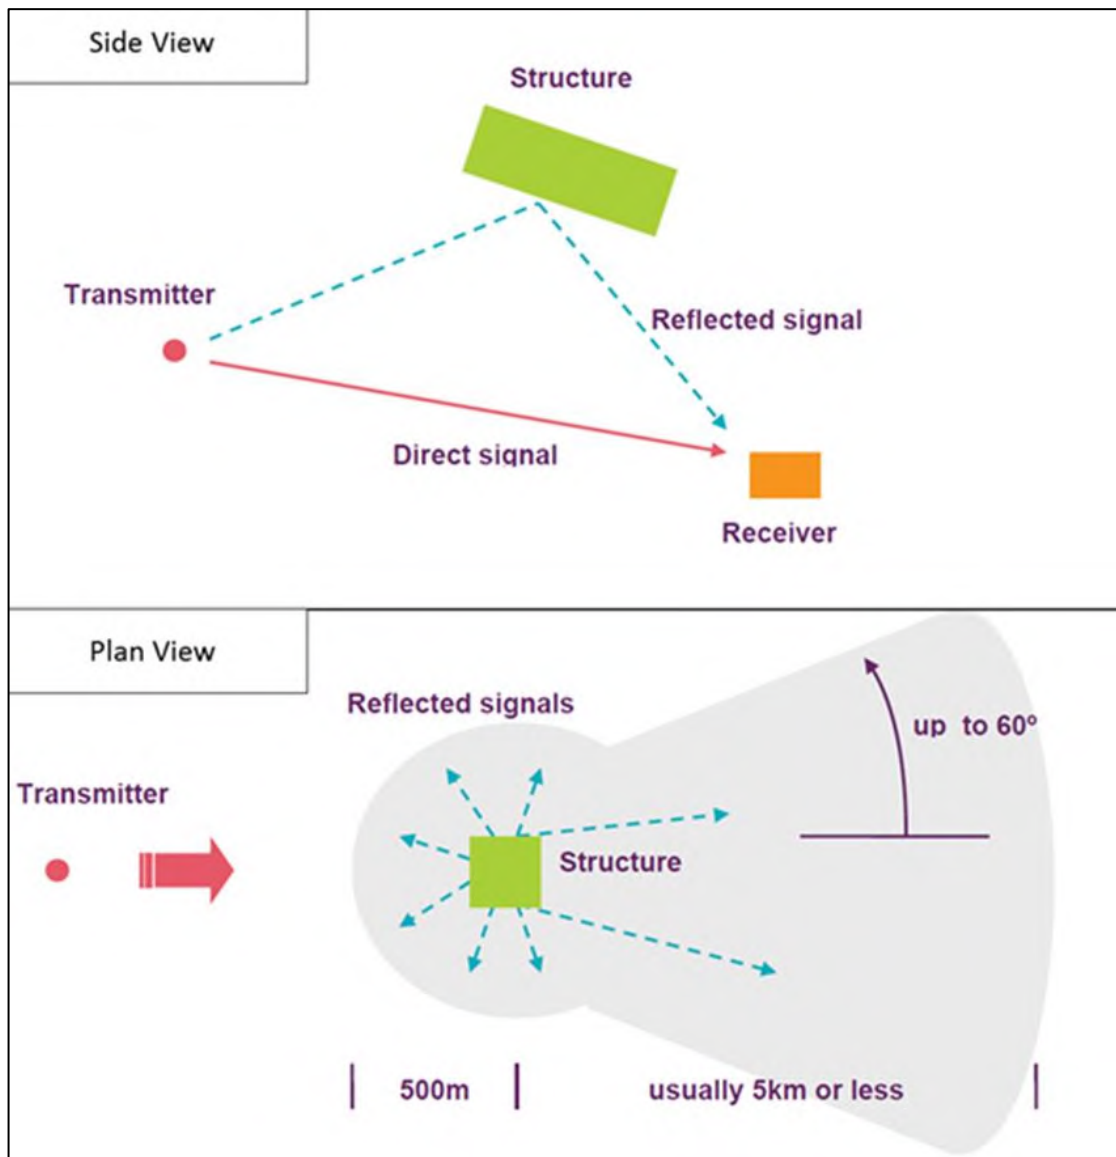
Figure 7 Diffraction Loss Zones

For large developments with straight edges, the transmitted signal can be reflected by the building itself. This causes an effect known as 'multipath interference' whereby the signal is received twice by an aerial at different times. The direct signal arrives first because it has a shorter distance to travel.

Figure 7 on the following page (taken from Section 3.3 of the Ofcom document referenced above) illustrates this effect.

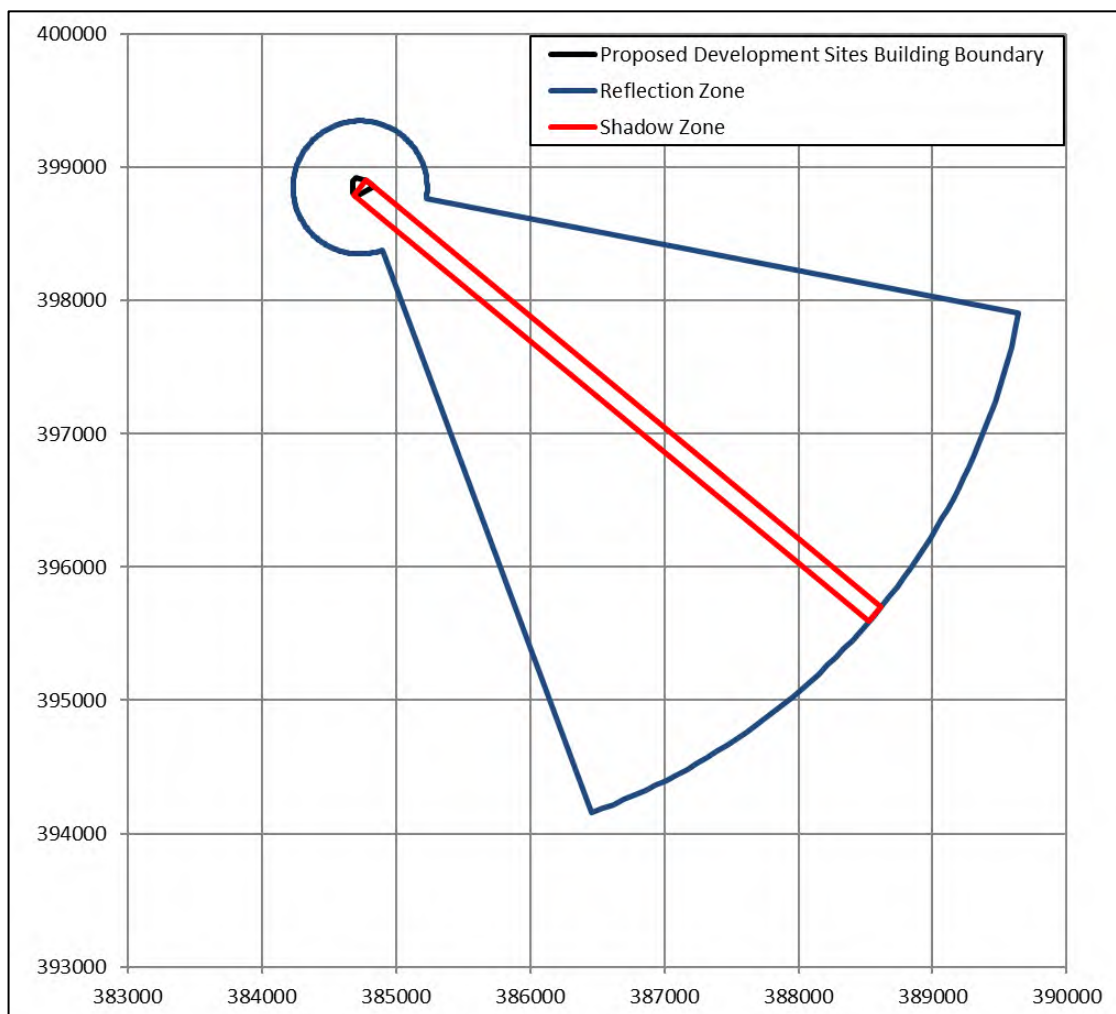
Figure 8 Interference areas

Figure 8 below shows the potential interference areas associated with the Proposed Development.

These have been defined based on the geometry of the potential interference zones as set out in the previous section. Both zones extend to a distance of 5km beyond the Proposed Development location in accordance with the Ofcom guidance.

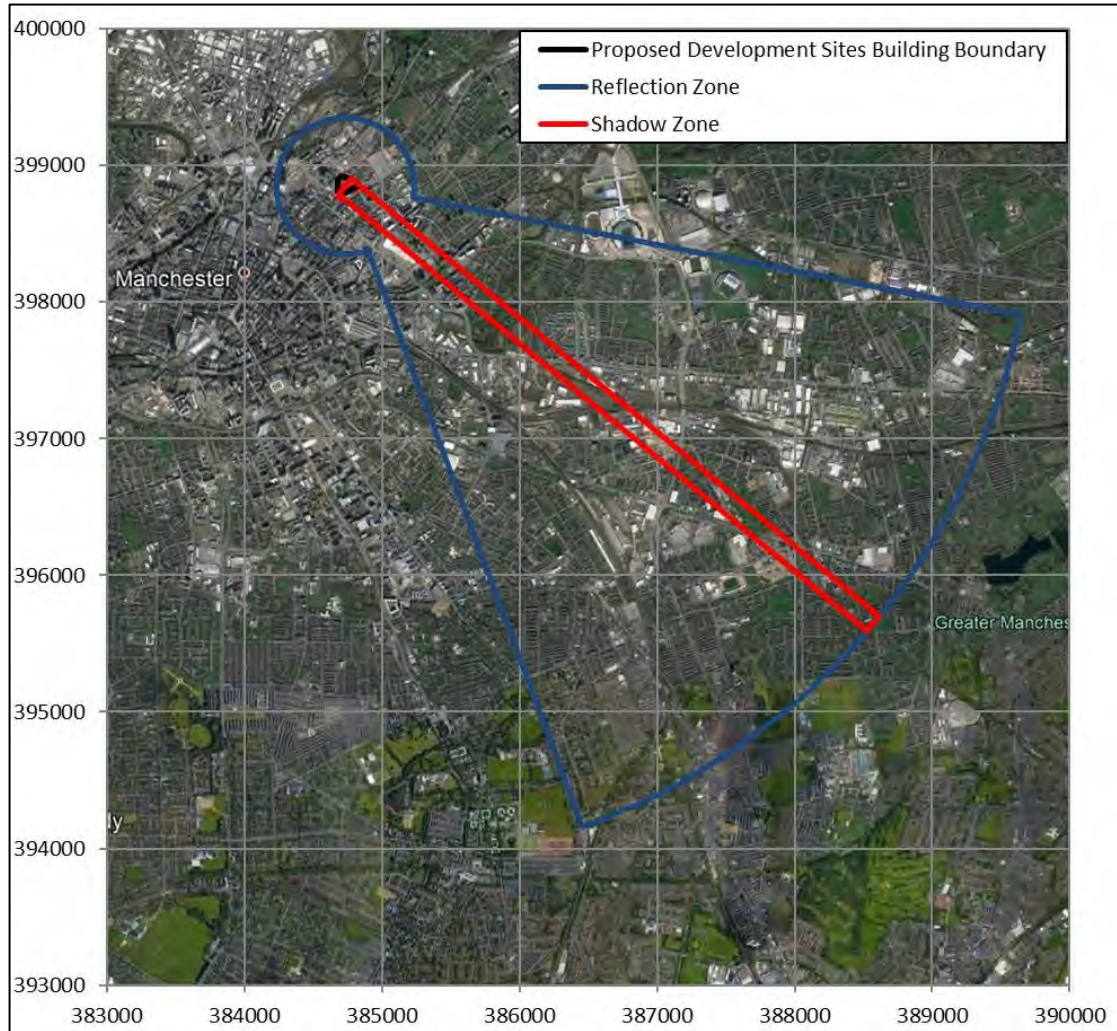
Figure 9 Interference zones map

Figure 9<sup>8</sup> below shows the interference zones overlaid onto mapping of the area.

It can be seen that the shadow zone passes over areas that are mostly urban containing industrial buildings as well as high and low-rise residential developments. Areas closest to the Proposed Development are at the highest risk of experiencing television interference.

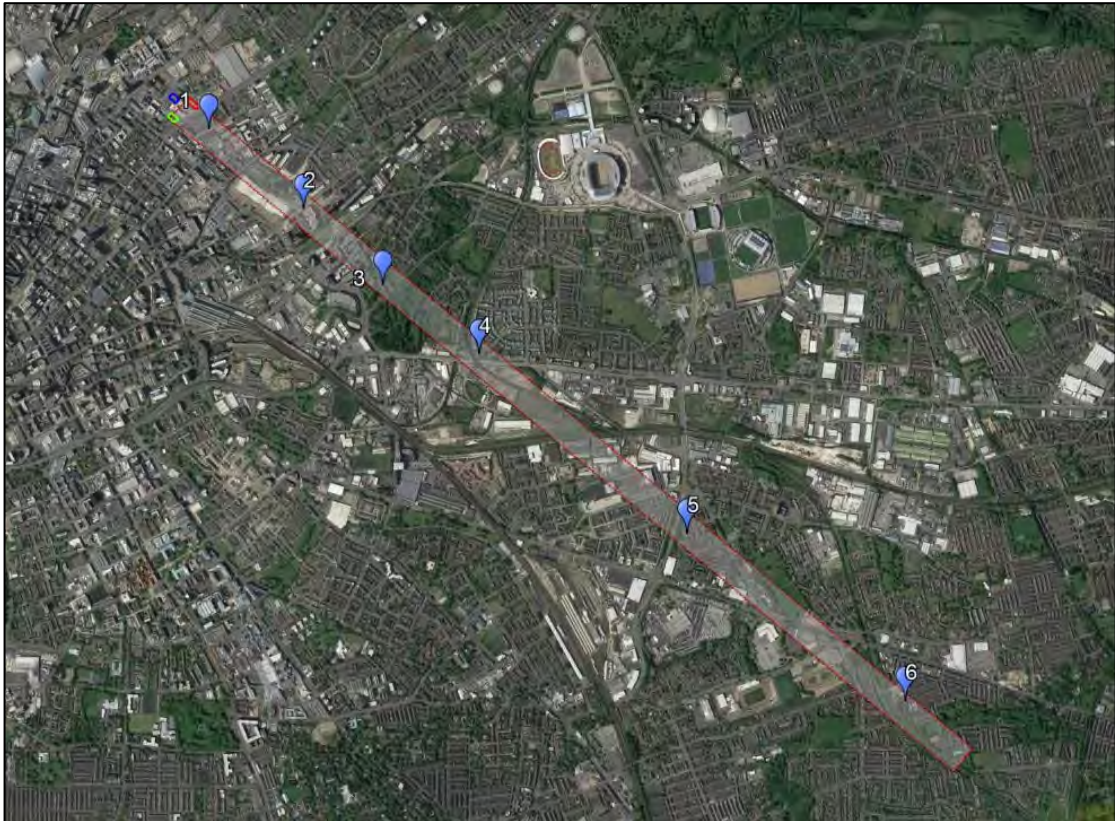
Figure 10 Survey locations

Figure 10<sup>9</sup> below shows the survey locations overlaid onto aerial photography. The Proposed Development's location and the shadow zone are also shown. Survey locations were chosen pre-survey (within the shadow zone) however safe and available access influenced the specific position on the day. The locations below show the actual survey locations.

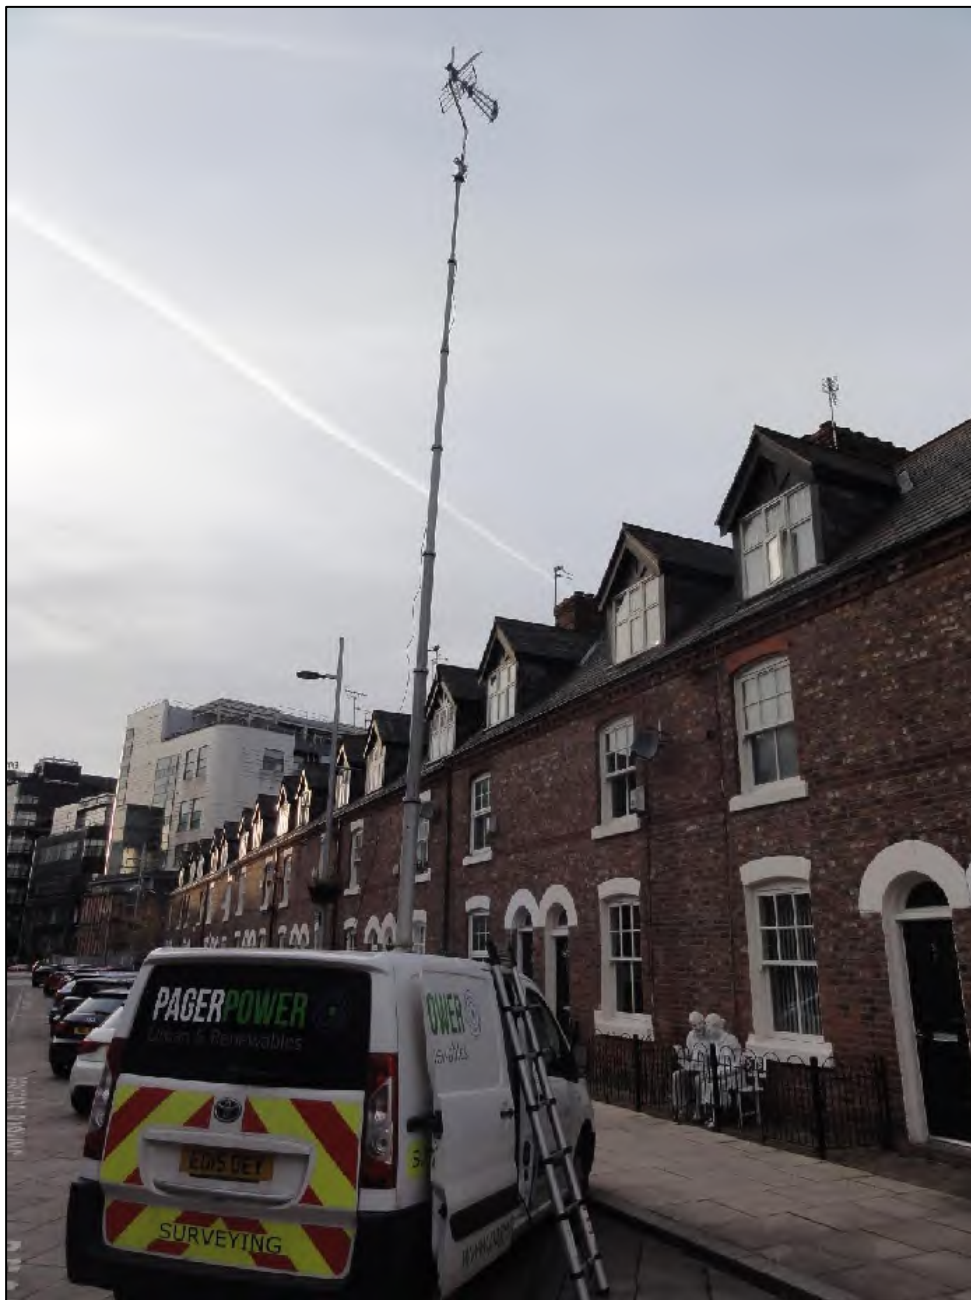
### Location 1

Notes: UHF aerials directed towards the Winter Hill transmitter and satellite dishes were observed.

| Location | Average Measured Signal Strength (dB) | Remarks | High Level Conclusion |
|---|---|---|---|
| 1 | Main TV MUX: 41<br>(Moderate)<br>Local TV MUX: 37<br>(Moderate) | Horizontally polarised aerials directed towards the Winter Hill transmitter and satellite dishes were observed.<br><br>All main multiplexes displayed fine picture and audio quality, with signal fluctuations of less than 1dB and no signs of interference.<br><br>Two local multiplexes were not decoded at this location. | The survey location is within 200m of the closest of the Proposed Development.<br><br>Effects are possible based on the proximity to the Proposed Development. This could depend on the relative height of the building development and any receiving aerials. |

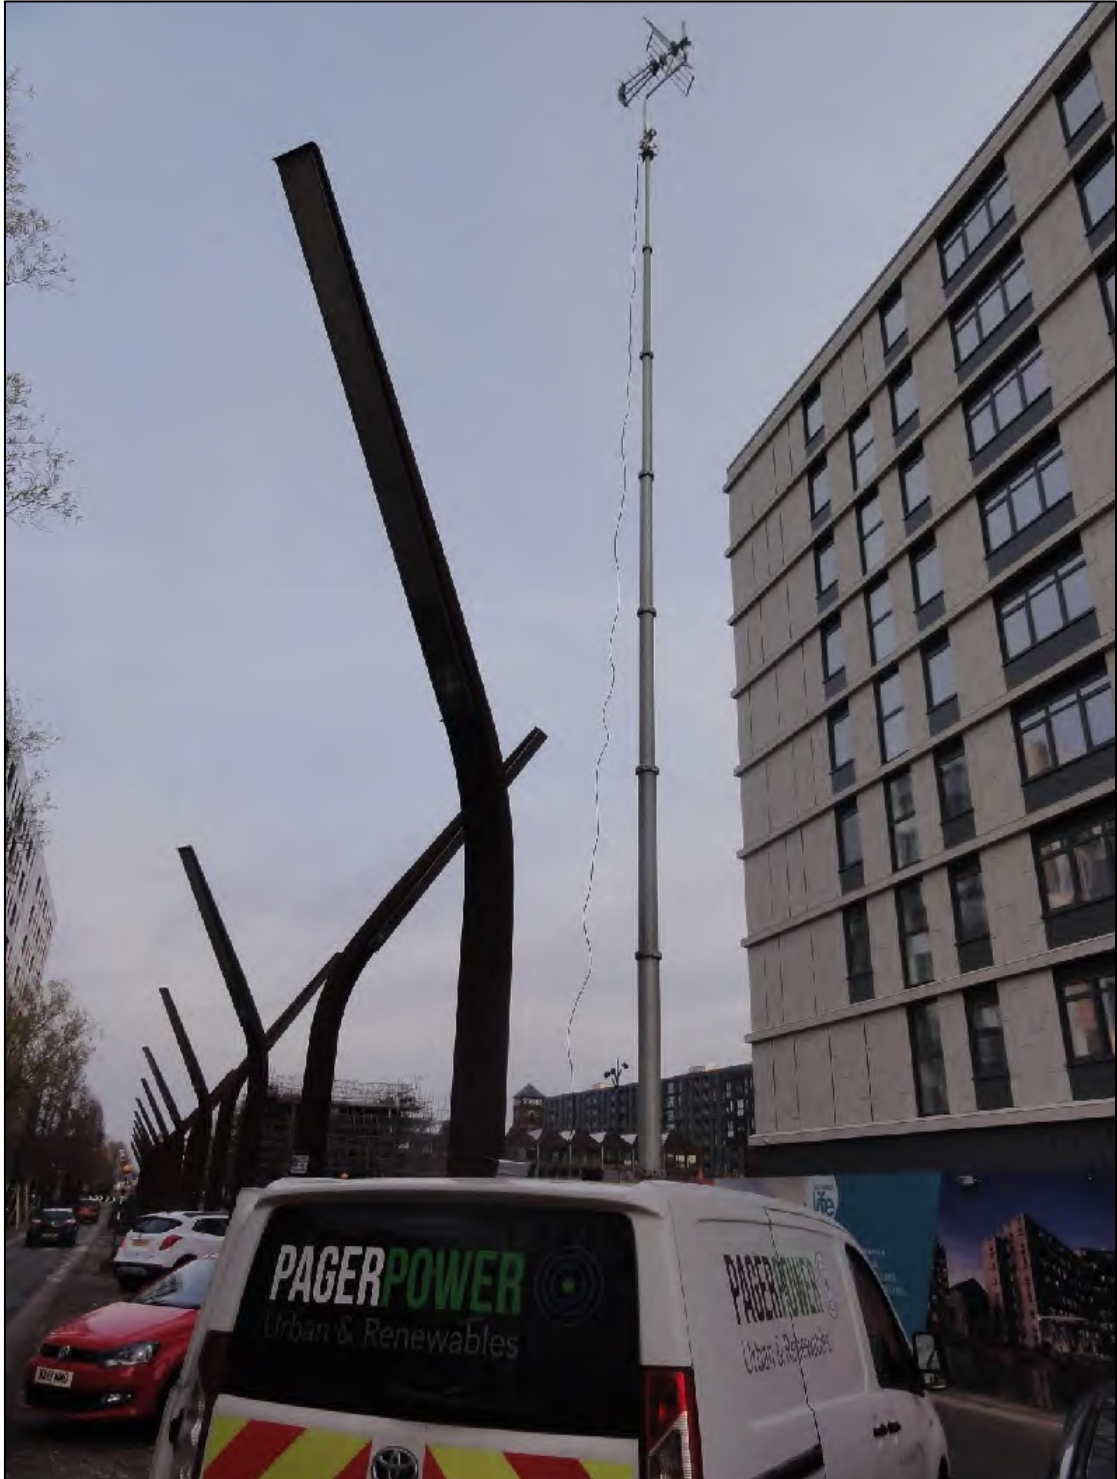
Location 2

Notes: External aerials were not observed at this location.

| Location | Average Measured Signal Strength (dB) | Remarks | High Level Conclusion |
|---|---|---|---|
| 2 | Main TV MUX: 49<br>(Good)<br>Local TV MUX: 39<br>(Moderate) | External aerials were not visible at this location.<br><br>All main multiplexes displayed fine picture and audio quality, with signal fluctuations of less than 1dB and no signs of interference.<br><br>Two local multiplexes were not decoded at this location. | The survey location is within 700m of the closest of the Proposed Development.<br><br>Considering the existing signal strength and the proximity to the Proposed Development, impacts are possible at this location. |

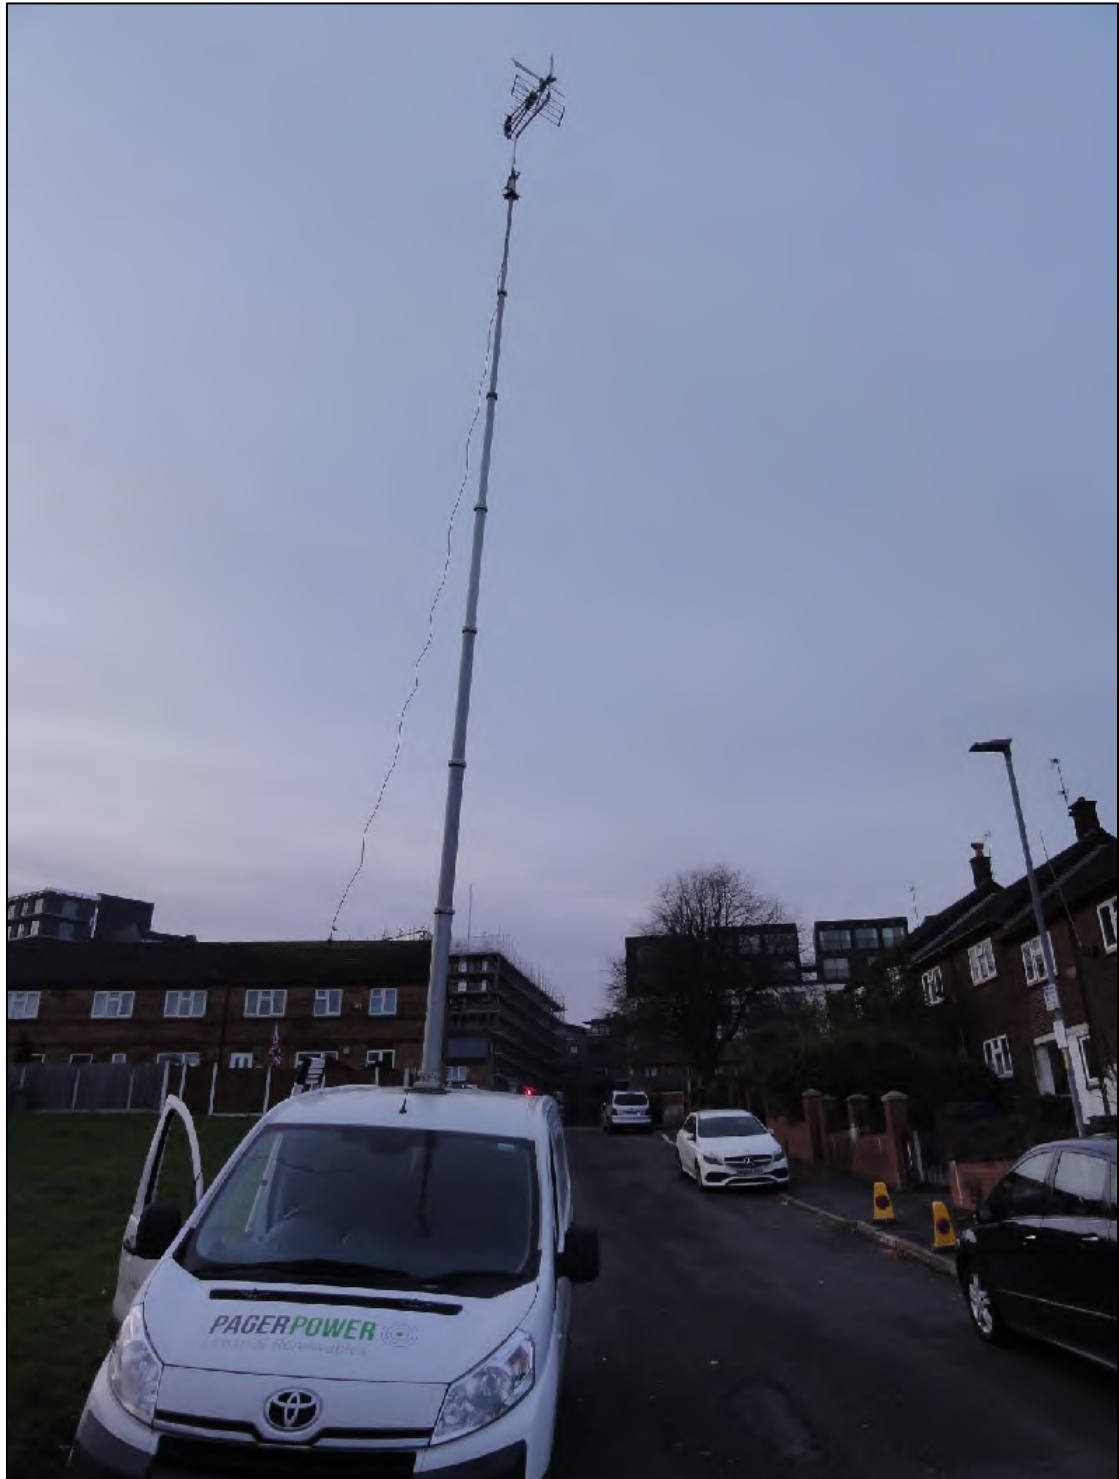
Location 3

Notes: UHF aerials directed towards the Winter Hill transmitter and satellite dishes were observed.

| Location | Average Measured Signal Strength (dB) | Remarks | High Level Conclusion |
|---|---|---|---|
| 3 | <p>Main TV MUX: 42 (Moderate)</p> <p>Local TV MUX: 36 (Moderate)</p> | <p>Horizontally polarised aerials directed towards the Winter Hill transmitter and satellite dishes were observed.</p> <p>All main multiplexes displayed fine picture and audio quality, with signal fluctuations of less than 1dB and no signs of interference.</p> <p>Two local multiplexes were not decoded at this location.</p> | <p>The survey location is within 1.3km of the closest of the Proposed Development.</p> <p>In principle, further degradation of the weaker signals could result in noticeable effects. In practice, noticeable losses are unlikely at this range from the Proposed Development.</p> |

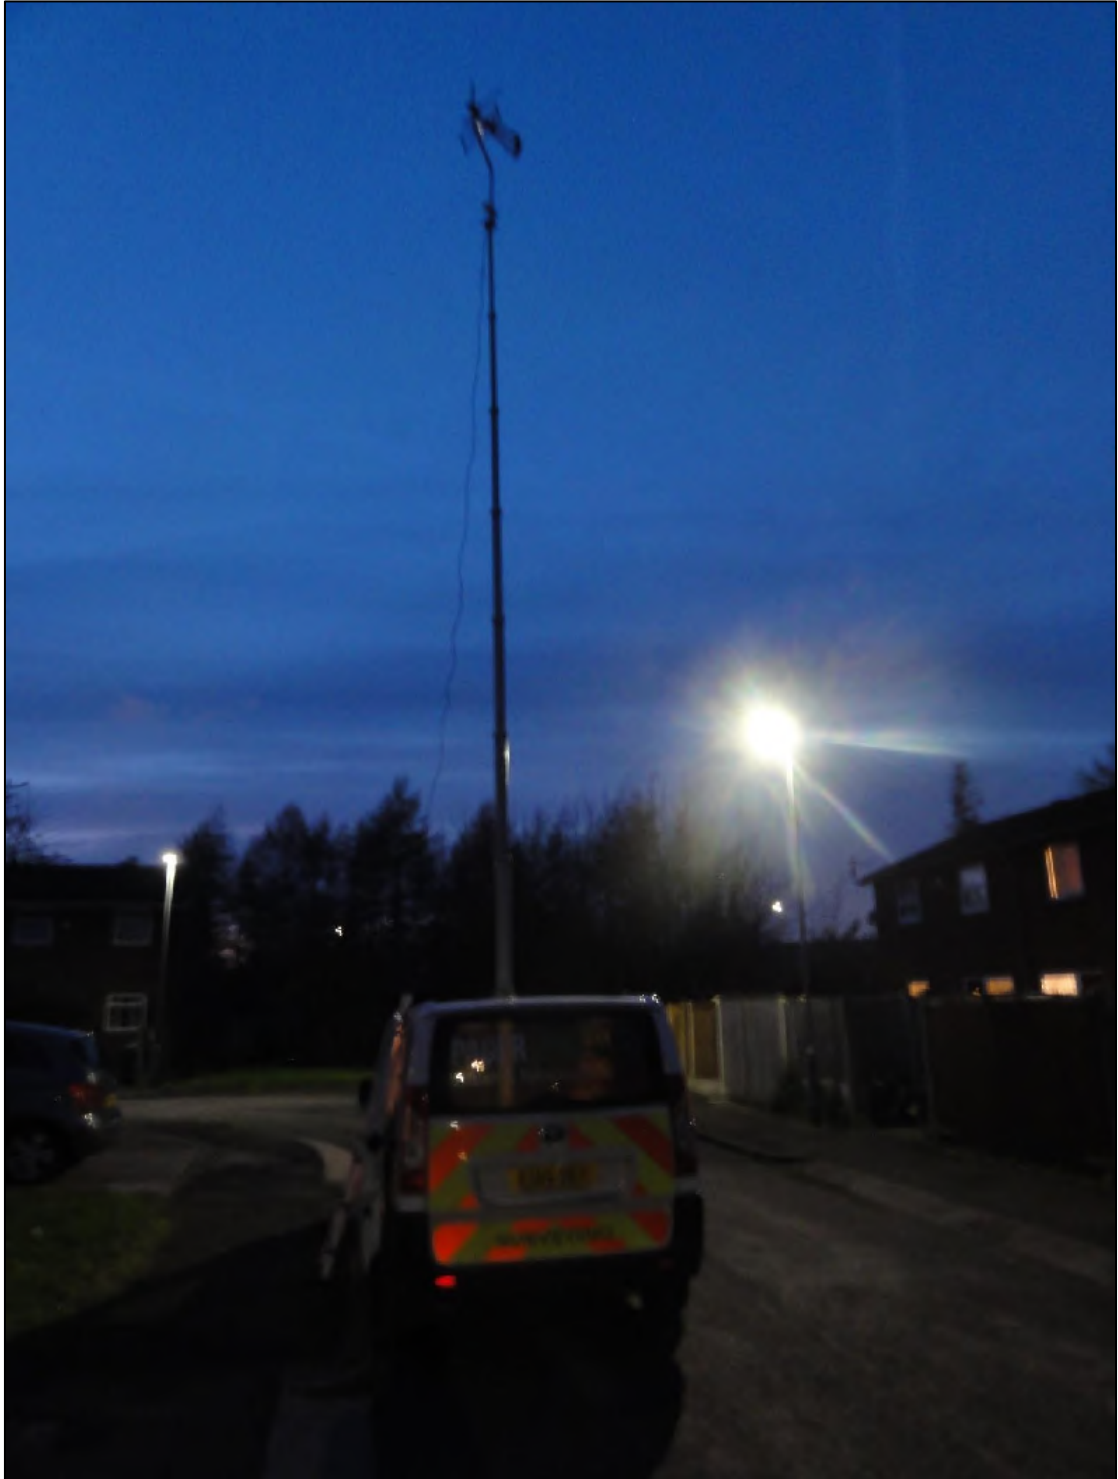
Location 5

| Location | Average Measured Signal Strength (dB) | Remarks | High Level Conclusion |
|---|---|---|---|
| 5 | <p>Main TV MUX: 70<br/>(Very Good)</p> <p>Local TV MUX: 51<br/>(Good)</p> | <p>Horizontally polarised aerials directed towards the Winter Hill transmitter and satellite dishes were observed.</p> <p>All main multiplexes displayed fine picture and audio quality, with signal fluctuations of less than 1dB and no signs of interference.</p> <p>One local multiplex was not decoded at this location.</p> | <p>It is unlikely that significant losses would be experienced at this location (approximately 3.2km from the Proposed Development) considering the existing signal strength and distance. Impacts are unlikely.</p> |
