**79 MOSLEY ST, MANCHESTER**

**RETAINED FAÇADE MONITORING**

**SPECIFICATION**

**PROJECT REF: TM/15/1129**

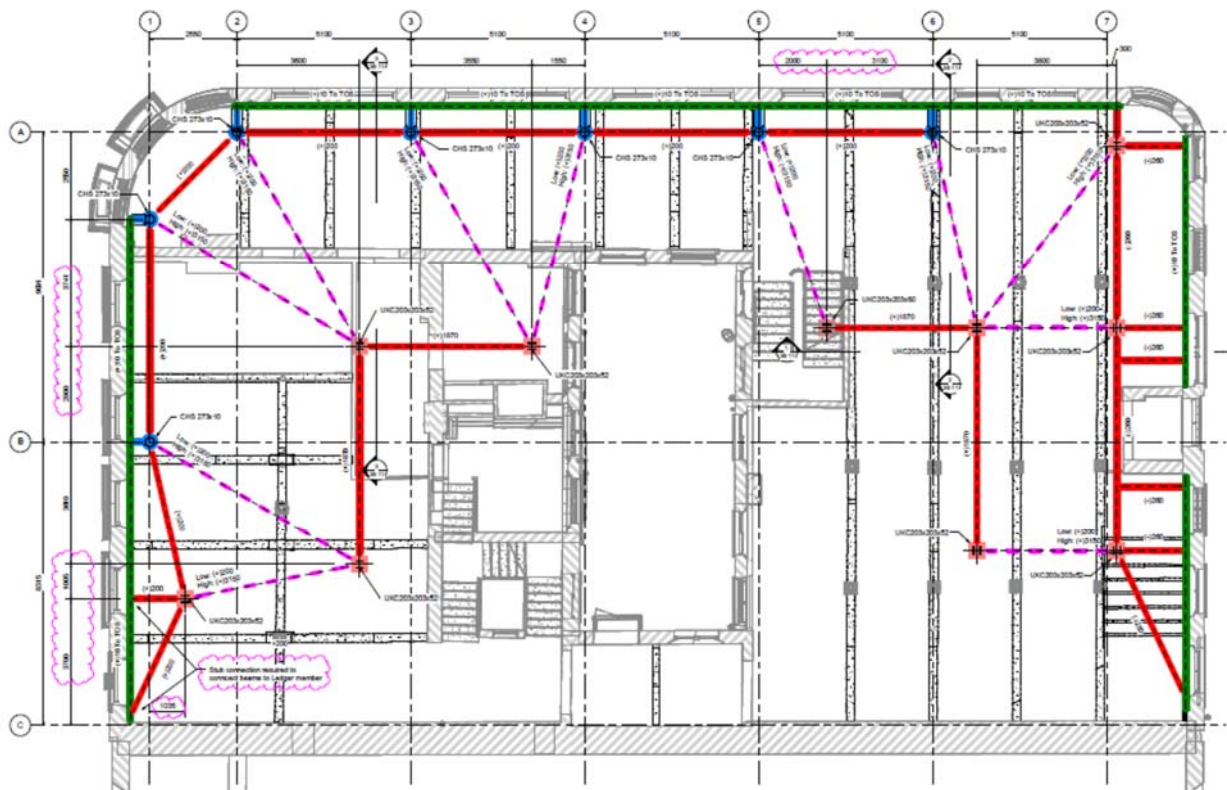
**Figure 4 Plan Showing Typical Restraint Framing**

Accordingly an internal restraint system has been developed utilising a combination of the proposed new structure and temporary steelwork members, the temporary members being removed upon the completion of the structure. The retained façade is to be tied to the new structure at each floor level. All the new vertical members are to be supported on piled foundations with a tension capacity where necessary to resist uplift forces in the temporary condition.

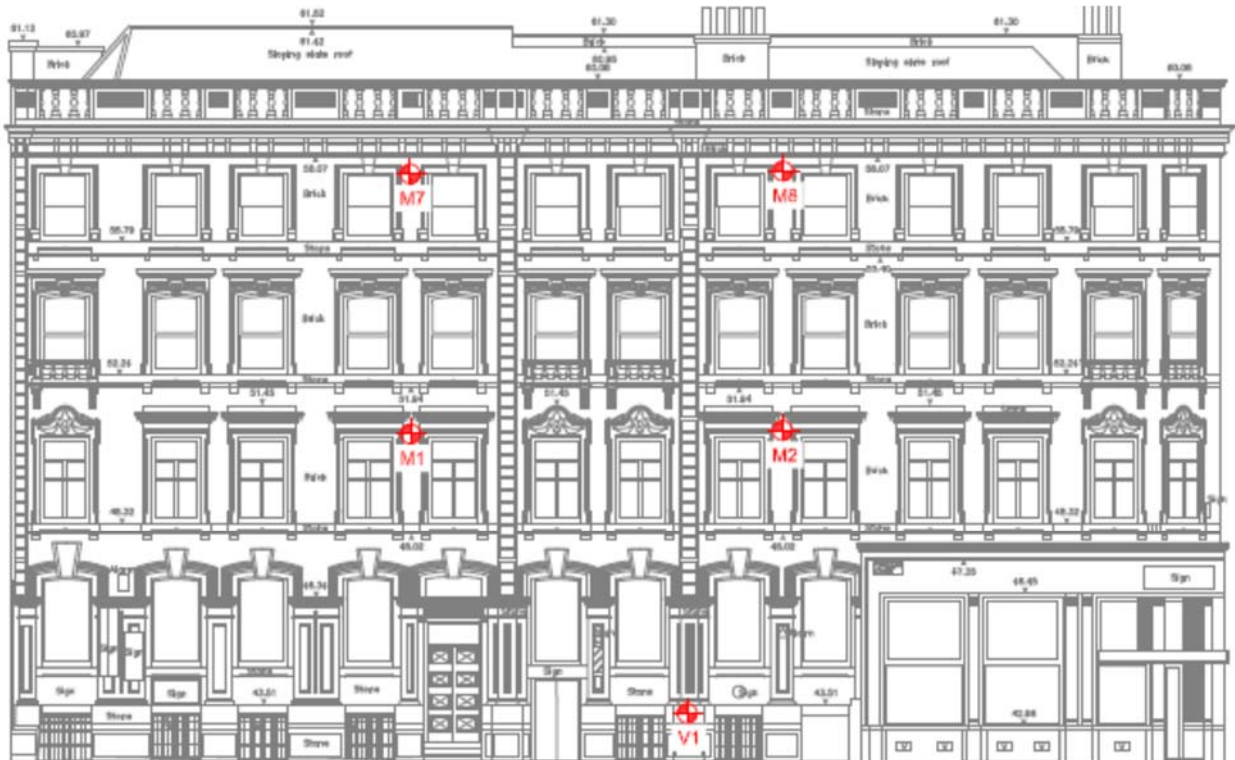
| | Page |
|---|---|
| <b>APPENDIX A - PRINCESS STREET ELEVATION MONITORING LOCATIONS.....</b> | <b>A</b> |

It is proposed that prism reflector targets are fixed to the façade in locations shown in Appendices A, B and C to allow measurement in all 3 directions using an EDM. Particular attention to be given to ensuring that clear lines of sight are maintained throughout the monitoring period.

Vibration monitors to be located on the façade in locations shown in Appendices A, B and C, it is suggested that these are remotely monitored with alarm limits as described in this report.
