## PHASE I GEO-ENVIRONMENTAL SITE ASSESSMENT

Oldham Road  
Manchester

Report Ref: 12-730  
Date Issued: November 2019

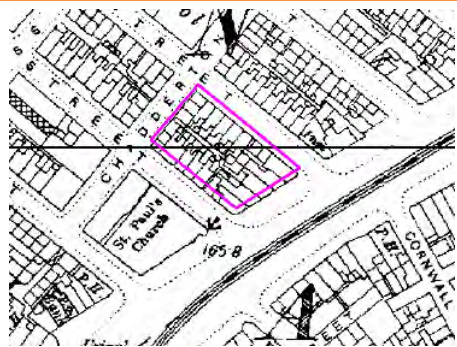
| MAP EDITION | HISTORICAL LAND USE | HISTORICAL MAP EXCERPT |
|---|---|---|
| <b>1892-93</b><br><b>1:2,500</b> | The site is occupied by terraced residential housing. | |

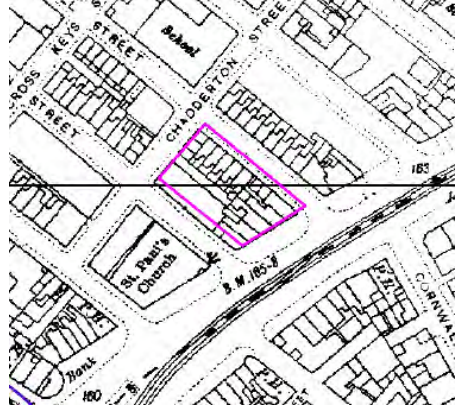
| MAP EDITION | HISTORICAL LAND USE | HISTORICAL MAP EXCERPT |
|---|---|---|
| <b>1922-33</b><br><b>1:2,500</b> | More of the terraced housing in the west sector has been replaced by a commercial building, indicating demolition and construction activities. | |

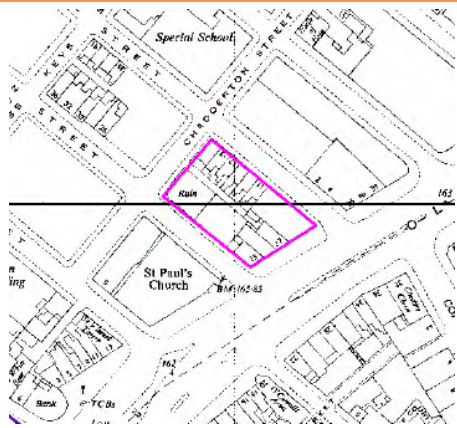
| MAP EDITION | HISTORICAL LAND USE | HISTORICAL MAP EXCERPT |
|---|---|---|
| 1948-49<br>1:1,250 | Terraced housing in the east sector has been removed, indicating demolition activities.<br>A building in the west sector is identified as a 'ruin'. | |

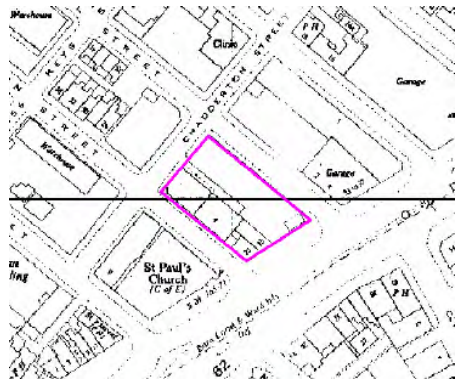
| MAP EDITION | HISTORICAL LAND USE | HISTORICAL MAP EXCERPT |
|---|---|---|
| 1959-66<br>1:2,500 | Terraced housing in the northeast sector has been removed, indicating demolition activities. | |

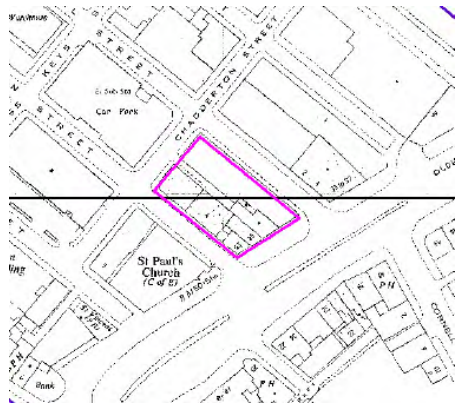
| MAP EDITION | HISTORICAL LAND USE | HISTORICAL MAP EXCERPT |
|---|---|---|
| 1978-85<br>1:1,250 | An additional terraced building is shown in the east sector. | |

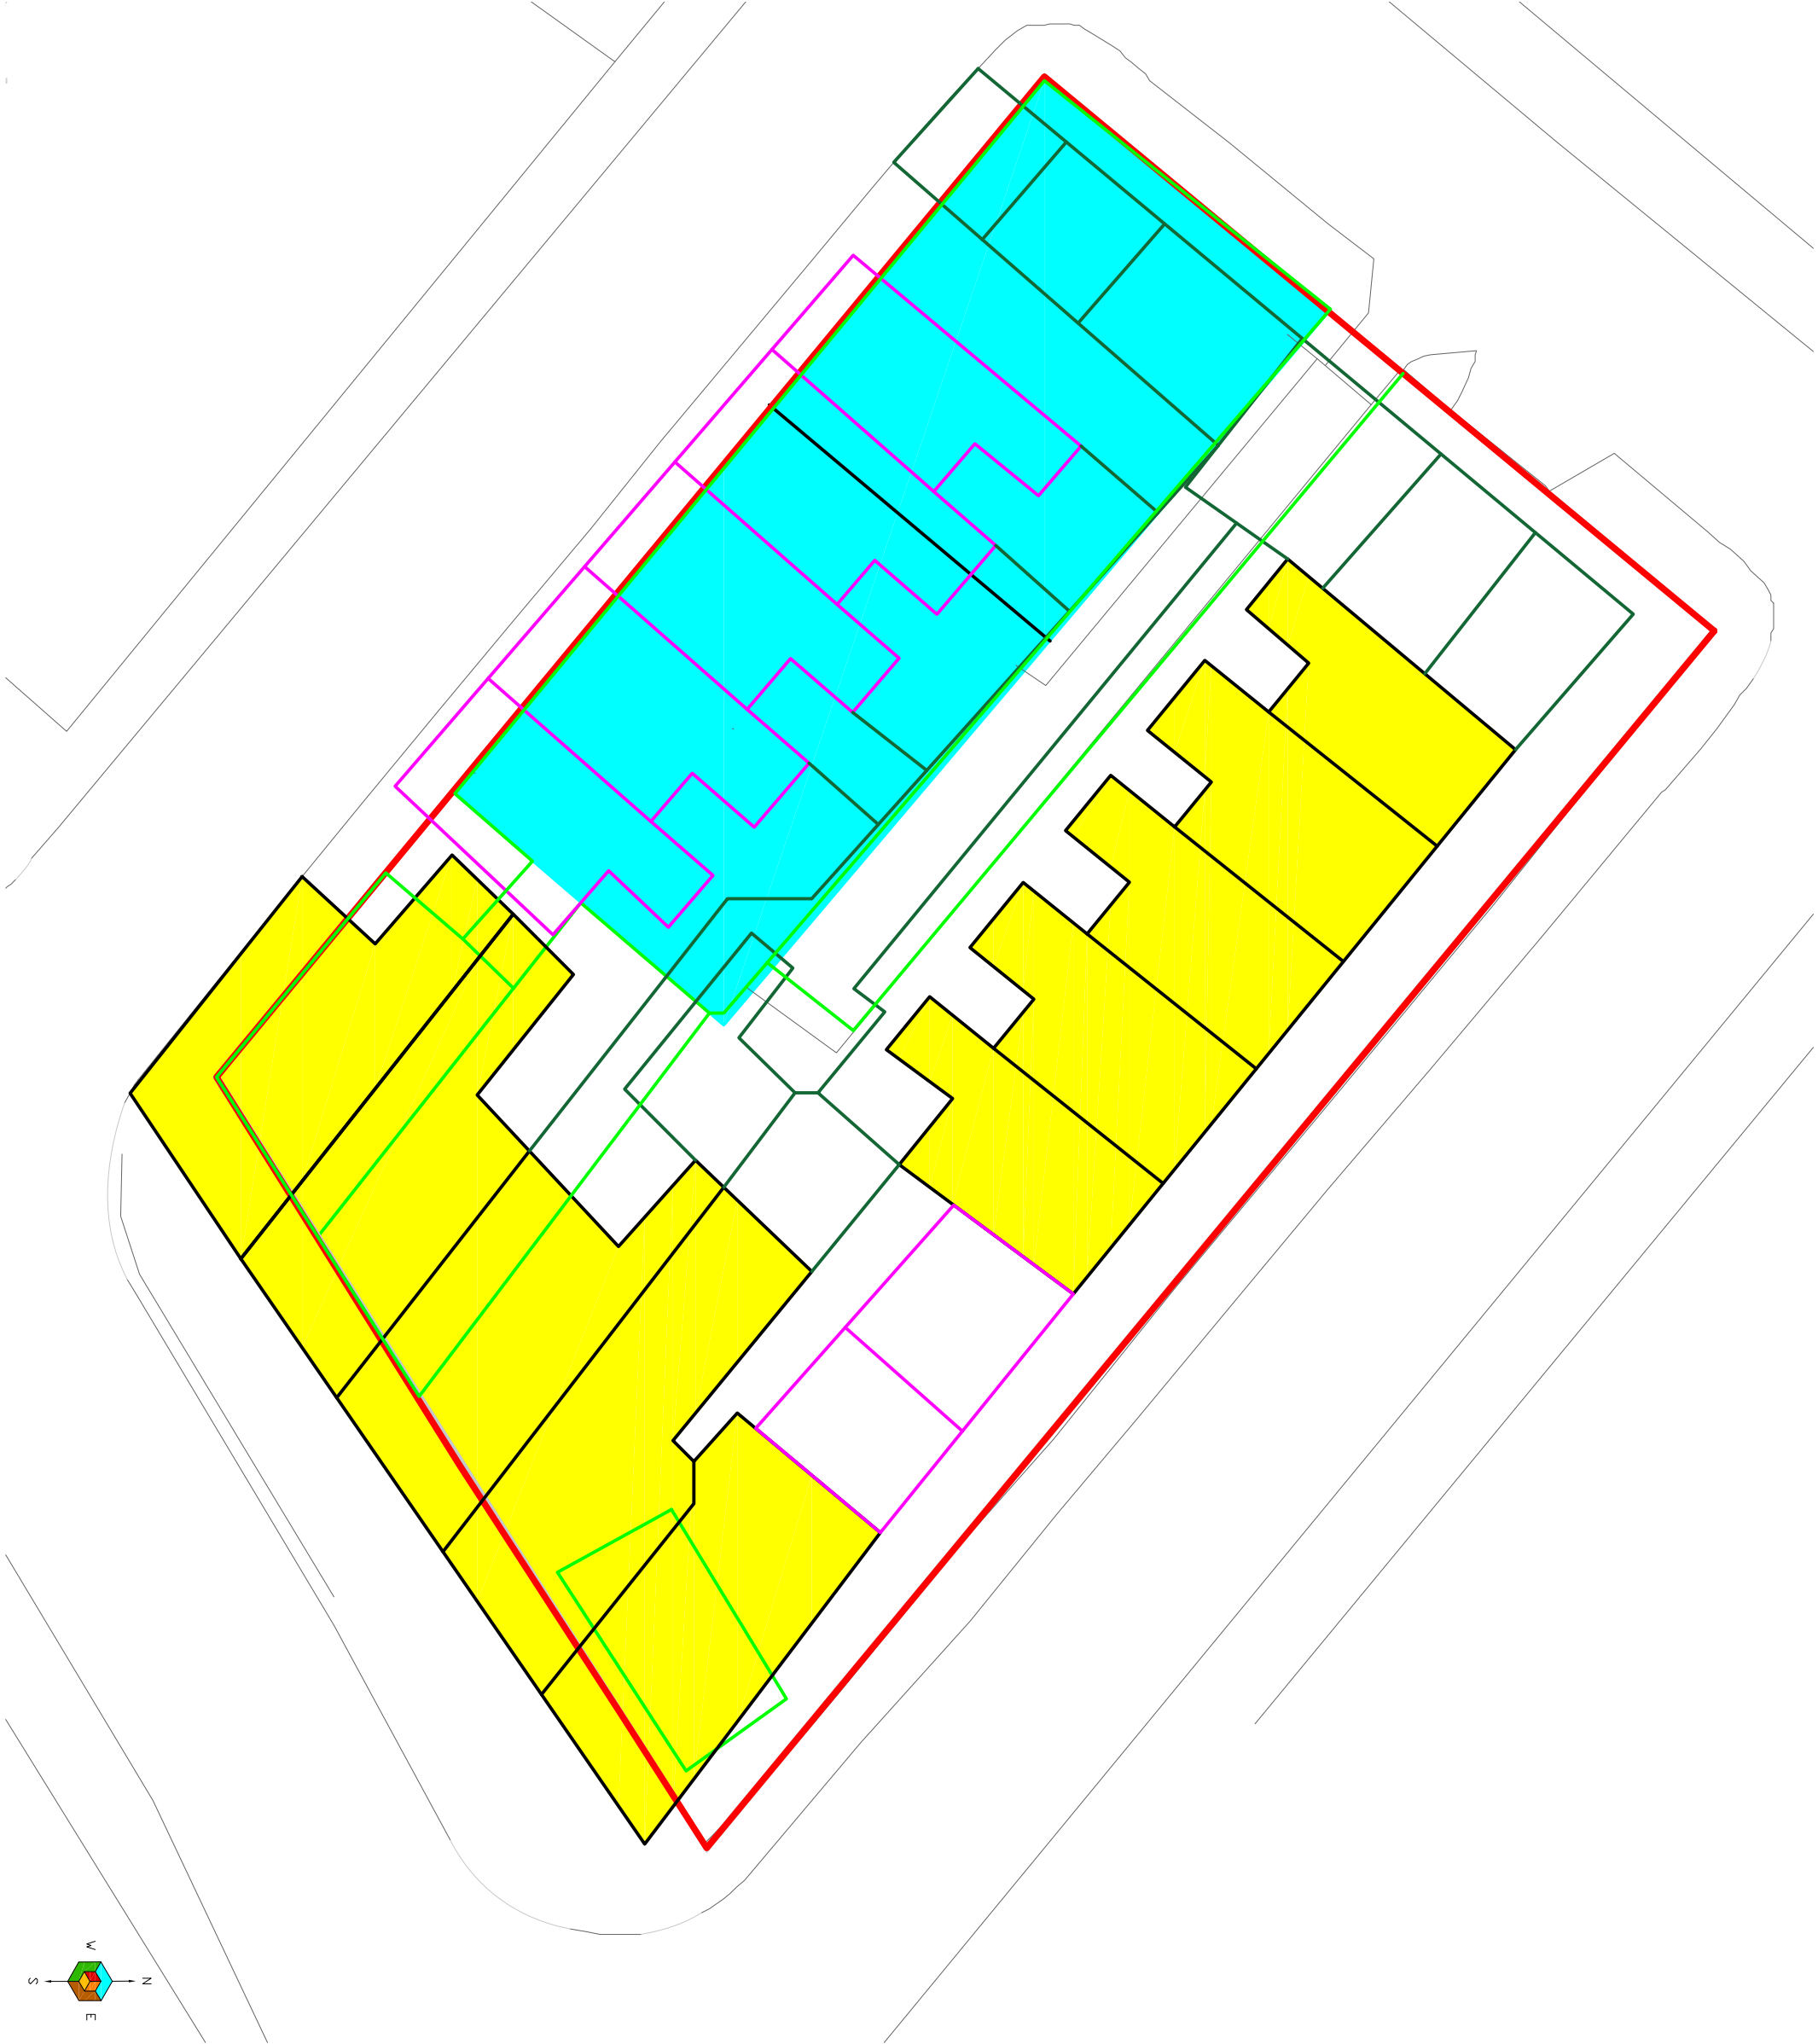
Historical Features

- Former Buildings (Pre 1892 - Pre 1922)
- Former Boundary (Pre 1892 - Pre 1958)
- Former Buildings (Pre 1892 - Pre 1958)
- Former Buildings (Pre 1958 - Pre 1993)
- Buildings (Pre 1993 - Present)

A review of historical mapping pertinent to the site is summarised in Table 3.1 below. In addition, historical site features are presented on Drawing No 12-730-002 in Appendix III.

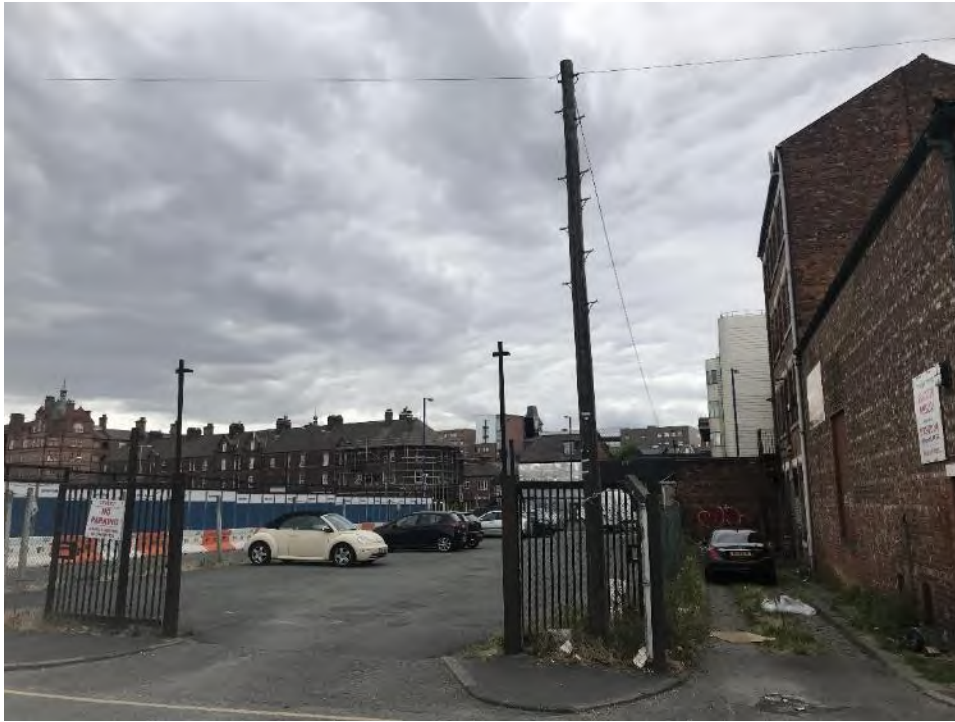
**PLATE 1 – ACCESS TO SITE VIA GATE ON NORTH WEST BOUNDARY.**

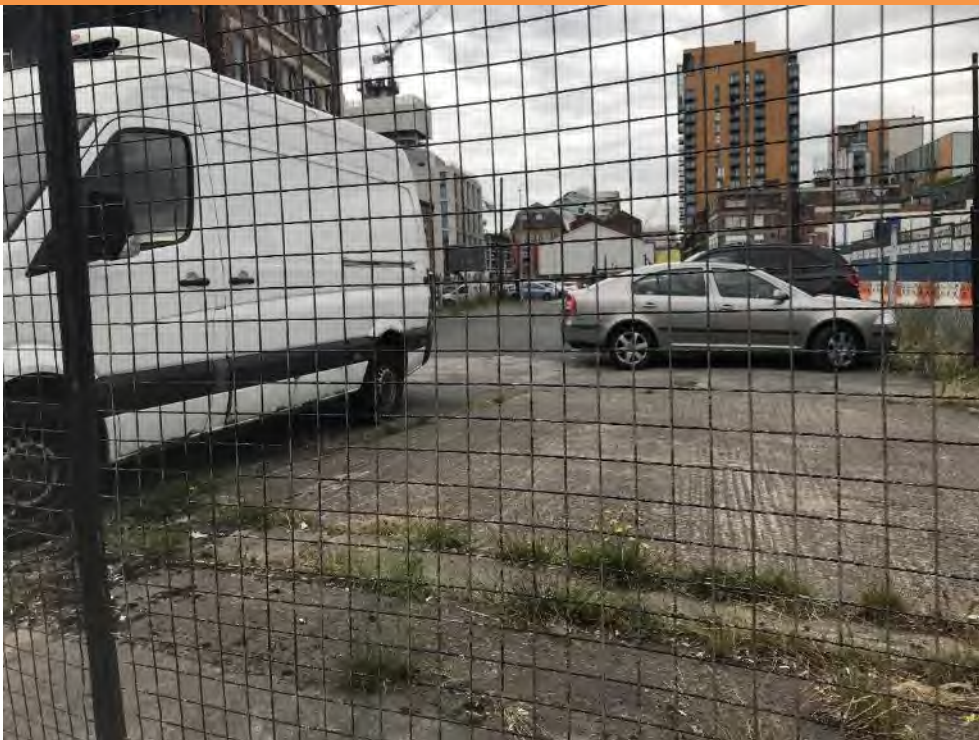
**PLATE 2 – VIEW OF CAR PARK FROM WESTERN BOUNDARY LOOKING TOWARDS EASTERN BOUNDARY.**

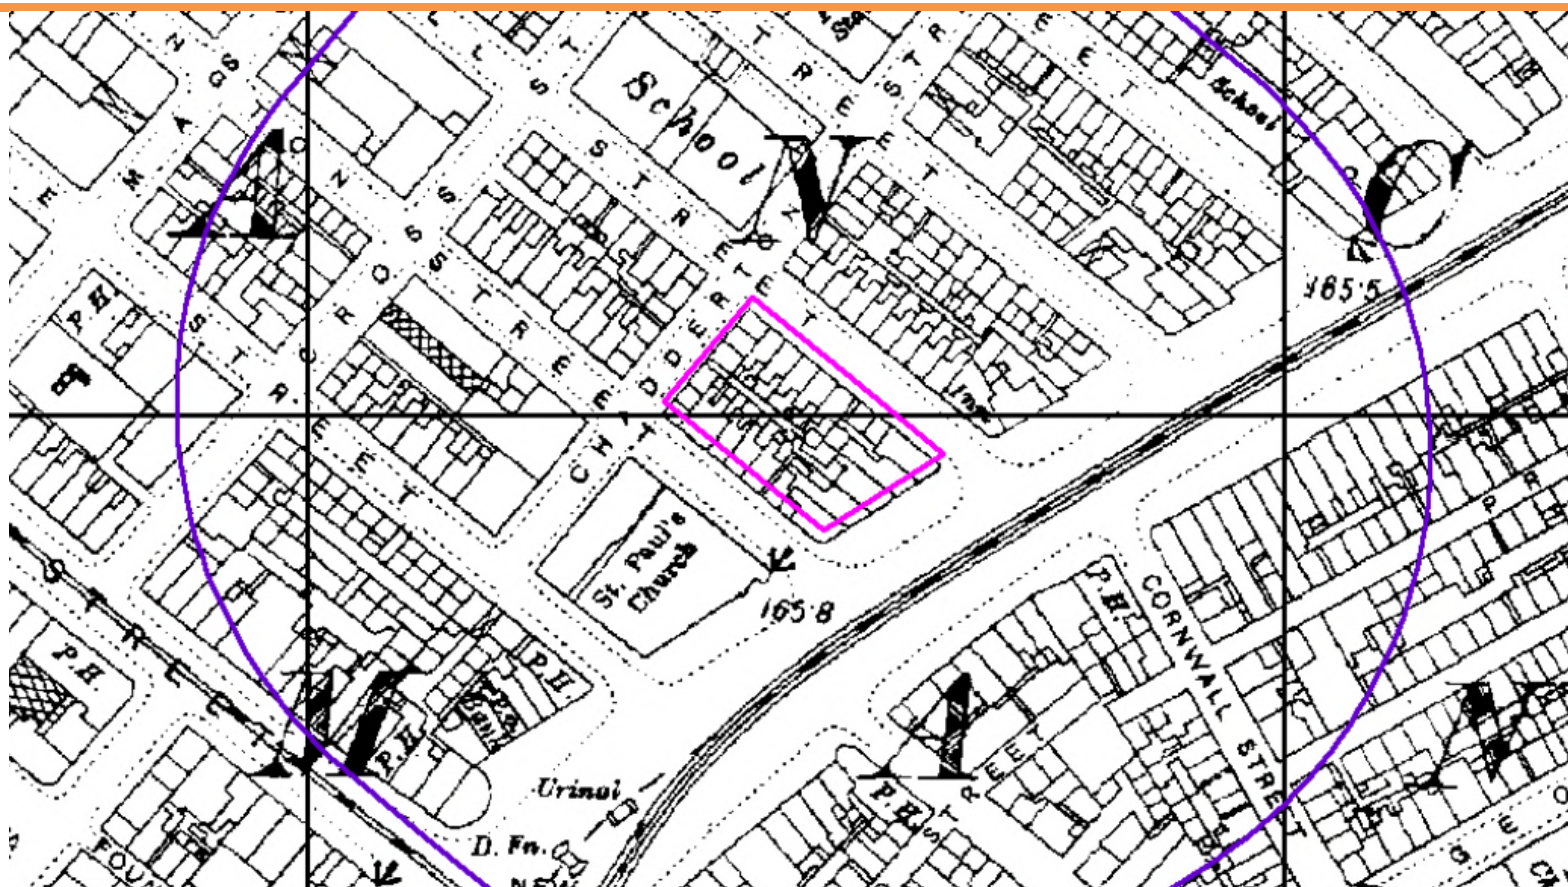
**Historical Map**

Dated: 1892-93

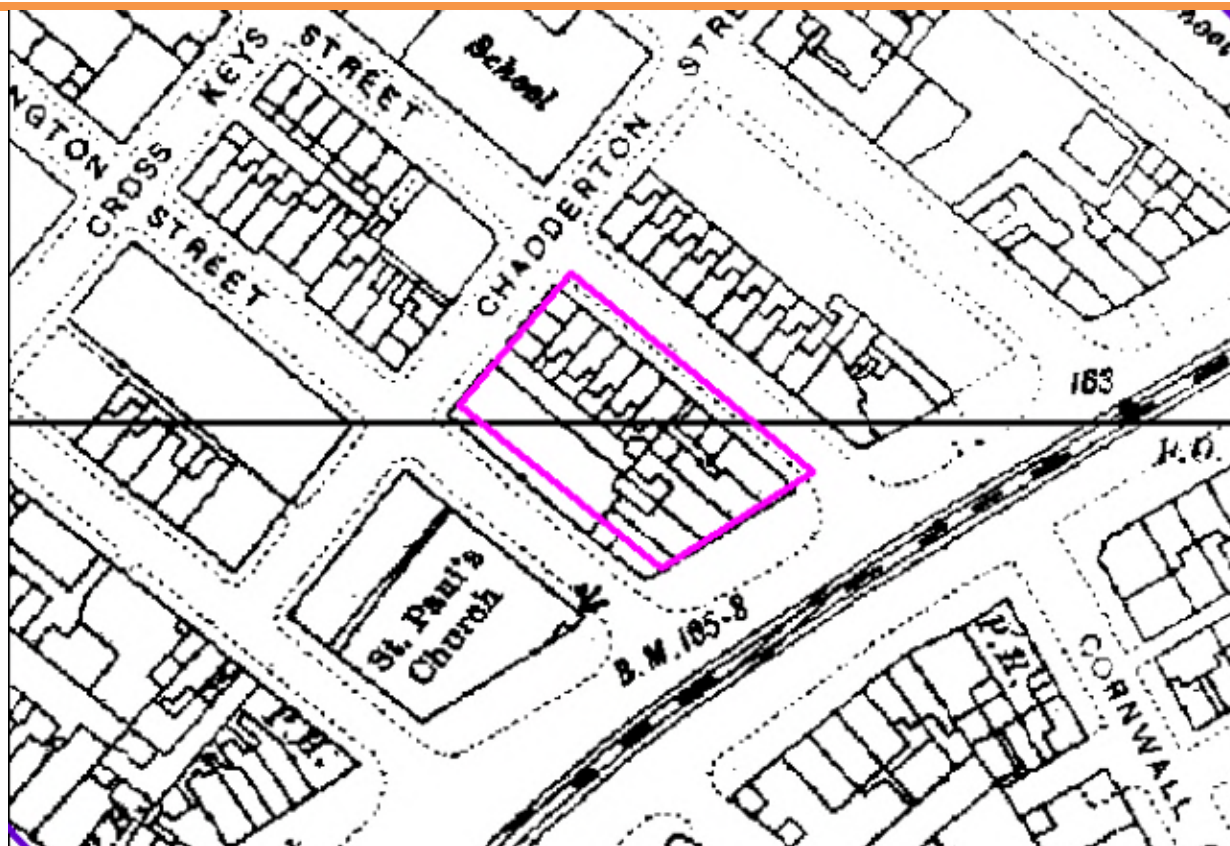
#### Historical Map

Dated: 1922-33
