# REMEDIATION AND ENABLING WORKS VALIDATION

New Little Mill  
Radium Street  
Ancoats  
Manchester

Prepared for:  
**Eric Wright Construction**

**Report Ref: 12-386-R2**  
**Date Issued: August 2019**

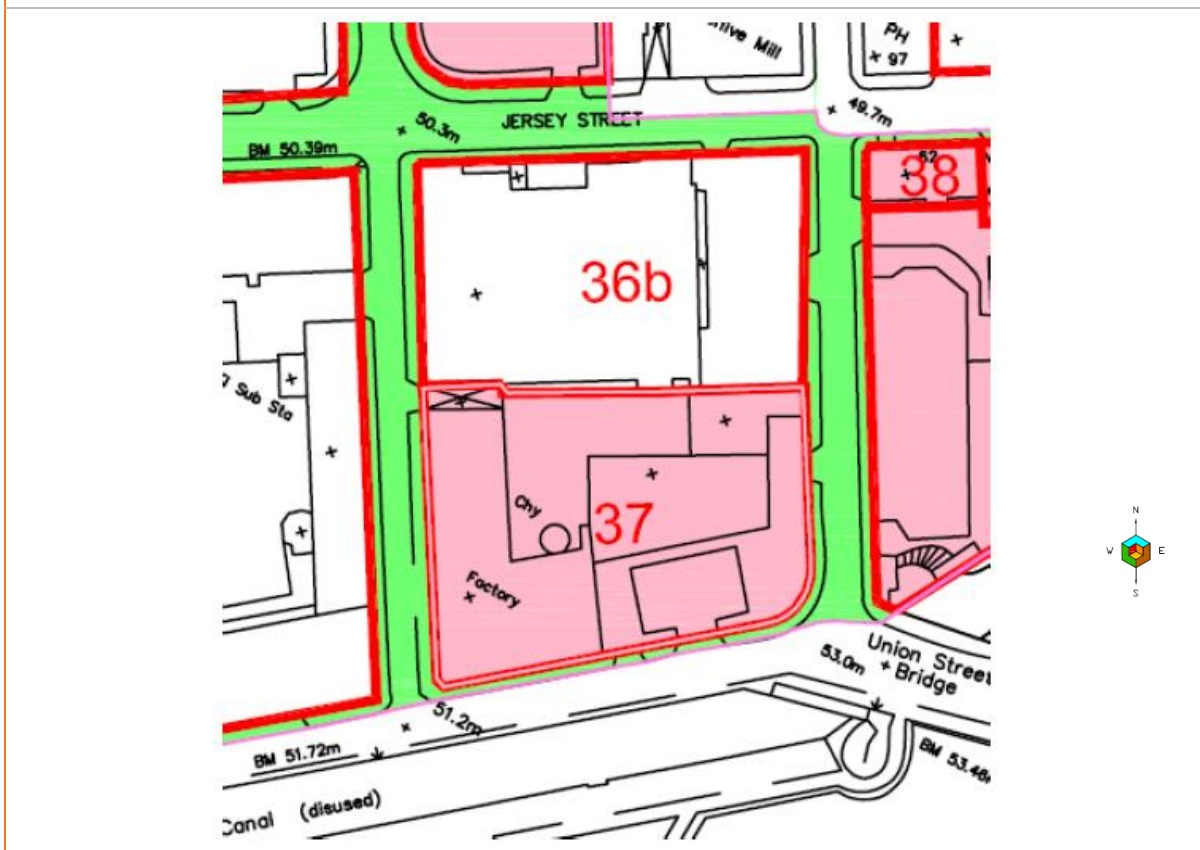
FIGURE 1.1      SNAPSHOT OF SITE LOCATION

E3P has not been provided with a proposed development plan at this time however figure 1.1 identifies the boundary and existing position of the mill that will remain (36B).

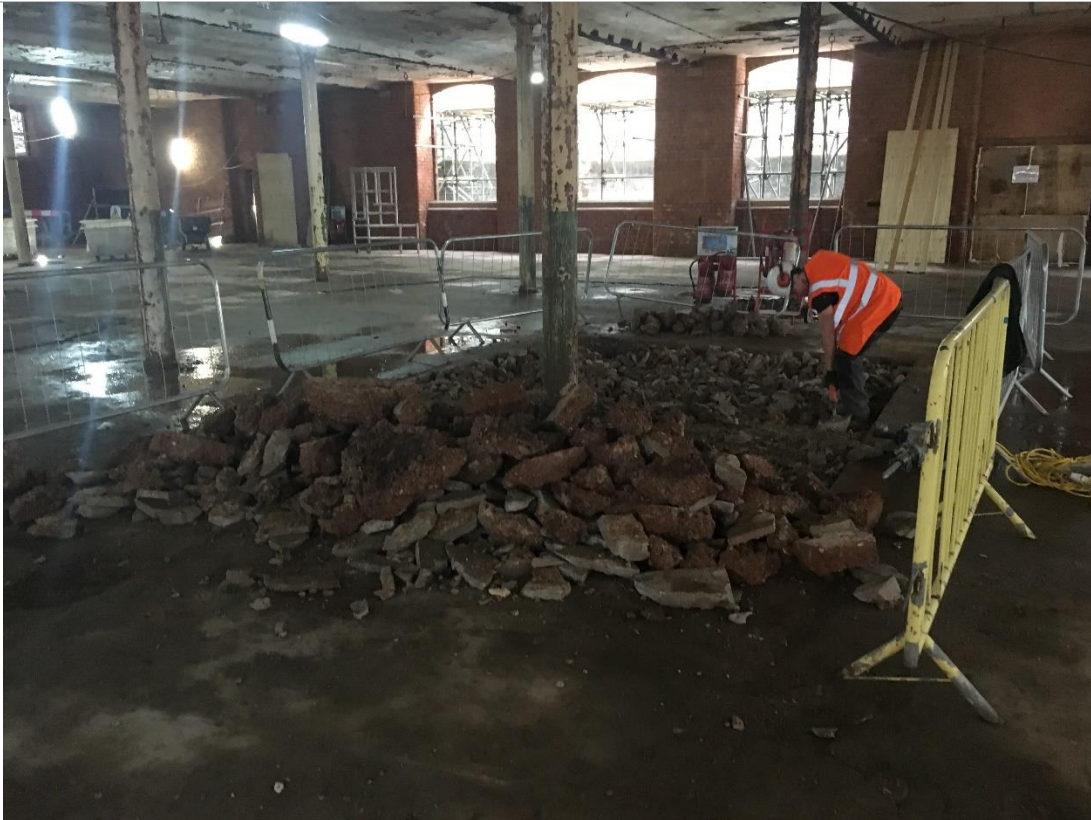
PLATE 1      BROKEN CONCRETE IN AREA OF LIFT SHAFT

| To date, and following the groundworks element of activities at the site, no further impact has been identified. Due to the design of the new structure within the historic building the existing ground slab has remained in situ, only broken out in one area to facilitate a lift shaft. On breaking of the concrete in this area E3P carried out soils analysis to confirm the absence of any contamination in this location. Two soils samples were obtained (Lift1, Lift 2) and show no exceedances or contaminants of concern. |

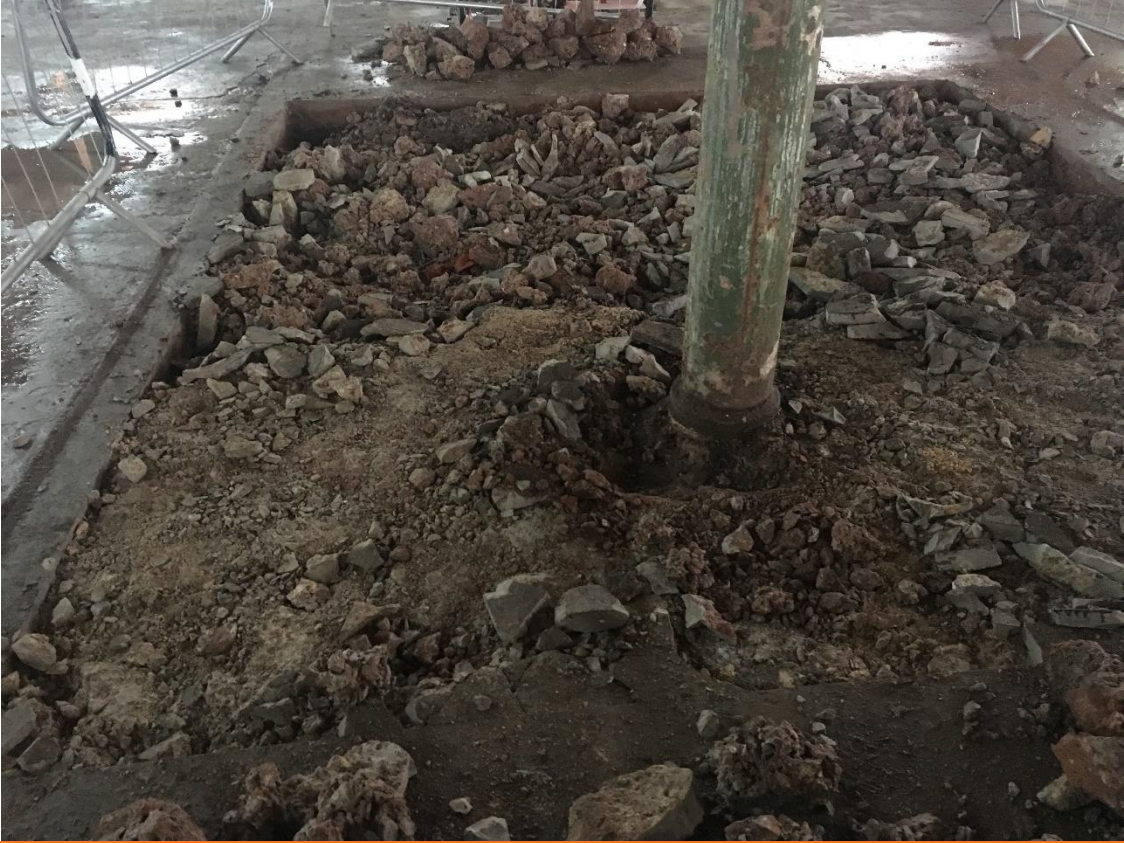
PLATE 3      MADE GROUND IN BASE OF LIFT SHAFT
