**The Qube**

**Phase I Desk Study and Phase II**

**Site Investigation Report**

**Pike Fold Primary School**

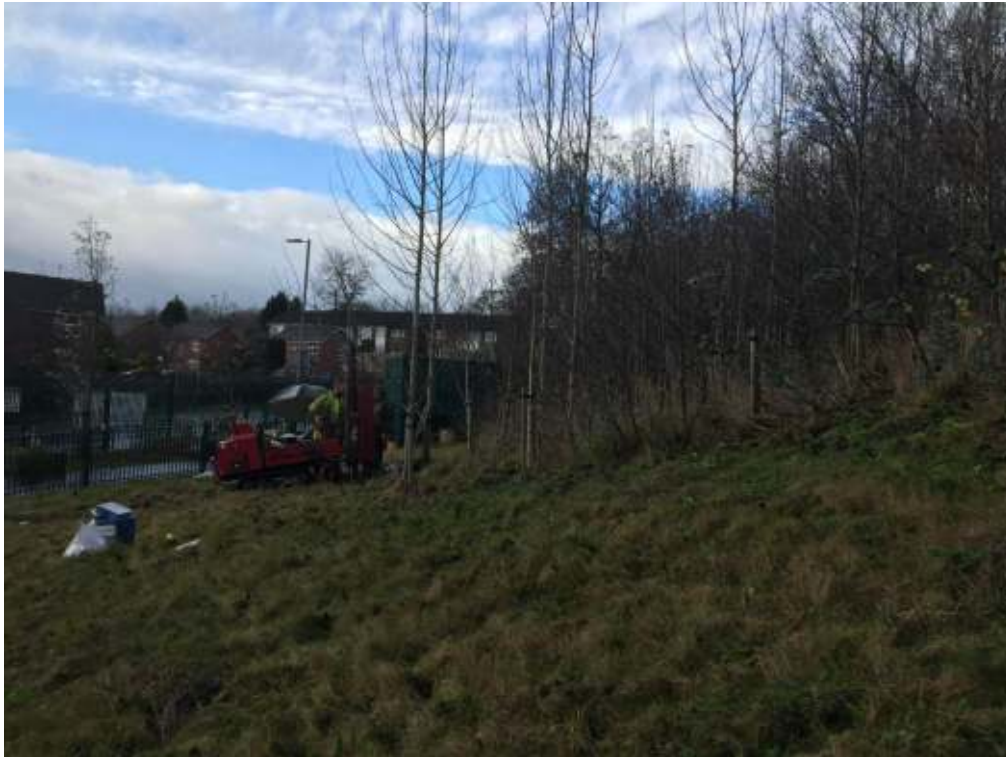
Photo showing the site and CT3

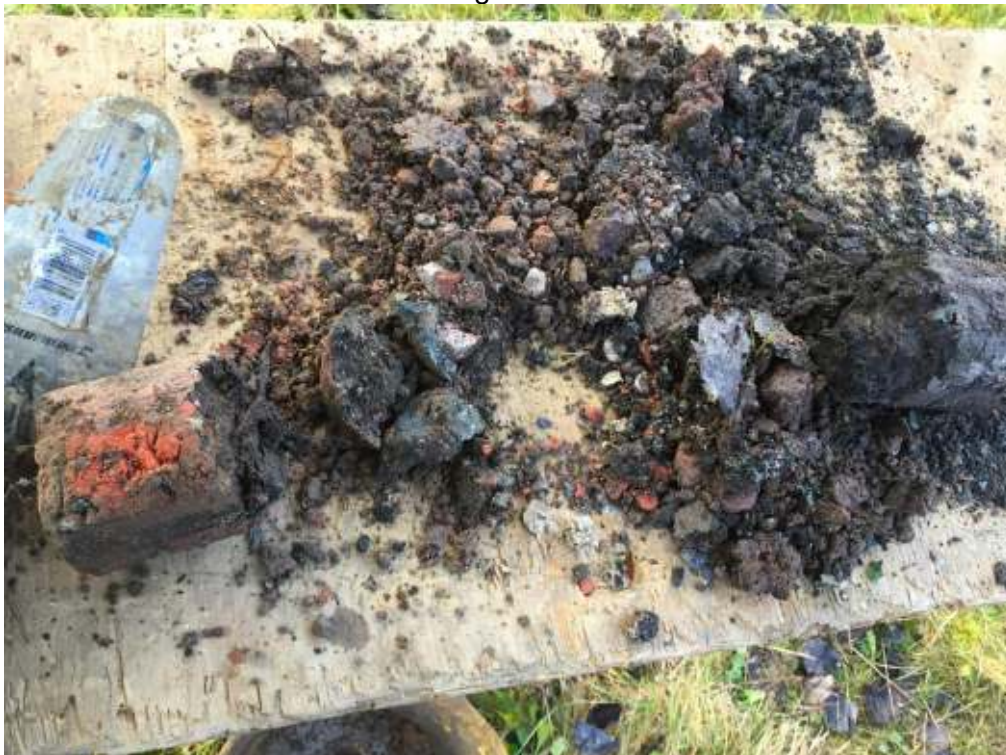
Encountered in each of the exploratory holes from ground level down to depths ranging from 1.50m to 2.00m bgl. The material encountered was loose dark brown, silty, clayey, sand and gravel. Gravels and cobbles were identified as brick, coal, slag, ceramic, slat, limestone and ash.

Photo showing the Made Ground found on site

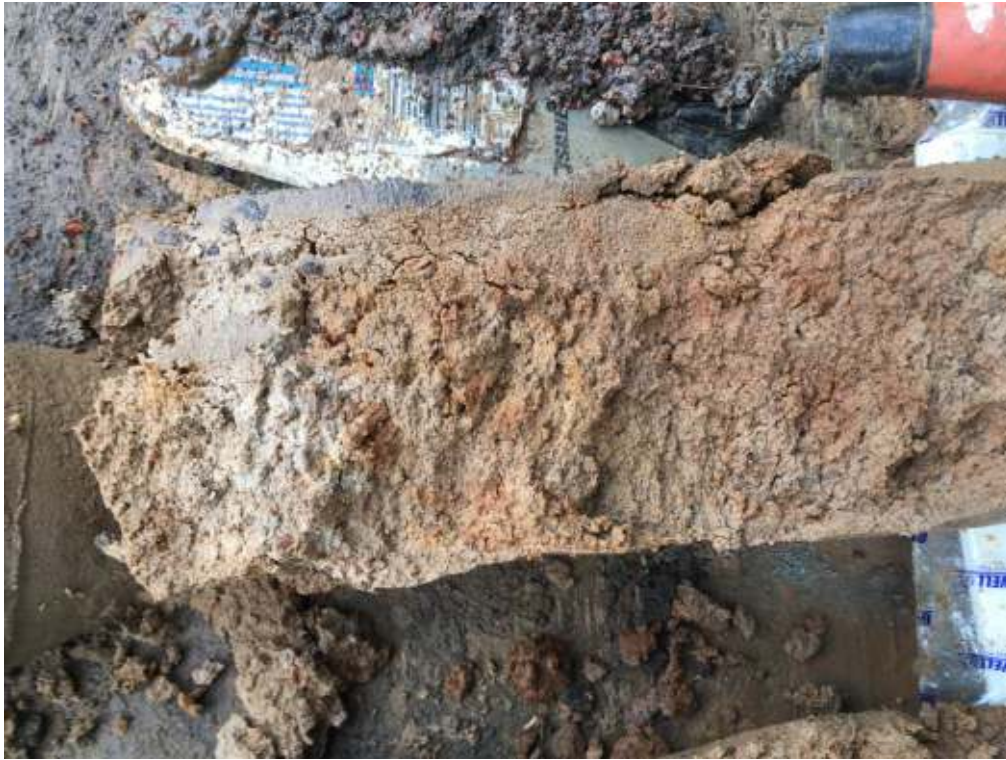
| <b>Ground Conditions Encountered</b> | The site and laboratory test work revealed that the general succession of strata can be represented in general by Made Ground down to a maximum depth of 2.00m bgl, overlying Glaciofluvial Deposit down to the base of the exploratory holes in excess of 4.80m bgl. |

Photo showing the Glaciofluvial Deposits found on site
