# Television Baseline and Post-Construction Survey Report

FQ Developments Limited

Owen Street

November, 2019

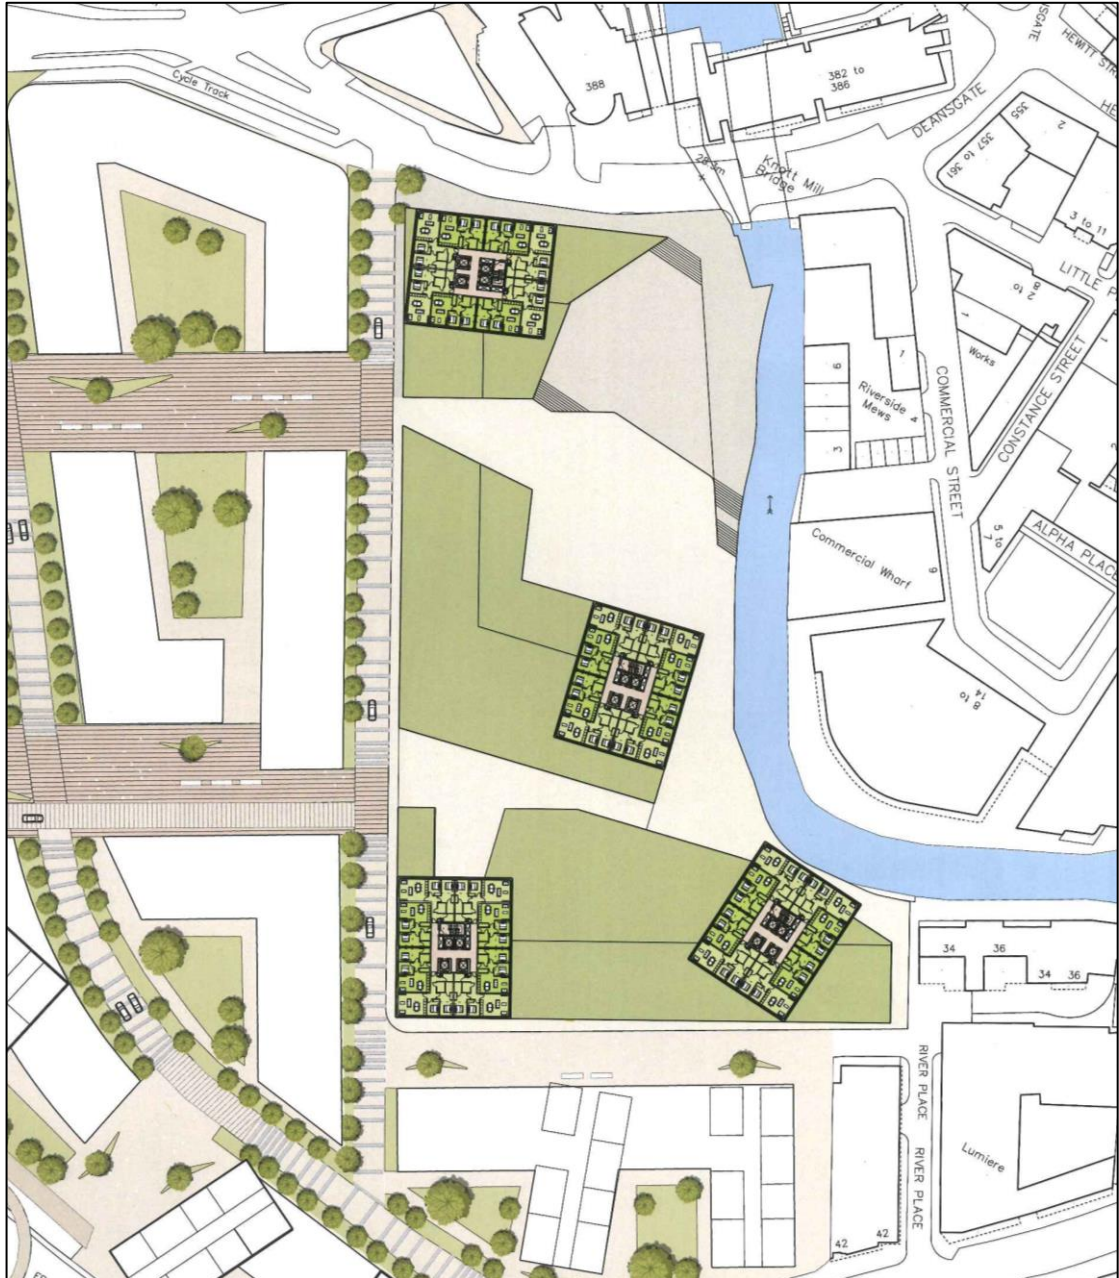
Figure 2 Top down development design

Figure 2<sup>4</sup> below shows a top down design of the development (not aligned north).

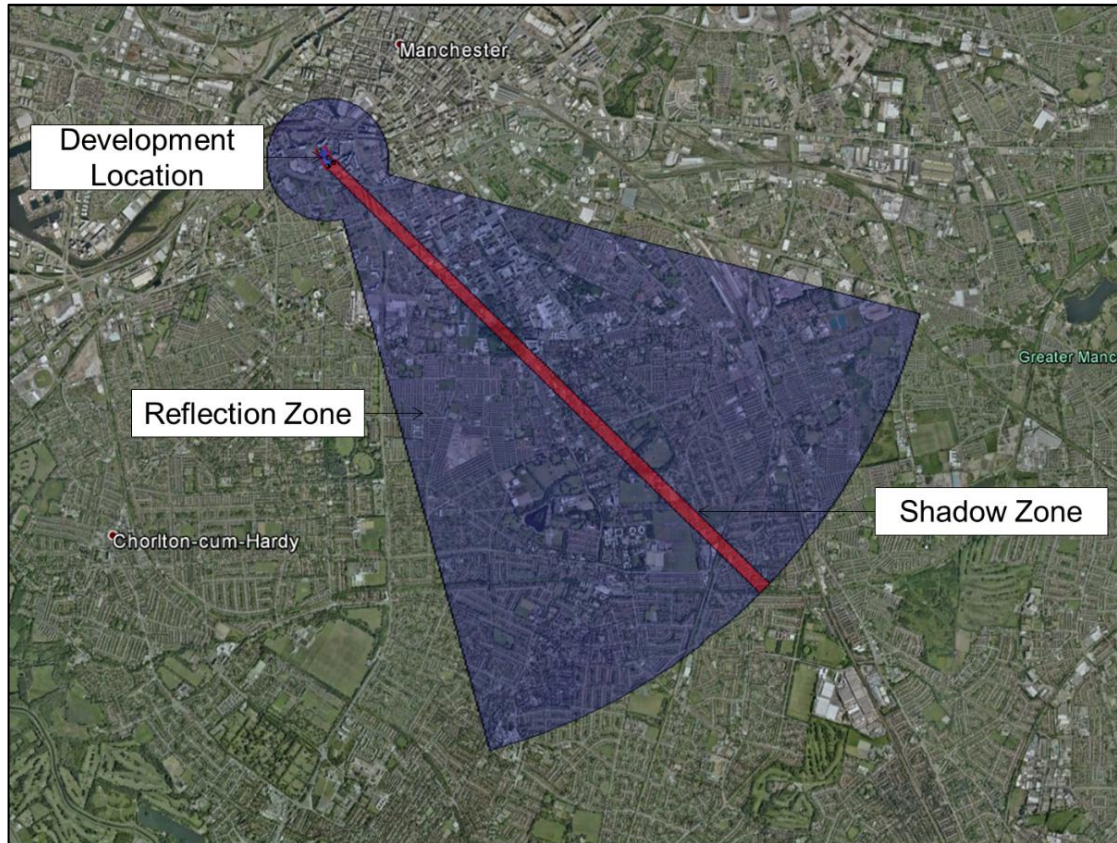
Figure 7 Interference zones – aerial image

Figure 7<sup>10</sup> below shows the interference zones overlaid onto aerial photography of the area.

It can be seen that the shadow zone passes over both urban and industrial buildings as well as high and low-rise residential developments. Areas closest to the development are generally<sup>11</sup> at the highest risk of experiencing television interference.
