**DAYTIME BAT SURVEY AND ECOLOGICAL  
SCOPING SURVEY  
OF  
LAND AT 27A CIRCULAR ROAD,  
WITHINGTON, GREATER MANCHESTER  
OCTOBER 2019**

**RACHEL HACKING ECOLOGY**

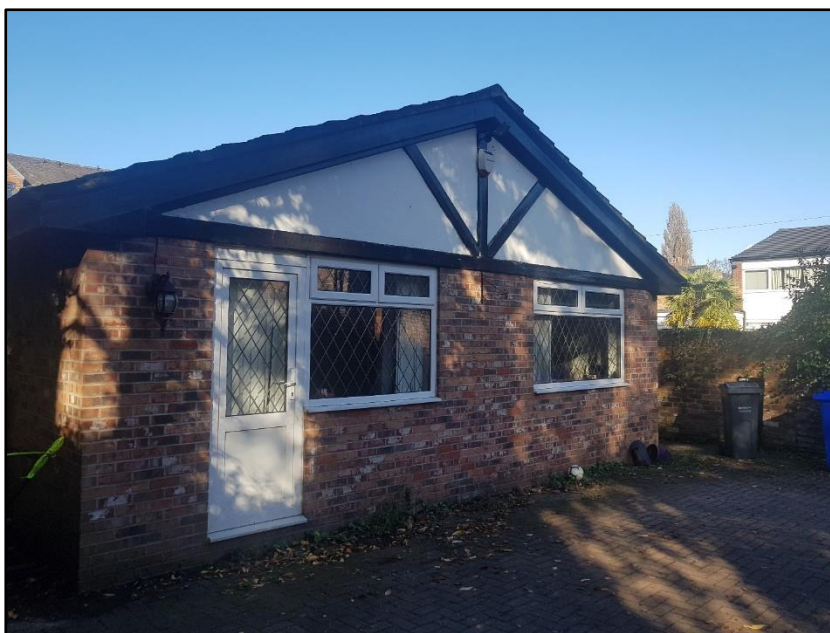
- 3.2 The external walls are constructed from brick (see Photograph 1). The brickwork is in excellent condition with no missing or damaged bricks. The mortar is also complete and in excellent condition. The upper courses of the gable ends are rendered and support Tudor style wooden cladding. There are no potential access points or crevices created by these features. The windows and doors are uPVC throughout and are flush to the brickwork. A small cavity exists where the wooden panel cladding meets the tops of the windows (see Photograph 2). These gaps are shallow and heavily cobwebbed.

**Photograph 1 showing the eastern gable end**

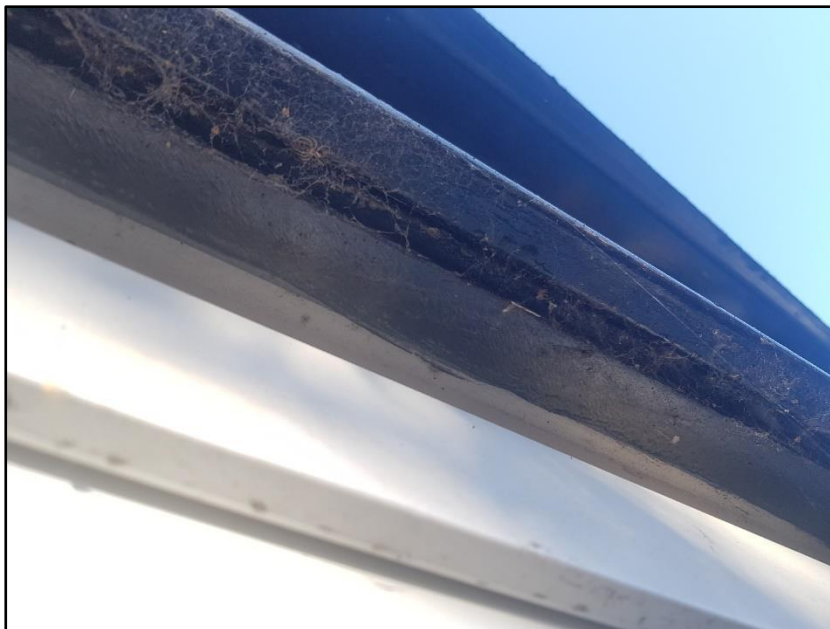
**Photograph 2 showing the gap between the cladding and the window**

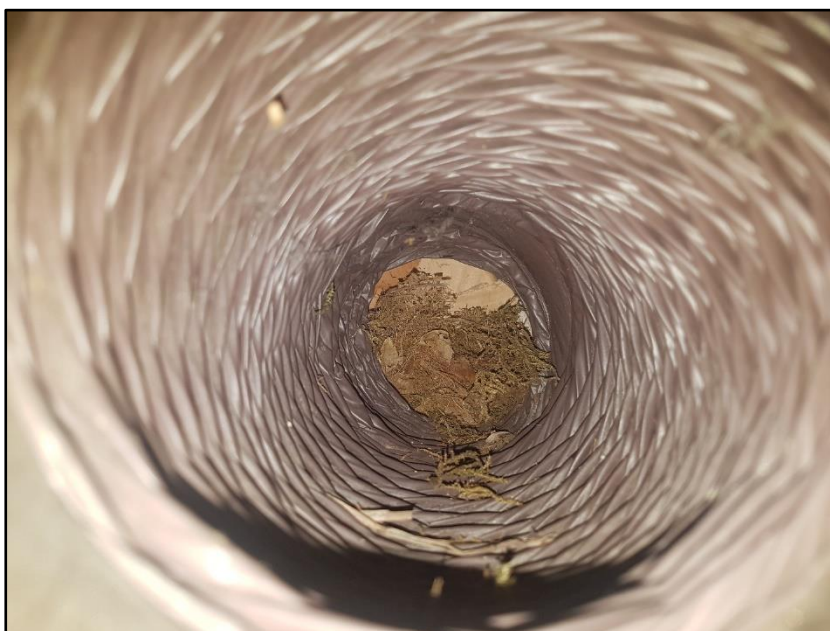
- 3.3 An exposed extraction vent is present on the building (see Photograph 3). A disused bird's nest was found within the vent. No evidence of bat activity, such as droppings were found within the vent or on the wall outside. It is unlikely that this is used by bats for roosting or as access into the property.

**Photograph 3 showing the vent**

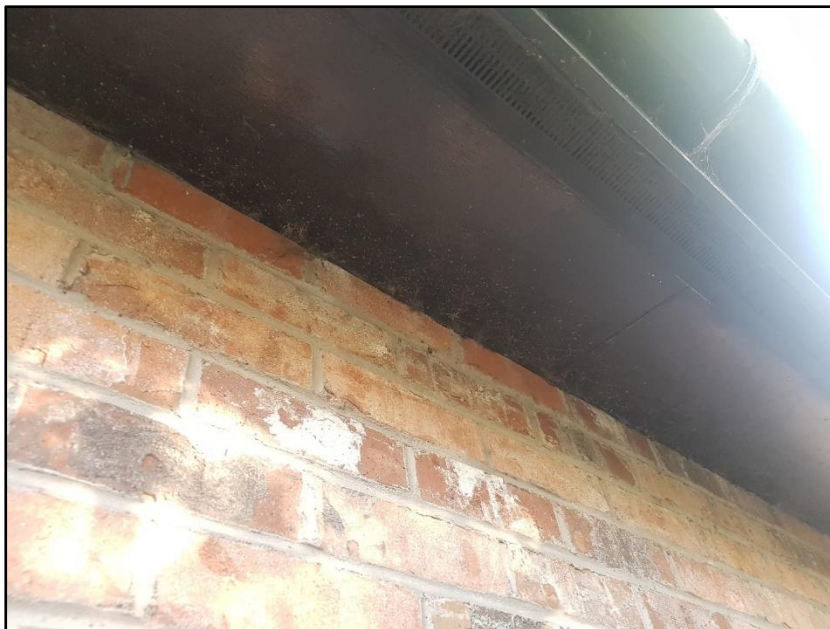
- 3.4 Wooden soffit and bargeboards are present on the roof edges (see Photograph 4). These are in excellent condition and flush to the brickwork. Small vents are present on the boards, these are all in good condition and do not provide a potential access point for bats.

**Photograph 4 showing the wooden soffit boards**

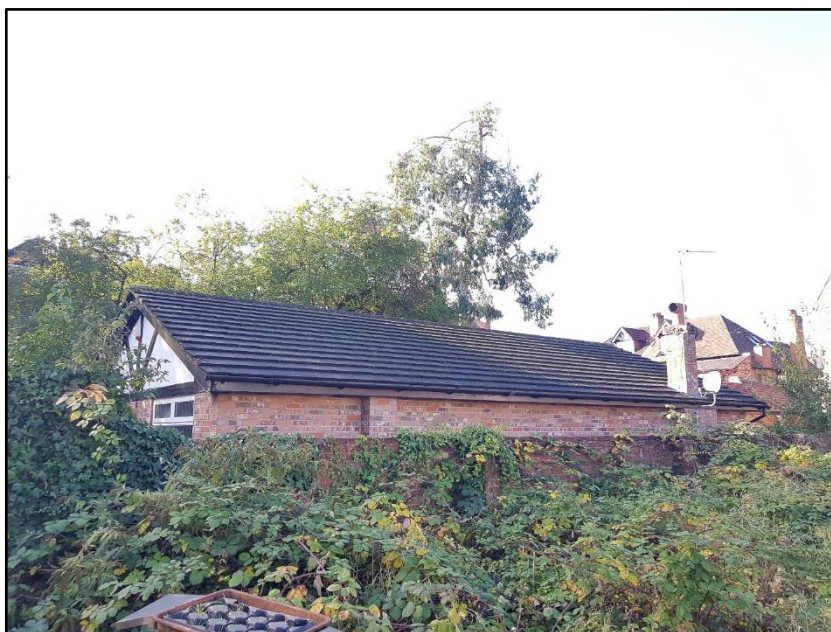
- 3.5 The roof of the property is pitched and covered with clay tiles (see Photograph 5). All the tiles are in position and flush to the surrounding tiles. There are no missing or slipped tiles. The ridge tiles are equally in good condition. All the tiles are in place and sealed with mortar to the tiles beneath. Lead flashing is present around the chimney stack. This is flush to the brickwork and the tiles.

**Photograph 5 showing the roof of the building**

- 4.3 It should be noted that bat absence is very difficult to prove definitively due to their mobility and size, and single or small numbers of bats are able to roost in extremely small spaces, such as between roofing tiles. Therefore, it is recommended that all removal of roof tiles and ridge tiles is to be undertaken with care, with the features lifted instead of dragged where possible.

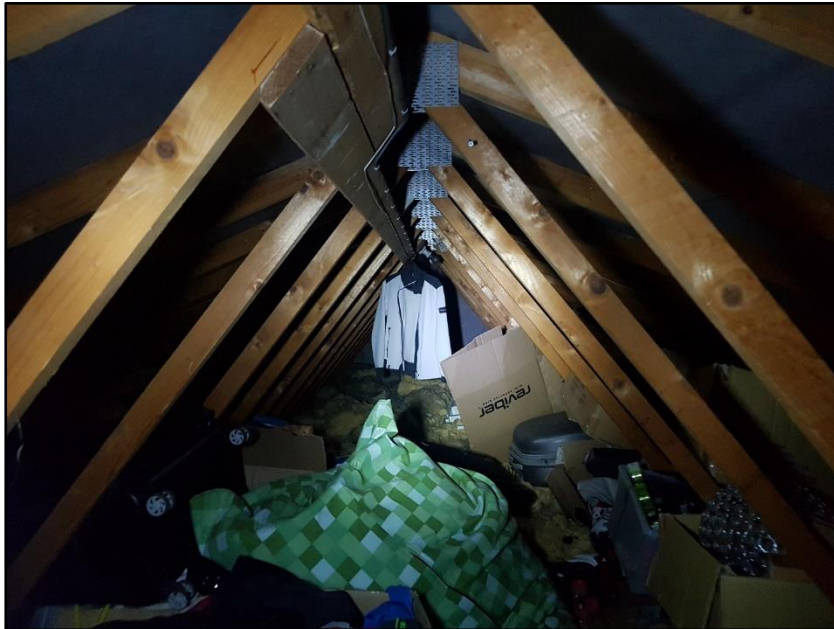
- 3.6 The ground floor rooms are finished spaces, currently lived in and do not provide suitable bat roosting habitat. A single roof void covers the whole property (see Photograph 6). This is a small space used for storage. The wooden support beams are in good condition, with no cracks or crevices

created where the beams meet. The roof has been lined with breathable roof membrane which is flush to the tiles above with no tears or sagging. The internal walls are constructed from breeze blocks which are in good condition and do not support any crevices that could be exploited by roosting bats. Rockwool insulation is present, but the vented soffits make the void cold. No access points for bats are present. No evidence of bat activity or crevices suitable for roosting bats were found within the void.

Photograph 6 showing the roof void

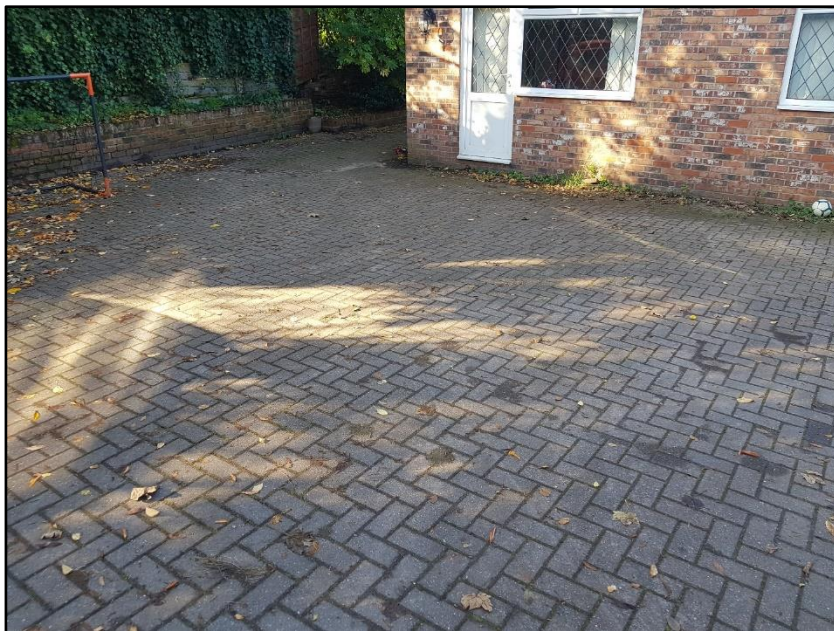
- 3.7 The site is composed of two areas separated by fencing. One is dominated by bare ground, the other is dominated by continuous scrub and tall ruderal herb. The first area comprises hardstanding around the building (see Photograph 7). Ephemeral vegetation has started to grow up on the edges of this habitat and species include Dandelion *Taraxacum officinale* agg., Columbine *Aquilegia vulgaris*, Herb-Robert *Geranium robertianum* and Ivy-leaved Toadflax *Cymbalaria muralis*. Around the site boundary are brick-built introduced shrub beds. These are filled with *Fatsia* var., Holly *Ilex aquifolium*, Ferns and Ivy *Hedera helix*.

**Photograph 7 showing the hardstanding and introduced shrub**

- 4.5 The introduced shrub, tree, continuous scrub and scattered scrub offer suitable bird nesting habitat. The building may also offer nesting opportunities. All bird species are protected whilst at the nest under The Wildlife & Countryside Act 1981 (as amended). It is recommended that work to the vegetation takes place outside the nesting season (which is generally March to August) or, a nesting bird survey is undertaken immediately prior to work commencing.

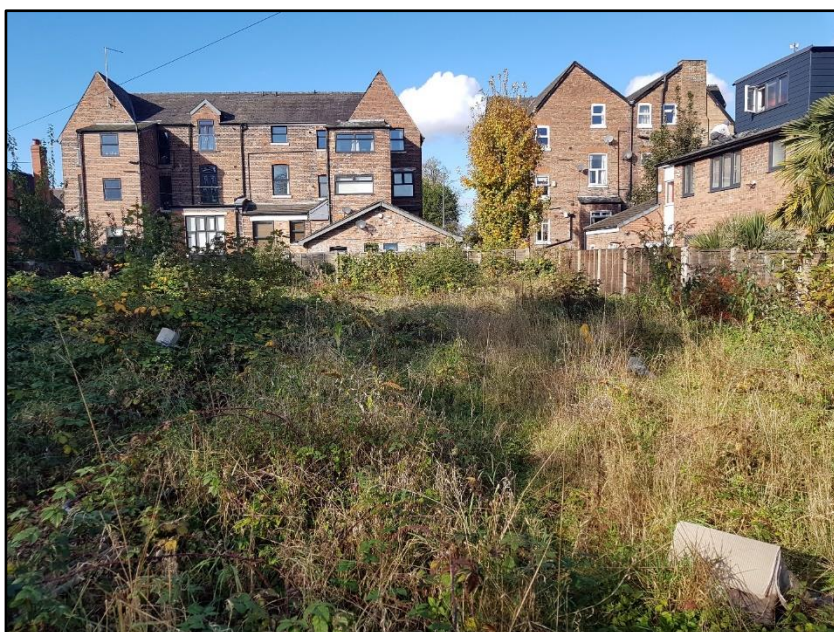
- 3.8 The area to the north of the site is unmanaged and overgrown, dominated by tall, ruderal vegetation and continuous scrub (see Photograph 8). The remains of a structure can be seen within the southern corner of this area. The scrub is composed of Bramble *Rubus fruticosus* agg., Blackthorn *Prunus spinosa* and Raspberry *Rubus idaeus*. The tall ruderal vegetation is composed of Common Ragwort *Jacobaea vulgaris*, Rosebay Willowherb *Chamaenerion angustifolium*, Wood Avens *Geum urbanum* and Yorkshire Fog *Holcus lanatus*.

**Photograph 8 showing the scrub and tall ruderal herb**
