**The King David High School, Manchester**

***Ecological Appraisal***

**December 2018**

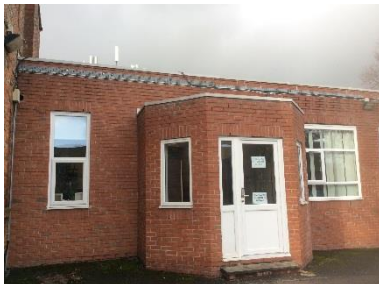
3.13 B1 is a single storey, flat bitumen roofed red brick building with standard and bay windows, adjacent to B2 and B3. The building is used as functioning classrooms. The metal bordering external walls and above windows is well sealed. Mortar between the brick work is generally well sealed, with a few small gaps behind the drain pipe on the eastern elevation and above uPVC windows which do not appear to extend further into the building. A slight gap, with vegetation growing, is evident above the window on the northern elevation where the timber barge board has come away.

B1; flat roofed building

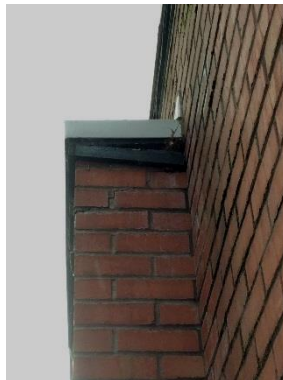
B1; gap behind bargeboard

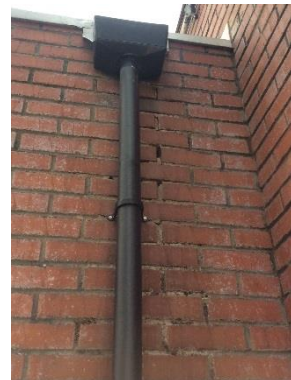
B1; gaps in the mortar

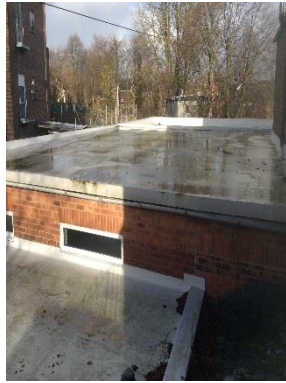
B1; bitumen roof

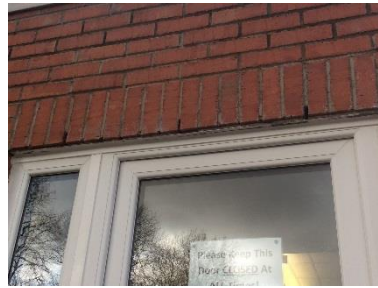
B1; gaps in the mortar

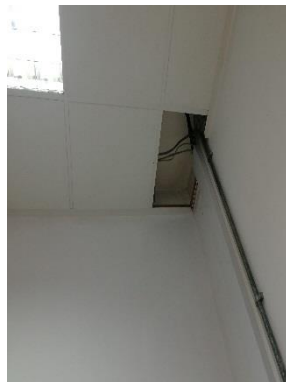
B2; Missing tile revealing roof

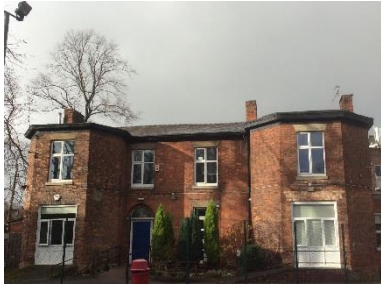
- 3.15 B2 is an old, two storey single pitched red brick building. Mortar between the brick work is generally well sealed and looks to have been repaired in places. uPVC windows are also well sealed and airtight. The timber soffit box is very weathered with numerous large holes (approximately 5cm by 8cm) evident along the eastern elevation of the building providing potential interior access into the soffit. Felt above the soffit box is also degraded with visible gaps underneath. The roof is slated with three brick chimneys present. All three chimneys are in poor condition with several gaps from missing mortar between brickwork. There are numerous gaps underneath roof slates below the central chimney and a slipped roof slate on the north east elevation below the chimney, providing potential bat access to the loft void. The roof ridge tiles are generally well sealed with one lifted tile on the southern edge of the roof ridge.

B2; Yavneh Girls building

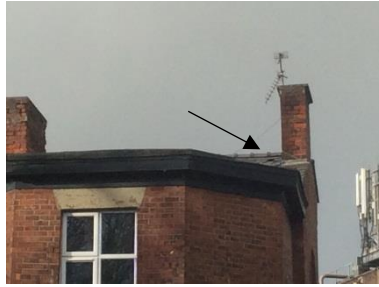
B2; Slipped roof slate

- **Moderate suitability:** The traditional red bricked building B2 is considered to have moderate potential for roosting bats. Abundant roosting opportunities suitable for crevice dwelling bats typically include lifted/shifted/broken roof slates, gaps along

- 5.5 Buildings within the site are considered to offer moderate (B2) and low (B3) potential to support roosting bats. No evidence of roosting bats was observed during the internal and external building inspections, however, the buildings provide numerous opportunities for crevice dwelling bats in particular, for which evidence of individuals/small roosts can be concealed from view. Furthermore, inspections within the loft voids or potential loft voids of B2 and B3 were limited as not all areas were accessible, meaning the potential presence of a larger bat roost cannot be ruled out. In line with the BCT emergence surveys are recommended.

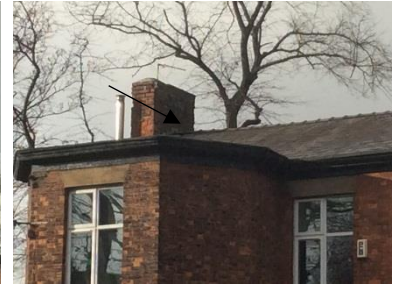
B2; Lifted ridge roof slate

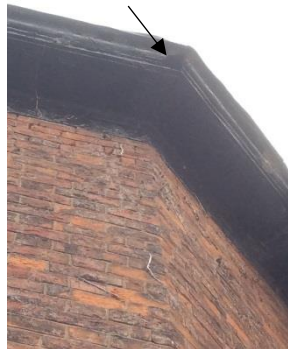
B2; Large hole in soffit box

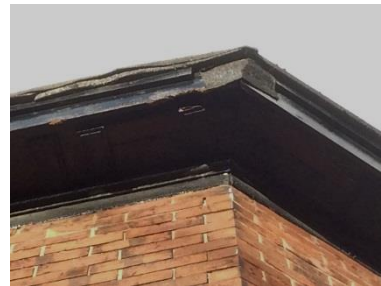
B2; Lifted felt above soffit box

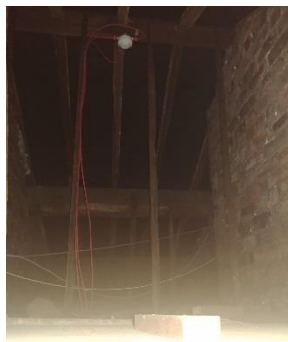
- 3.16 Internally, the building has large functioning classrooms on both levels with a kitchen staff room on the first floor. A false ceiling is present in all upper rooms with a loft hatch present above the false ceiling at the south east end of the first floor corridor. Only the loft space above the corridor could be accessed due to the false ceiling. The space is approximately 1 - 1.25 m high with timber joists and beams. The roof is lined with felt, which is in good condition with thick brick supporting walls. The brick wall has collapsed in places and exposed more areas of the loft void. Electrical wires and water pipes were visible. A potential old squirrel drey was present on the loft floor, with evidence of chewing on the wall plate timber. The building has **moderate** potential to support roosting bats.

B2; Loft void above corridor

the roof ridge and gaps into soffit boxes. B2 also has a sheltered loft void and could not be inspected thoroughly on survey.

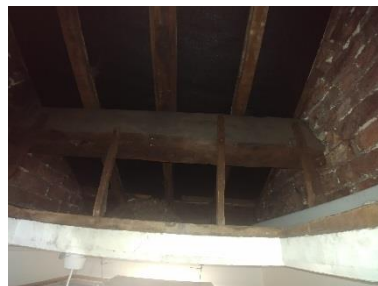
B2; Loft void and squirrel drey

- 3.22 The introduced shrub on site provides habitat for small mammals, specifically hedgehog, which is a Species of Principal Importance (SPI). The data search returned two hedgehog records in the search area. It is likely that the species is common in the area due to the abundance of residential properties with gardens and tree lines, which provide ample foraging and nesting opportunities for the species. Grey squirrels are also likely to be in the area due to the drey in the loft void of B2.

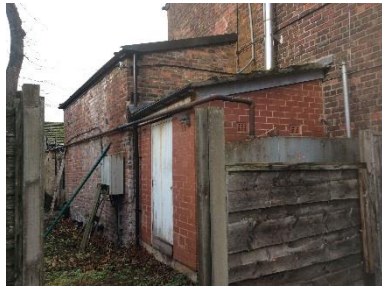
- 3.17 Two red brick lean-to structures are present on the southern edge of B2. B2b is of more recent construction. Both roofs are sloped with corrugated tiles and air vents are present within the brick walls on both structures. B2b has an approximate 2 cm gap above the door providing access into the interior but also creating a draught. B1b has cracked brickwork where the structure joins Building 2, with lifted felts and lead flashing along the south western elevation. Mortar within the brick work is well sealed on both structures. No

internal access was available. The surrounding habitat is of an urban nature as described in paragraph 3.11 and therefore favourable for pipistrelle bats which are a crevice dwelling species. These structures will likely have no internal crevice roosting features, they are therefore considered to be of **negligible** potential to support roosting bats.

B2a and B2b

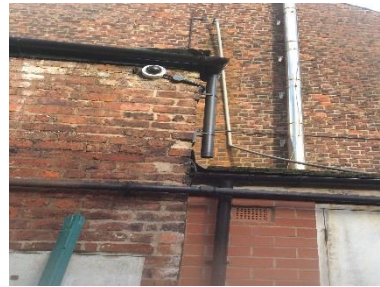
B2a; Lifted roof felt

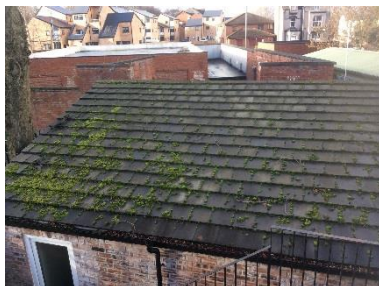
- 3.18 B3 is a single storey, red brick building with a sloped tiled roof. This building is a more recent extension of B1. UPVC windows on the western elevation of the building are covered with metal mesh. The roof is in good condition with no gaps between tiles or felt visible. The mortar between the brick work is well sealed. The barge board along the western elevation of the property is rotten with numerous holes evident. No internal access was available. The building has **low** potential to support roosting bats.

B3; sloping tiled roof

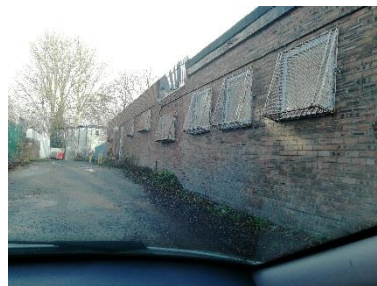
B3; Western elevation

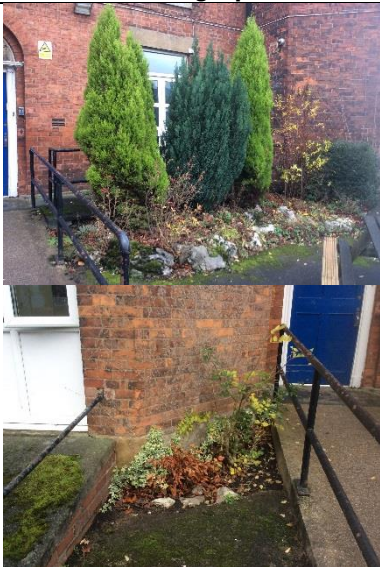
| TN/T | Description | Photograph |
|---|---|---|
| TN1 | <p>A small section of introduced shrub with young beech (<i>Fagus sylvatica</i>) and ash (<i>Fraxinus excelsior</i>) saplings (scrub) situated either side of the Yavneh Girls access ramp. Species include conifer sp. (<i>Pinophyta</i>), dog rose (<i>Rosa canina</i>), Wilsons honeysuckle (<i>Lonicera nitida</i>), and butterfly bush (<i>Buddleja davidii</i>). Ground flora includes herb Bennet (<i>Geum urbanum</i>), rosebay willow herb (<i>Chamerion angustifolium</i>), herb Robert (<i>Geranium robertianum</i>) and dandelion (<i>Taraxacum</i> agg.). The introduced shrub provides potential foraging and nesting opportunities for small mammals.</p> | |

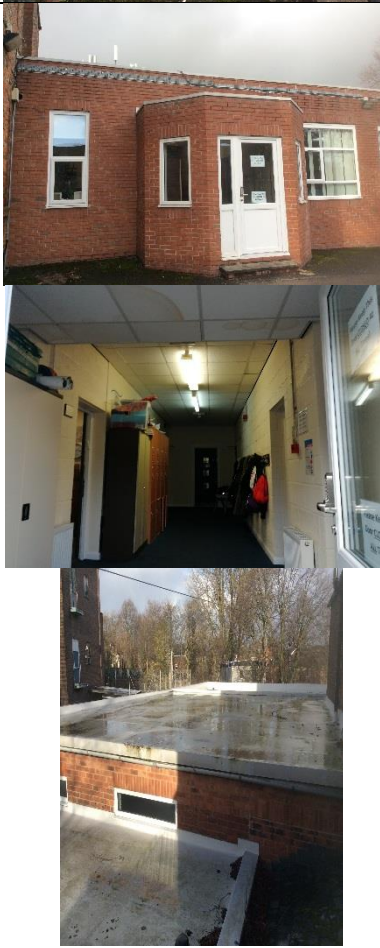
| TN/T | Description | Photograph |
|---|---|---|
| B1 | <p>B1 is a single storey, flat bitumen roofed red brick building with protruding windows, adjacent to B2 and B3. The building is used as functioning classrooms. The metal bordering external walls and above windows is well sealed. Mortar between the brick work is generally well sealed, with a few small gaps behind the drain pipe on the eastern side and above uPVC windows which look to not extend further into the building. A slight gap, with vegetation growing, is evident above the window on the northern side where the timber barge board has come away.</p> <p>Internally, the building comprises of large classrooms and interlinked corridors with all rooms having a false ceiling with dampness present on some of the ceiling tiles. Above the false ceiling, a view of electrical wires and the plaster/ bitumen roof can be taken with no loft void present. All rooms are heated and well-lit during the day which is likely to deter roosting bats. The building has <b>negligible</b> potential to support roosting bats</p> | |

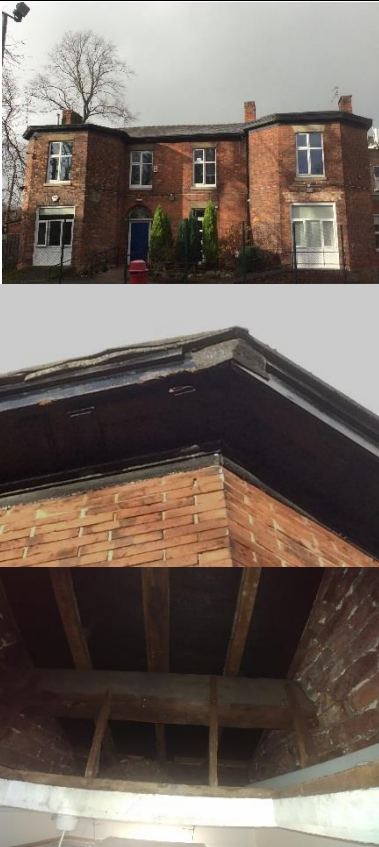
| B2 | <p>B2 is an old, two storey single pitched red brick building. Mortar between the brick work is generally well sealed and looks to have been repaired in places. uPVC windows are also well sealed and airtight. The timber soffit box is degraded with numerous large holes (approximately 5cm by 8cm) evident along the eastern elevation of the building providing potential interior access into the soffit. Felt above the soffit box is also weathered with evident gaps underneath. The roof is slate with three brick chimneys present. All three chimneys are in poor condition with several gaps from missing mortar between brickwork. There are numerous gaps underneath roof slates below the central chimney and a slipped slate on the north east elevation below the chimney, thus providing potential bat access to the loft void. The roof ridge slates are generally well sealed with one lifted slate on the southern edge of the roof ridge. Internally, the building has large functioning classrooms on both levels with a kitchen staff room on the first floor. A false ceiling is present in all rooms with a loft hatch behind the false ceiling at the end of the first floor corridor. Only the loft space above the corridor could be accessed due to health and safety. The space is approximately 1 – 1.25 m high with timber joists and beams. The roof is lined with felt, which is in good condition with thick brick supporting walls. The brick wall has collapsed in places and exposed more areas of the loft void. Electrical wires and water pipes were visible. A potential old squirrel drey was present on the loft floor, with evidence of chewing on the wall plate timber. The building has <b>moderate</b> potential to support roosting bats.</p> | |

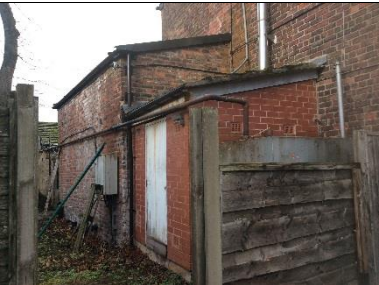
| B2a<br>B2b | <p>Two red brick structures located on the southern side of B2. B2b is of more recent construction. Both rooves are sloped with corrugated tiles and air vents are present within the brick walls on both structures. B2b has an approximate 2 cm gap above the door providing access into the interior but also creating a draught. B1b has cracked brickwork where the structure joins Building 2, with lifted felts and lead flashing along the south western elevation. Mortar within the brick work is well sealed on both structures. No internal access was available. The building has <b>negligible</b> potential to support roosting bats.</p> | |

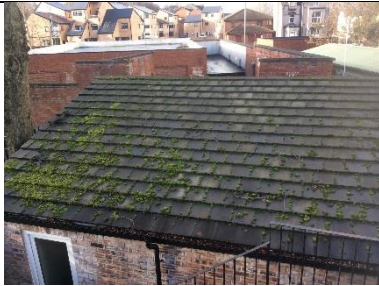
| B3 | <p>B3 is a single storey, red brick building with a sloped tiled roof. This building is a more recent extension of B1. UPVC windows on the western rear of the building are covered with metal mesh. The roof is in good condition with no gaps between tiles or felt visible. The mortar between brick work is well sealed. The barge board along the western elevation of the property is rotten with numerous holes evident. No internal access was available. The building has <b>low</b> potential to support roosting bats.</p> | |
