Jersey Street Bridge

Deconstruction Methodology  
Report

Faithful and Gould on Behalf of  
MCC

21 March 2022

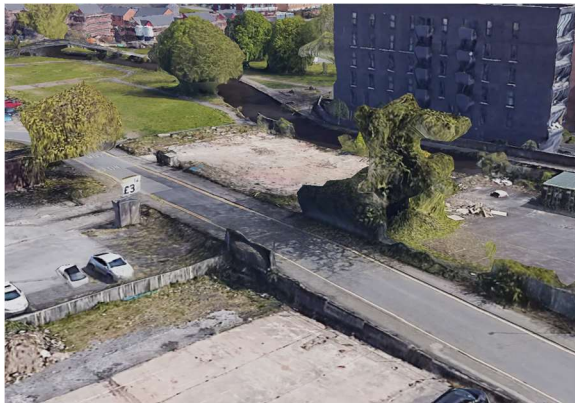
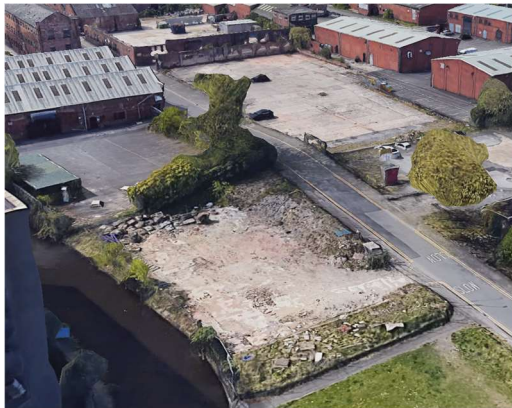
Figure 3- Ariel and Approach Views of Jersey Street Bridge

Bridge Ariel View Facing West

Bridge Ariel View Facing East

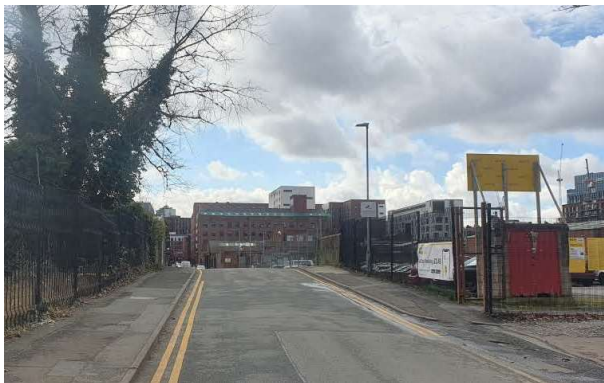
Bridge Approach from Jersey Street South

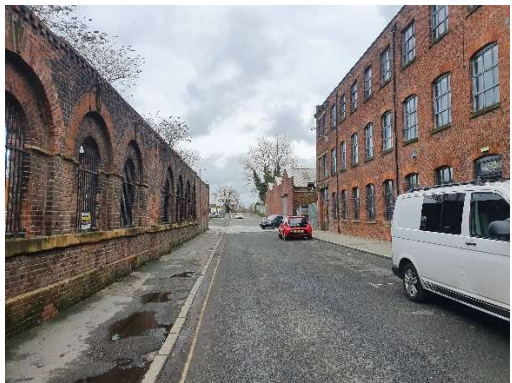
Bridge Approach from Jersey Street North

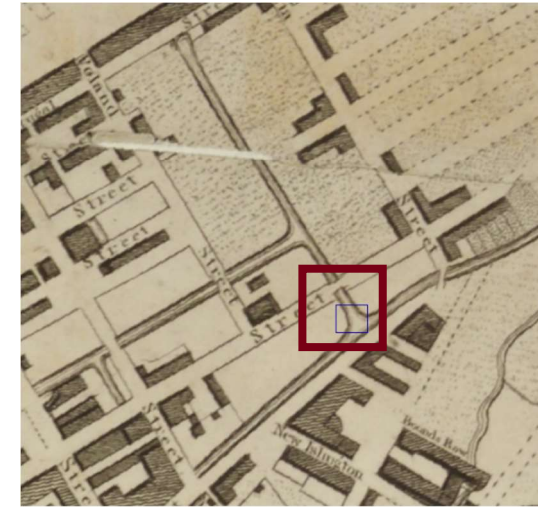
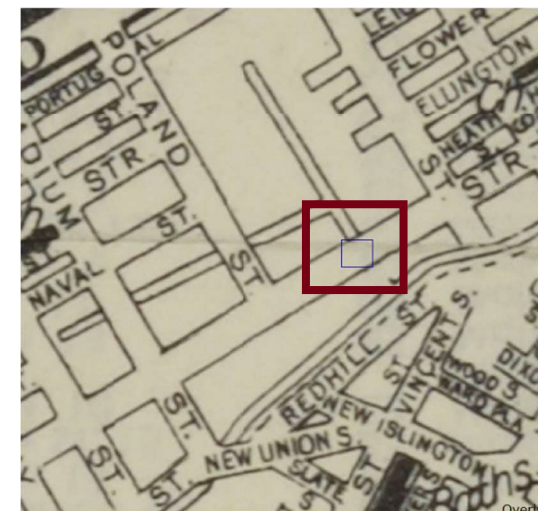
Figure 4. - Historic Maps Showing Bridge Location

The Bridge was built to span a canal arm branching from the Rochdale Canal 40m to the south and a crossing has been located at this point from at least 1821 (figure 4).

Based on the available maps there is evidence that the canal arm existed until at least the early 1960's but the waterway has since been dammed at its junction with the Rochdale Canal and infilled.

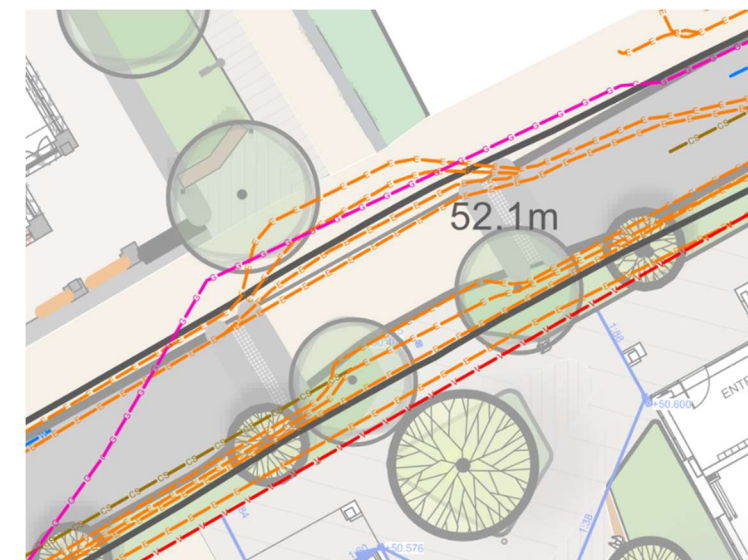
Figure 6. - Extract of Landscape Architects utilities GA

As seen in the extract of the landscape architect's services general arrangement for the site it is evident that a number of utilities routes including electricity, gas and communications cross the bridge alignment. The location of chamber lids within each bridge approach suggests that some of the services identified in the drawing cross the bridge. The Contractor is to confirm the location of all services prior to the commencement of dismantling works. Services either side of the bridge are to be protected throughout the duration of the works and services crossing the bridge are to be capped at the approaches and diverted.

As the bridge provides a pathway for a number of utilities there is a significant risk of damage to these services during demolition. To mitigate unplanned disruption a GPR survey should be carried out to locate utility locations at an adequate distance from both sides of the bridge in order to cap them off and redirect services prior to deconstruction works.

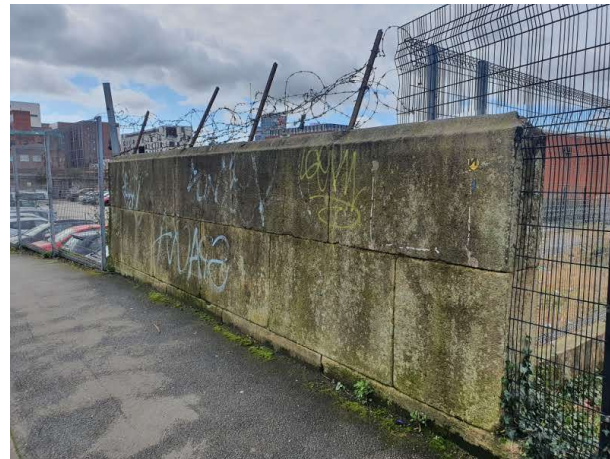
Figure 7. - North Side Bridge Parapet

Above the bridge deck consists of two 1.4m high, 0.3m thick stone parapets constructed in 1.3mWx0.65mH blocks, which due to the slenderness of the parapet are assumed to be dowelled into one another at tied into the bridge deck at the base.

Following the closure of the road, it is proposed that the dismantling of the bridge is carried out in stages. This should start with the removal of the stone parapets, assumed to be tied into either the bridge decking or the primary beams.

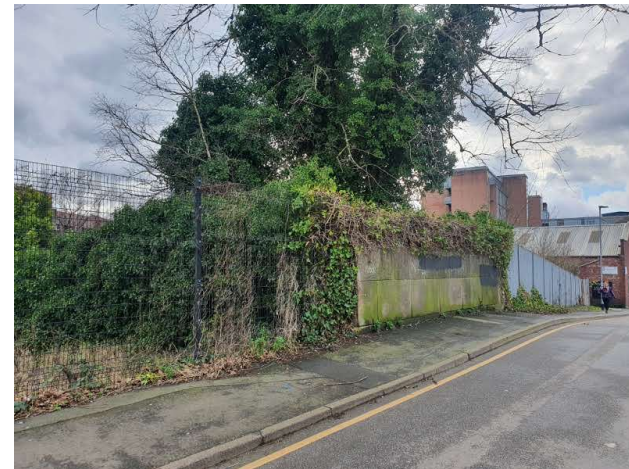
Figure.8 - South Side Bridge Parapet

In both of the depressions on either side of the bridge there is clear vegetation growth however this is very significant on the southern side where the vegetation has grown on the outer face of the parapet which may have affected its structural integrity. Additionally, the root spread of the mature tree growing within the recess on the southern side of the bridge may have an influence on the condition of the existing bridge foundations and bearing which may lead to instability.

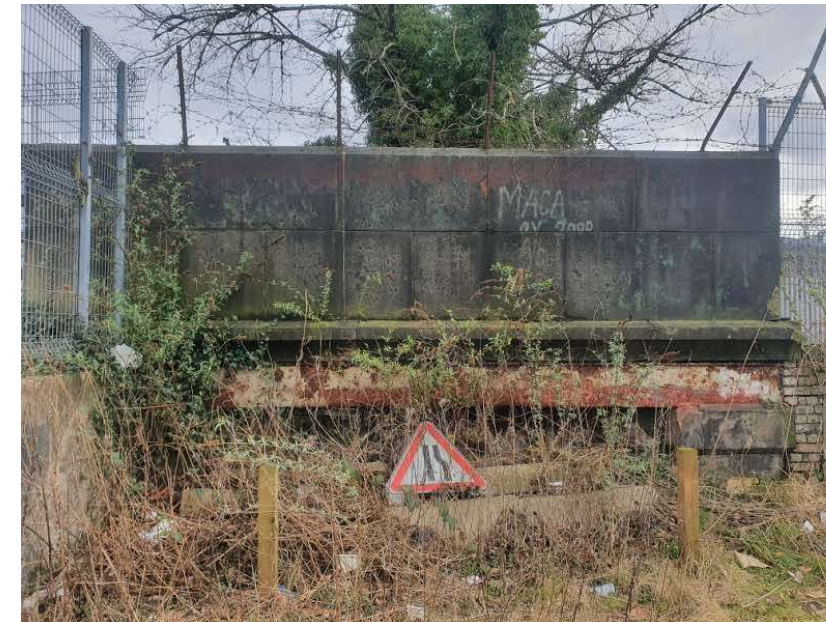
Figure 9. - Elevation 1 Photograph

During the site visit there was full access to the top of the bridge deck as well as the north elevation 1 shown in Figure 9. Due to lack of access to the loading yard space adjacent to the warehouse it was not possible to inspect the bridge from the southern elevation 2.

Based on the visible structure in Elevation 1, the primary structure of the bridge span consists of 2 No. 400x400mm rectangular metal beams spanning left-right with 30mm top flange and no visible bottom flange. The metal beams look to span onto circa 750mm wide stone upstands approximately 900mm high forming the bridge abutments.

Behind the primary beam the area beneath the deck and original depression level has been infilled with what appears to be a brick/stone/cement mix which may have been used to provide some level of bearing support of the bridge deck to ground level. Due to this infill and the metal beam, it was not possible to inspect the construction of the bridge deck itself though it is assumed that it consists of a concrete slab supported on metal beams spanning between abutments.

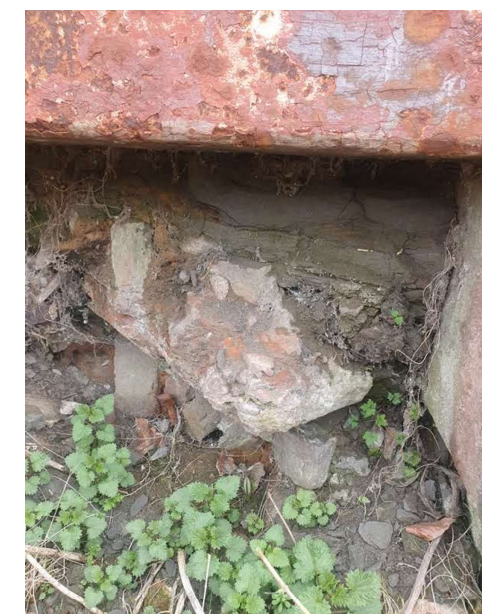
Figure 12 - Infill Material

It would appear that work has historically been undertaken to reduce the risk of structural damage and decay by infilling the void beneath the bridge beams to provide additional support the bridge deck. This may also have been completed as a response to increasing traffic loads experienced since the construction of the bridge.

Once the structure of the bridge has been removed the remaining infill and bridge abutment material should be removed using an excavator and where possible sorted, crushed, and reused for the desired releveling of the site to produce the new road. The remaining fill material should then be taken off site via Poland street connecting to major roads. Once works are complete and site services have been removed the site will then need to be cleared of any leftover debris that may potentially lead to site contamination.

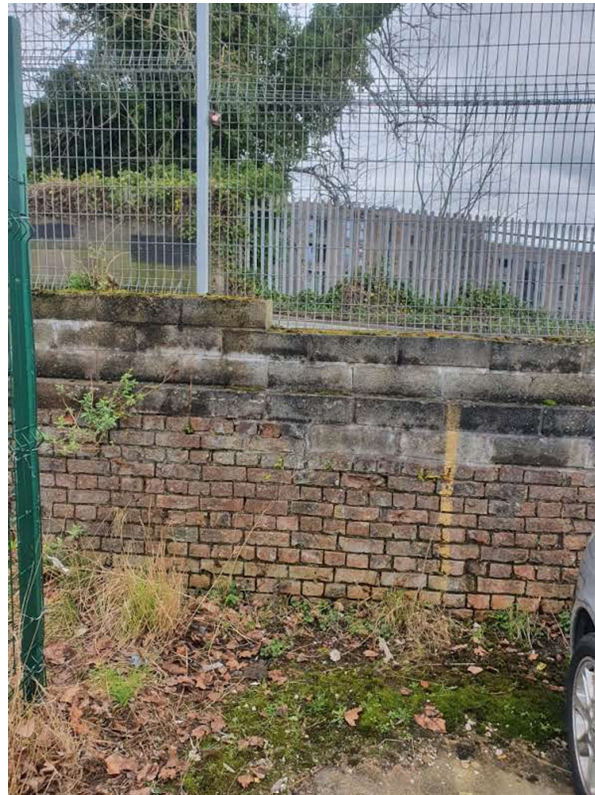
Figure 13 Bridge Abutment Masonry Wall

The bridge abutment structure comprises of dressed stone. Brickwork wing walls extend approximately 40m to the north and south from the edge of the bridge which support the approach road and act as retaining walls raising the approaches above the adjacent land. It is assumed that the approaches bear on compacted fill.

Generally, the bridge appears to be in poor condition evidenced by spalling brickwork within the abutment and return walls, corrosion to the bridge beams and damage to the parapets.
