# THE PORTICO LIBRARY, MANCHESTER

Conservation Management Plan  
Chambers Conservation Ltd, July 2025 – Issue 3

The purpose of this report is plan is to assess the significance of the building and its components to help guide future decision making and change.

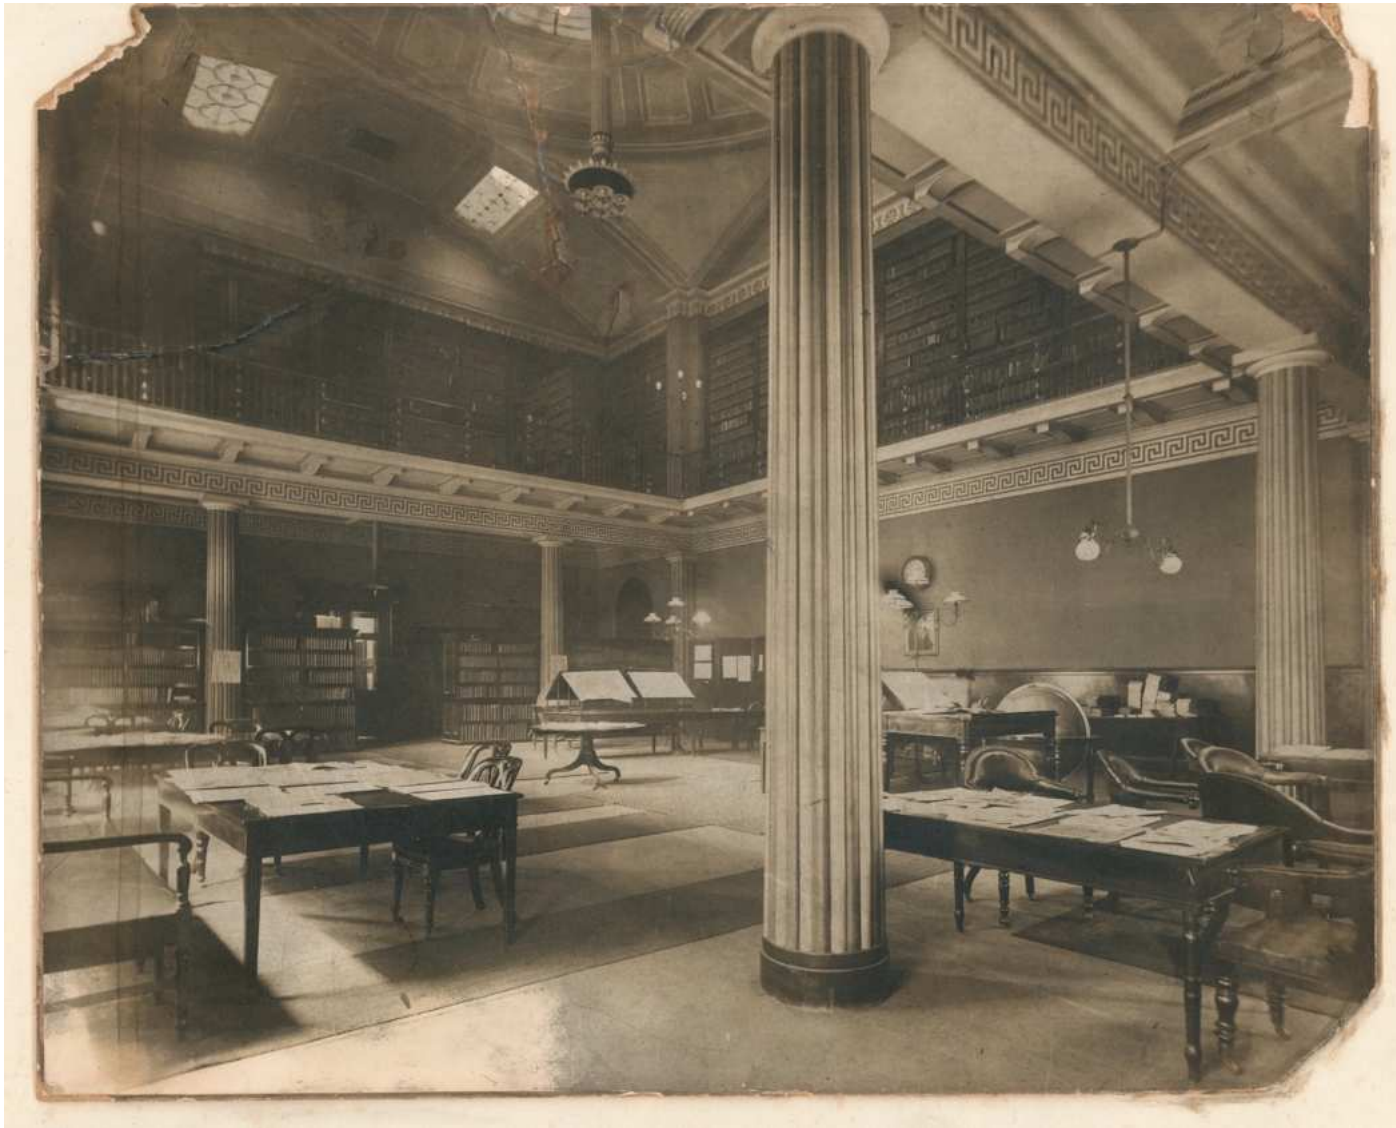
Photograph from the Library's own collection showing the original form of the interior, prior to the 1920s alterations (c. 1910)

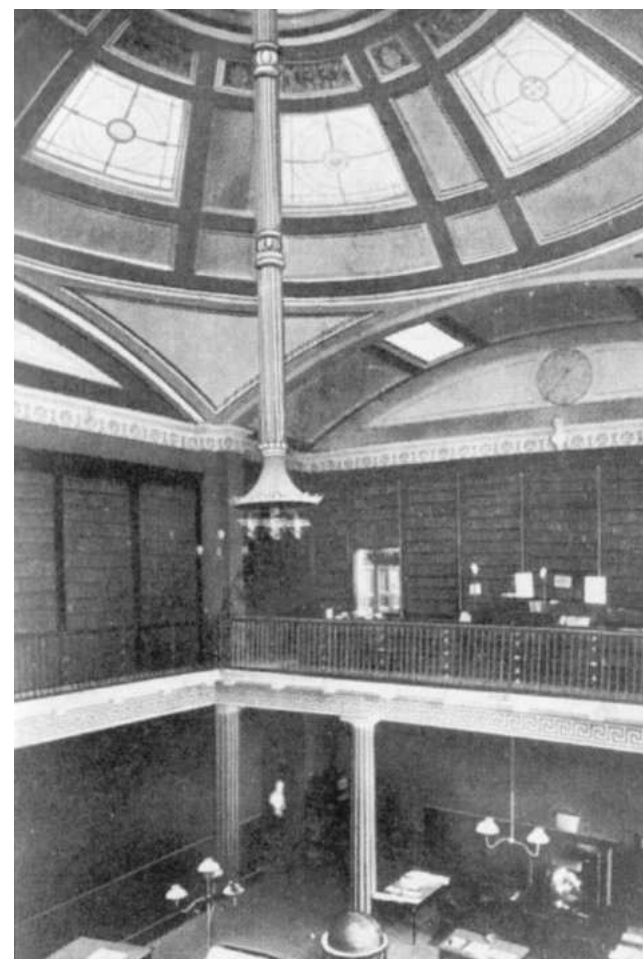
Interior before the 1920s alterations, showing the gasolier of c.1875.

- 3.2.10 Gas lighting had been fitted within the building in 1844 (it had been installed earlier on the exterior with large globe fittings). initially the use of gas internally caused problems with excess heat and 'noxious gases' and in 1851 improvements to ventilation had to be made. The interior was originally lit by the central dome of plain glass - in 1856 the stained-glass panels were fitted to a design by a Mr Bowman. Under the dome, a feature 'gasolier' was installed later in 1875.

3.2.19 In the early 20<sup>th</sup> century, there were continued problems with roof leaks – in 1916 meetings were reportedly stopped as a result and in 1925 dry rot was discovered in roof beams, suggesting a lack of maintenance. Extensive leaks occurred due to blocked gutters in 1932 and 1953, before a significant part of the ceiling collapsed in 1960 in the reading room. The main feature gasolier was removed in 1914 to be replaced with electric lighting.

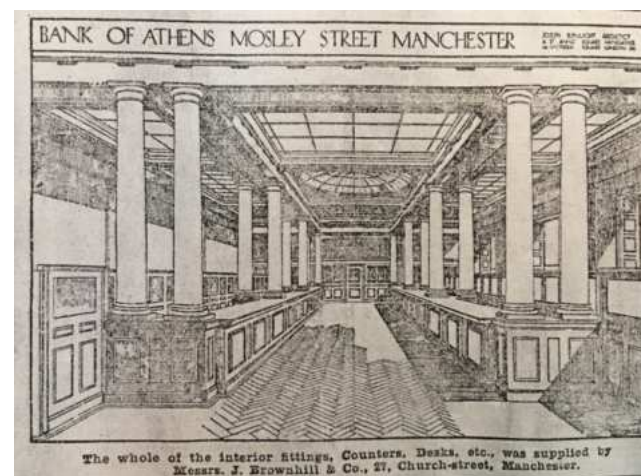
Design for the interior of the Bank of Athens within the ground floor of the Portico building

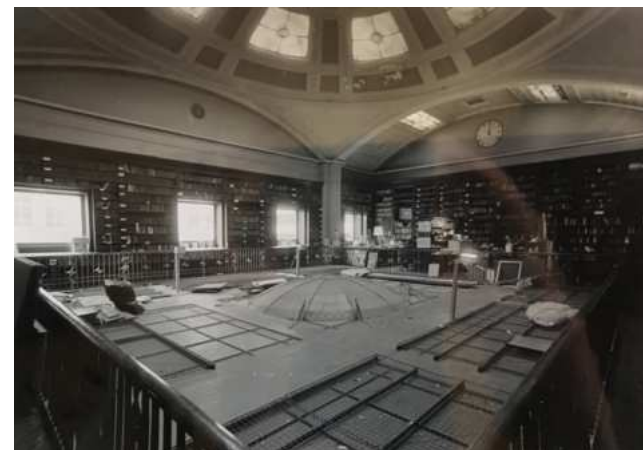
Interior during the 1980s prior to the removal of the glazed ceiling

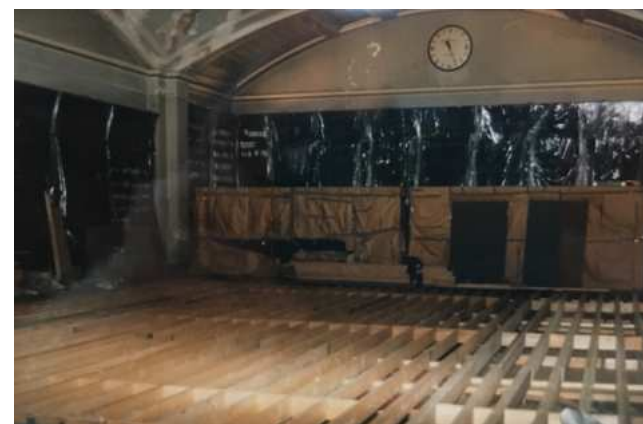
Interior during the 1980s during the work to install a new floor

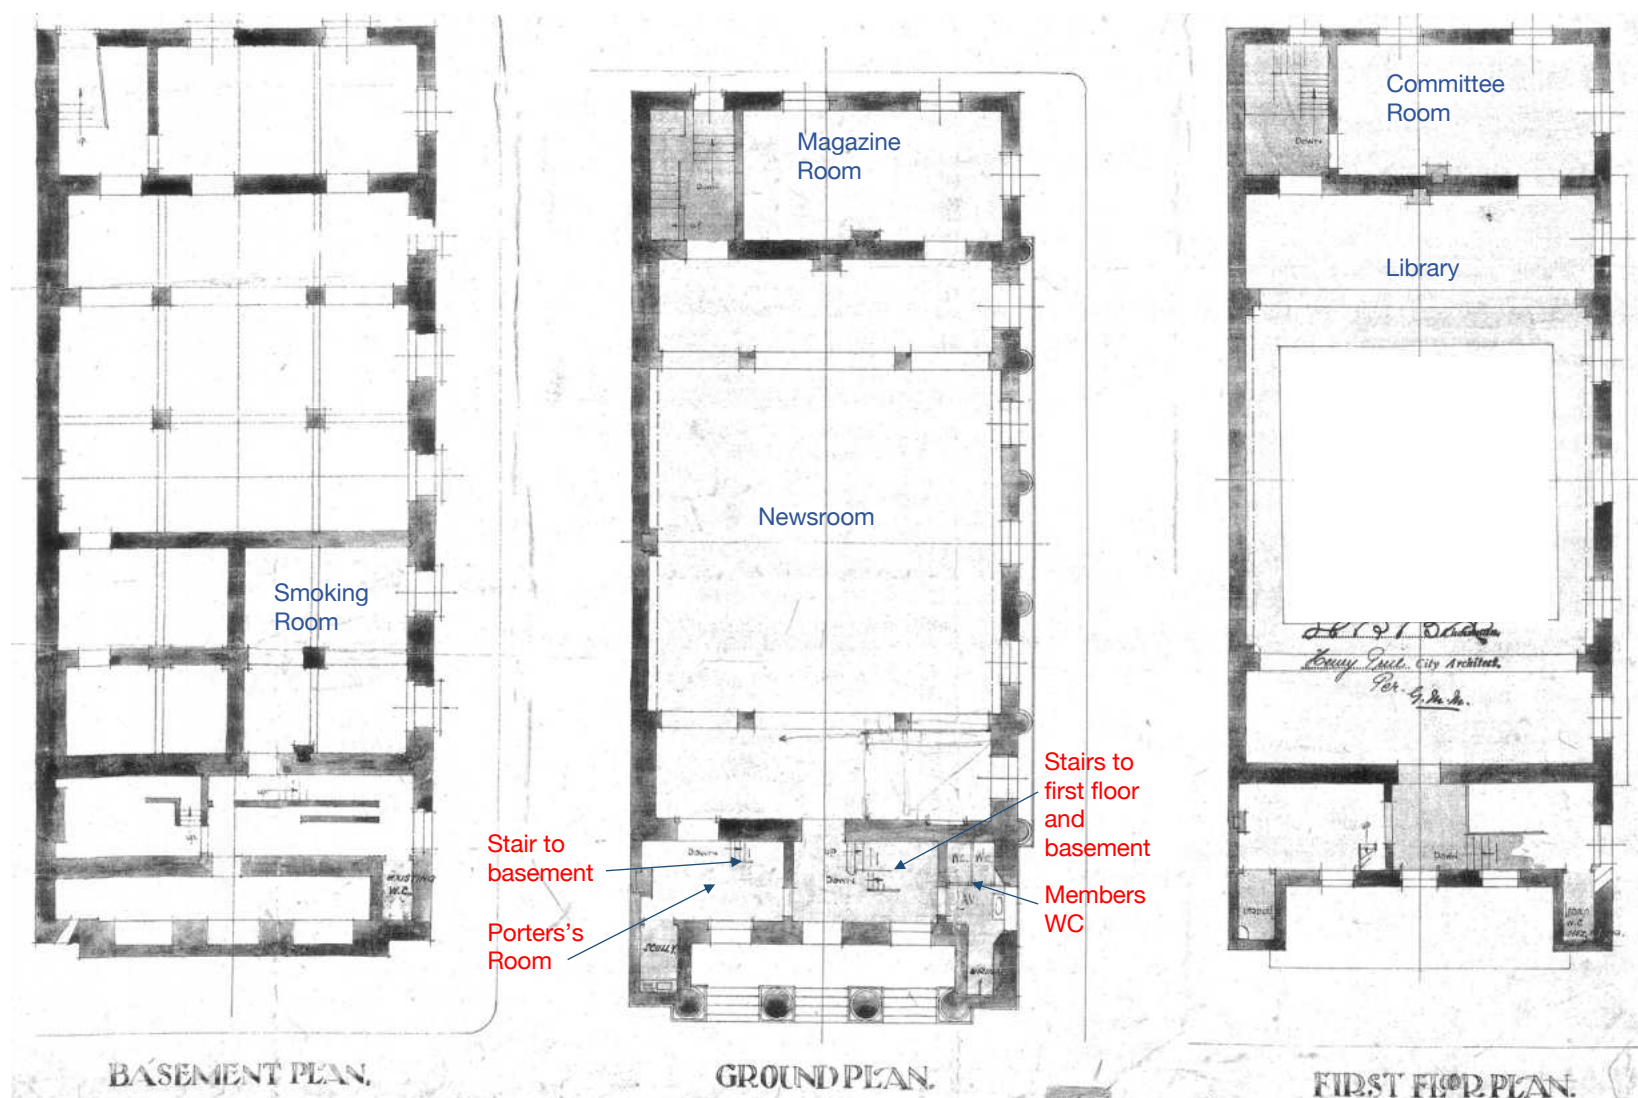
Plan of the building in 1920, annotated showing uses of rooms (blue) and features that have been removed subsequently (red)

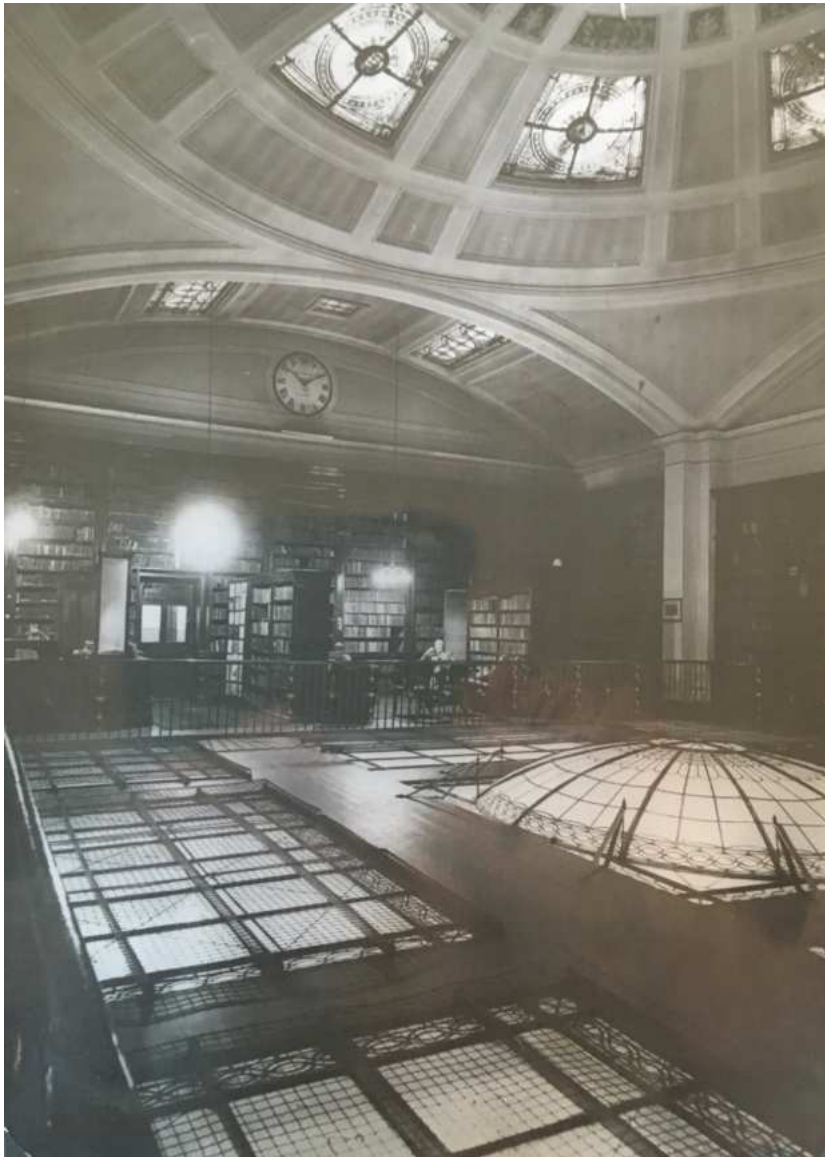
Photo of the Library level prior to the 1980s alterations

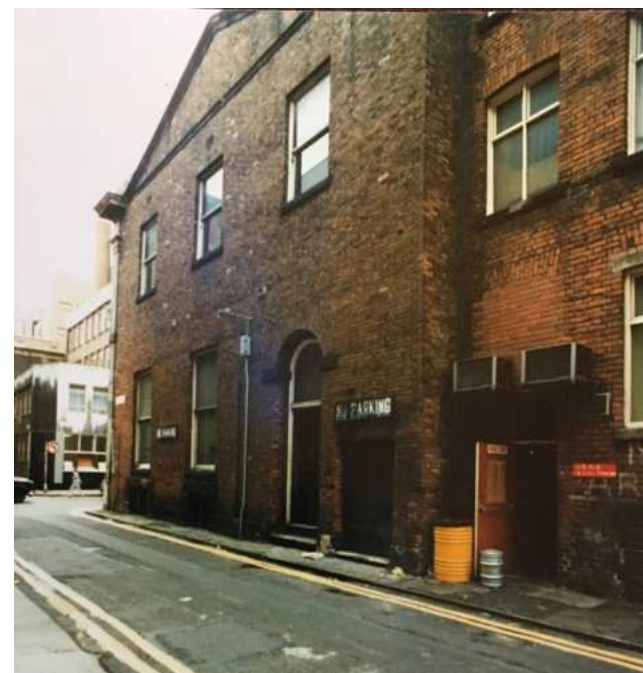
1986 photograph showing the central ground floor window that was subsequently converted into a fire escape for the Pub. The smaller escape door on the righthand side is already in place.

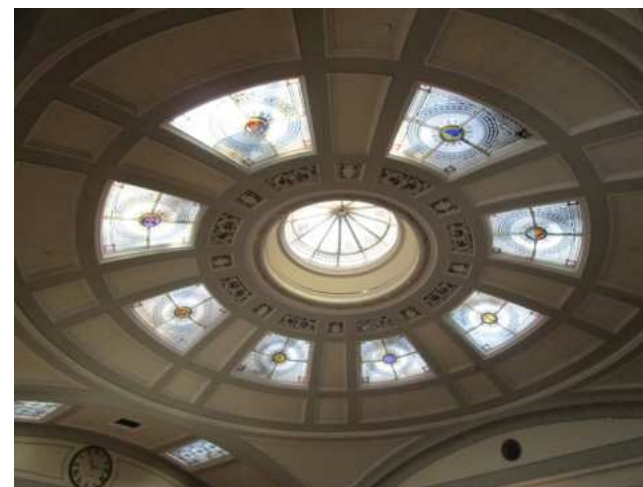
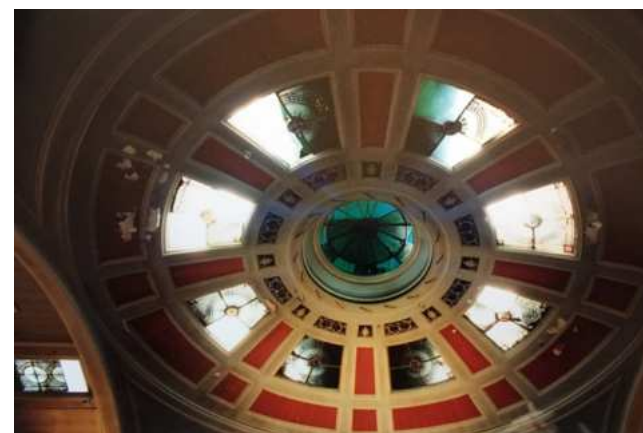
Above: the simple current colour scheme of the ceiling that highlights its form and detail – this is in contrast to the bold colour scheme of 1986 shown below, before repair and redecoration

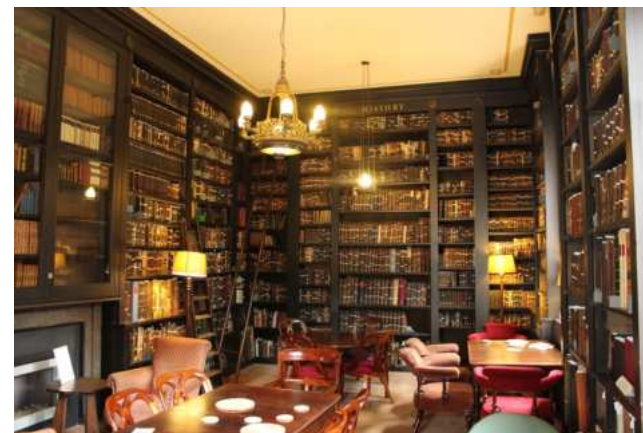
The Reading Room

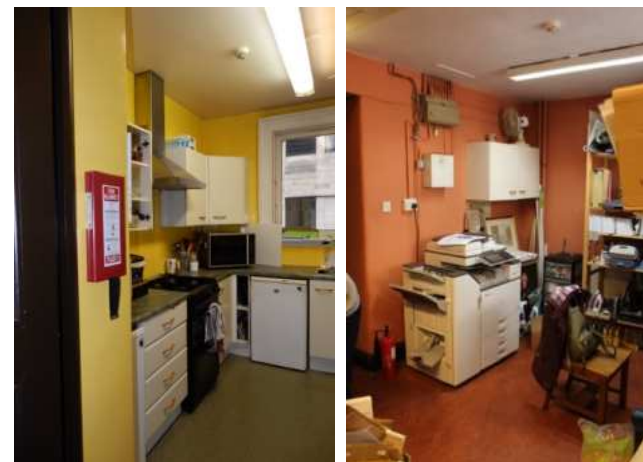
- 4.6.11 The Work Room also lacks significant features, with no historic joinery visible within the space. The room is visually dominated by an abundance of exposed services, such as the boiler, electrical distribution board and several pipes, plus fittings / equipment such as metal shelving and a photocopier. It should be noted, however, that an original cornice is understood to exist above the Work Room and Kitchen ceilings which is of significance to the building and should be considered in any proposals for this area.

The Kitchen and Work Room

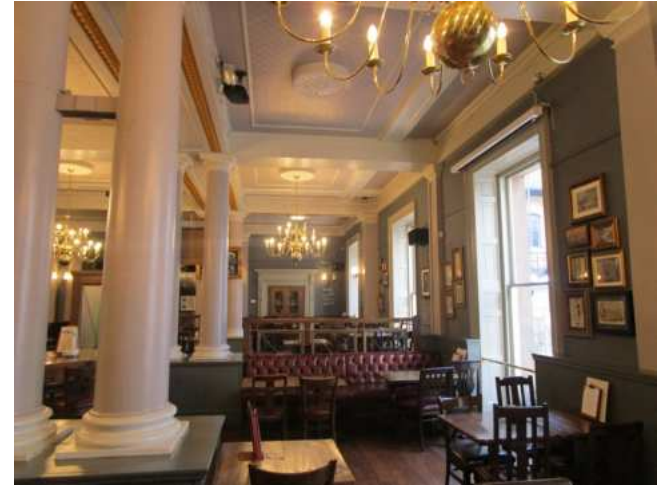
- 4.7.3 The main space still has much of the character of the bank space due to the visual dominance of the paired columns and large sash windows. There is some confusion caused by the recent insertion of 'replica' finishes and fittings – including: anaglypta wallpaper on the ceiling, ceiling roses, heavily-gilded picture frames, etc. There is also a slight detrimental incursion into the otherwise uninterrupted rectangular space – this is to form a protected staircase into the basement. Despite of a large number of changes, the space still has an overall high level of significance, retaining the proportions and some detail from the Hall of the Bank of Athens.

Main ground floor space

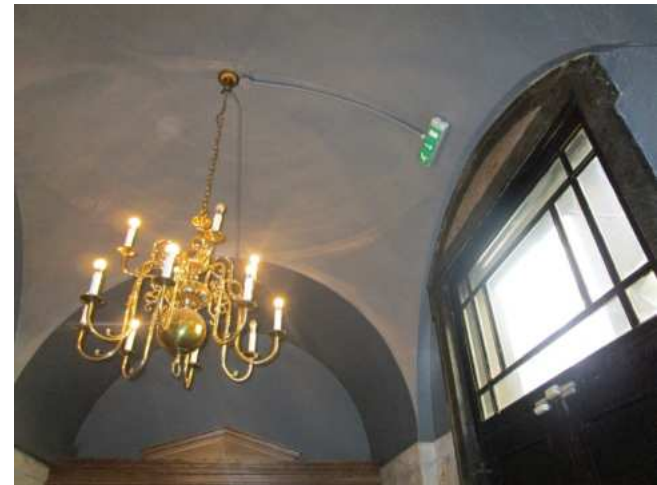
- 4.7.6 The main entrance vestibule appears to have retained its 1920s form generally intact. It has a domed (vaulted) ceiling with arched recesses either side. This, together with

Ground floor entrance vestibule

the doors and the marble lining make for a highly attractive space, which has a high level of significance relating to the development of the ground floor as a banking hall.

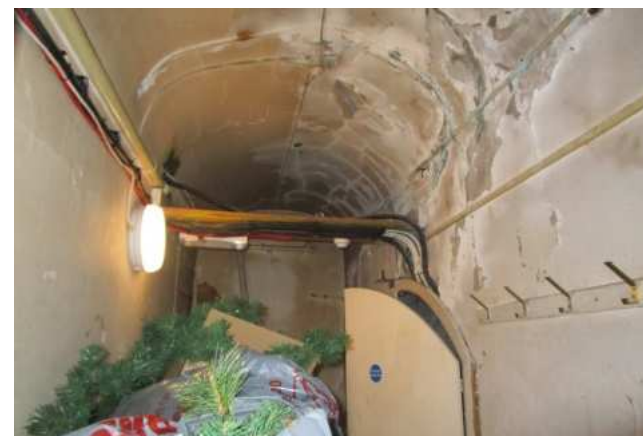
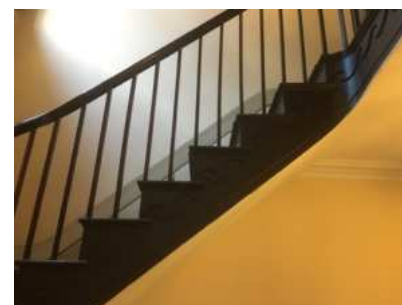
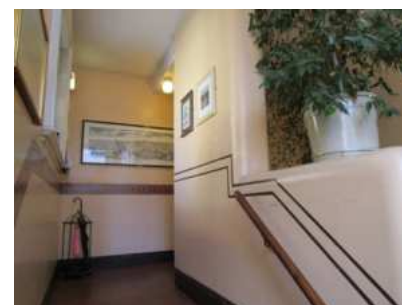
- 4.9.1 The main staircase serving the library dates from the 1920s and is very much reflects the characteristics of that period, with smooth curving corners and a distinct absence of timber mouldings or other plaster details. Visual interest is provided by simple lines painted on the walls that reflect the flow of travel and the Greek key on the outer wall – this detail, together with the colour scheme, are not original, however, as photographs from the 1980s show pink-red walls (also in an eggshell finish) with white lines. Sadly, now missing from the top of the stair is the bronze figurine that held a simple light fitting – it is understood that this was stolen. In summary this staircase

(From top) Barrel vaulted ceiling beneath from steps; rear staircase; WC; main stair as existing and in the 1980s.

has a high level of significance as it as it represents a key component of the 1920s changes and has some architectural features.

- 4.9.2 Situated off this staircase on three different levels are single toilet cubicles. The rooms themselves also date from the 1920s, but the only original elements are the doors, which were modified to replace the glass panels in painted MDF. This was undertaken at the same time as the general refitting, which included replica fixtures and fittings. In summary, these toilets have little historic interest, but contribute to the overall character of the stair therefore they moderate significance.

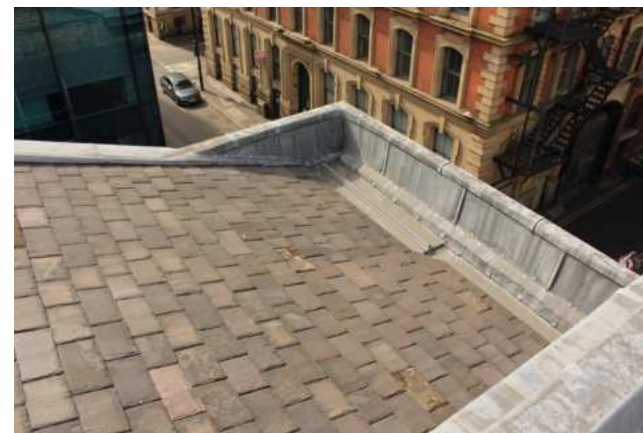
Roof – the low parapets pose a risk when attempting to clean lead gutters

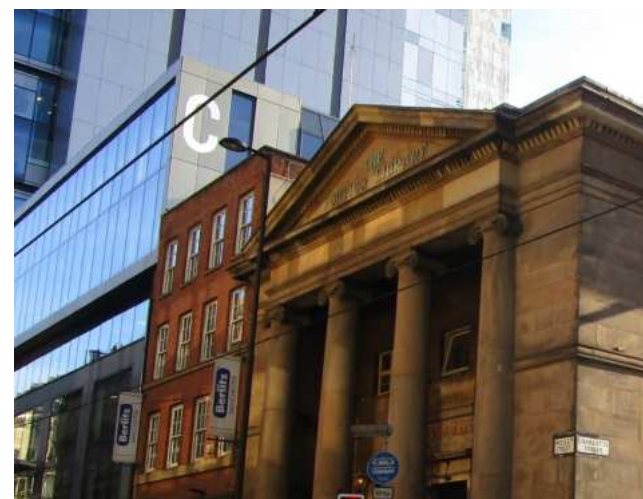
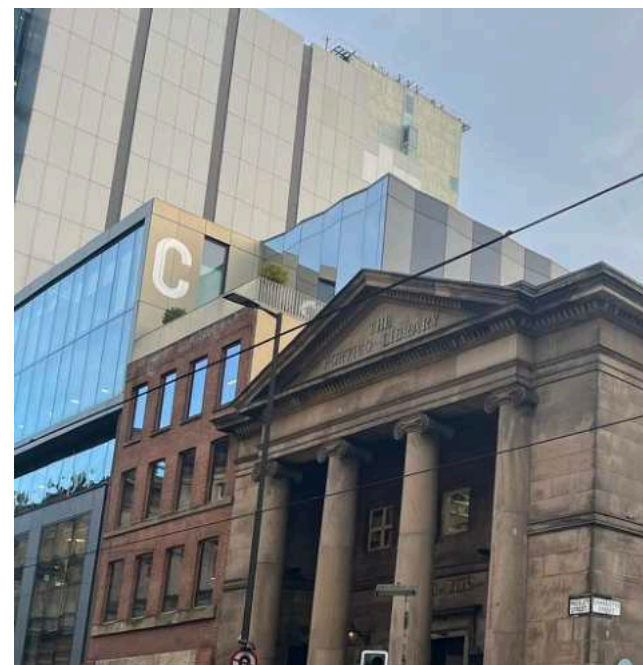
The impact of recent works to the adjacent building

- 5.2.5 Recent work to refurbish and extend the neighbouring building has highlighted the potential impact changes beyond the boundary may have on the Portico's fabric (there have been concerns that the rooftop extension may lead to a higher level of rainwater entering the existing disposal system and may therefore increase changes of leaks / subsequent damage.
- 5.2.6 In the future, it is equally possible that work along the street (e.g. by utilities companies or highways work) may also impact the fabric. Whilst the impact was not proven, the installation of the tramway also was thought to have potentially damaged internal plasterwork.

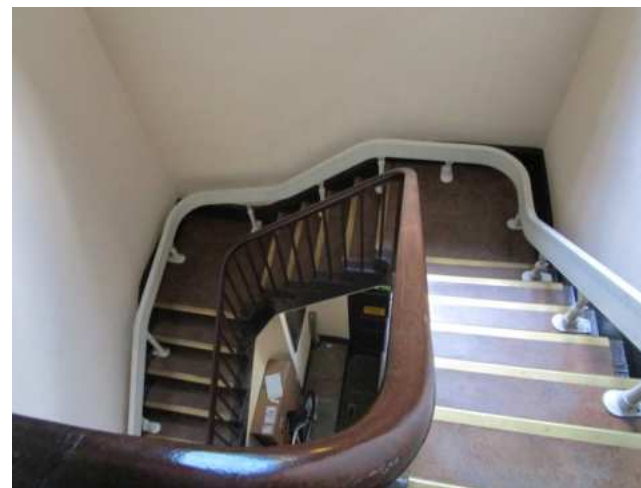
Stair lift in rear stair

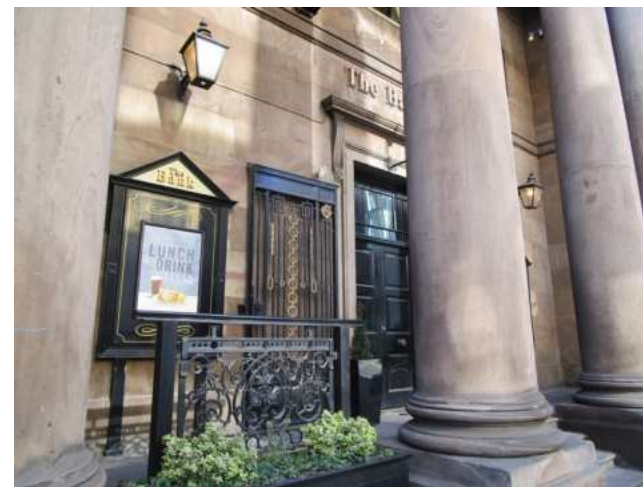
Evidence of the old window openings can be seen at ground floor level

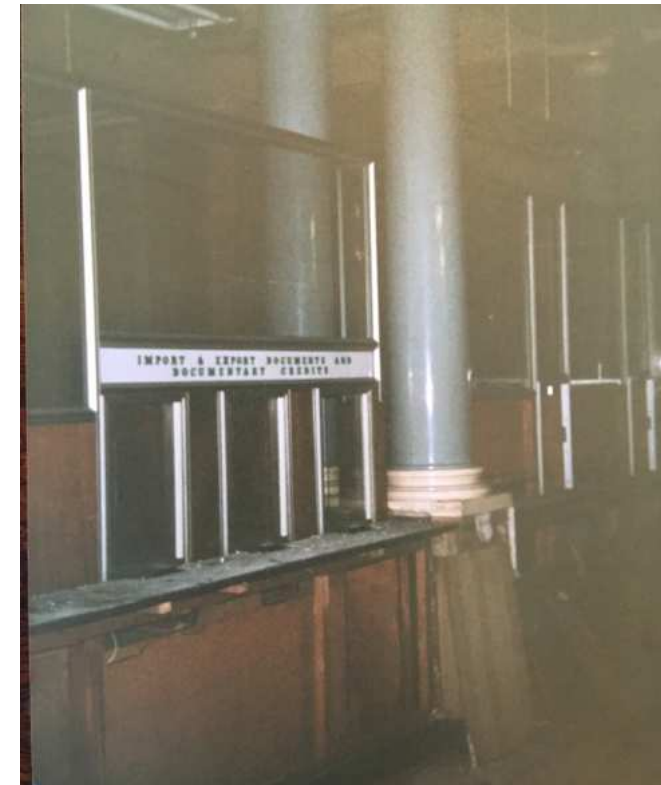
1986 image of the bank counters being dismantled. Note to the greeny-blue colour of the columns, which also appear highly polished, perhaps in imitation of granite.

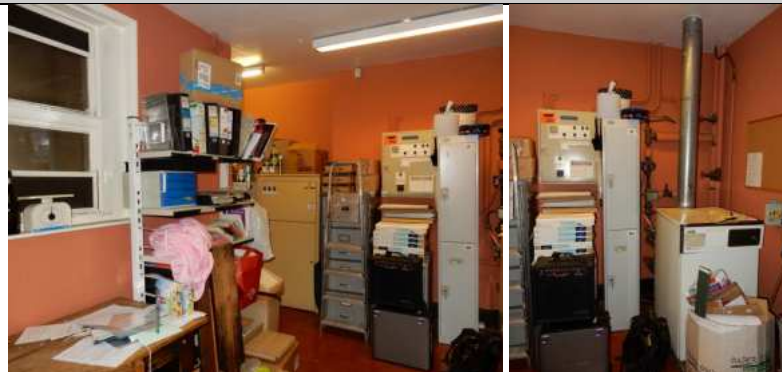
### Room F01 – Workroom / Staff Office

**Description:** L shaped room, containing storage, staff desks, the boiler and an access hatch to the roof space in the pediment.

**Condition / Notes:** Fairly unsatisfactory as an office, due to presence of boiler and storage pressure

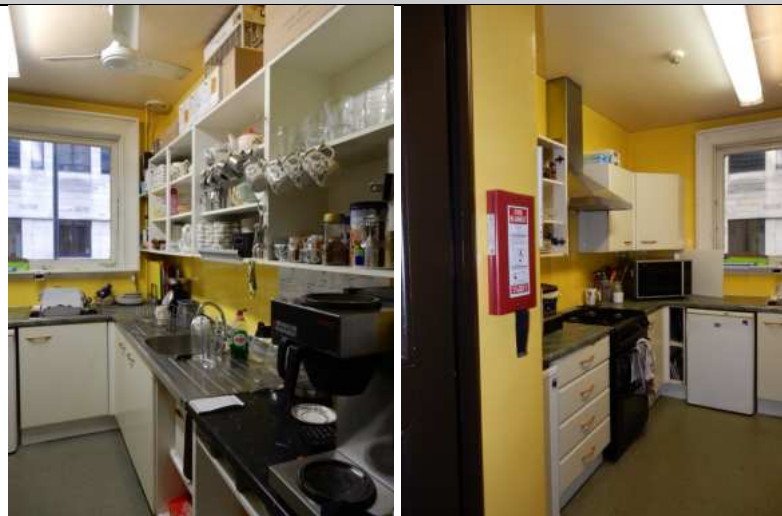
### Room F02 – Kitchen

**Description:** Small, square-shaped room, containing kitchen equipment and storage

**Historic Changes / Previous Forms:** Current form dates from 1994/5, when a new partition was installed between the staff room and kitchen, although the earlier, larger space had already been subdivided. Panelled door added to connect the kitchen to the main space in the 1994/5. Door blocked to the landing at this time.

**Condition / Notes:** Fairly unsatisfactory as a kitchen due to very small size.

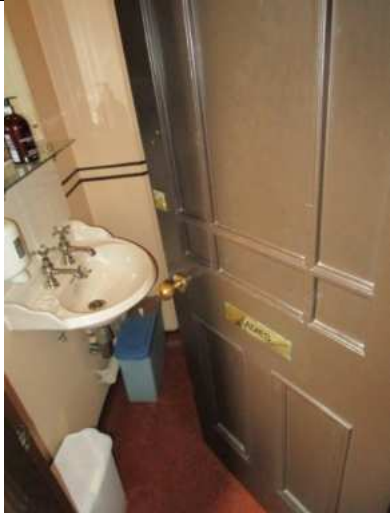
| Room F03a – First Floor Landing WC (note: also includes mezzanine level) | |
|---|---|
| | <b>Description:</b> Single WC off landing |
| | <b>Historic Changes / Previous Forms:</b> Dates from 1920s changes. Door glazing removed in 1995 and replaced with MDF. New plasterboard ceiling 1994. It is not completely clear whether the toilet fittings are reclaimed or fitted at this time. |

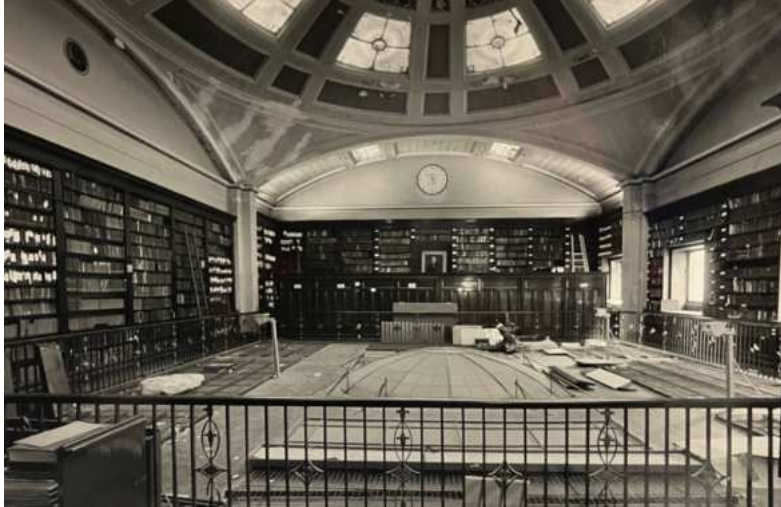
## Room F04 – Main Library Space

**Description:** Large rectangular space, now the main reading room of the library. The central section is used for events and seating for the café.

The large, unsupported dome is the most striking feature in the main space – it is in its original form, but the glazing dates from 1856. Running around the circumference of the raised lantern are a series of decorative vents. The remainder of the large dome (where not glazed) has coffered panels. The dome spans across the full width of the room – the areas to each end (where it does not reach) have shallow-arched vaulted ceilings, again with small laylights. The ceiling has been painted with a series of subtly varying shades of stone-coloured paint, which give it its form greater depth whilst adding to the airy-feel of the space.

**Condition / Notes:** Ceiling in need of redecoration and some repair.

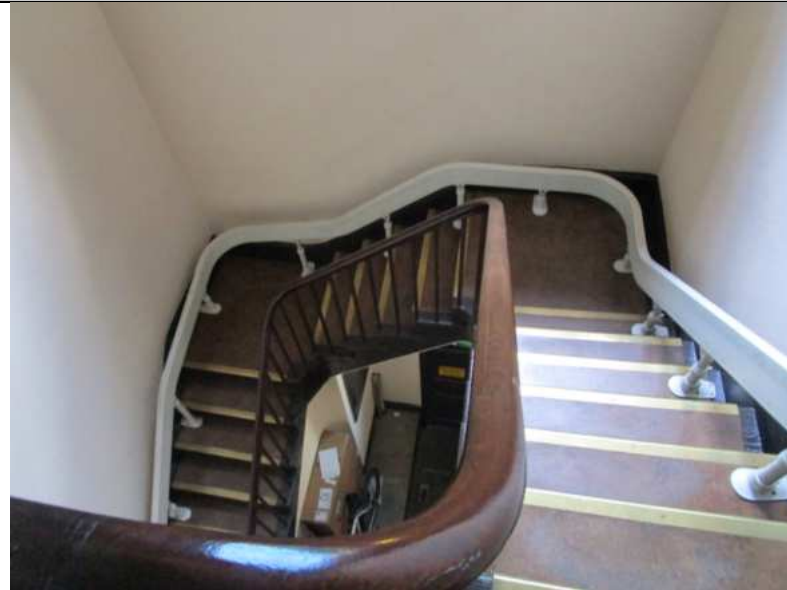
## Room F05 – Rear Stair

**Description:** Relatively airy / spacious stair and landing. Wheelchair lift installed. Stair has vinyl floor coverings and modern nosings.

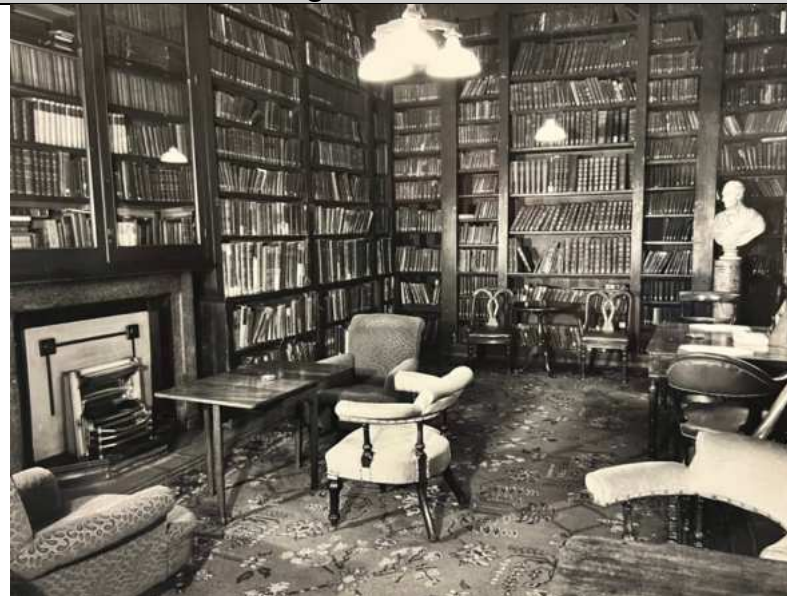
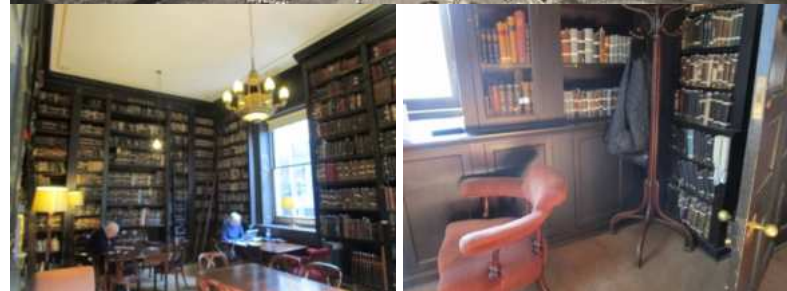
## Room F06 – Reading Room

**Description:** Rectangular room in its original form. Room fully lined with bookcases and with a fireplace on the internal wall. The reading room is a very attractive and relaxing space, but it has been altered over the years e.g. following a number of roof leaks. The bookcases onto Charlotte Street and the ceiling are modern (c. 1980s) and the remaining bookcases are distinctly different from those in the main library and possibly were installed at the time of the 1920s changes. The fireplace is again simple and presumably dates from the early 20th century, with a simple marble surround – the insert has been replaced in recent decades to accommodate a modern electric fire.

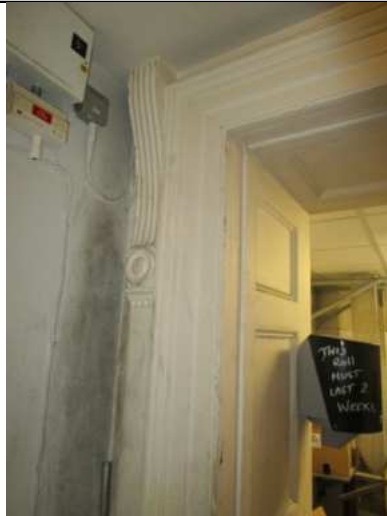
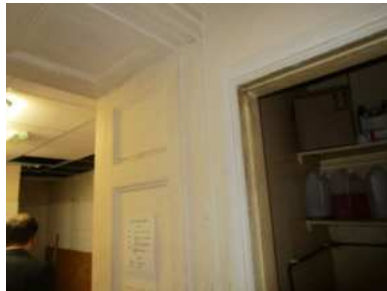
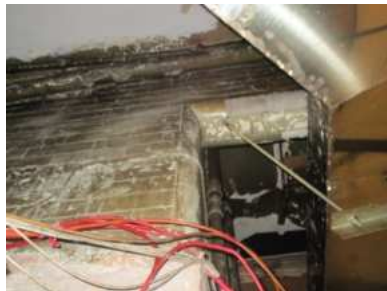
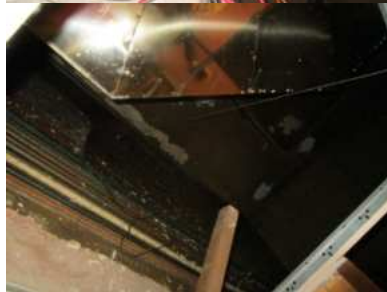
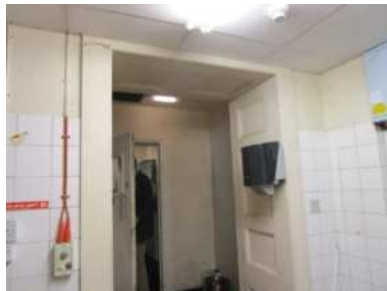
## Room G01 – Store

**Description:** L-shaped corner room, used for general storage.

**Historic Changes / Previous Forms:** Originally the porter's room with a small stair down to the basement and a 'scully' area in the recess. It was then probably converted to a cloakroom and WC in the 1920s and the stair removed. It was known to be a male lavatory during latter years of the bank's use.

**Significance / Sensitivity to Change:** Moderate significance as has some features from 1920 changes and earlier. Some change possible without harm, but loss of early features would need strong justification in terms of benefit to the rest of the building and/or mitigation in terms of recording etc.

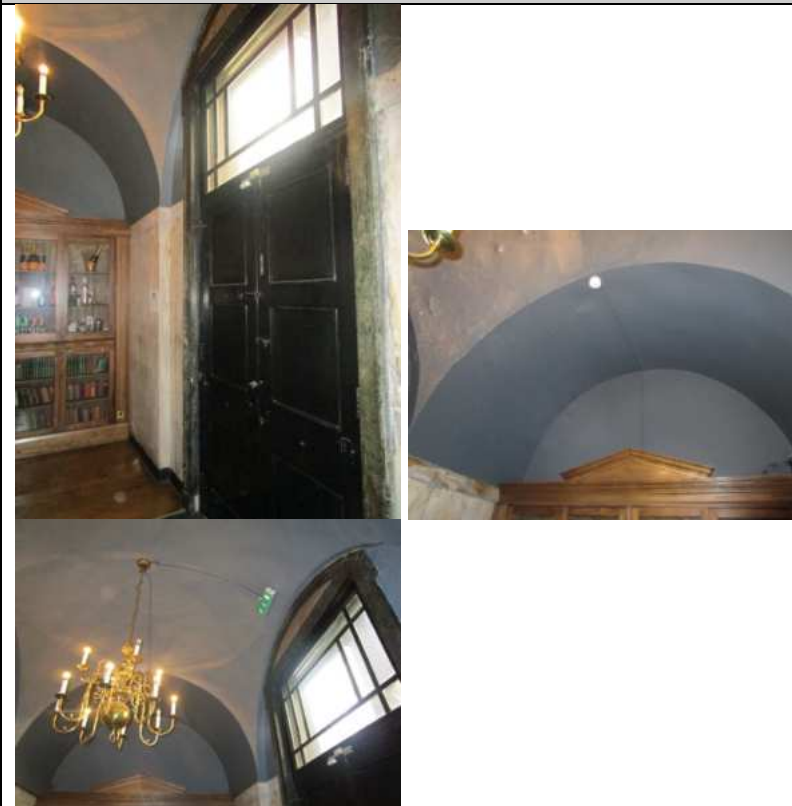
## Room G02 – Vestibule

**Description:** Rectangular lobby acting as main entrance to pub, but would have been the main entrance to the Library and Bank.

**Historic Changes / Previous Forms:** Current shape and form dating from 1920s remodelling – the original stair leading from the shape was removed, the vaulted ceiling presumably inserted, together with the symmetrical walls and finishes (e.g. door surround and wall cladding?).

**Significance / Sensitivity to Change:** High significance as strong architectural form dating from the 1920s works. Some change possible without harm, but the retention of the architectural character and symmetry/ balance would be important.

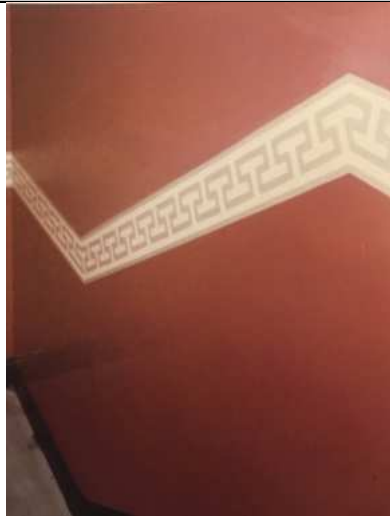
### Room G03 – Stair (Part of Library)

**Description:** Relatively small hallway, landing and stair

**Historic Changes / Previous Forms:** Dates from 1920s alterations. Changes to doorways made in 1990s.

**Significance / Sensitivity to Change:** High significance as it represents a key component of the 1920s changes and has some architectural features. Some degree of change may be possible without harm, provided that it is justified as benefitting the elements of very high significance.

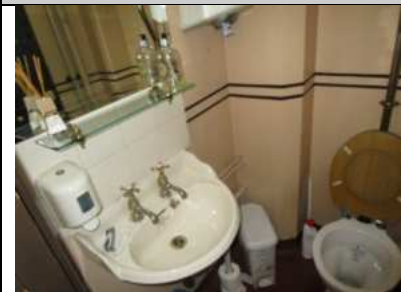
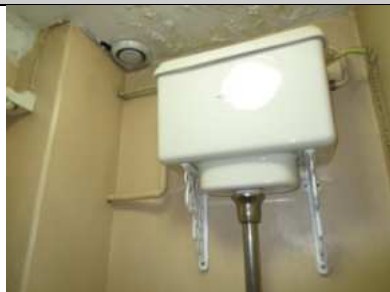
### Room G03a – Ground Floor WC

**Description:** Single WC off small hallway

**Historic Changes / Previous Forms:** Dates from 1920s changes. Door glazing removed in 1995 and replaced with MDF. New plasterboard ceiling 1994. It is not completely clear whether the toilet fittings are reclaimed or fitted at this time.

**Significance / Sensitivity to Change:** Moderate significance as part of 1920s changes but probably without original fittings, except door. Some change possible without harm, with consideration to the character of the part of the building in question.

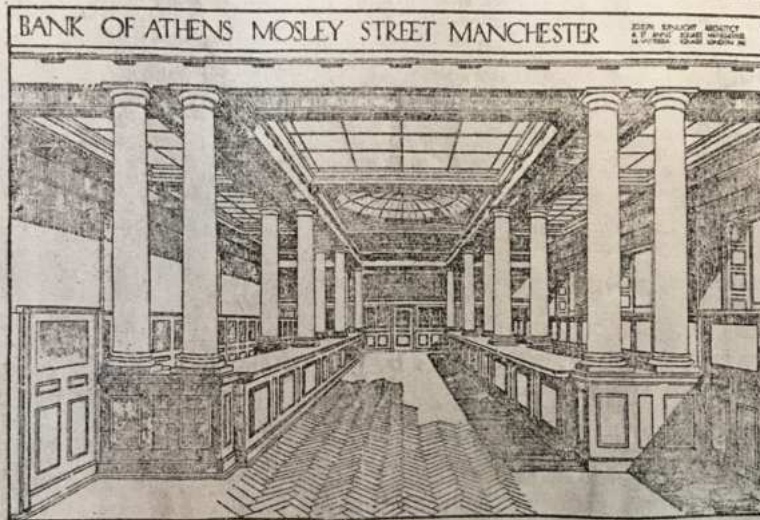
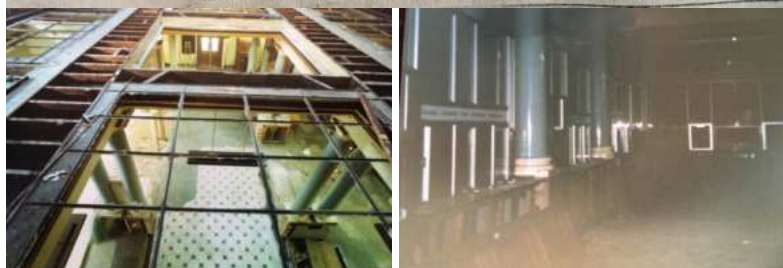
## Room G04 – Main Pub Space

**Description:** Currently main public area of pub. Large, nearly rectangular space with a small modern addition in one corner. Eight pairs of columns on square bases support the coffered ceiling above, which has moulded decoration and downstands. Modern bar. Pilasters, window linings and door surrounds survive. Central tiled floor likely to be from early-mid 20<sup>th</sup> century from Bank use. Panelling at top of stair down to basement from early banking hall.

**Historic Changes / Previous Forms:** Originally the Newsroom of the Library prior to conversion into the main Banking Hall for the Bank of Athens in the 1920s. Later during the use as a bank, subdivisions were added to form offices on the south-west (window) side.

**Significance / Sensitivity to Change:** High significance due to the survival of the much of the 1920s character and fabric, probably together with a few components probably from the original scheme, such as architraves. Some change possible without harm, particularly where modern elements are replaced, but changes should preserve and enhance the strong architectural form of the space and the understanding of both the original and 1920s forms. There would be a presumption against removal of original / 1920s components without a strong justification.

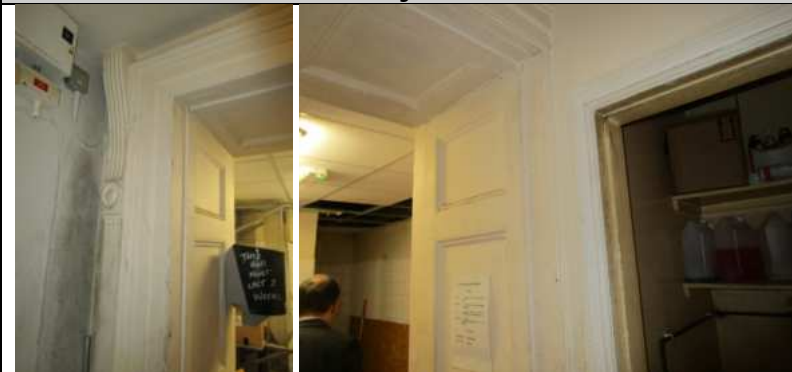
### Room G05 – Store / Lobby

**Description:** Small pair of linked rooms created in the late 20th century. Historic door surround visible however.

**Historic Changes / Previous Forms:** Modern partitions, fixtures and fittings.

**Condition / Notes:** Basic quality

**Significance / Sensitivity to Change:** Detrimental to the significance of the building as a whole as the installation adversely impacts the balance, proportions and character of the main ground floor space.

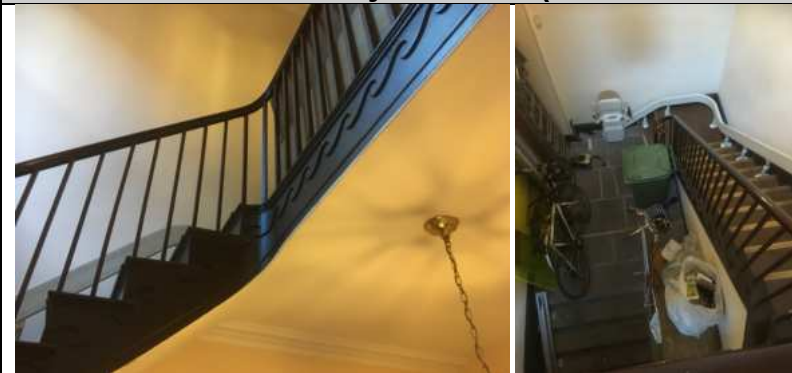
### Room G06 – Rear Lobby and Stair (Connects to Library)

**Description:** Relatively airy / spacious stair and hallway. Wheelchair lift installed. Stair has vinyl floor coverings and modern nosings.

**Historic Changes / Previous Forms:** Generally in original form (i.e. from 1806) but refurbished in c. 1990 (e.g. installing new skirtings and replacing damaged slates etc).

**Condition / Notes:** The wheelchair lift has been beneficial for access as a temporary measure but it has an unexcitable impact of the usability of the stair for able-bodied people and also impacts the character of the original stair.

Some degree of change may be possible without harm, provided that it is justified as benefitting the elements of very high significance and alterations do not impact original fabric.

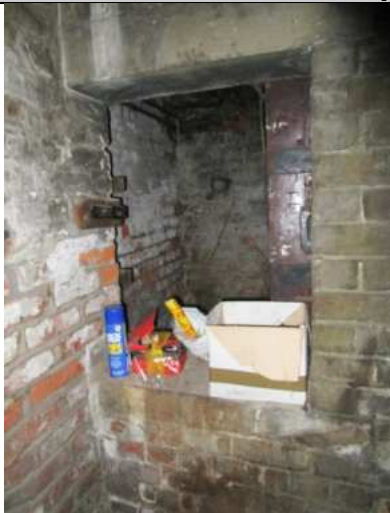
| Room B01 – Basement Space – Fuel Store | |
|---|---|
| | <b>Description:</b> Unused space with low-height sliding door from adjacent room |
| | <b>Historic Changes / Previous Forms:</b> Wall blocked – originally the space extended all of most of the way across the frontage. Probably originally a fuel (coal?) store. Door later – not on 1920 plan, but presumably early in bank's history. |
| | <b>Condition / Notes:</b> Not accessed. |
| | <b>Significance / Sensitivity to Change:</b> Moderate significance as the space survives largely in an early form. Some change possible without harm, but alterations should be justified in terms of benefit to the overall significance of the building. |

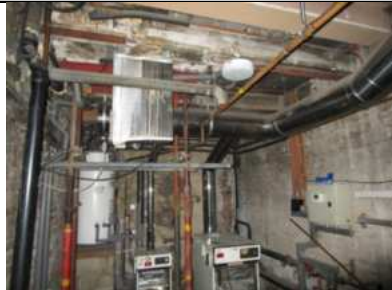
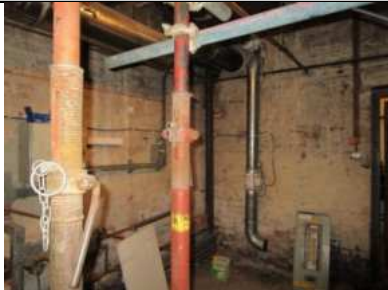
## Room B02 – Basement Plant Room

**Description:** Plant room with exposed brick walls.

**Historic Changes / Previous Forms:** Originally room had its own stair to Porter's Room above – may have been a small bedroom? Probably converted to boiler house in 1920s – still shown as heating chamber in 1980s

**Condition / Notes:** Modern M&E equipment visually dominates space. Some propping?

**Significance / Sensitivity to Change:** Neutral significance as space greatly altered leaving little or nothing in the way of historic features. A fairly large degree of change possible without harm to the significance of the building as a whole provided no original features (if found) are lost.

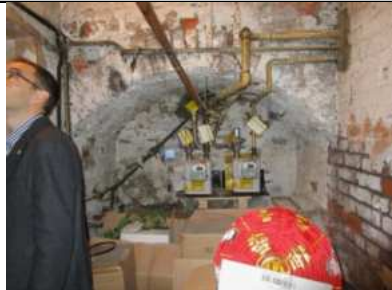
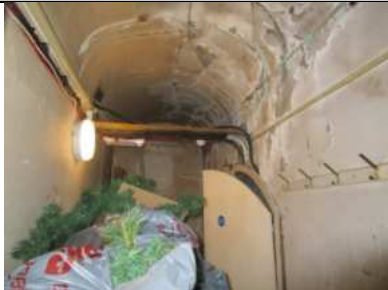
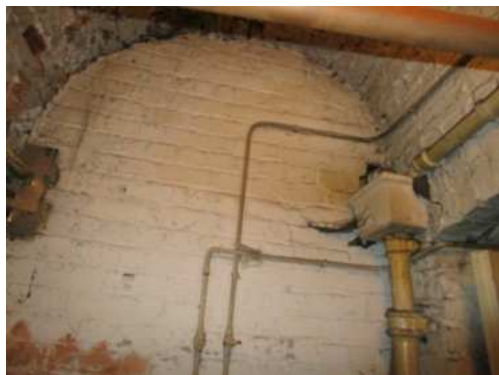
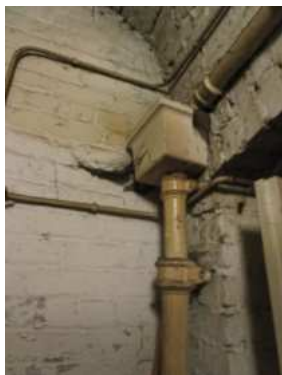
## Room B03 – Basement Room

**Description:** Narrow space under front steps, possibly originally a fuel store but now used for general storage. Part of the room is plastered, implying a use, such as a WC.

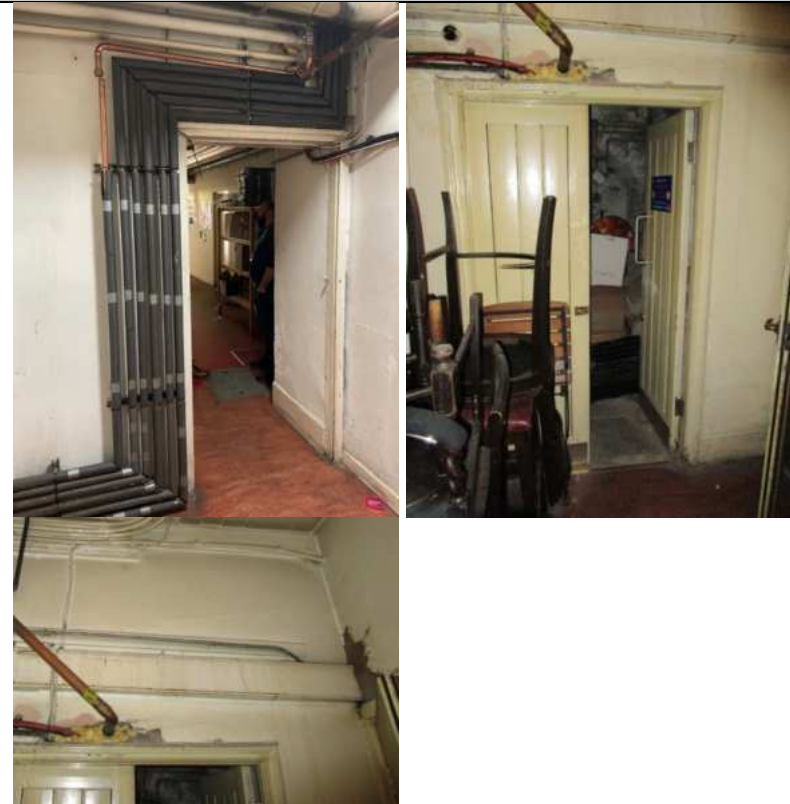
## Room B04 – Basement Lobby / Corridor

**Description:** Small lobby. Painted plaster walls / ceiling and vinyl covered floor.

**Historic Changes / Previous Forms:** Area reconfigured during 1920s changes. Additional wall put in presumably in the late 1980s to separate off the library WCs.

**Condition / Notes:** Visually dominated by service runs.
