# THE PORTICO LIBRARY, MANCHESTER

Conservation Management Plan  
Chambers Conservation Ltd, July 2025 – Issue 3

The purpose of this report is plan is to assess the significance of the building and its components to help guide future decision making and change.

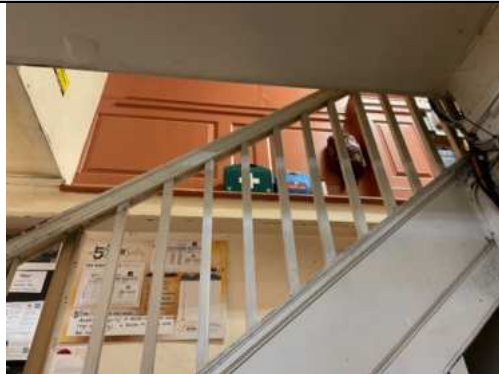
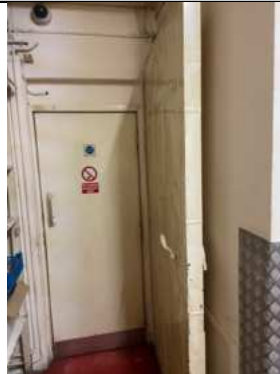
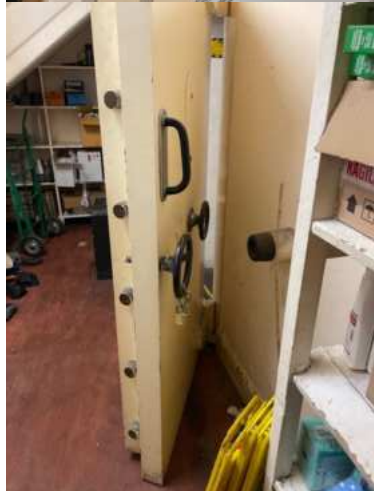
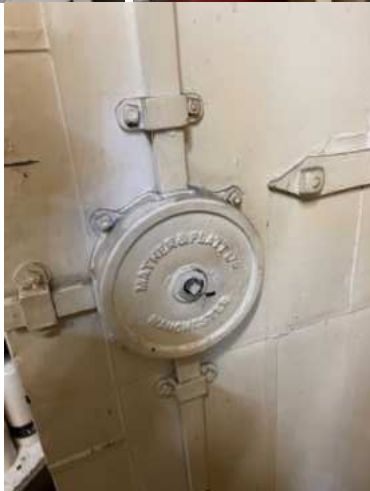
## Room B06 – Basement Room

**Description:** Small storage room with timber stair coming from ground floor. Painted plaster walls / ceiling / vinyl covered floor. Hoist to ground floor.

**Historic Changes / Previous Forms:** Stair dates from after 1920s

**Condition / Notes:** Stair relatively simple, with a modest amount of detailing to the strings and plain square-section balusters. Robust 20<sup>th</sup> century metal security / safe door to Room B07 adjacent. Older (20<sup>th</sup> century) secure door retained to corridor B08 with modern flush door in front.

**Significance / Sensitivity to Change:** Moderate significance as the partial survival of the stair and 1920s cupboard helps visually tell the story of the evolution of the building. The exposed brickwork shows some of the original / early character. Some change possible without harm but alterations should be justified in terms of benefit to the overall significance of the building.

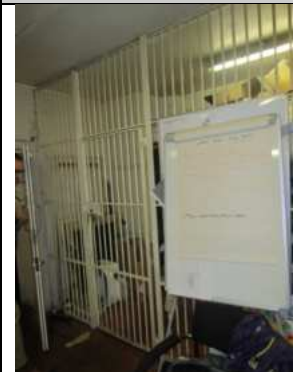
## Room B07 – Basement Room – Staff Office / Strong Room

**Description:** Staff office with secure area behind a railing.

**Historic Changes / Previous Forms:** Shown as 'strong room' during 1980s. Originally would have had a different opening to adjacent room plus another to the larger space beyond.

**Condition / Notes:** Finishes appear to be modern.

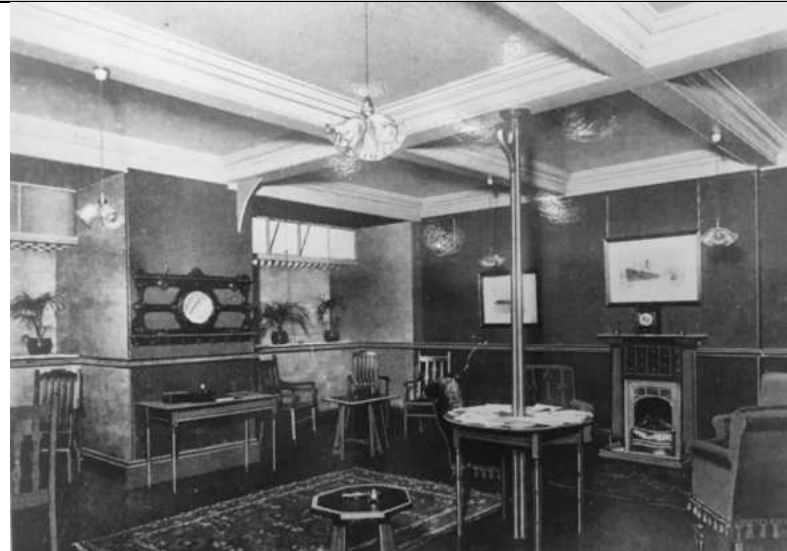
## Room B08 – Basement Corridor

**Description:** Corridor connecting various basement rooms. Painted plaster walls and ceiling. Vinyl floor covering. All modern flush doors. Decorative cast iron vent at high level on solid wall may be an older feature.

**Historic Changes / Previous Forms:** Was part of Smoking Room (up to 1920s) and then possibly a staff room in initial bank years. Subdivided later during bank occupation and further for the pub use.

**Condition / Notes:** It appears likely that the cornice and dado features in the historic photo have been lost (it is understood that the ground floor was entirely replaced in concrete). Modern services visually dominate.

**Significance / Sensitivity to Change:** Neutral significance as space greatly altered leaving little or nothing in the way of historic features. A fairly large degree of change possible without harm to the significance of the building as a whole provided no original features (if found) are lost.

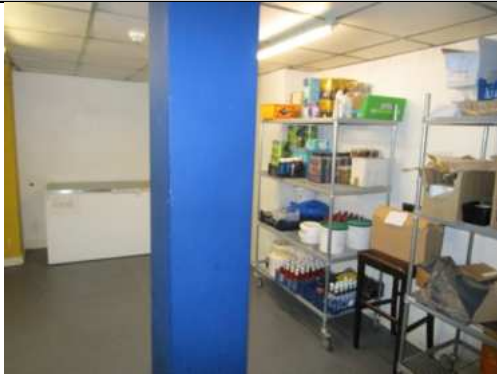
| Room B11 – Basement Room | |
|---|---|
| | <b>Description:</b> roughly square room, subdivided from a previous larger space. Painted brick walls to NW and NE, modern plasterboard (?) to other walls. Concrete column roughly centrally. |
| | <b>Historic Changes / Previous Forms:</b> Partitions added in mid – late 20 <sup>th</sup> century. Was previously one large space across full width of basement. Wall on north-west side likely to be a later skin, possibly to provide additional security for the bank. |

| Room B12 – Basement Room – Small lobby | |
|---|---|
| | <b>Significance / Sensitivity to Change:</b> In current form / presentation detrimental to the significance of the building as a whole as original / early form of room not visible and has little in the way of historic features. A fairly large degree of change possible without harm provided original walls remain intact. |

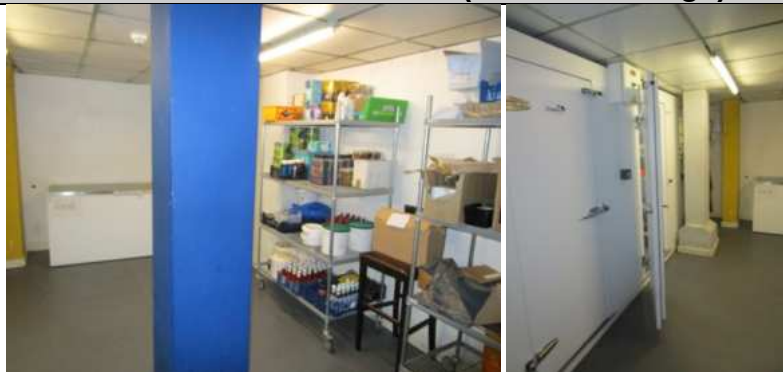
### Room B14 – Basement Room (Kitchen Storage)

**Description:** Space entirely lined with modern panels. Suspended tiled ceiling and vinyl floor. Modern refrigerator built within space. Square sectioned, presumably concrete, columns. Modern flush doors.

**Historic Changes / Previous Forms:** Partitions added in mid – late 20<sup>th</sup> century to the north-west and south-west sides of the room. Was previously one large space across full width of basement.

**Condition / Notes:** It is not possible to know what may survive (in terms of historical evidence) under the modern surfaces.

**Significance / Sensitivity to Change:** In current form / presentation detrimental to the significance of the building as a whole as original / early form of room not visible and has little in the way of historic features. A fairly large degree of change possible without harm provided original walls remain intact.

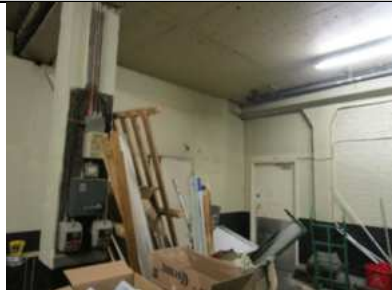
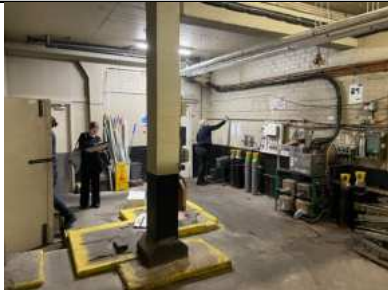
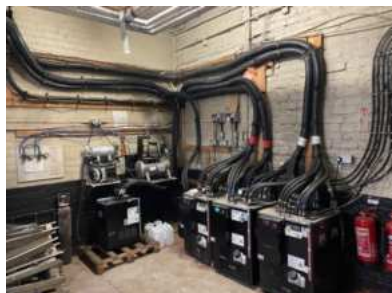
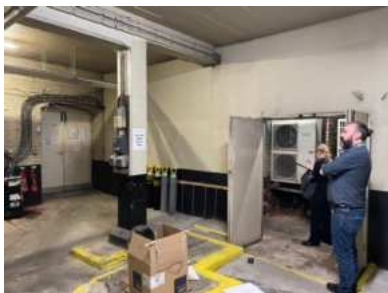
## Room B15 – Basement Room

**Description:** Rectangular room with concrete floor above exposed. Concrete floor and a square column. 20<sup>th</sup> century infill brickwork. Later plasterboard (?) partition to south-west.

**Historic Changes / Previous Forms:** Partitions added in mid – late 20<sup>th</sup> century. Was previously one large space across full width of basement.

**Historical Documents / Evidence:** Shown as an unnamed space in 1920s plans. Shown as 'Air Conditioning Plant' on 1980s plan as one space with adjacent room. Concrete bases presumably from previous equipment.

**Condition / Notes:** Visually dominated by service runs and equipment. Modern flush doors.

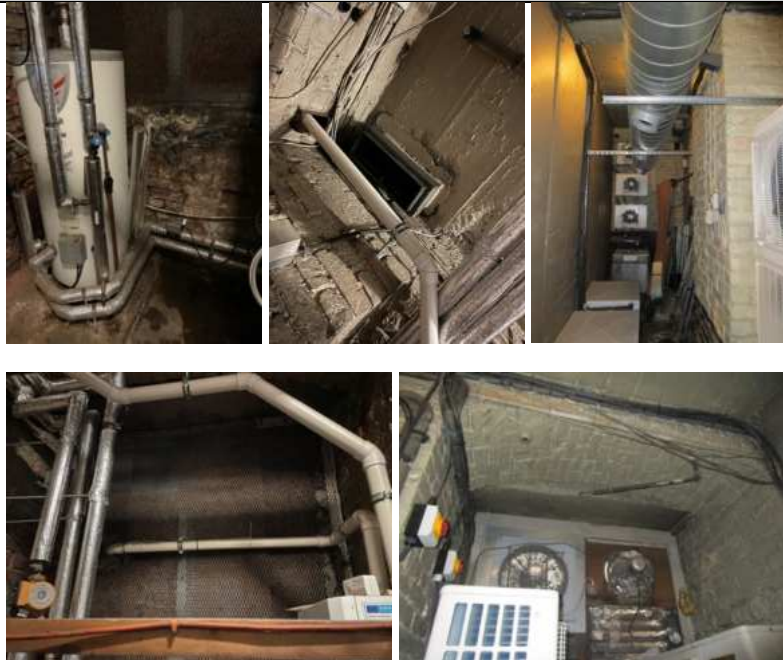
**Description:** Long, thin space using former lightwells. Exposed brickwork with modern boarded partition to north-east side. Now contains water tanks and heating / air handling equipment. Steel mesh fixed over openings.

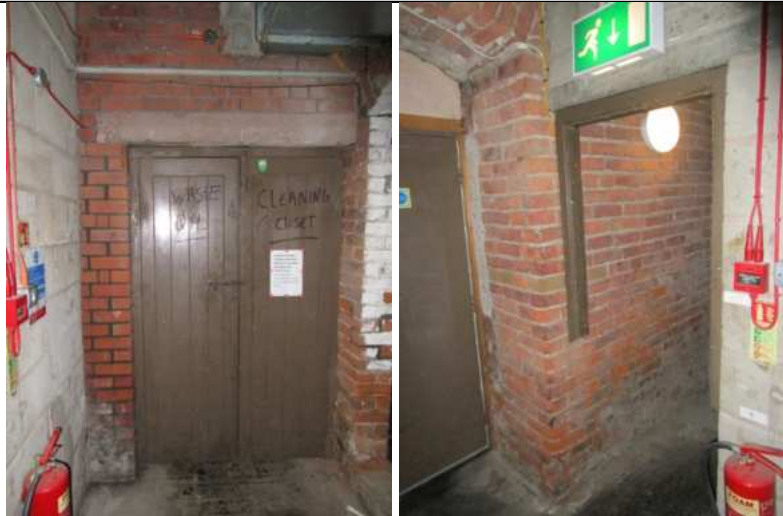
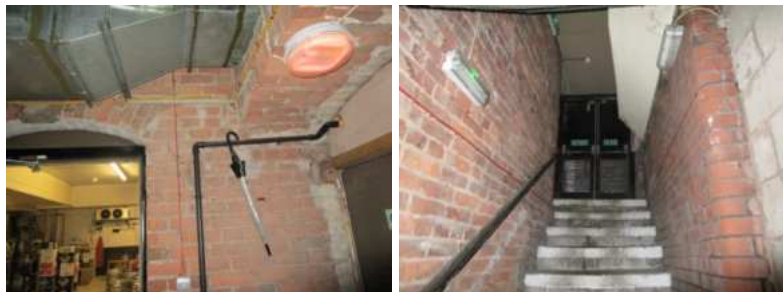
## Room B17 – Basement Room – Rear Stair Lobby

**Description:** Stair to connect basement with rear ground floor. Small cleaners store in cupboard.

**Historic Changes / Previous Forms:** Room generally as pre-1920s alterations. Stair appears to have been simplified as was originally wider at base. Walls added and amended alongside stair. Cupboard added in 1920s work.

**Condition / Notes:** Space poorly presented due to services, modern blockwork and crude repairs and alterations.

**Significance / Sensitivity to Change:** Moderate significance as the partial survival of the stair and 1920s cupboard helps visually tell the story of the evolution of the building. The exposed brickwork shows some of the original / early character. Some change possible without harm but alterations should be justified in terms of benefit to the overall significance of the building.

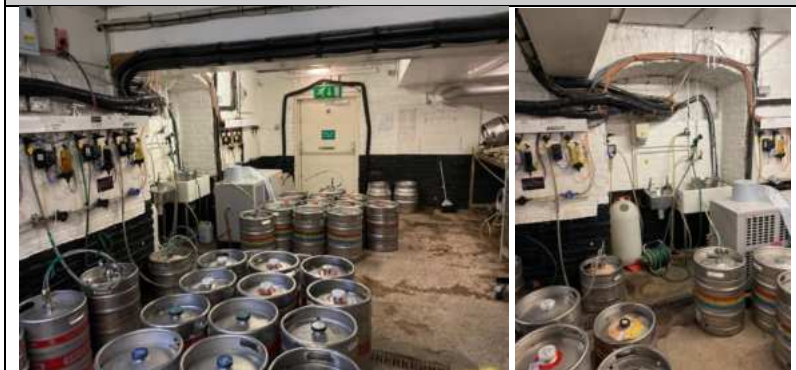
## Room B18 – Basement Room

**Description:** Rectangular room which appears to be in its original form, currently used for beer storage. Painted brick walls and a possibly older (?) concrete floor. Modern flush panelled ceiling. Modern mechanical barrel drop / hoist.

**Historic Changes / Previous Forms:** Remains in its early form.

**Condition / Notes:** Visually dominated by services. Lightwell blocked over.
