# Preliminary Ecological Appraisal and Roost Assessment

St George's, Abbey Hey Lane, Manchester M18 8RB

Imaan Capital LTD

This report is prepared to inform a planning application with the Manchester City Council. The proposal is described as:  
The demolition of the existing dwelling on site and the construction of a new build dwellings

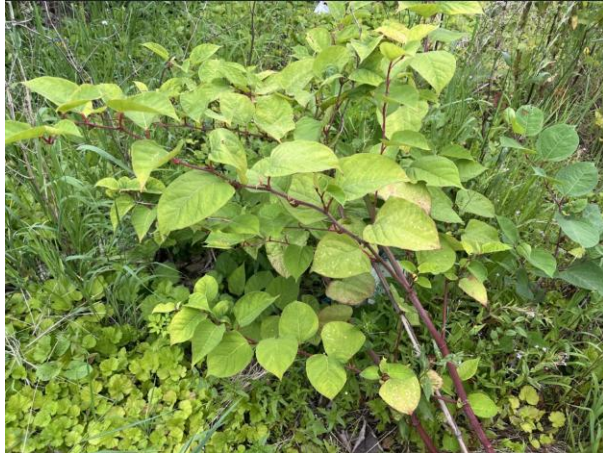
| <i>Summary of Survey Findings</i> | <p>Japanese Knotweed was identified on the site which is listed as an invasive, non-native species under Schedule 9 of the Wildlife and Countryside Act 1981.</p> <p><i>Figure 1 - Japanese knotweed</i></p> |

| <i>Foreseen Impacts</i> | Construction could result in the spread of Japanese Knotweed. |
| <i>Recommendations</i> | An invasive species management plan will be required to control and/or eradicate Japanese Knotweed. |

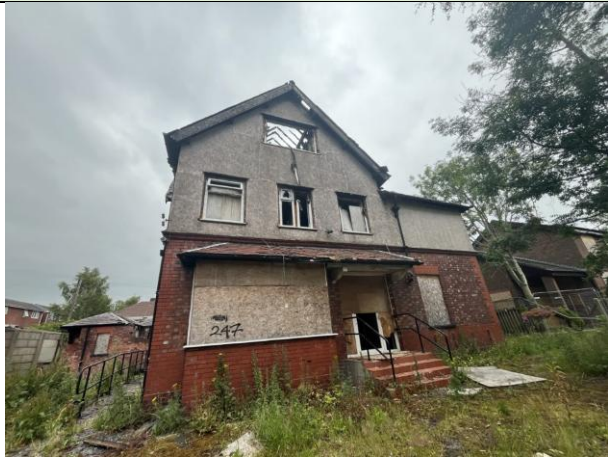
| <b>B1 Building description</b> | | | <b>Photographs</b> |
|---|---|---|---|
| <p><i>Summary</i></p> <p>B1 is a three storey, disused residential dwelling. The building has been subject to heavy fire damage and anti-social activity. The interior of the building could not be fully inspected due the unknown stability of the structure due to the damage from extensive fire damage and damp. The building has several damaged windows and doors, with ~30% of the roof remaining. The roof is slate constructed and multi-gabled, with wooden soffits. The walls are a mix of render and brick. Some of the doors and windows are boarded, with others smashed. There is a single storey, L shape extension to the northeastern corner of B1 with a hipped roof structure.</p> <p>The building has <b>moderate habitat value</b>.</p> | | | |

| | <p><b>B2:</b> In the unlikely event that a bat or evidence of bats is discovered during the development all work must stop and a bat licensed ecologist contacted for further advice.</p> <p><b>B1:</b> Three bat emergence/re-entry surveys are required on B1 during the active bat season (May – September) to confirm presence/likely-absence of bats roosting in or on the building. Although the building is considered moderate habitat value, the dropping found indicates exploratory behaviour and therefore full investigation is required to assess the use of the building by bats.</p> <p>These survey visits should be completed during the optimal survey period mid-May to August inclusive. The survey visits should be at least three weeks apart.</p> <p>Sub-optimal: early May and September. Would require greater justification of timing e.g., weather conditions, known local bat activity.</p> <p>Four surveyors and two unmanned IR cameras are required to provide full coverage of the building's elevations to look for emerging/re-entering bats. An infrared camera should also be employed at each position as part of the survey to see where any specific roost locations are located.</p> <p>Lighting mitigation may be required based on the outcome of the night bat survey(s).</p> <p>If any bat roosts are confirmed from this survey schedule, a bat licence would be required to demolish the buildings as it would involve the destruction of roosts. This is applied for with the help of a class 2 licensed bat ecologist after planning permission is granted, but before commencement of works.</p> <p>DNA analysis of the dropping found will also be required to inform the survey effort.</p> <p><b>Roosting habitat [Trees]</b></p> <p>In the unlikely event that a bat or evidence of bats is discovered during the development all work must stop and a bat licensed ecologist contacted for further advice.</p> <p><b>Foraging and commuting habitat</b></p> <p>No further surveys are required.</p> <p><b>Artificial lighting</b></p> <p>A low impact lighting strategy will be adopted for the site during post-development which outlines the areas of the site that will be retained as dark corridors. Parameters can be found on the Bat Conservation Trust website:<br/> <a href="https://www.bats.org.uk/our-work/buildings-planning-and-development/lighting-2">https://www.bats.org.uk/our-work/buildings-planning-and-development/lighting-2</a></p> <p><b>Suggested biodiversity enhancements</b></p> |

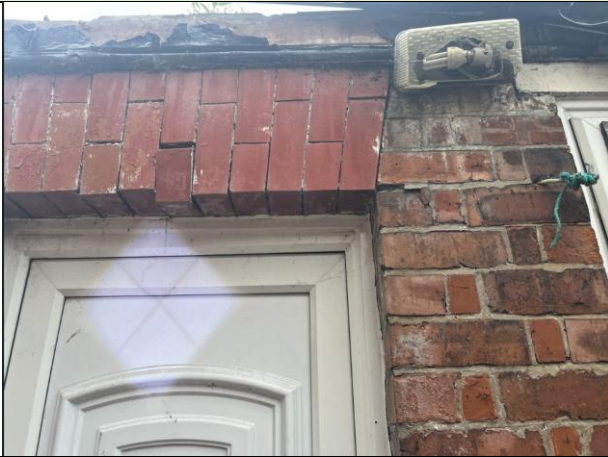
| <b>B1 Building description</b> | | | <b>Photographs</b> |
|---|---|---|---|
| Walls | Brick and render | <p><b>Condition/description</b></p> <p>There are a small number of observed crevices between the bricks on the single storey extension on the western facing wall elevation.<br/>No further crevices noted.</p> <p><b>Suitability/access/evidence of bats</b></p> <p>The crevices are suitable for small numbers of crevice dwelling bats.</p> | |

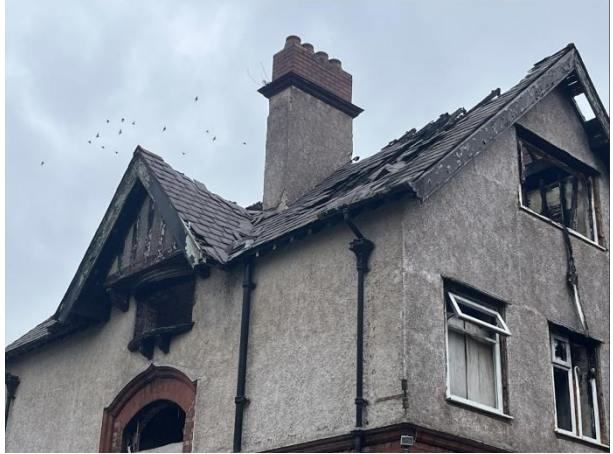
| Roof | Slate | <p><b>Condition/description</b></p> <p>The majority of the roof has been subject to fire damage and therefore a large portion of the roof is missing. The remainder of the roof have lifted tiles present. These lifted tiles provide crevices and gaps.</p> <p><b>Suitability/access/evidence of bats</b></p> <p>The lifted tiles on the remainder of the roof allow for roosting features for small numbers of crevice dwelling bats.</p> | |

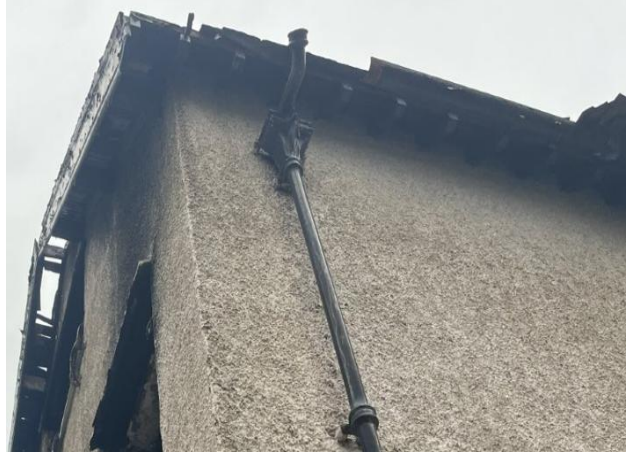
| Eaves | Overhanging | <p><b>Condition/description</b></p> <p>No observed gaps or crevices.</p> <p><b>Suitability/access/evidence of bats</b></p> <p>No observed features suitable for roosting bats.</p> | |

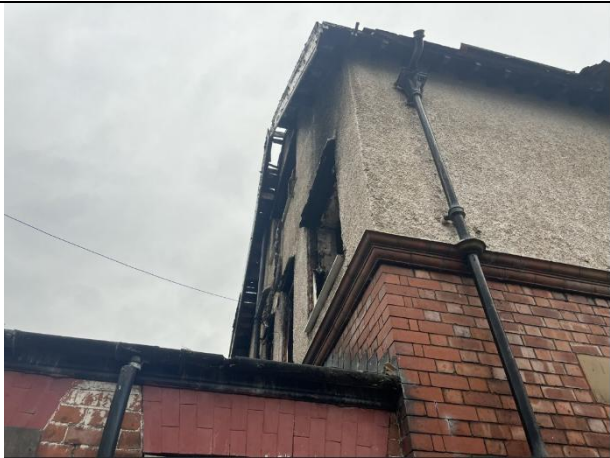
| Window/doors frames and lintels | Timber | <p><b>Condition/description</b></p> <p>Due to the antisocial behaviour and the fire damage, the windows have no glass present and the doors are damaged, therefore allow ingress into the building.</p> <p><b>Suitability/access/evidence of bats</b></p> <p>The windows and doors allow ingress into the space.</p> | |

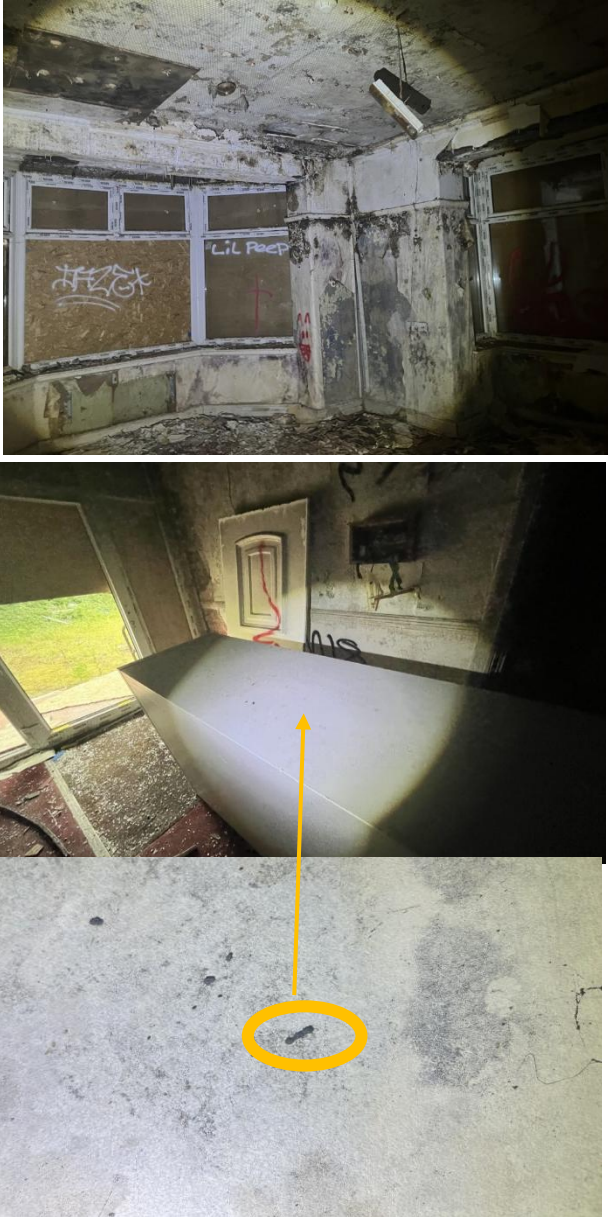
The upstairs of B1 could not be inspected due to the unknown safety of the building due to fire and water damage, therefore further bat evidence may have been missed if present.

| Internal voids | Open roof,<br>no loft | <p><b>Condition/description</b></p> <p>The interior of the building is open to external elements due to the damaged windows, doors and roof. There is no loft space present. There is a high level of water damage within the internal of the space due to rain and damaged pipe work. Due to the lack of roof and damaged windows, there is little protection from external elements such as temperature, rain and wind. Furthermore, there is a high level of sunlight within the internal of the space.</p> <p>The internal of B1 matches the temperature and humidity of the external of B1 at the time of the survey. The upstairs of B1 could not be accessed due to the unknown safety of the building.</p> <p><b>Suitability/access/evidence of bats</b></p> <p>Two bat droppings were observed to the north of the building, in the downstairs hallway, near to a damaged open doorway. The droppings were found on a table, with no observed features above. No further droppings were found or other evidence such as feeding remains. The internal of the building is suboptimal for void dwelling bats due to the high levels of sunlight entering the space and the lack of protection from wind and rain. The upstairs was not accessed and therefore further bat evidence may have been missed. The bat droppings do not confirm the building as a roost, however, could indicate exploratory behaviour.</p> | |

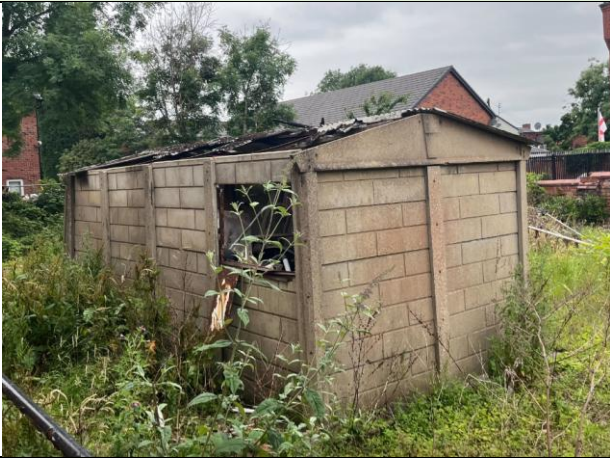
| <b>B2 Building description</b> | <b>Photographs</b> |
|---|---|
| <p><i>Summary</i></p> <p>B2 is a single storey gable ended building, with corrugated sheeting roof and cinderblock walls. The roof is heavily damaged which allows in high levels of wind, rain and does not offer thermoregulate properties making it suboptimal for void dwelling bats. Furthermore, there are no noted roosting features suitable for crevice dwelling bats. B2 is <b>negligible</b> for roosting bats.</p> | |

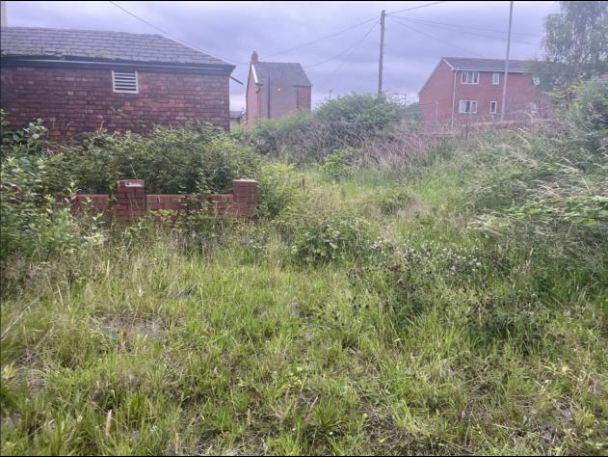
| <b>Mixed Scrub</b> | |
|---|---|
| | Fig 1 – scrub on site. |

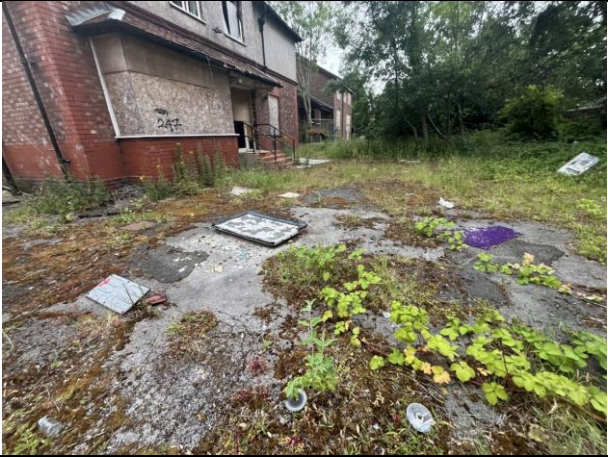
| <b>Mixed Scrub</b> | |
|---|---|
| | Fig 2 – sparsely vegetated land onsite. |

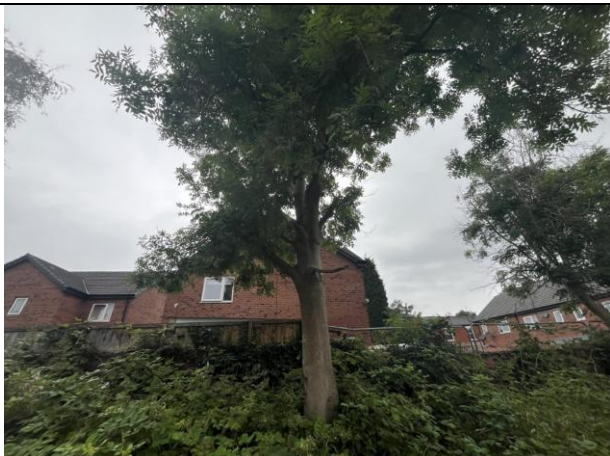
| | | Fig 3 – scattered trees on site. | |

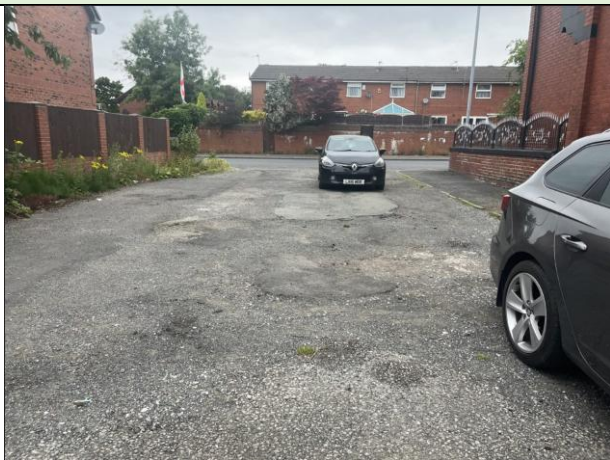
| | | Fig 4 – developed land to the north of the site. | |
