## **Preliminary Roost Assessment for Bats**

**Grey Mare Lane, Beswick, Manchester**

**May 2025**

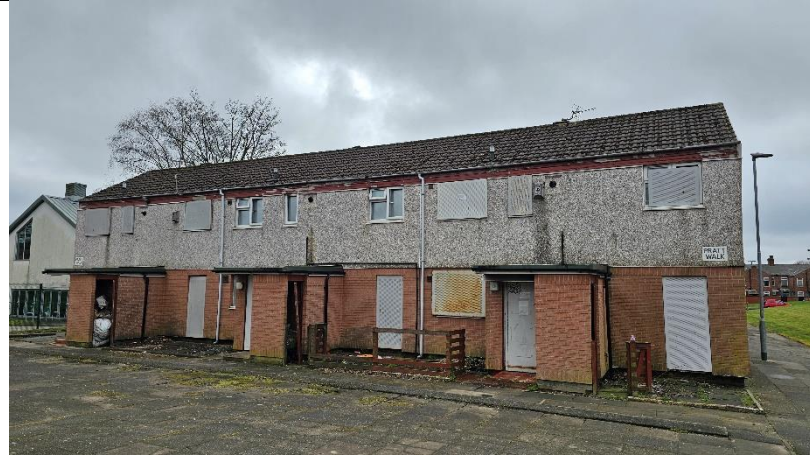
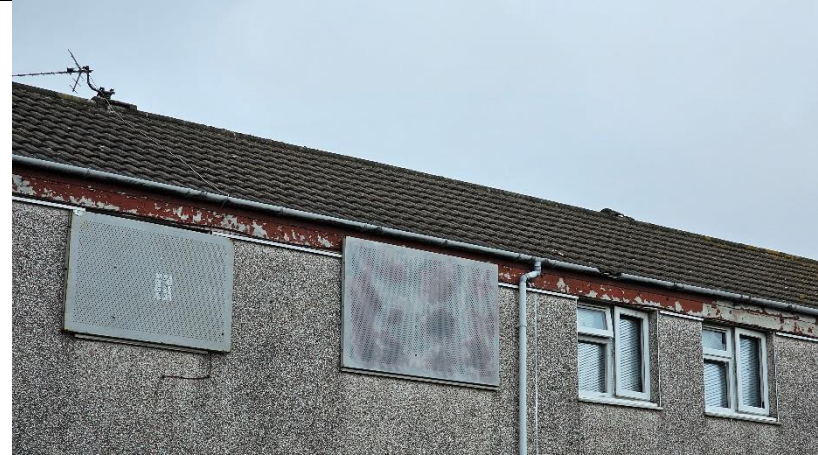
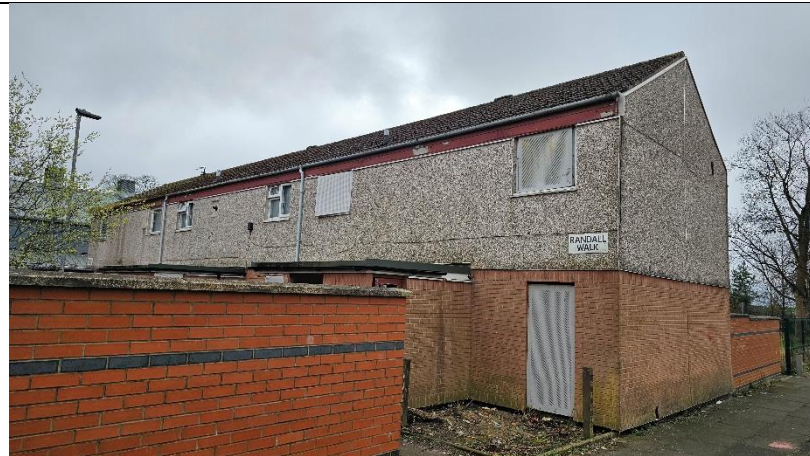
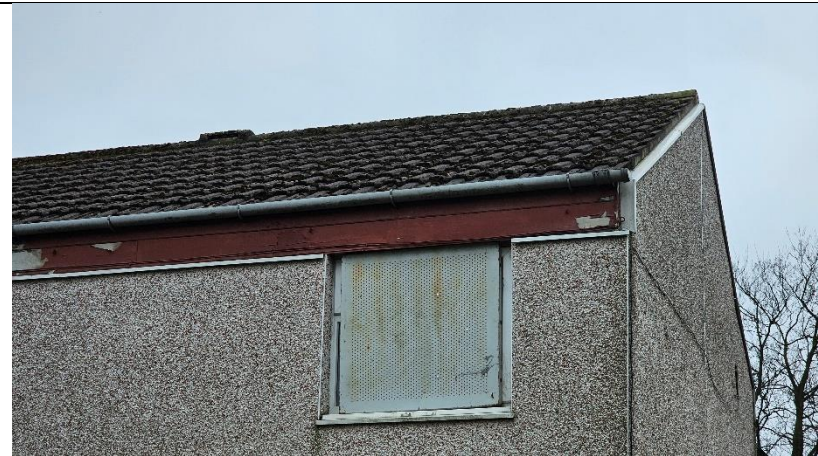
Plot C comprised two separate buildings, with three terraced houses on both Pratt Walk and Randall Walk (six houses in total). Each measured approx. 24m x 7m and 8m tall. All buildings were empty/disused at the time of survey. The vast majority of the UPVC double glazed windows had been boarded up with high security metal coverings, as had the doors.

Each of the two terraced houses were two storeys with a single pitched roof. The lower half of the buildings were constructed with red brick with upper half being pebble dash rendered. The exterior of the buildings were in very good condition with no missing brickwork or mortar, although there was superficial 'tiredness' of the buildings, no PRFs were identified. Wooden fascias, has presumably dried and split in places with paintwork peeling off but only superficially with no obvious PRFs recorded. The roof was constructed of interlocking concrete tiles which were in excellent condition with no missing or slipped tiles being

recorded. The mortar on each of the four gable ends was in-situ thus no PRFs were recorded.

Buildings within Plot C were of negligible suitability to support a bat roost.

Photograph 1: Plot C.

Photograph 2: Plot C.

Photograph 3: Plot C.

Photograph 4: Plot C.

There is no requirement for any further surveys or assessments regarding bats. As the plans are simply for demolition at this stage, the only recommendations would be that if bats are found during any works, then works must stop on the building in question and a suitably qualified ecologist be contacted. If bats are found, then potentially further survey work will be required in order to determine the roost type within the building where bats are found.

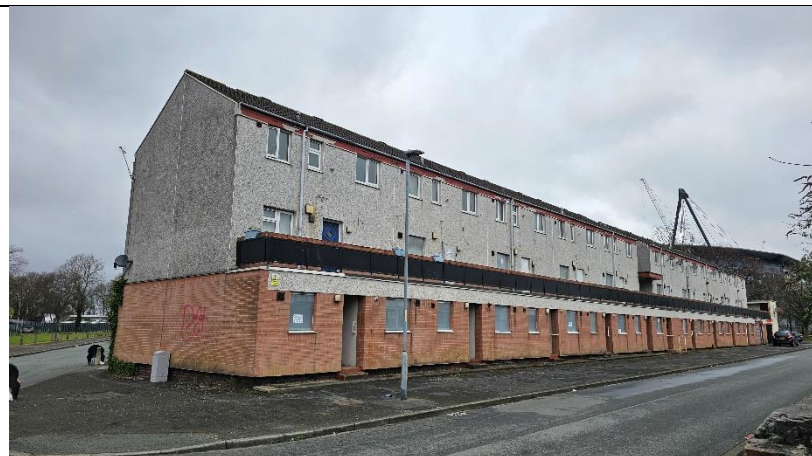
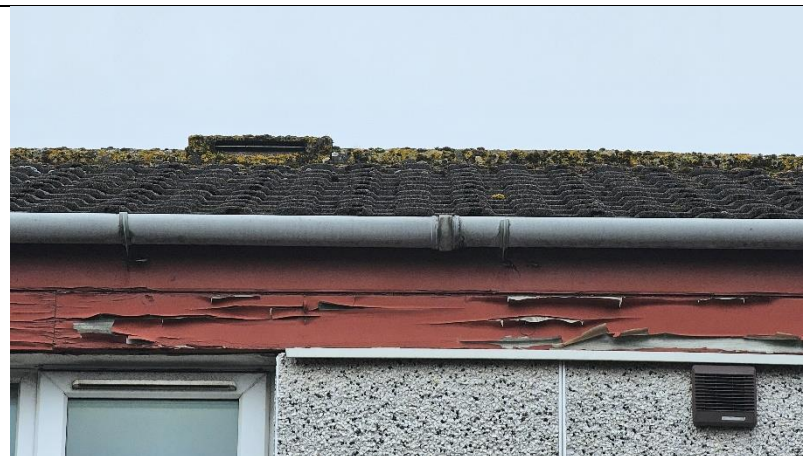
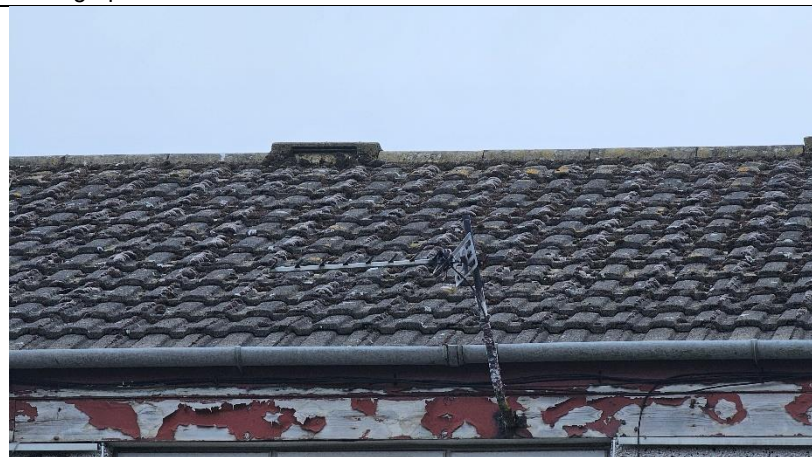
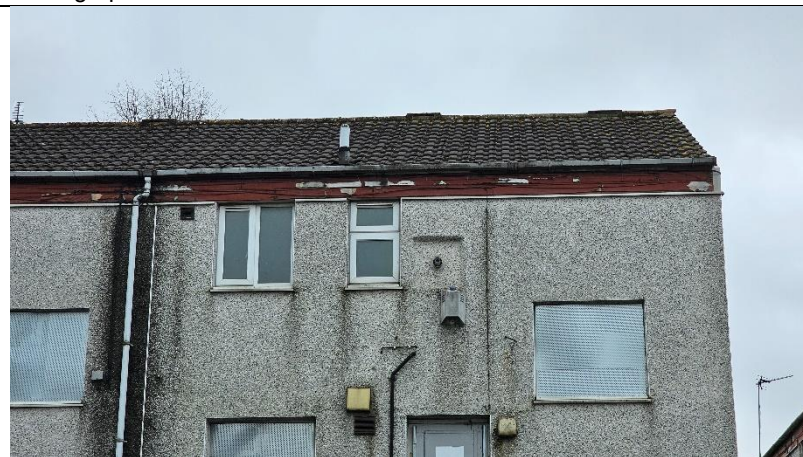
Newcombe Close comprised two buildings, each measuring approx. 35m x 10m and 12m tall. The residential buildings were across three floors with a single pitched roof. These properties appeared to be lived in, or at least the windows/doors had not been boarded over. A walkway above the first floor on the building's south eastern aspect appeared to how the properties were accessed. It was unsure whether the ground floor were included within each property or a separate ground floor living space.

As for Plot C, the lower portion of the two buildings was constructed of red brick with the upper portion, up to the fascia/eaves was pebble dash render. Both were in excellent condition. The wooden fascias were again superficially in a poor state of repair with minor splitting recorded and the peeling of paint but no obvious PRFs were recorded. The roof and ridge tiles were constructed of interlocking concrete. The roof was in excellent condition with no obvious PRFs recorded. No missing mortar was recorded beneath the ridge tiles. The mortar on each of the four gable ends was in-situ thus no PRFs were recorded.

Buildings within Plot D were of negligible suitability to support a bat roost.

Photograph 5: Plot D.

Photograph 6: Plot D.

Photograph 7: Plot D.

Photograph 8: Plot D.

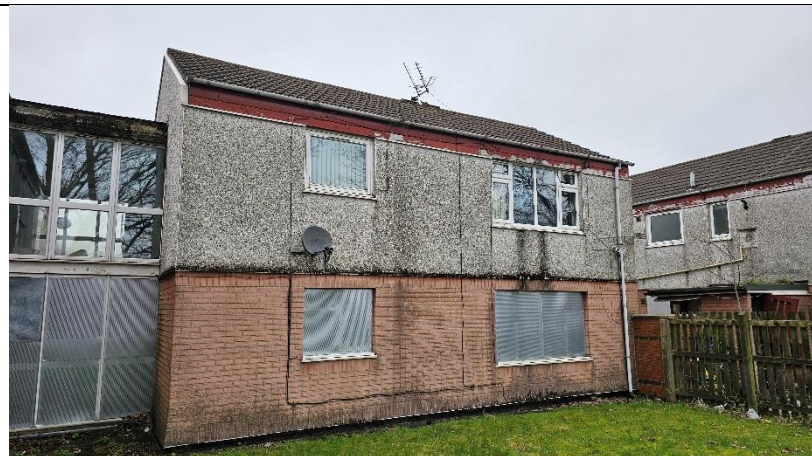
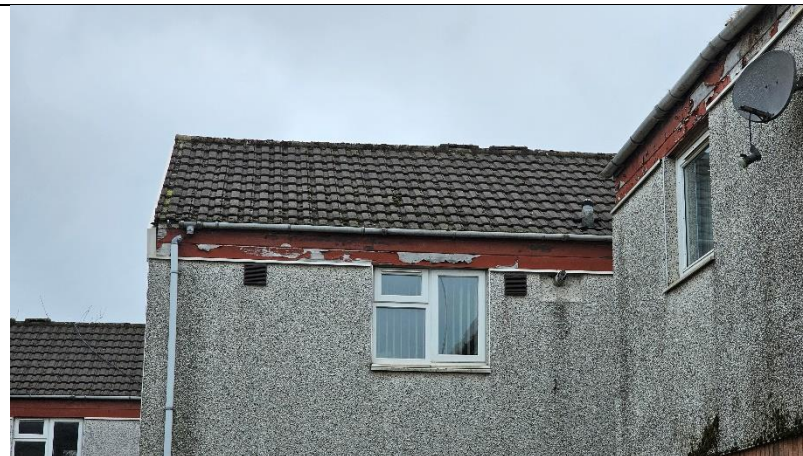
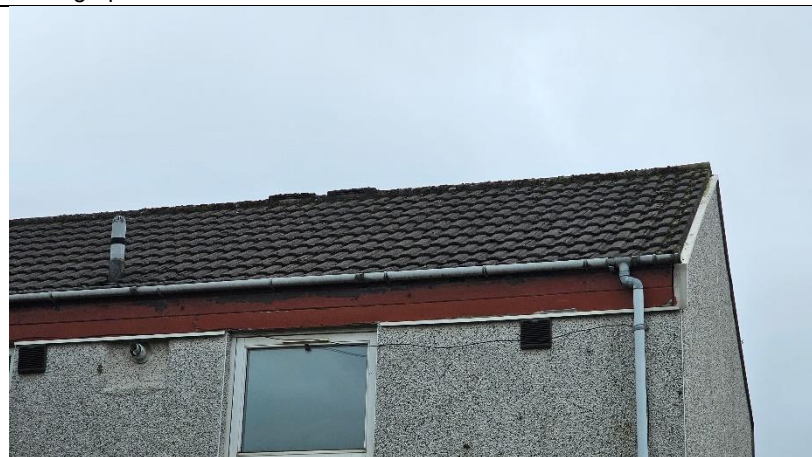
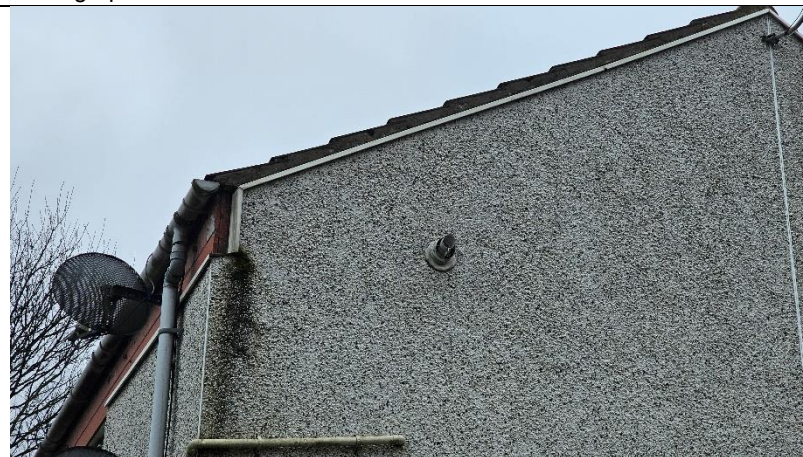
There were three groups of buildings within Plot I, comprising 12 houses/flats. As for Plot C, each building was two storeys with a pitched roof. The lower portion being constructed of red brick and the upper portion up to the fascias/eaves being pebble dash rendered. The roof and ridge tiles were in excellent condition with no obvious gaps being recorded. All mortar on the numerous gable ends was all in-situ with no PRFs being recorded.

Photograph 9: Plot I.

Photograph 10: Plot I.

Photograph 11: Plot I.

Photograph 12: Plot I.

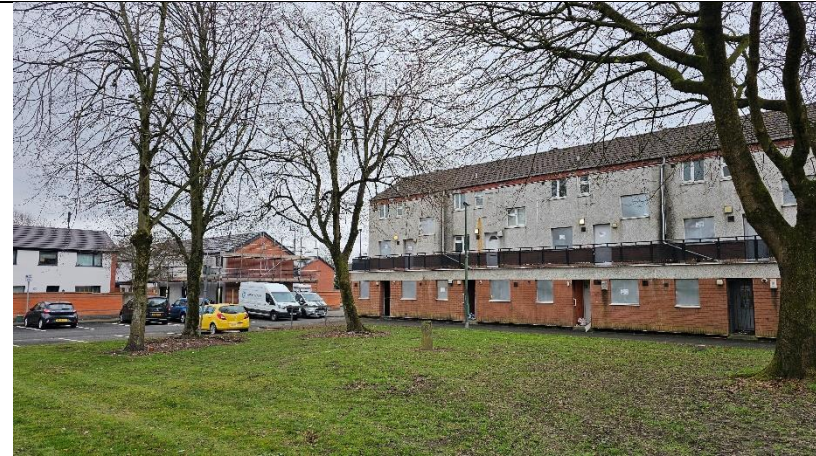
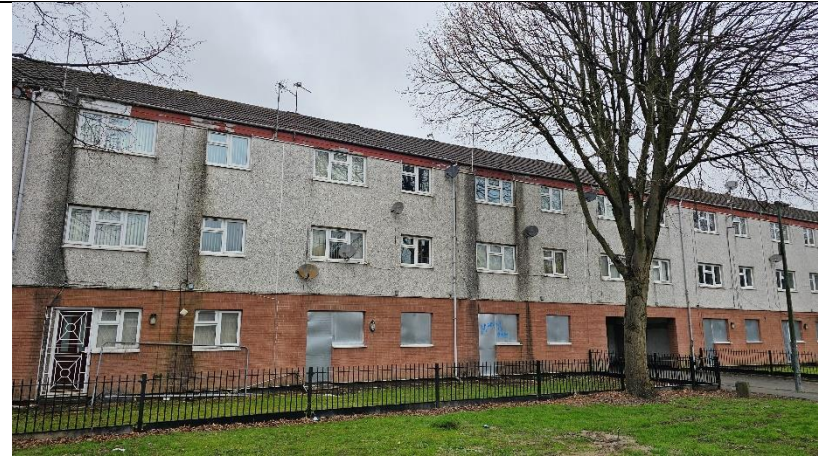
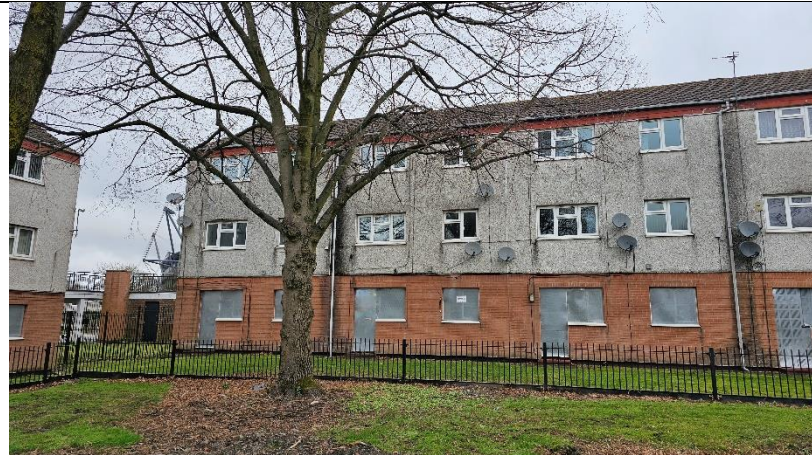
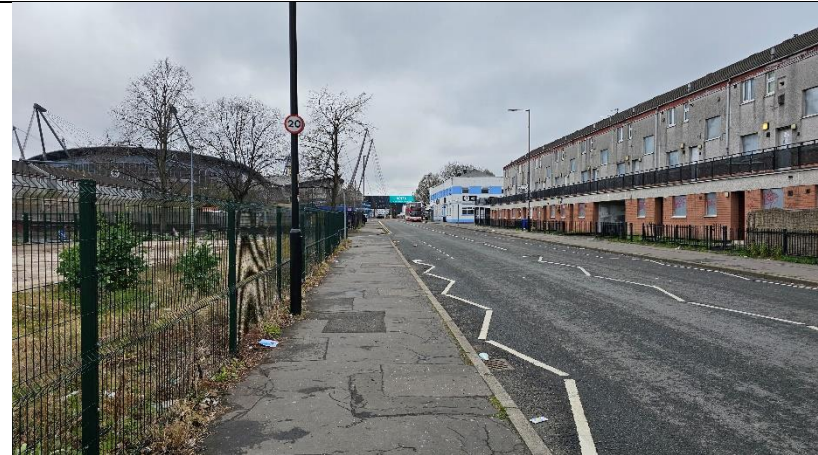
In plots G and H, the U-shaped buildings were three storeys with a single pitched roof. The lower half of the buildings were constructed with red brick with upper half being pebble dash rendered. The exterior of the buildings were in very good condition with no missing brickwork or mortar, although there was superficial 'tiredness' of the buildings, no PRFs were identified. Wooden fascias, has presumably dried and split in places with paintwork peeling off but only superficially with no obvious PRFs recorded. The roof was constructed of interlocking concrete tiles which were in excellent condition with no missing or slipped tiles being recorded. The mortar on each of the four gable ends was in-situ thus no PRFs were recorded.

Buildings within the two plots (G and H) were of negligible suitability to support a bat roost.

Photograph 13: Northern aspect of Plot H.

Photograph 14: Eastern aspect of G and H.

Photograph 15: Southern aspect of F.

Photograph 16: Western aspect of F and G.
