## **GROUND INVESTIGATION OF EMBANKMENT VINE STREET, GORTON**

**Vine Street, Gorton**  
Slope Investigation  
March 2025

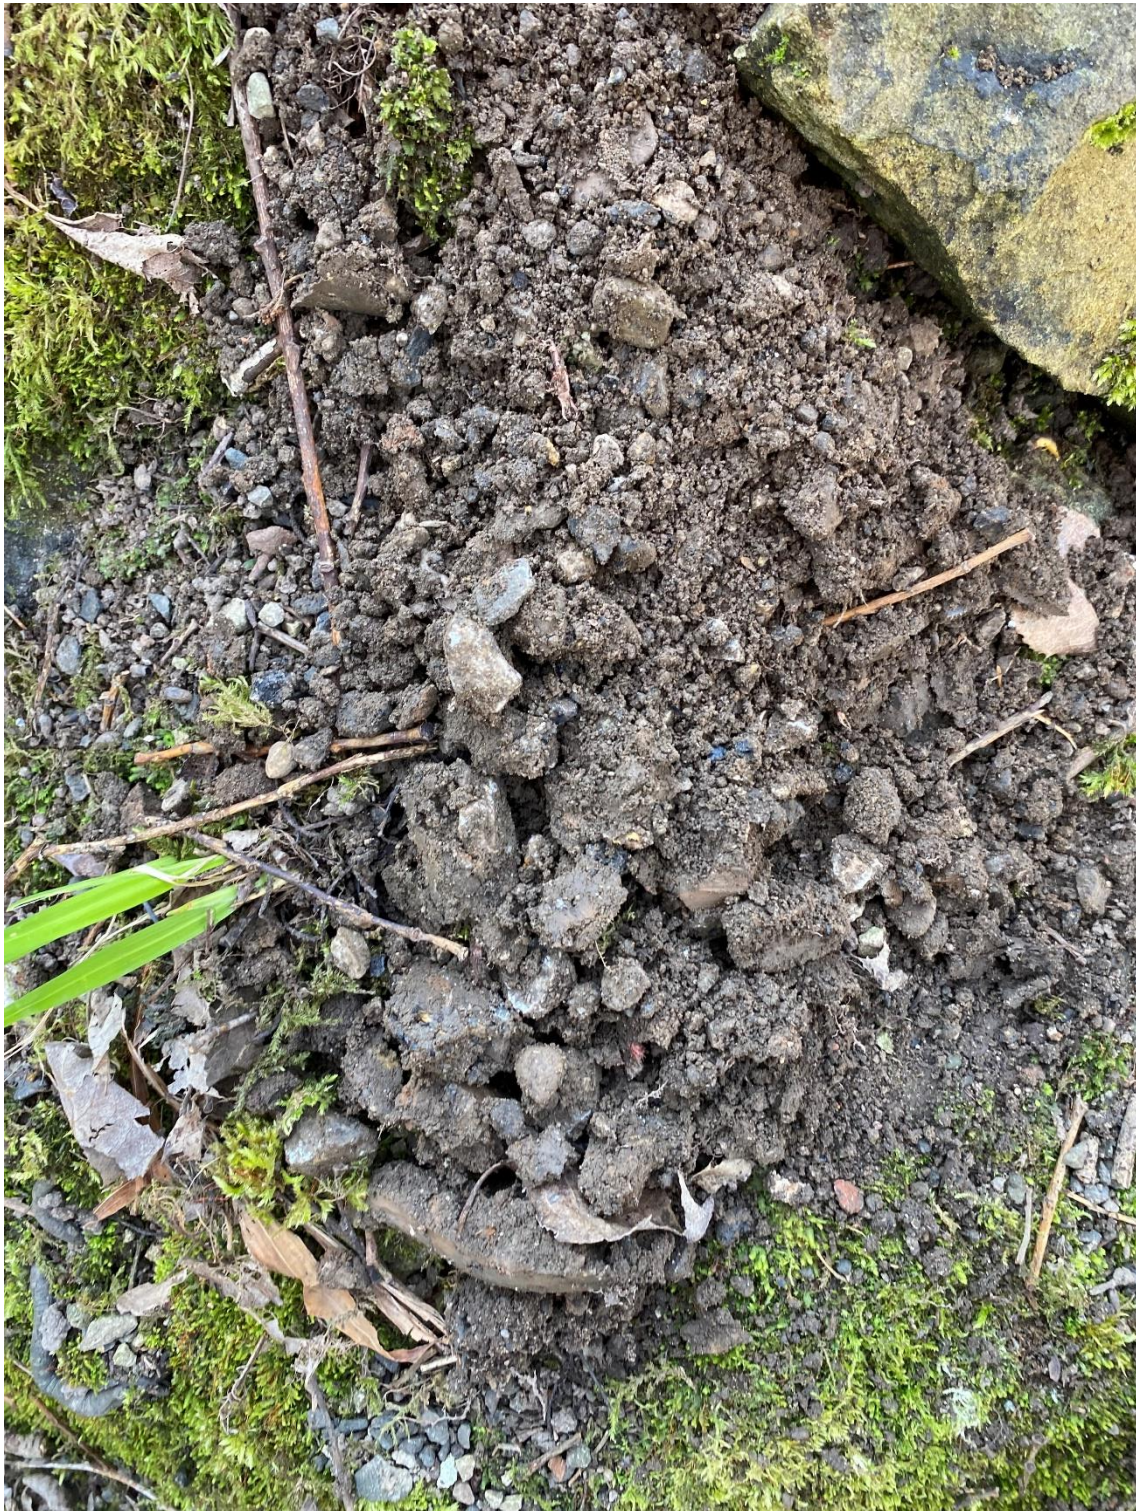
In all seven probehole locations, the Made Ground was recorded as a black slightly clayey gravel with frequent oversize fragments, the granular constituents typically comprised brick, concrete, sandstone and mixed lithology.

PLATE 1 HA105 ARISINGS TYPICAL OF THE EMBANKMENT

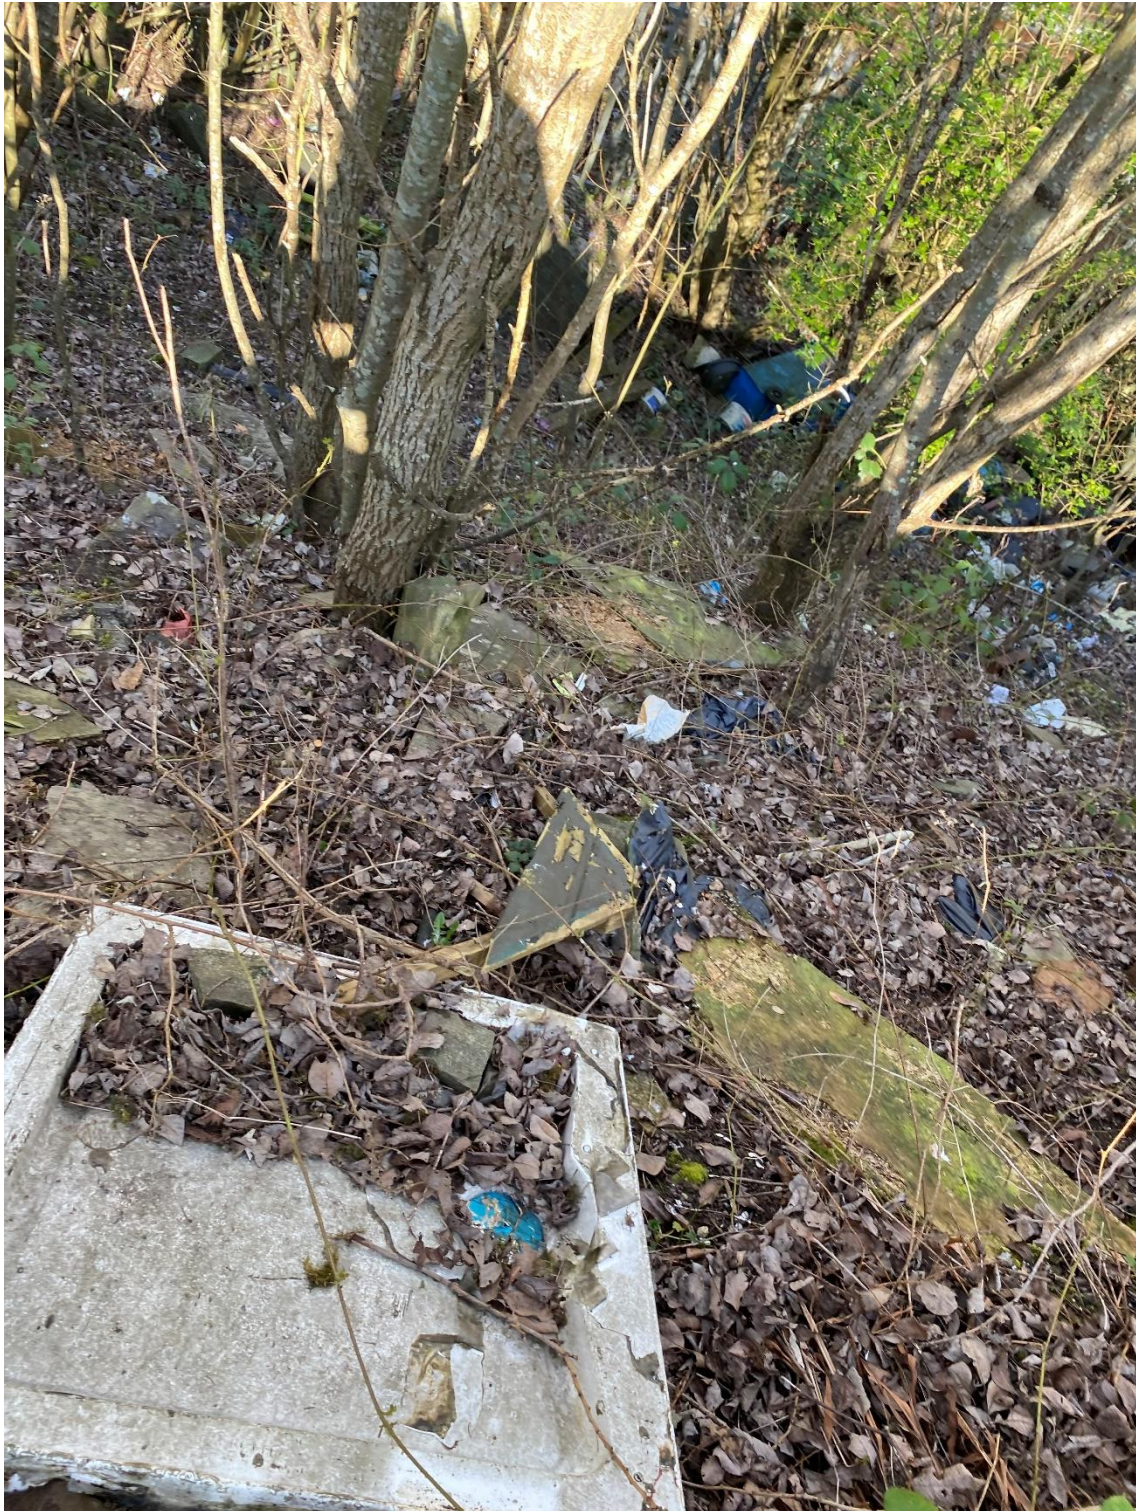
PLATE 2 EVIDENCE OF OVERSIZE HARD MATERIALS WITHIN THE EMBANKMENT
