## **REMEDiation STRATEGY REPORT**

**FOR  
GRANGE SCHOOL,  
MATTHEWS LANE,  
LEVENSHULME,  
M12 4GR**

**PREPARED FOR  
JOHN TURNER CONSTRUCTION GROUP  
LTD**

**REPORT NO. 8032C  
SEPTEMBER 2025**

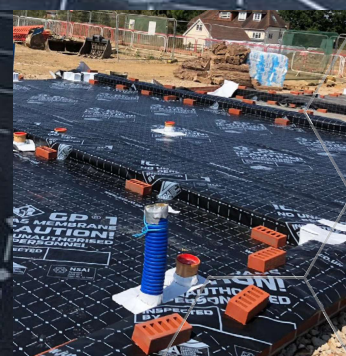
**GP<sup>®</sup>1**

GP<sup>®</sup>1 proprietary gas resistant damp proof membrane (DPM) is a multi-layer, low density polyethylene membrane, reinforced with a polypropylene reinforcing grid with an integral aluminium foil. GP<sup>®</sup>1 is specifically designed and manufactured to perform as a methane, carbon dioxide, radon, ground gas, air & moisture protection system.

It is recommended GP<sup>®</sup>1 be heat welded where possible, with welding carried out by competent personnel with suitable qualifications in accordance with best practice, and guidance contained within BS 8485:2015.
