# The Portico Library Manchester

## Structural & Civil Engineering Stage 3 Report

| Document Reference: | <b>31593-S-RP-0001</b> |

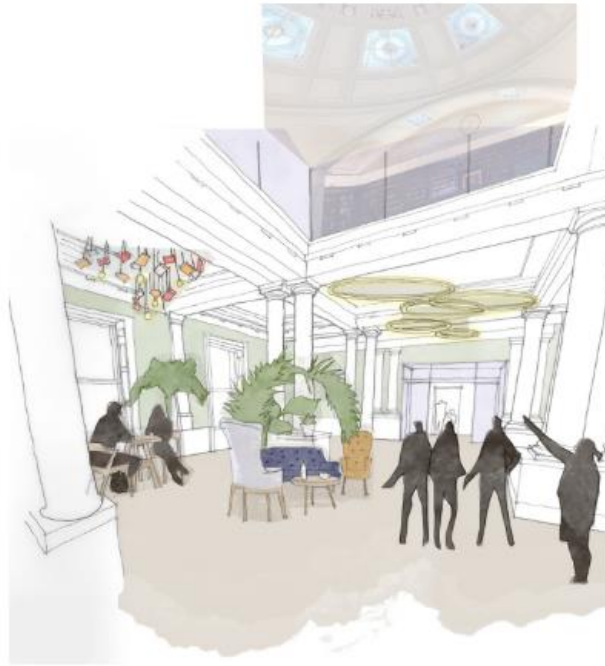
Figure 1.2 Extract of Architect's Proposed Perspective Internal Sketch

Additionally, the project seeks to establish connections between the library spaces on the ground and first floors. A lightbox on the first floor is planned to enhance visibility between the two levels and allow natural light to flow through the entrance void.

The project aims to create the most accessible library in the UK by creating equitable access to the entire building, including the ground and first floors. This will be achieved by removing the existing main entrance stairs and lowering the lobby ground floor slab to the existing pavement level, which will create level access to a new lift.

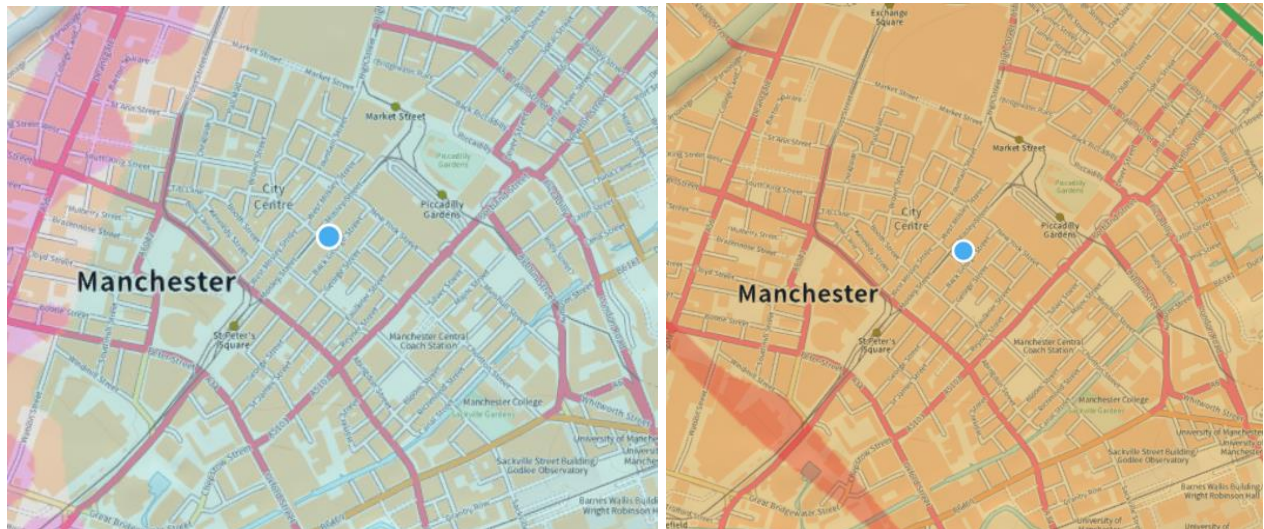
Figure 2.5a) BGS Superficial Deposits Survey Map (left), 2024 b) BGS Bedrock Geology Survey Map (right), 2024

The British Geologic Survey (BGS) map for the site indicates that the superficial deposits are found to be Till, Devensian-Diamicton. Sedimentary superficial deposits formed between 116 and 11.8 thousand years during the Quaternary period.

The BGS map also indicates the Bedrock geology as Chester Formation – Sandstone. Sedimentary bedrock formed between 250 and 247.1 million years ago during the Triassic period.

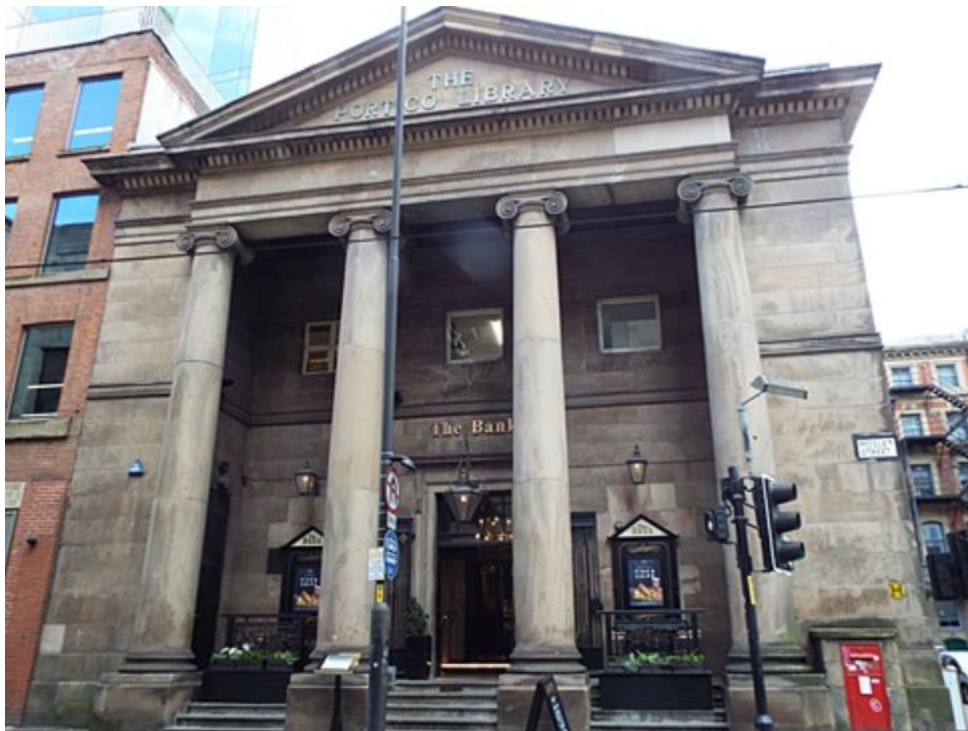
Figure 3.2 The Portico Library – Mosley Street Elevations

The Mosley Street elevation features a stone central pediment supported by four Ionic columns. The Charlotte Street facade is also of stone masonry construction and is divided into seven bays, with the middle five bays further divided by Ionic semi-columns. The column bases rest on a plinth at the bottom of the wall. The Back George Street elevation has a gable wall constructed from brick masonry.

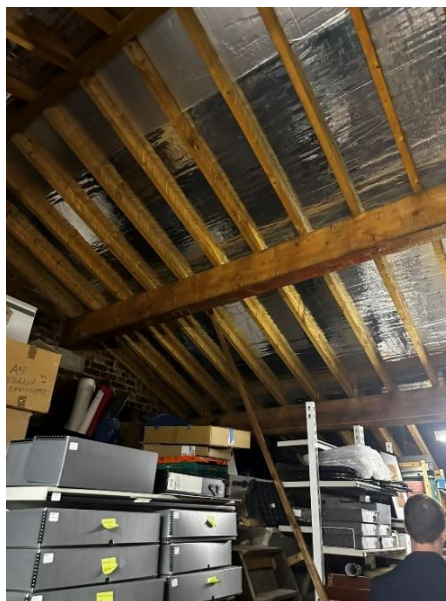
Figure 3.4 Roof space showing rafter and purlin arrangement., 2024

The roof is divided into three distinct sections: two duo-pitched roofs are located at the northwest and southeast ends of the building, and the central complex roof structure is above the main library chamber. The duo-pitch roofs are of conventional rafter construction, as shown in Figure 3.4. The timber purlins span between masonry walls, and the rafters are supported on the primary beams. It appears that the roof construction was replaced relatively recently, perhaps during the 1980s roof repair works.

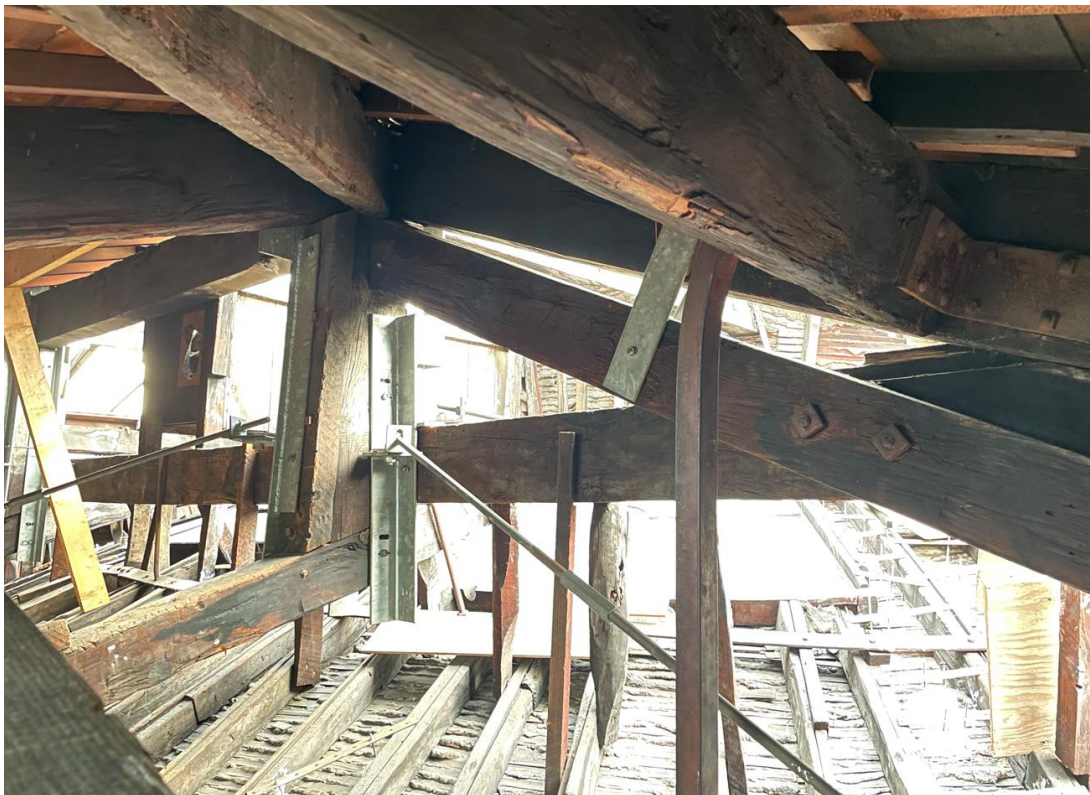
Figure 3.6 Roof truss, tension rods and dome ceiling

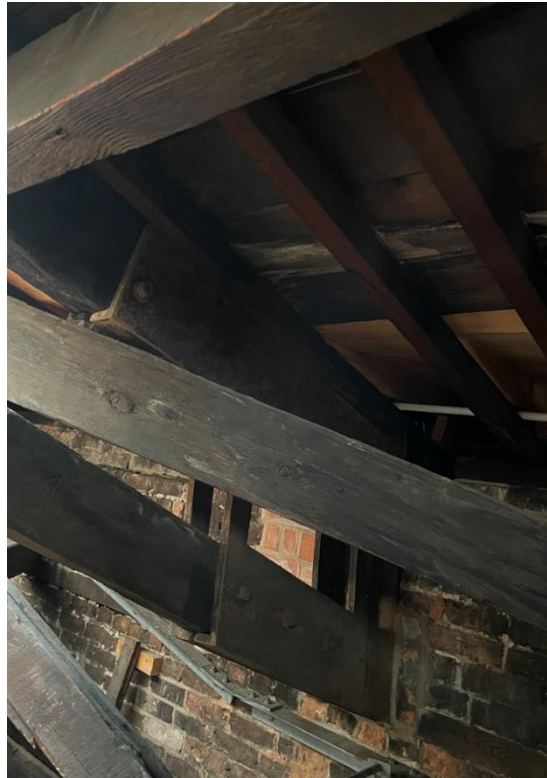
Figure 3.7 Steel plated 'shoe' remedial detail to truss bearing end

The timber roof appears to be of original construction, judging by the apparent age of the timber beams. However, several members have been replaced or repaired. Notably, the ends of the roof trusses have likely been retrofitted with steel plates (although these could have been a part of original structure), likely to address previous timber decay (see Figure 3.7). Additionally, extensive plan bracing has been retrofitted to enhance the lateral stability of the structure (refer to SK01-E). This suggests that the roof has previously experienced displacement.

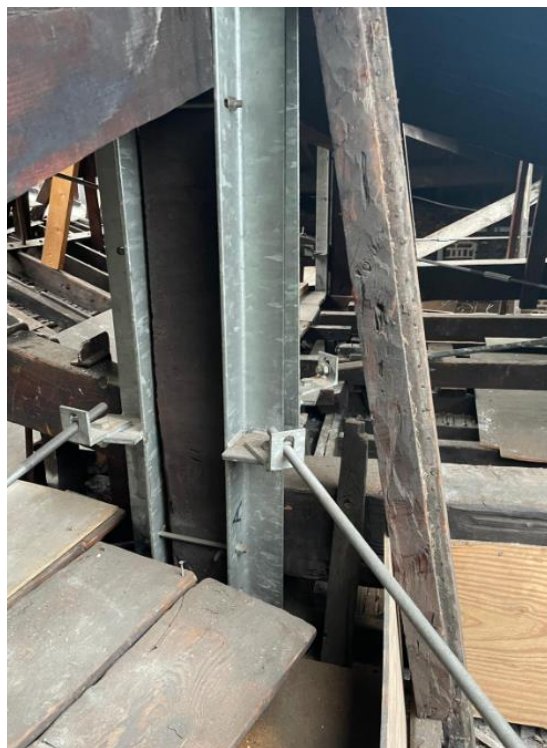
Figure 3.8 Steel rod fixing detail to the angle

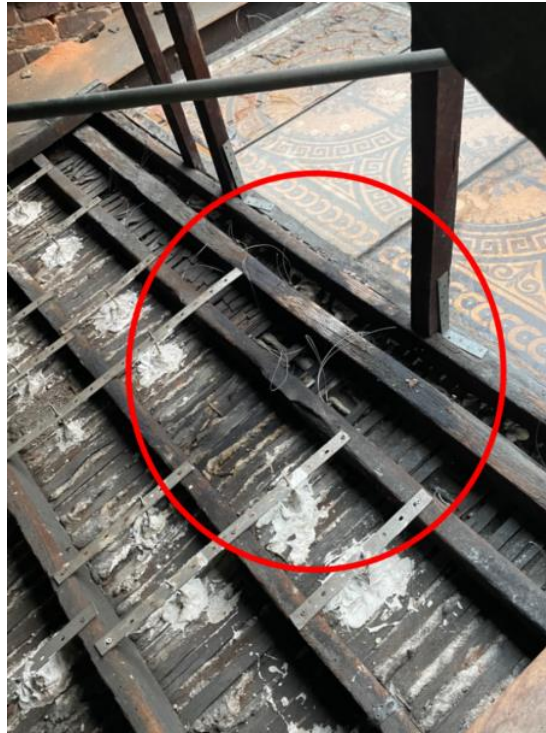
Figure 3.9 Localised water damage near a roof light in the arched section in the N-W corner of the central roof.

Despite evidence of previous roof distortion, there are currently no apparent signs of ongoing roof spreading. The only exception is a small localised area in the northwest section of the roof (see Figure 3.9), where some signs of water ingress were noted during the site walkover.

There is evidence of prior lath and plaster ceiling issues. Straps, dowels and pads repair detail to the ceiling shown in figure 3.9 can be found throughout the roof footprint.

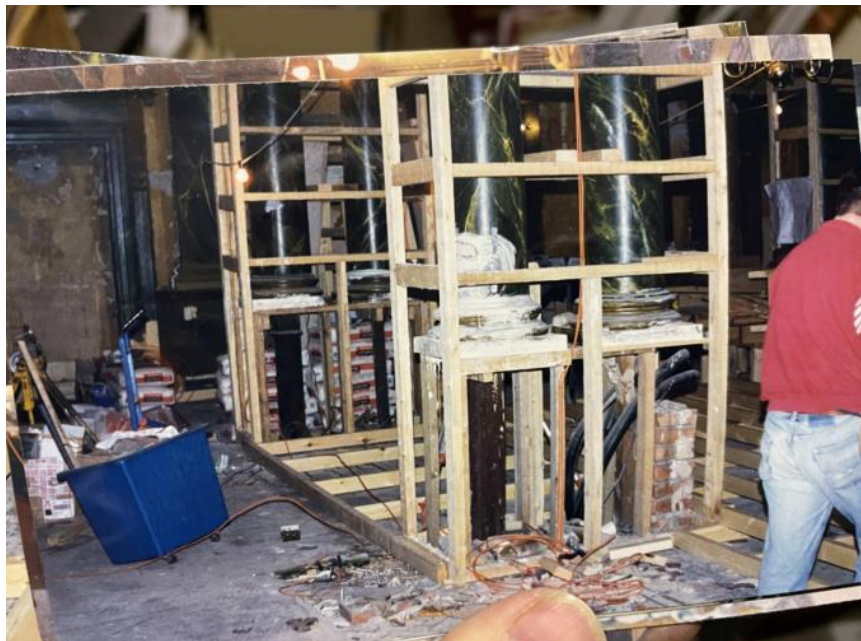
Figure 3.14 – Archive photograph showing column bases at ground floor stripped from cladding.

In its current arrangement, the first floor is supported by eight double columns arranged on a rectangular grid. Figure 3.14, an archive photograph showing the column bases on the ground floor, indicates that the outer column is made of steel, while the inner column is purely decorative.

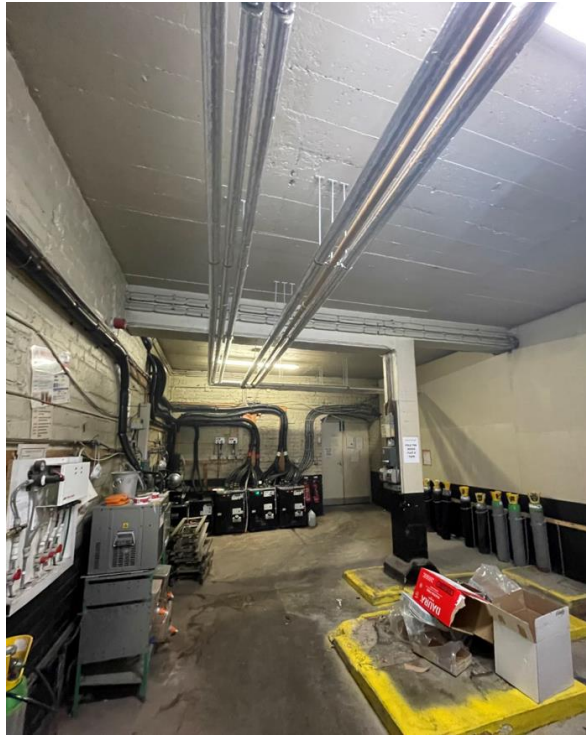
Figure 3.15 – Underside of ground floor slab viewed from basement.

The majority of the ground floor slabs appear to be either filler joist or hollow pots, but could potentially also be of reinforced concrete construction (refer to Fig. 3.15). The downstands are likely comprised of steel beams encased in concrete. This floor plate was installed during the adaptations made by the Bank of Athens in the 1920. The area directly beneath the existing portico stairs features original barrel vault construction (refer to Fig. 3.16). The concrete slab in the current boiler room is supported by steel beams encased in concrete. This slab is propped by a series of acrow props and is observed to be in poor condition (refer to Fig. 3.17).

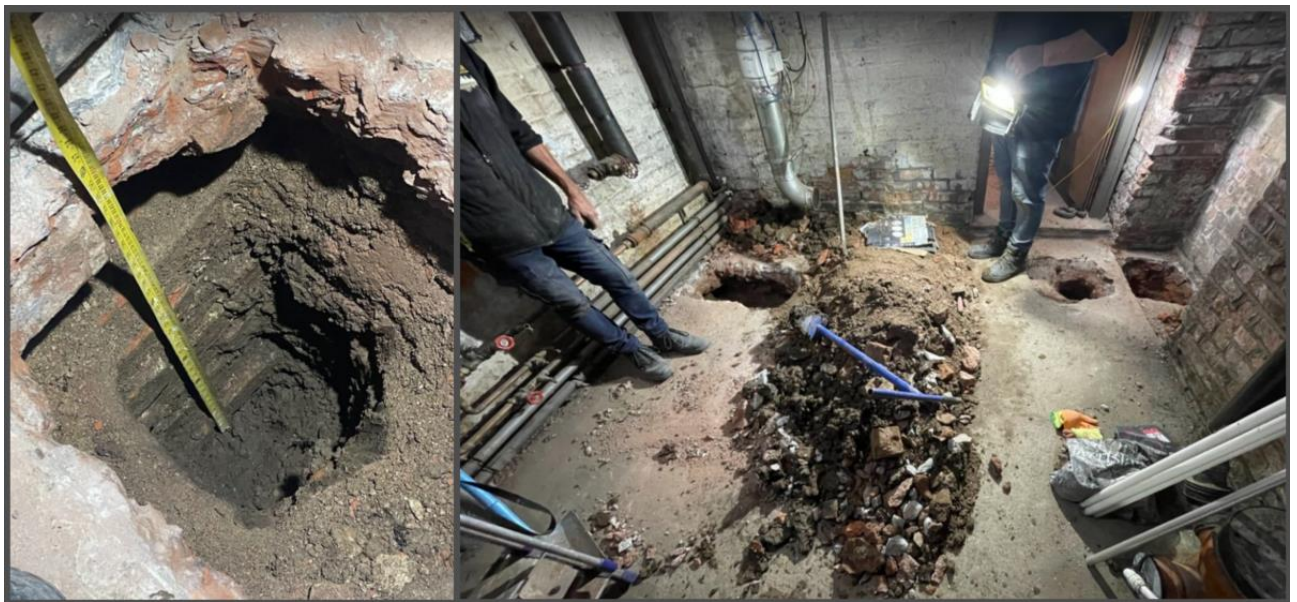
Table 5.1 Basement trail pits

Trail pits in the basement area were dug out on Tuesday 8<sup>th</sup> 2025. The revealed the foundations reaching the depth of 1m below basement FFL. The ground was of silty clay composition and not saturated.

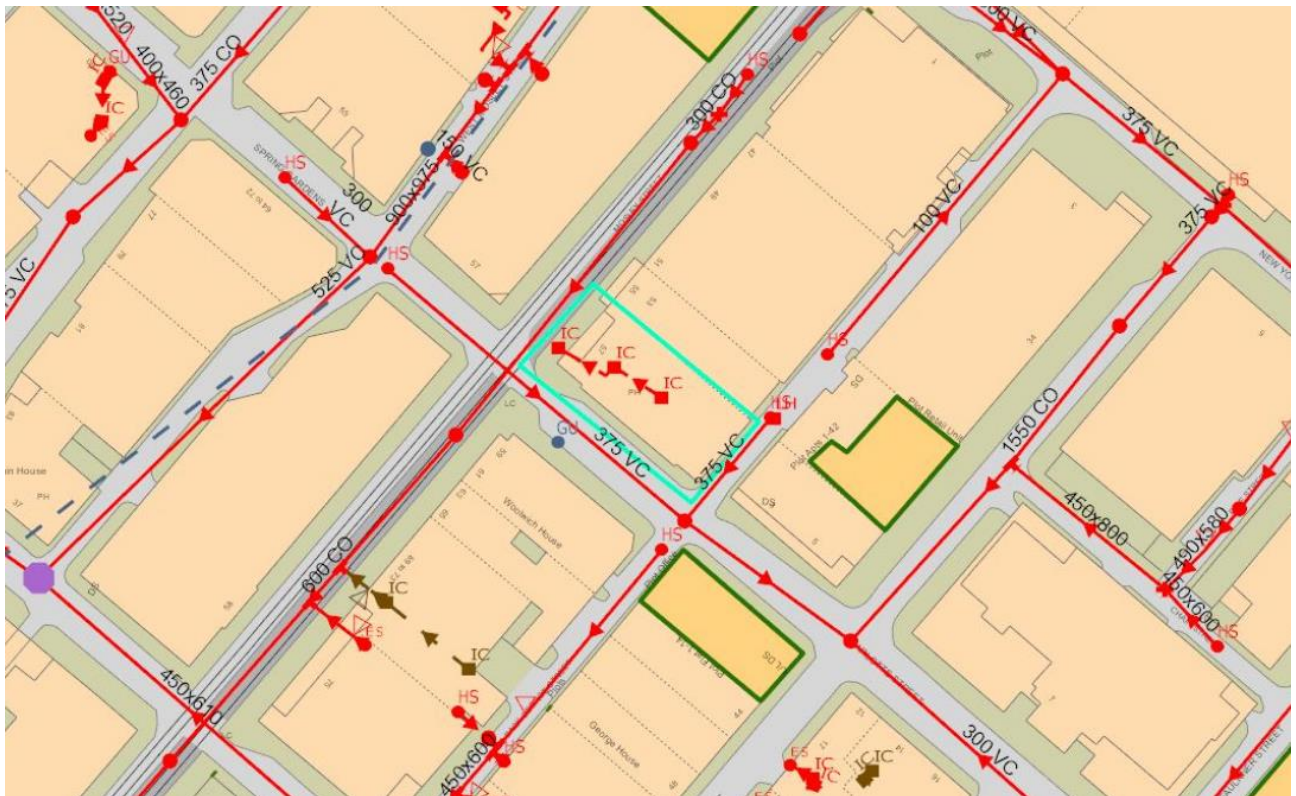
Figure 7.2: United Utilities sewer records

The CCTV drainage survey condition report shows that the primary drainage is in good working order and free from defects. This excludes the final brick-built manhole at the outfall to the United Utilities public sewer. This appears to be blocked, and the interceptor trap should be remediated or replaced to mitigate the risk of future blockages occurring.

It is assumed that the shared basement drainage is a 'Private Sewer', as noted on United Utilities asset record maps. The proposed lift pit is in proximity to this basement drainage, however, this is not subject to a 'Build-Over Agreement' from United Utilities due to the drainage's private ownership. Regardless, the structural proposals will ensure that the drainage is suitably protected from loading. For the avoidance of any doubt, P&M will liaise with United Utilities to define the sewer type.
