# **North Manchester General Hospital**

Bat Emergence Survey Report

2486953

**JULY 2024**

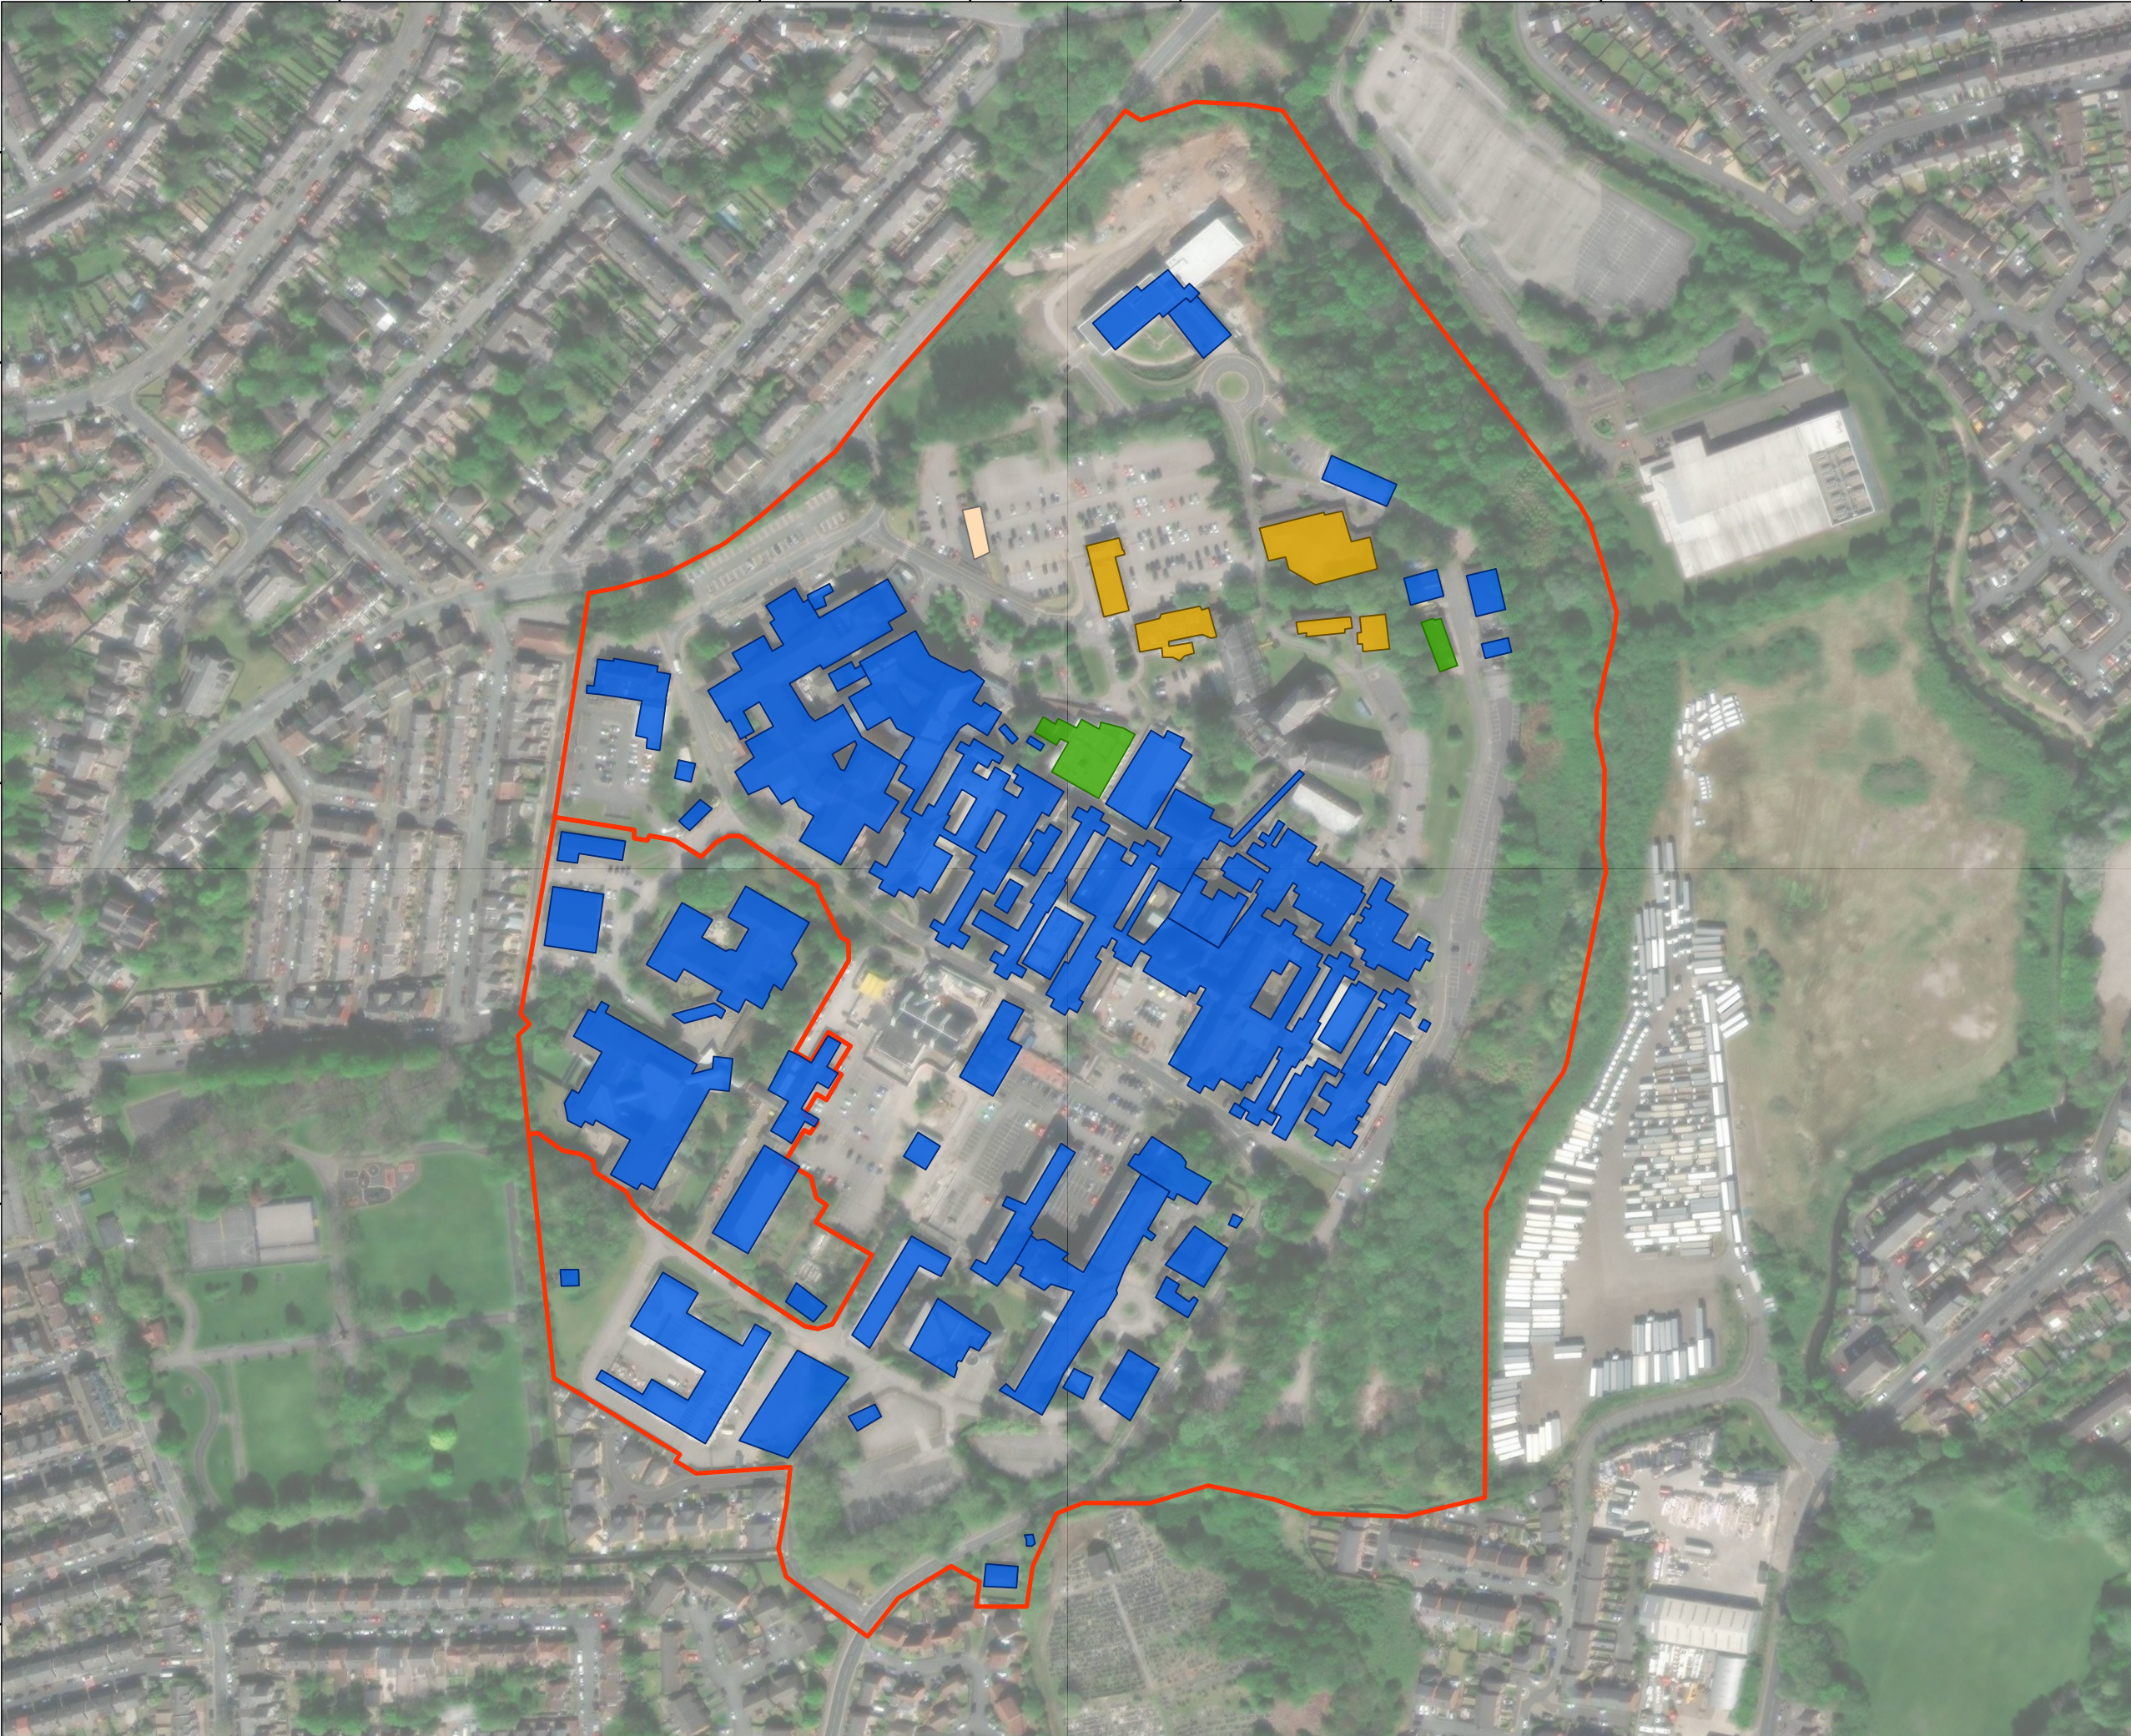
TITLE: Figure 2:  
**Potential Roost Features  
Building Locations**

- 2.2.1 All eight buildings on the site (Figure 2) were searched externally for bat presence and features associated with bat activity, as detailed in BCT guidance (Collins, 2023). The assessment was completed on 12 December 2023, a detailed methodology is provided within *RSK Biocensus - North Manchester General Hospital - Preliminary Roost Assessment* report.
- 2.2.2 The quality of bat roosting habitat within Buildings 47, 54, 70, 71 and 75 is moderate, within Buildings 32 and 50 is low while the quality of roosting habitat within Building 59 is negligible.

- Site Boundary
- Bat Roost Potential
  - Moderate
  - Low
  - Negligible
  - Not surveyed
