# PORTLAND ST WINDOW SCHEDULE

Portland st (NW GROUP

Wednesday 3 July 2024

58 Issues Identified

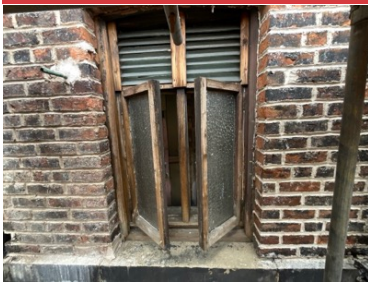
#### **W4B7**

These windows are currently direct glazed modern timber frames installed into the existing box sash frames. These old original sash frames must have been removed from site.

We propose 2 new sash's to install into the existing box frames to match all other windows with 12mm heritage glass.

Replace any rotten cills

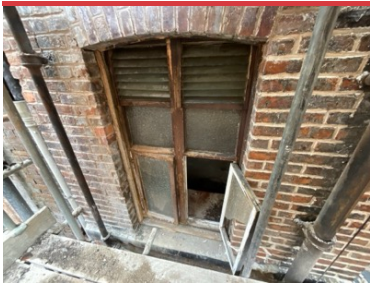
**W3B7**

These windows are currently direct glazed modern timber frames installed into the existing box sash frames. These old original sash frames must have been removed from site.

We propose 2 new sash's to install into the existing box frames to match all other windows with 12mm heritage glass.

Replace any rotten cills

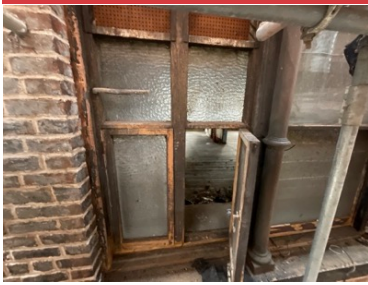
**W2B6**

These windows are currently direct glazed modern timber frames installed into the existing box sash frames. These old original sash frames must have been removed from site.

We propose 2 new sash's to install into the existing box frames to match all other windows with 12mm heritage glass.

Replace any rotten cills

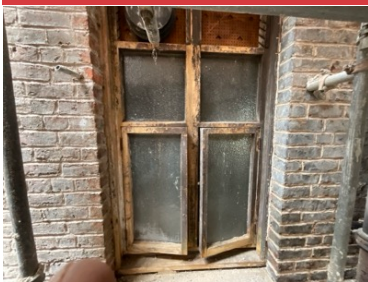
**W2B7**

These windows are currently direct glazed modern timber frames installed into the existing box sash frames. These old original sash frames must have been removed from site.

We propose 2 new sash's to install into the existing box frames to match all other windows with 12mm heritage glass.

Replace any rotten cills

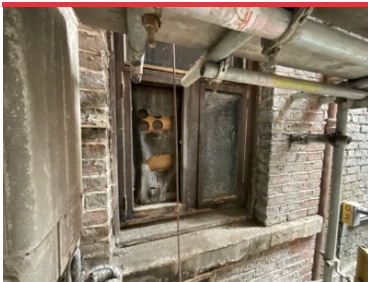
**W1B7**

These windows are currently direct glazed modern timber frames installed into the existing box sash frames. These old original sash frames must have been removed from site.

We propose 2 new sash's to install into the existing box frames to match all other windows with 12mm heritage glass.

Replace any rotten cills

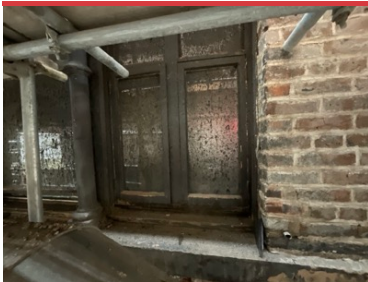
**W1B5**

These windows are currently direct glazed modern timber frames installed into the existing box sash frames. These old original sash frames must have been removed from site.

We propose 2 new sash's to install into the existing box frames to match all other windows with 12mm heritage glass.

Replace any rotten cills

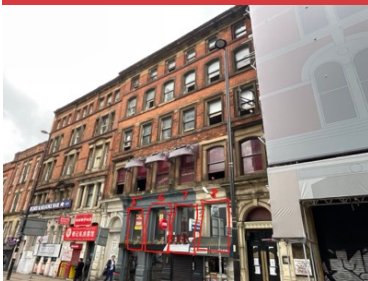
### **1FW5 , 6 , 7 , 8**

These windows are currently direct glazed modern timber frames installed into the existing box sash frames. These old original sash frames must have been removed from site.

We propose 2 new sash's to install into the existing box frames to match all other windows with 12mm heritage glass.

Replace any rotten cills
