**Leigh Ecology Ltd**

**120-124 Grosvenor Street,  
Manchester,  
M1 7HL.**

**Preliminary Ecological Appraisal and Bat  
Scoping Report**

Report number: GROSV/25-001

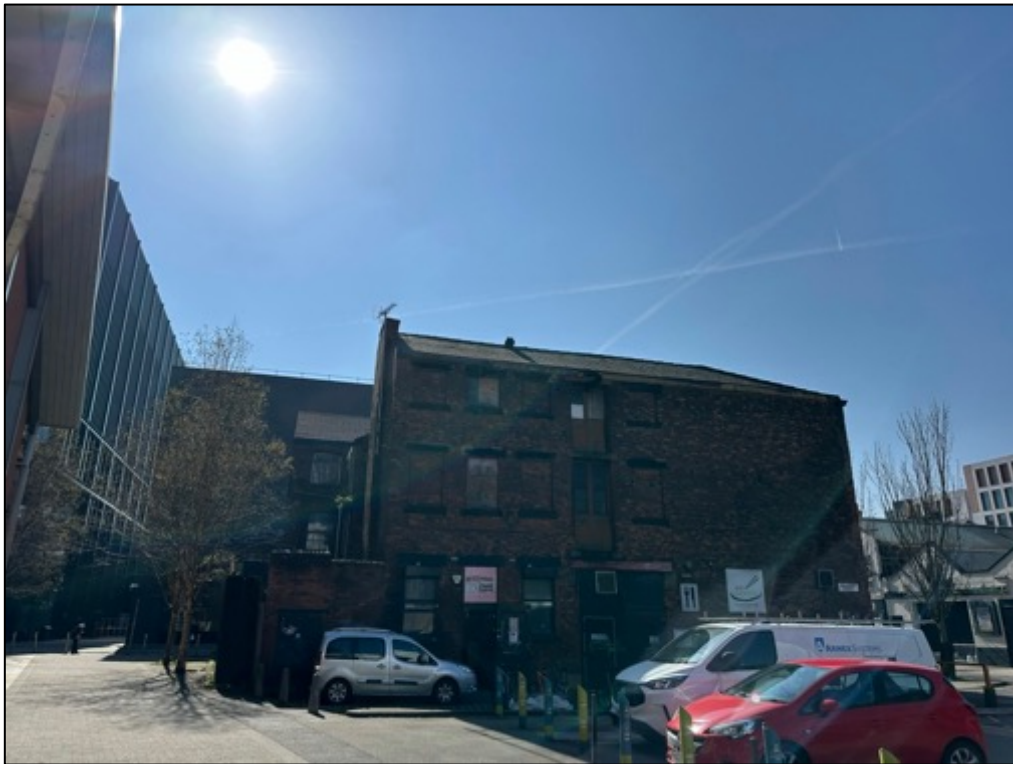
**Photograph 1;** An external view of the northern face of the building. Majority of external windows have been boarded or bricked over.

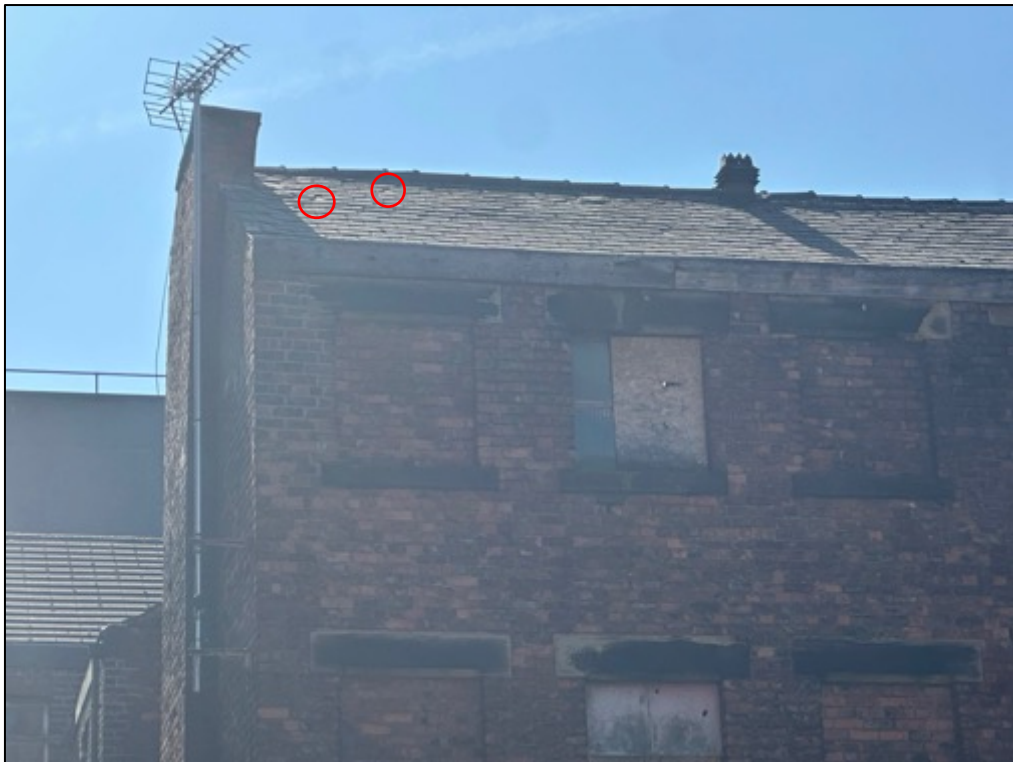
**Photograph 2;** A closer view of the northern face of the external roof. Some instances of damage/displaced tiles noted across the roof has been circled above.

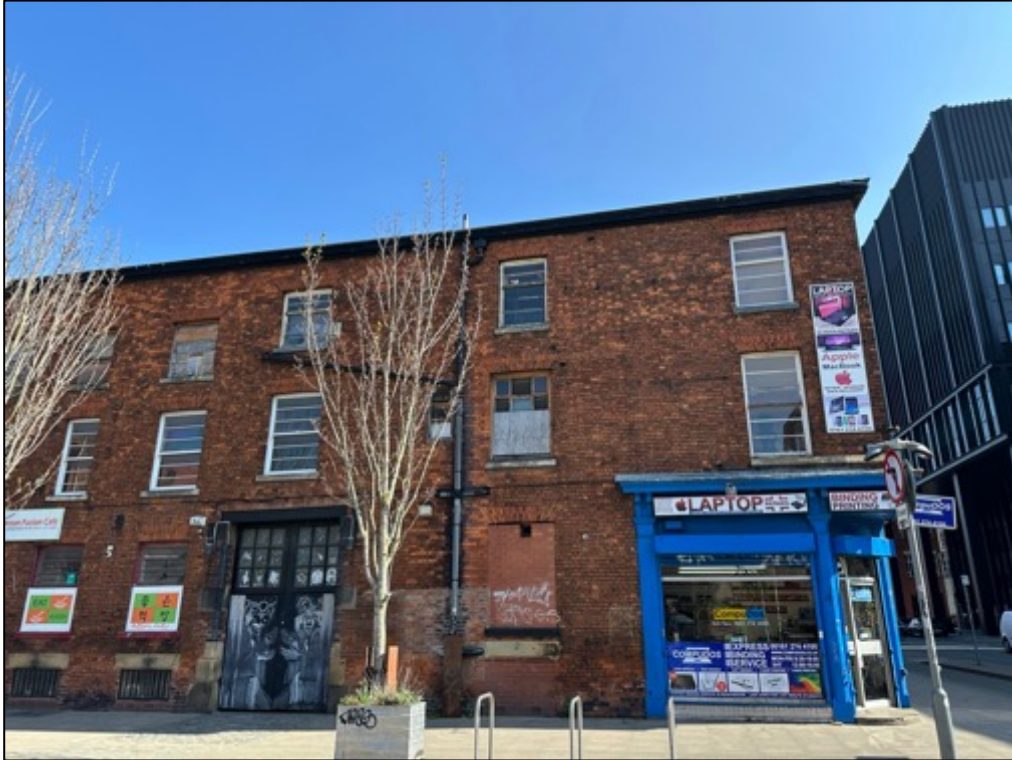
**Photograph 3;** Another external view of the western face. As mentioned, the building is still in active use at ground level for vendors.

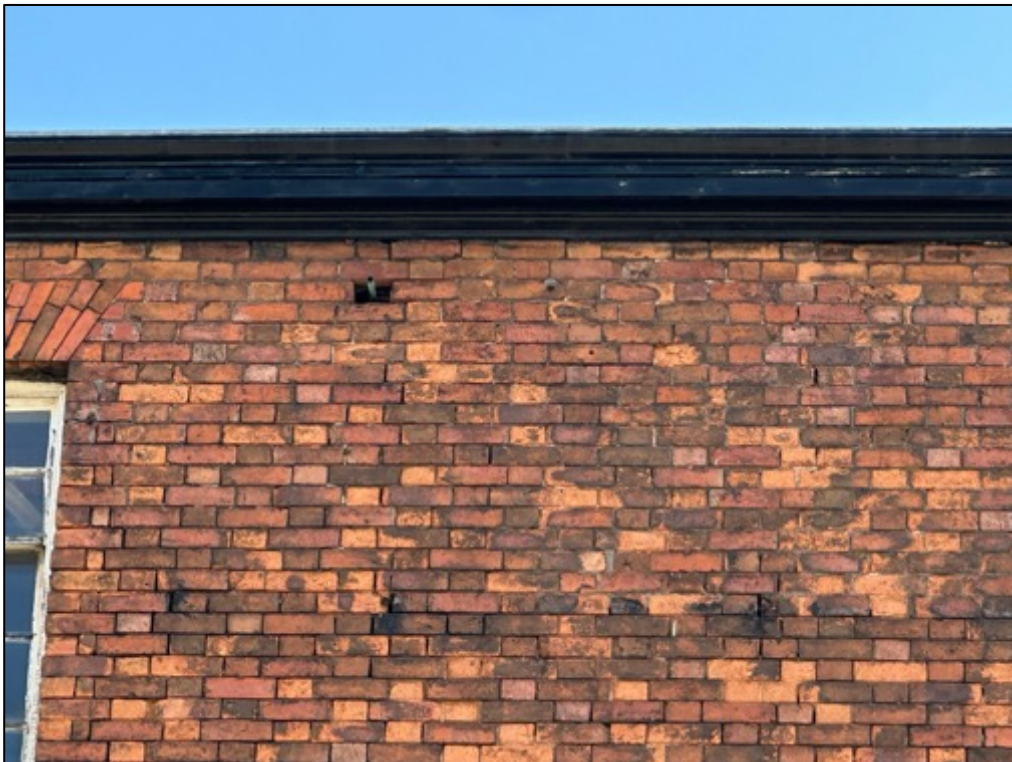
**Photograph 4;** A closer view of the soffit and fascia structuring beneath the roof. Brickwork is in fair condition, though with some prominent gaps in the mortar.

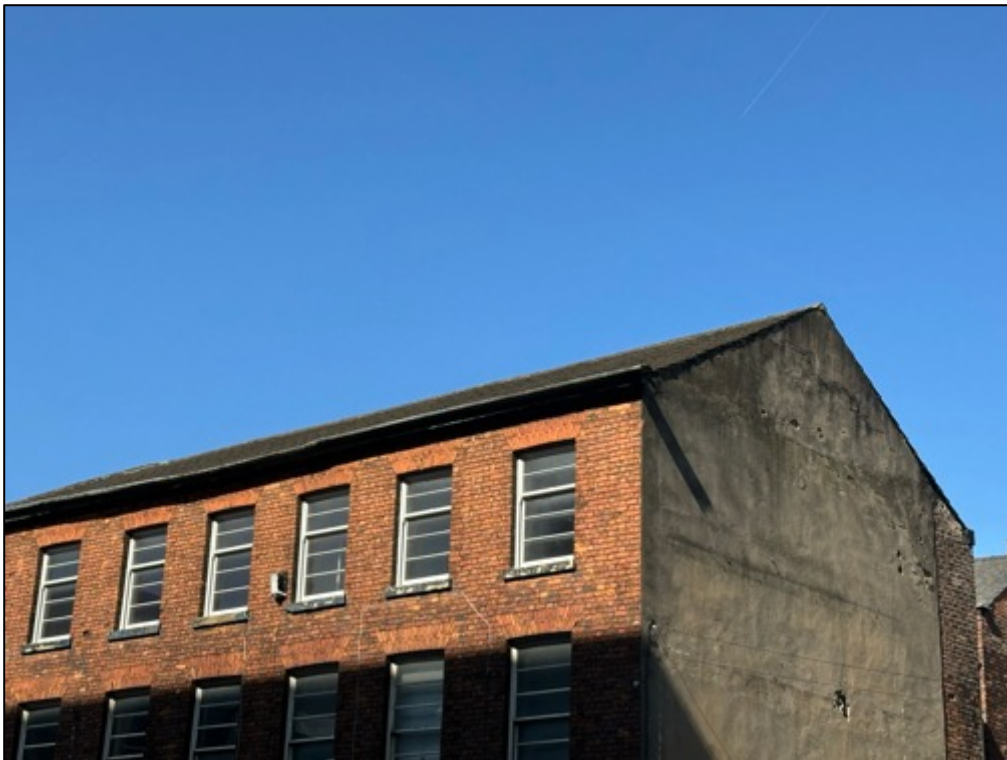
**Photograph 6;** A wider view of the external roof, which does not highlight many instances of displacement.

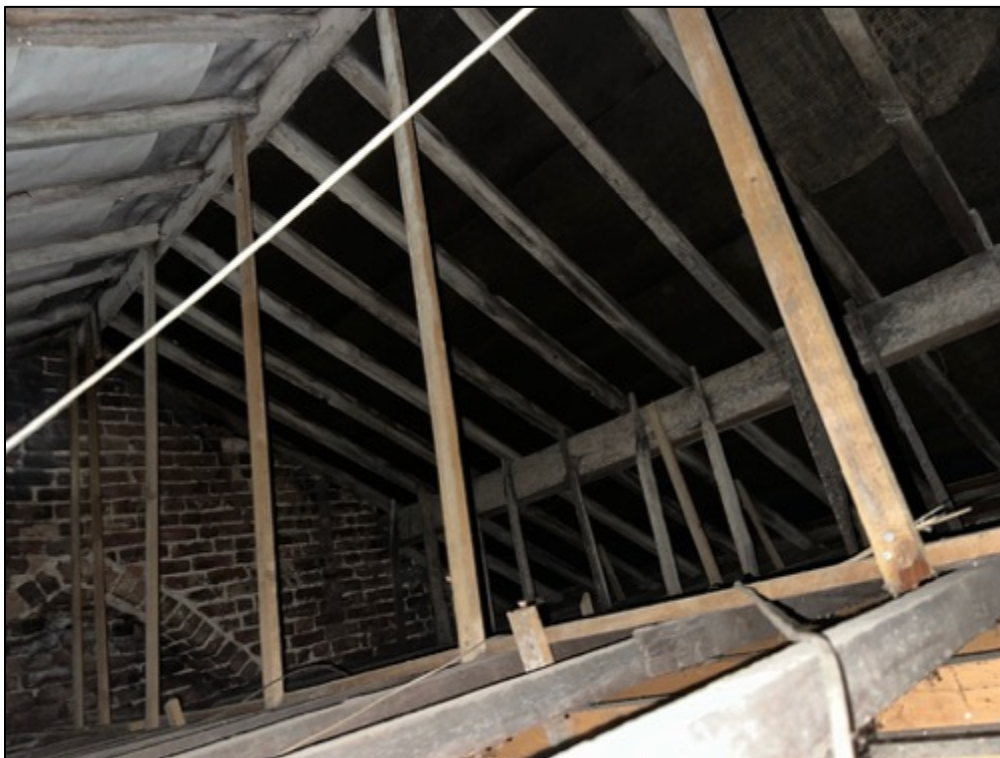
**Photograph 7;** A view into one section of the internal roof space was obtained through a loft hatch; however, due to the hatch's small size, the inspection was limited to observations from the opening. As a result, the floor of this roof section could not be fully assessed for signs of bat activity.

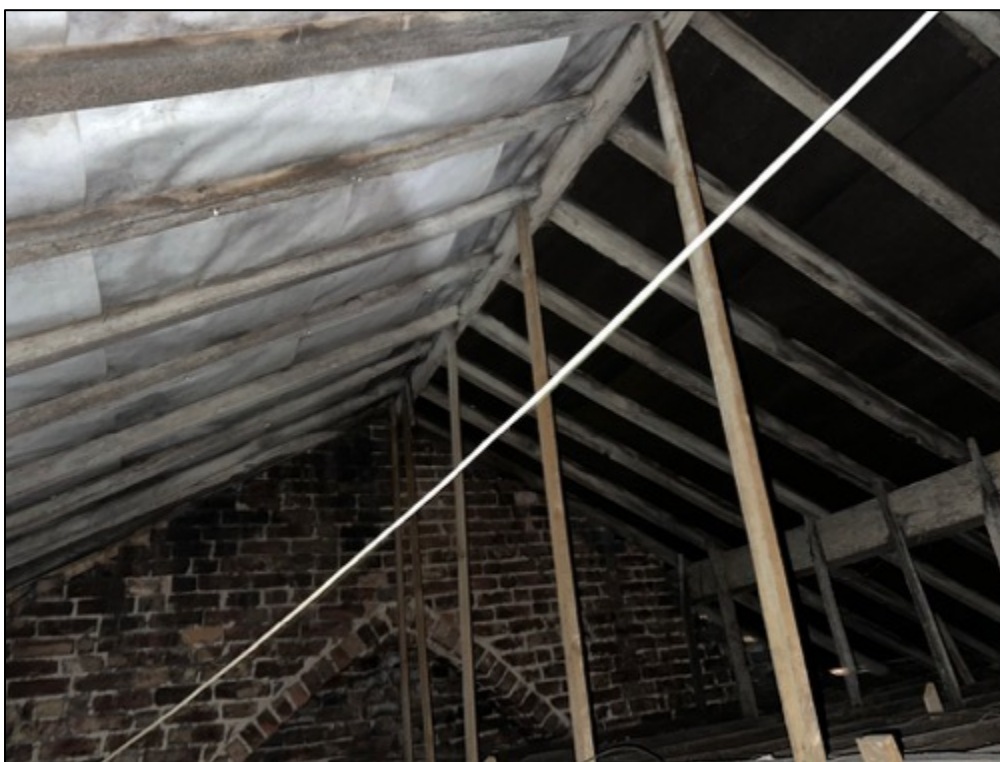
**Photograph 8;** Another view of the same section of internal roof revealed plastic sheeting installed beneath the external roof covering, with wooden purlins and rafters supporting the roof structure.

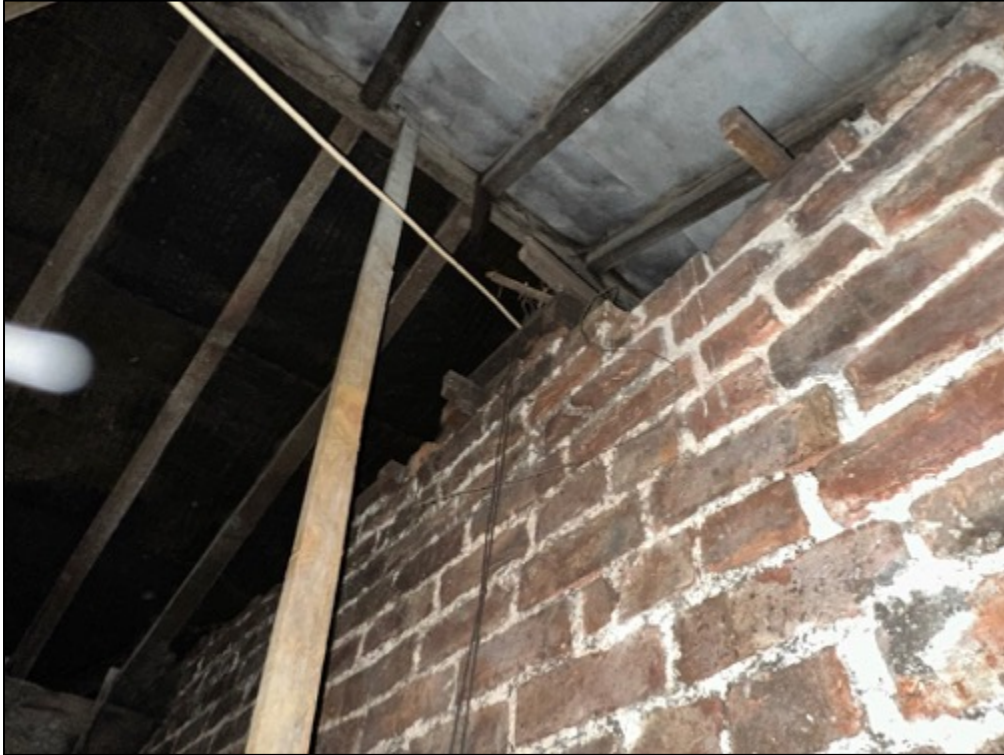
**Photograph 9;** A section of the internal wall within the roof space was observed to be in good condition.

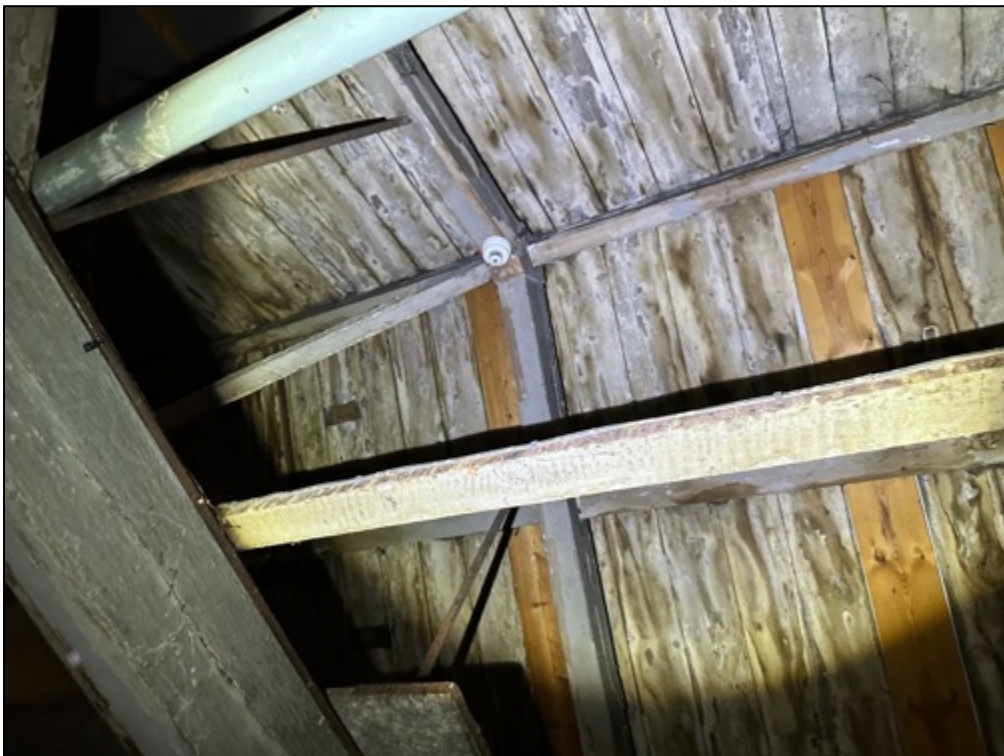
**Photograph 10;** A view of another section of the internal loft space, showing the internal roof structure. This section consists of wooden boarding supporting the external roof, along with wooden purlins and rafters providing additional structural support.

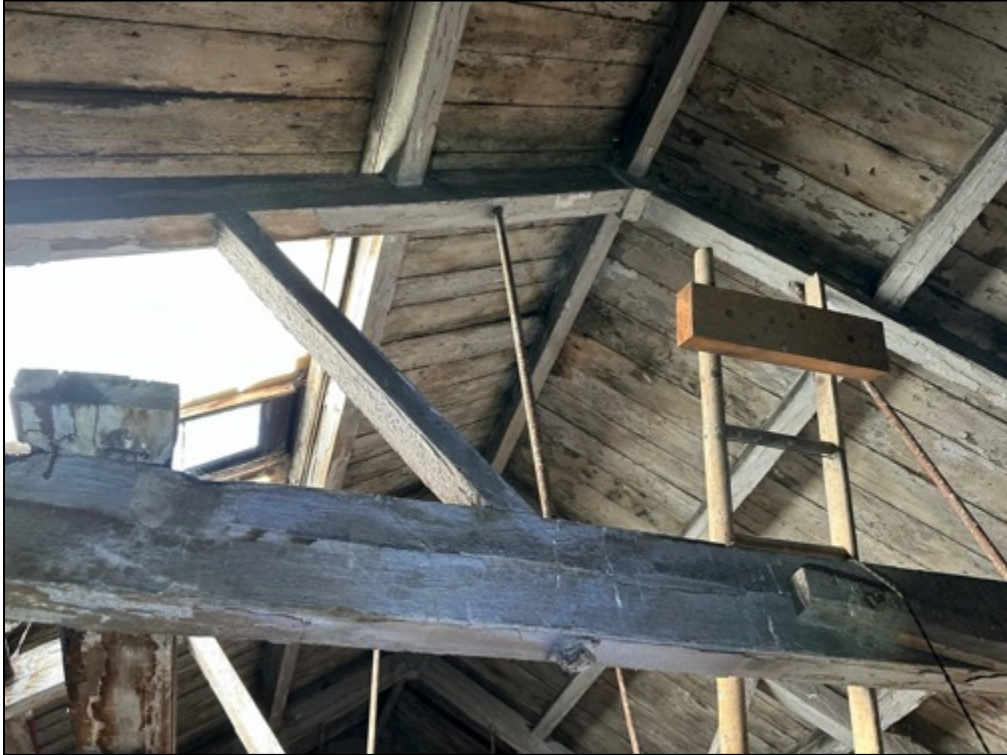
**Photograph 11;** A view of the open internal section, which is seemingly an unfinished work area. The roof space again, comprises wooden boarding beneath the roof tiles with wooden purlins and rafters supporting.

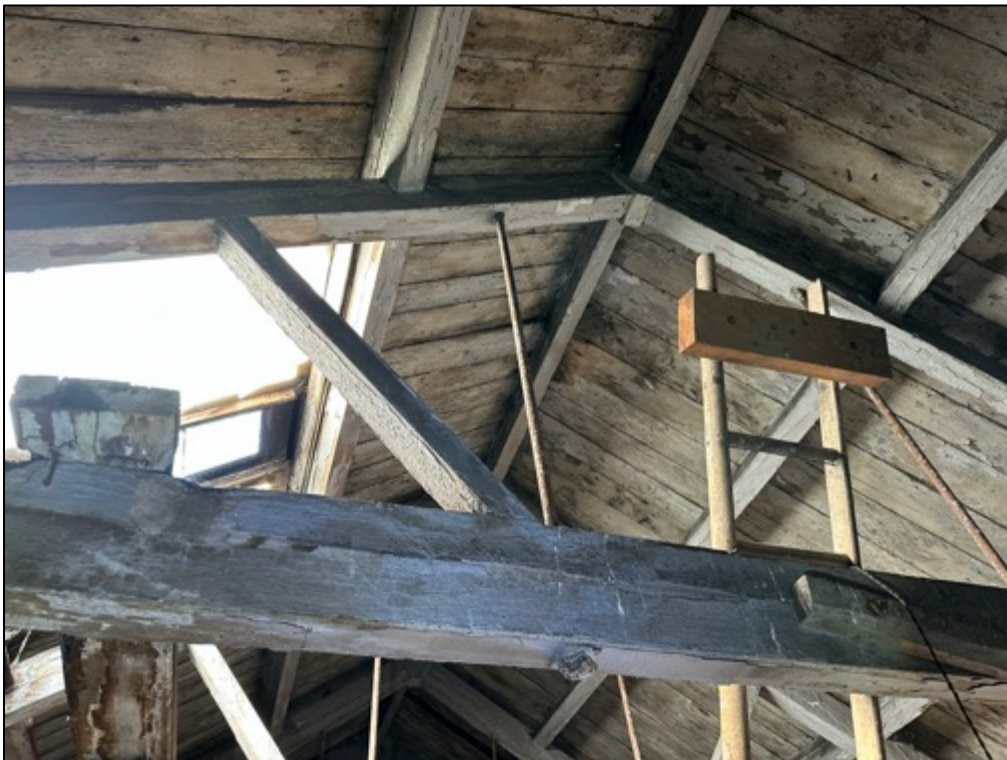
**Photograph 12;** This section of the roof features some skylight windows within the roof.

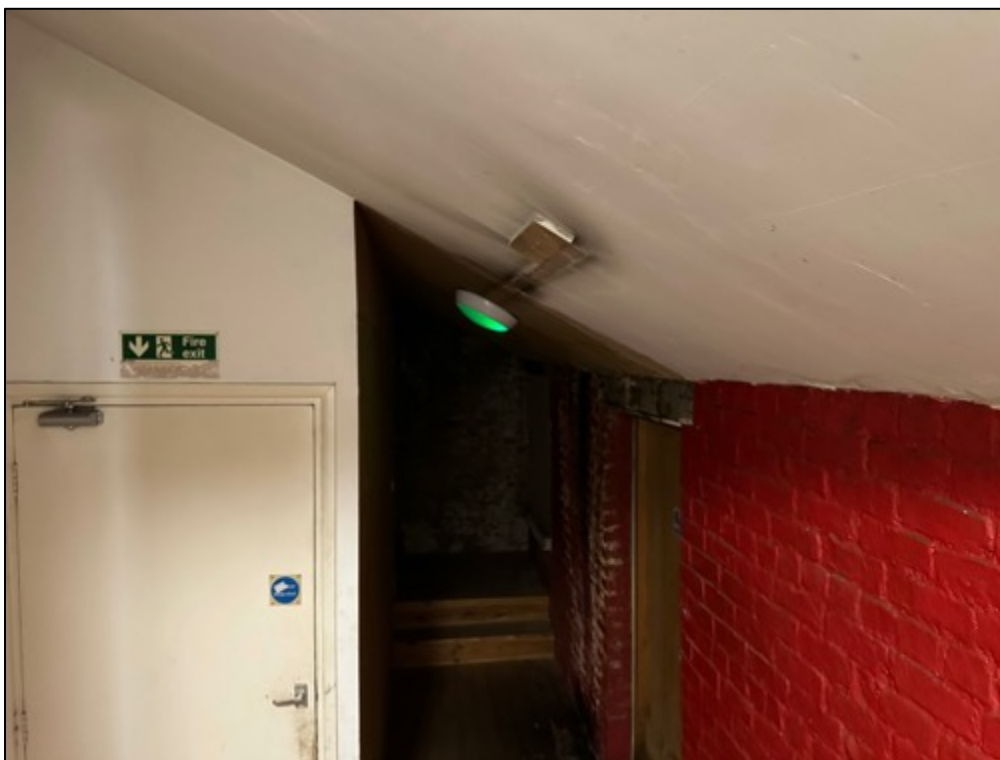
**Photograph 13;** Many of the rooms on the upper floors featured vaulted ceilings.
