# **BRIDGEWATER HOUSE, MANCHESTER**

Phase 2 Geo-Environmental Assessment

**PROJECT NO. 8383**

**OUR REF. NO. 8383-SI-001**

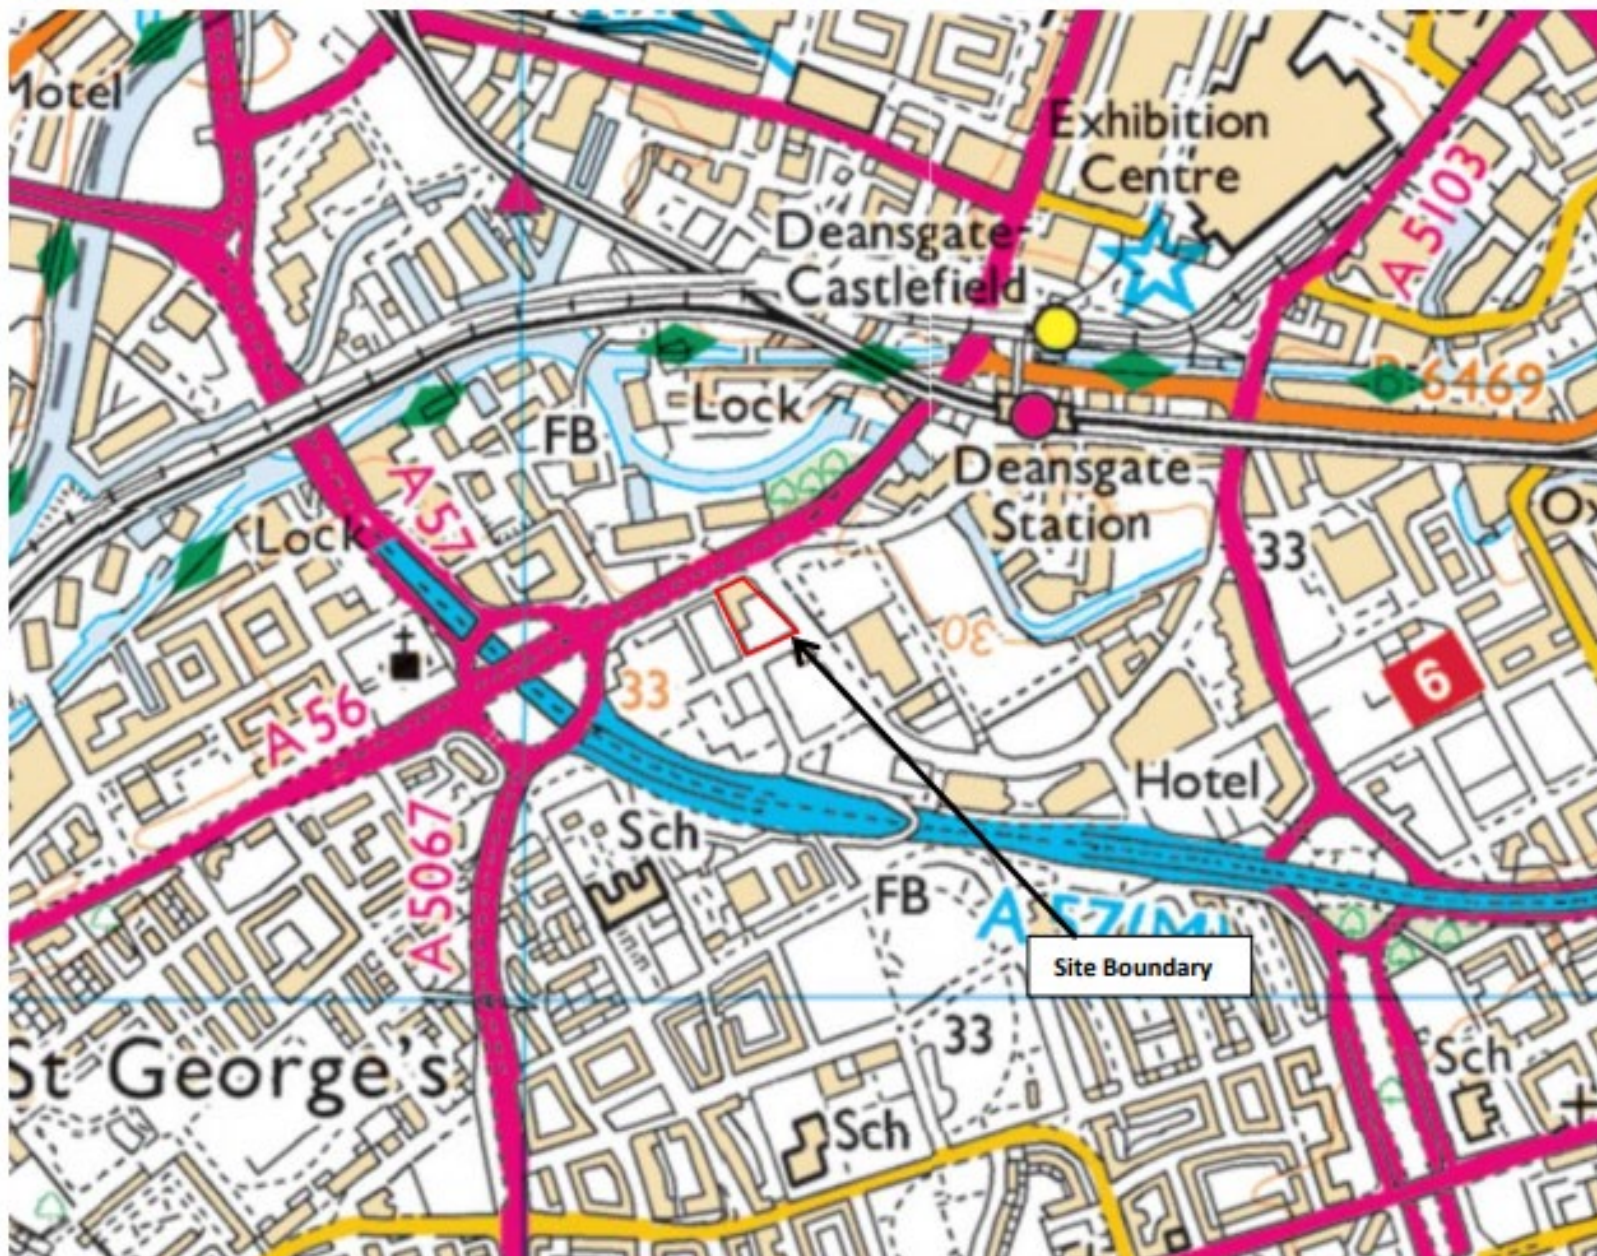
- Existing with Bridgewater House
- Proposed with Bridgewater House
- Outline of apartments (S10.1)
- New landscaping
