**PHASE I GEOENVIRONMENTAL DESK STUDY**

**54 DERBY ST**

**CHEETHAM HILL**

**Report No. A6542/25/FDS**

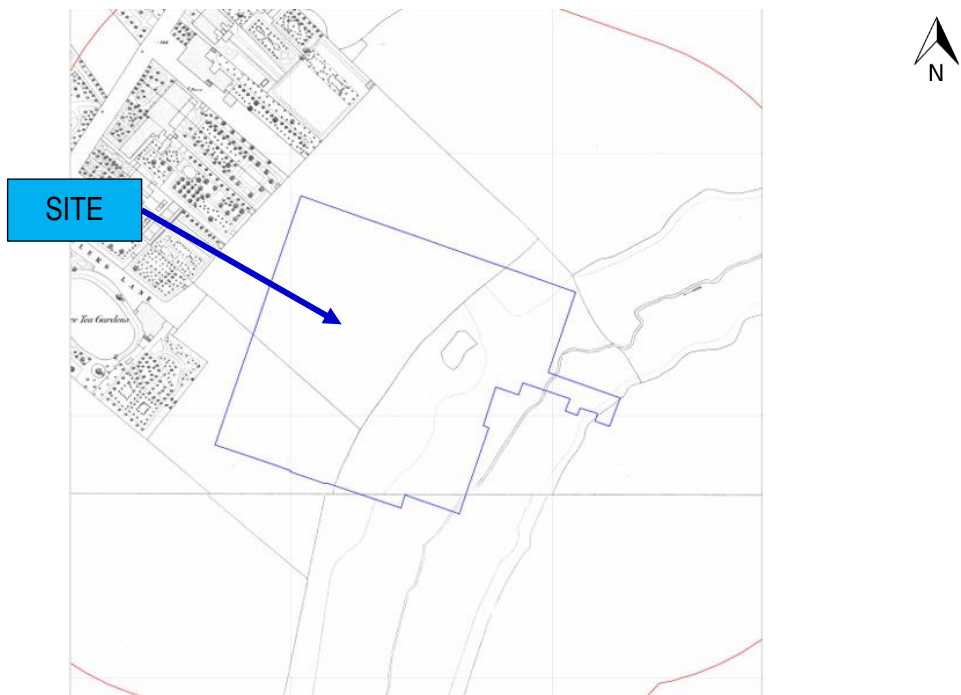
**Figure 5 OS Map Extract 1850**

- 4.5 Offsite, from 1848, residential developments with formal gardens and pathways were visible northwest of the site, indicating an organized estate. By 1891, industrial activity expanded with Old Clay Pits and structures east and south, alongside new buildings northwest, likely industrial or warehouse operations. Between 1892-1893, widespread clay pits and brickworks developed northeast and southwest, with roads becoming more established. In 1906, major civic and industrial additions included His Majesty's Prison and Assize Courts to the south, an Electrical Substation southwest, Iron Works southeast, and Victoria Station 750m south. By 1922, commercial growth included the Ice Palace southeast of the site, while by 1933, Printing and Chemical Works replaced earlier industries southwest and southeast. Cheetham Park and a football ground emerged northwest by 1938. Between 1980-1985, surrounding buildings and infrastructure increased in density or changed function, with road networks expanding significantly by 2001, particularly into Cheetham Hill, reflecting ongoing urbanization

- 4.3 The earliest available historical mapping covering the site dates back to 1848. The site history is summarised in Table 2 and Table 3, below, followed by selected extracts from maps and aerial photographs in Figure 5 to 8.

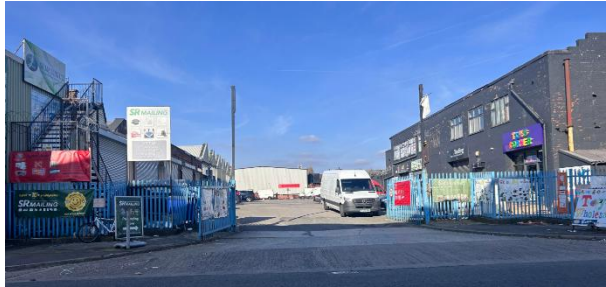
| <p style="text-align: center;"><b>Plate 1 View of Southern site access</b></p> | <p style="text-align: center;"><b>Plate 2 View of eastern site access</b></p> |

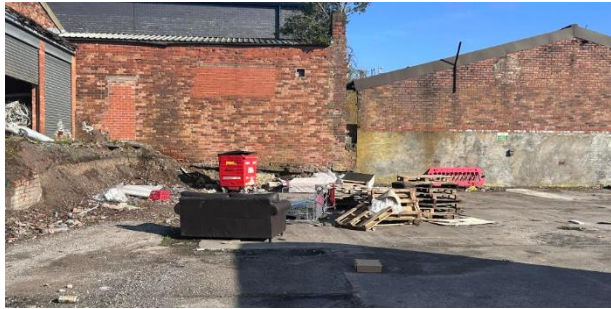
| <p style="text-align: center;"><b>Plate 3 View facing north east showing commercial wheelie bins, household waste and wooden pallets.</b></p> | <p style="text-align: center;"><b>Plate 4 View facing east showing cardboard skip.</b></p> |

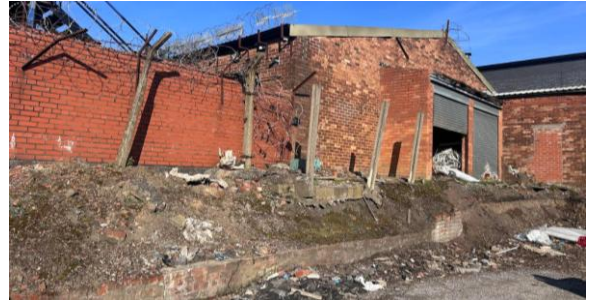
| Geotechnical Design Considerations | |
|---|---|
| Retaining Walls | At the northern end of the site, a collapsed retaining wall is present, behind which built-up soils are observed, containing made ground. |

**Plate 6 View facing northeast showing retaining wall.**
