# Arboricultural Impact Assessment and Method Statement

Northern Pathology Development

TG Report No. 16986\_\_JP

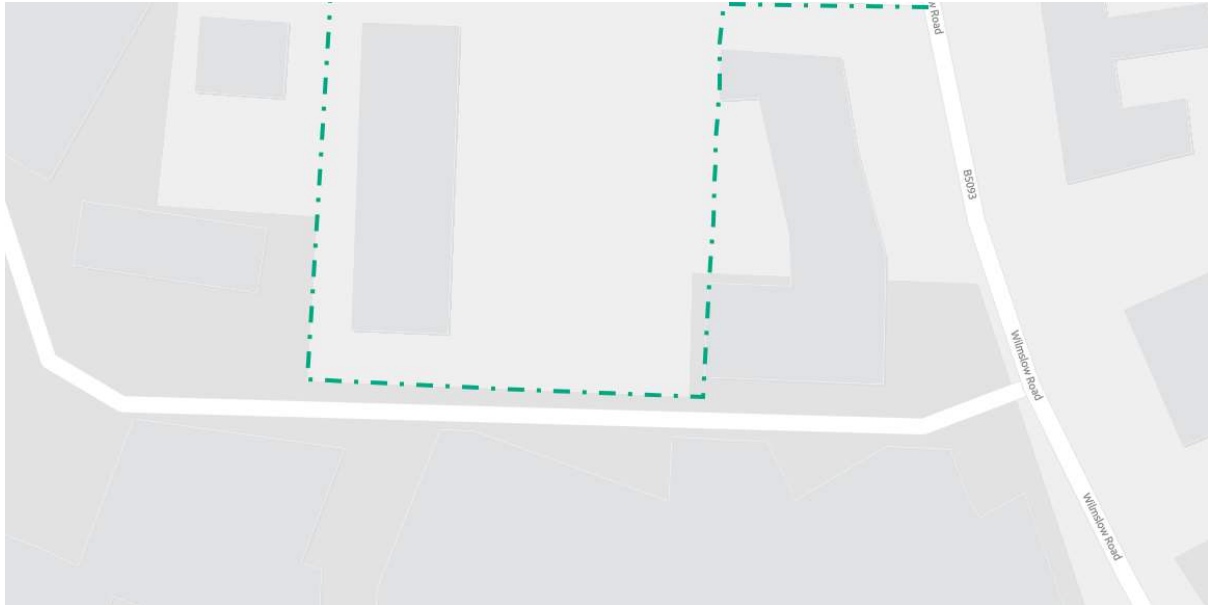
**Figure 2.** Extract of Conservation Area Map showing boundary of Withington Conservation Area (provided by MCC Interactive Maps).

- 1.7. The trees surveyed are located within the Withington Conservation Area (See Figure 2 below). Trees located within a Conservation Area are legally protected. Further details of the legislation are provided at Appendix 4.

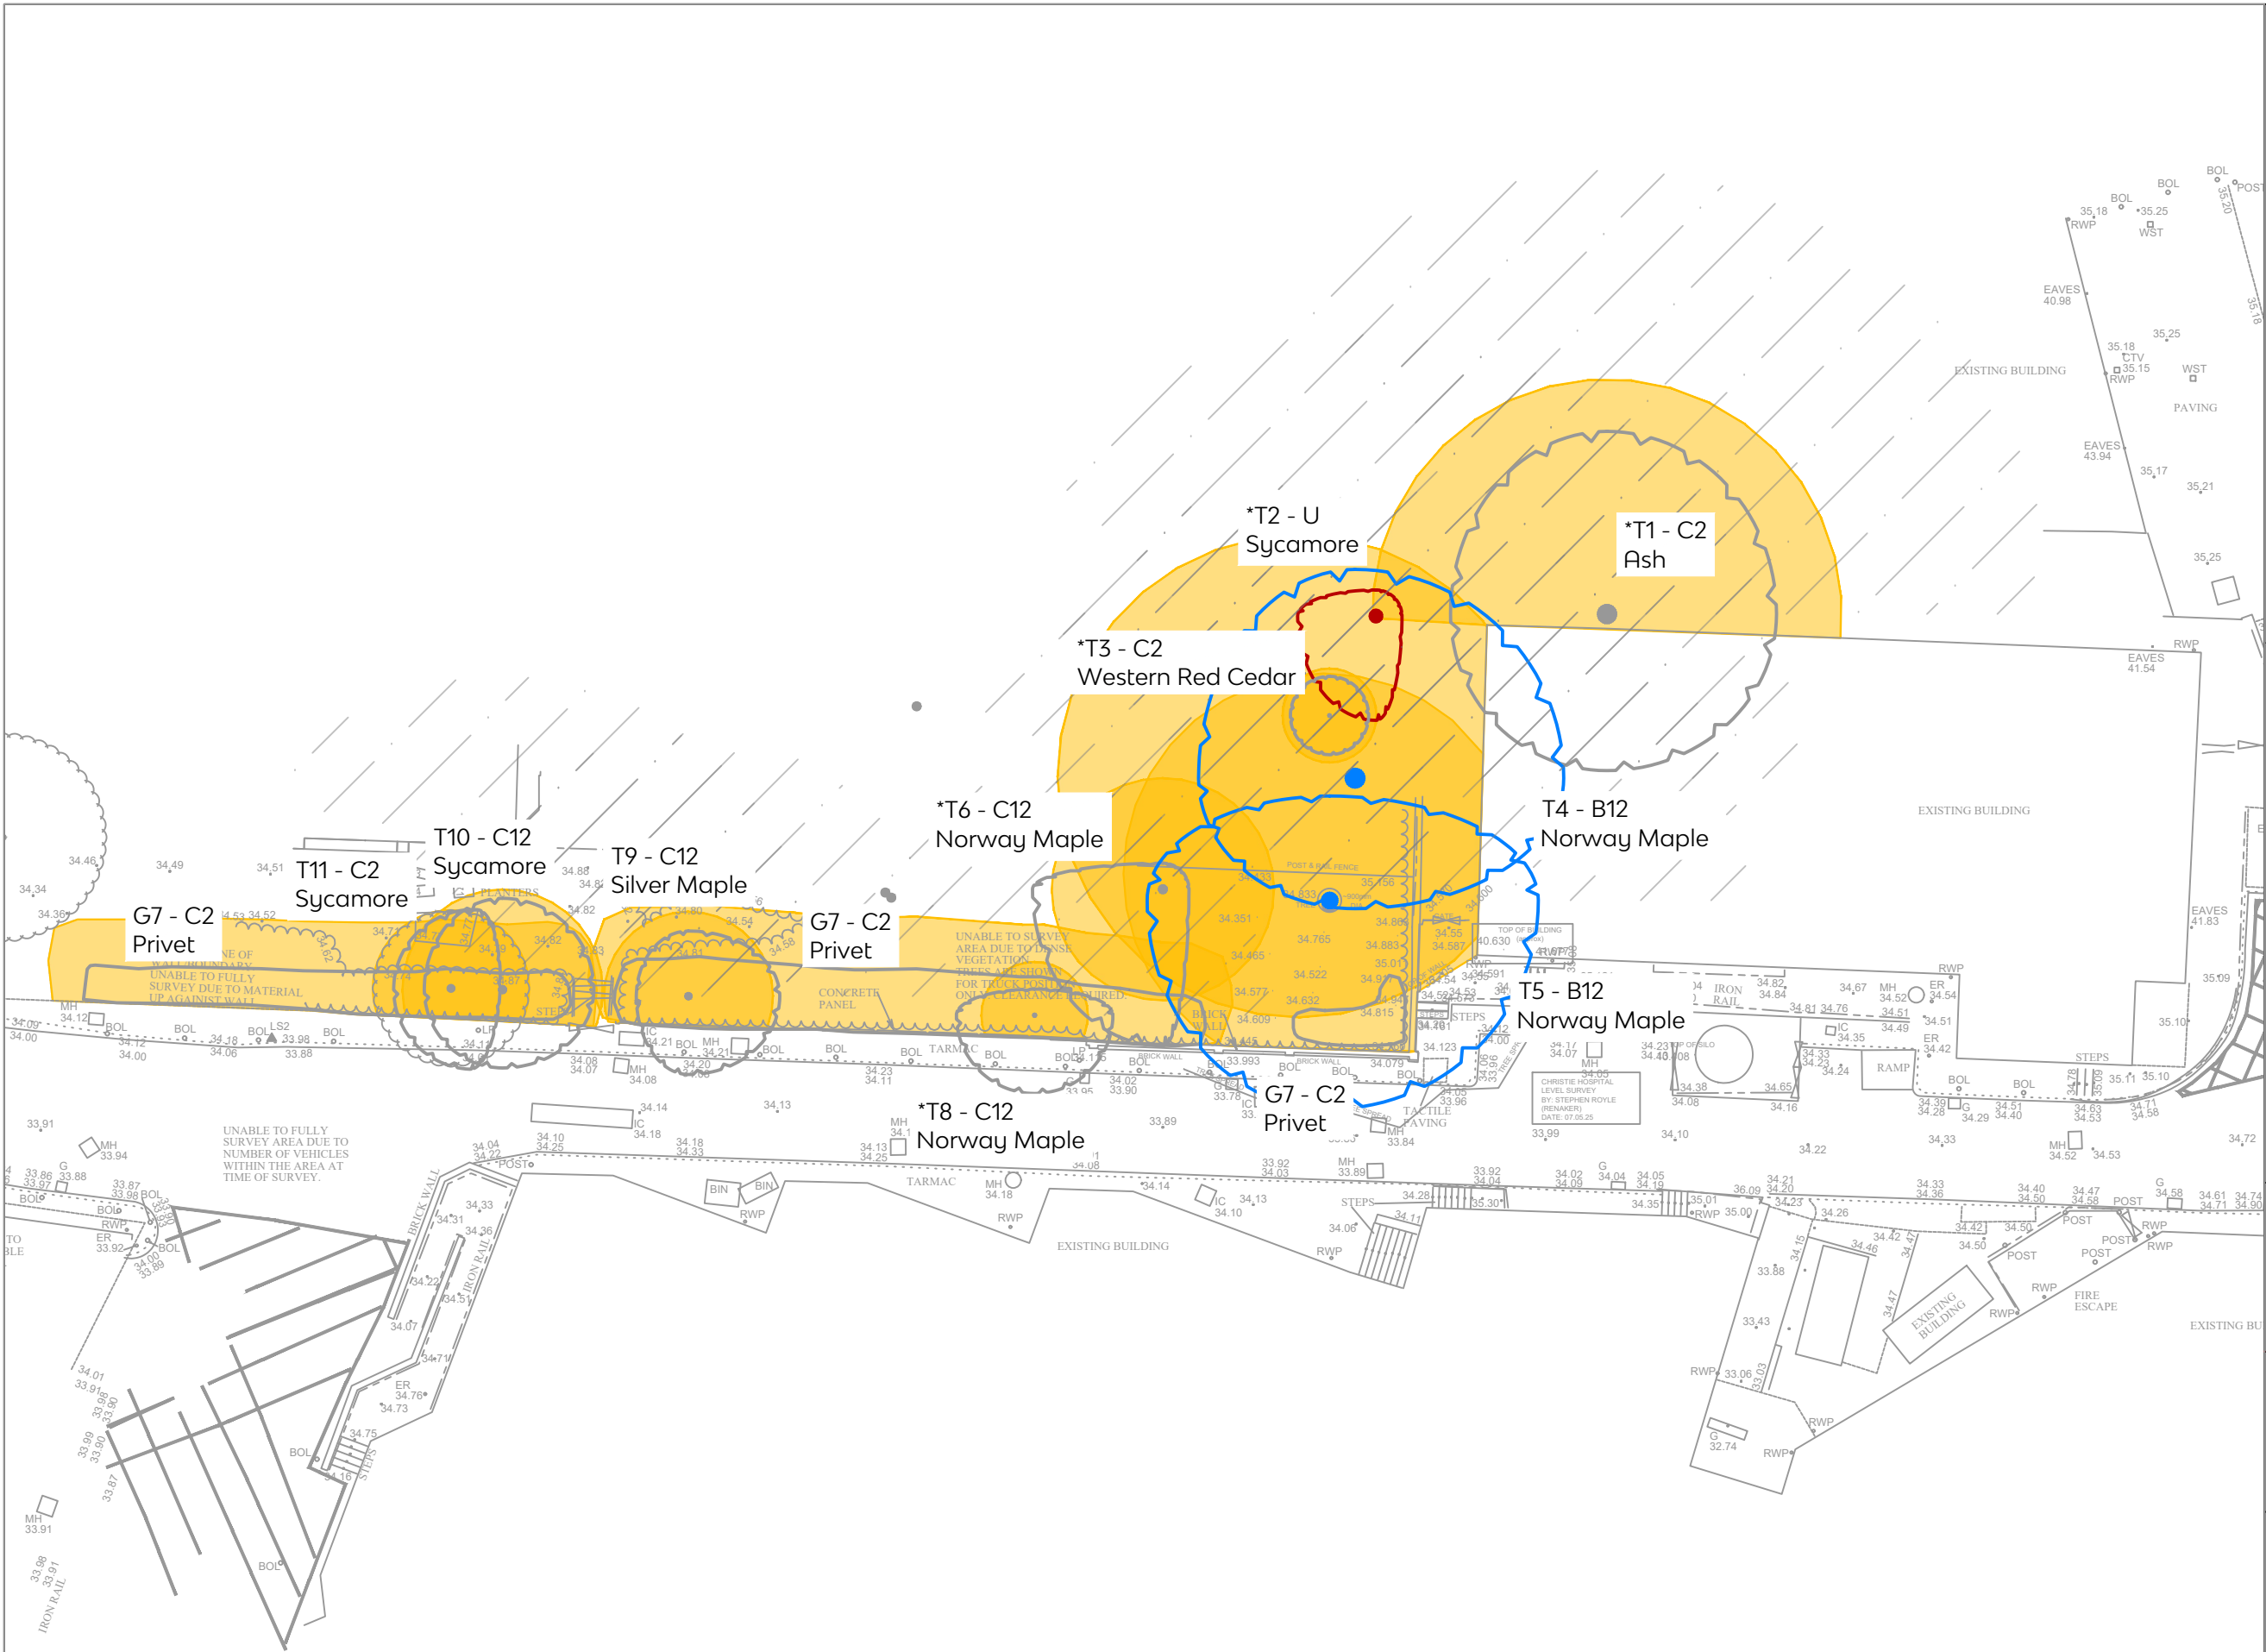
| Plan 3: Tree Protection Plan (TPP) |

- AMS06** - General Site Precautions
- AMS07** - Procedures for Incidents
- 3.3. The **TPP (See Plan 3)** shows the Root Protection Areas (RPAs) and branches spread of retained trees. The RPA signifies the area that must be protected during the construction works to avoid harm to the rooting environments of trees. Where development and site works occur within RPAs or close the tree branches, there are mitigative measures and protocols that must be adhered to as detailed within this document. Unless otherwise stated within this document, within the areas protected by tree protection barriers the following shall apply:

- 3.18. The **TPP (See Plan 3)** identifies the location of the tree protective fencing. The fencing will comprise a scaffold framework, well braced to resist impacts, with vertical tubes spaced at a maximum of 3m to add further stability. Onto this, weldmesh panels will be securely fixed with wire or scaffold clamps (**See Figure 3 overleaf**). The TPP also shows where existing features will be retained to serve as tree protection barriers. This includes an existing wall to the south / east of tree T5, and a concrete panel fence at the eastern side of trees T2, T3 and T4.

- 3.23. The **TPP (See Plan 3)** identifies the location of existing hard surfacing which is to be retained and remedied between the proposed building and trees T4 and T5. Should the hard surfacing be replaced, ground protection will be required to avoid compaction within the RPAs.

- 3.25. The **TPP (See Plan 3)** shows the RPAs of retained trees. This signifies the area that must be protected during the demolition and constructions works to avoid harm to the rooting environments of trees. Where development and site works occur in these areas, there are mitigative measures and protocols to adhere to as detailed within the document.
- 3.26. RPAs for trees T1, T4 and T5 have been reshaped to reflect the presence of the existing building foundation which is considered to act as a barrier towards root growth. The RPA of tree T5 has also been reshaped to reflect the presence of a retained wall to the south of the tree. Where the shape of an RPA has been altered, the extent of the RPA has not been reduced but compensated to include areas that are considered to be more advantageous to root development.

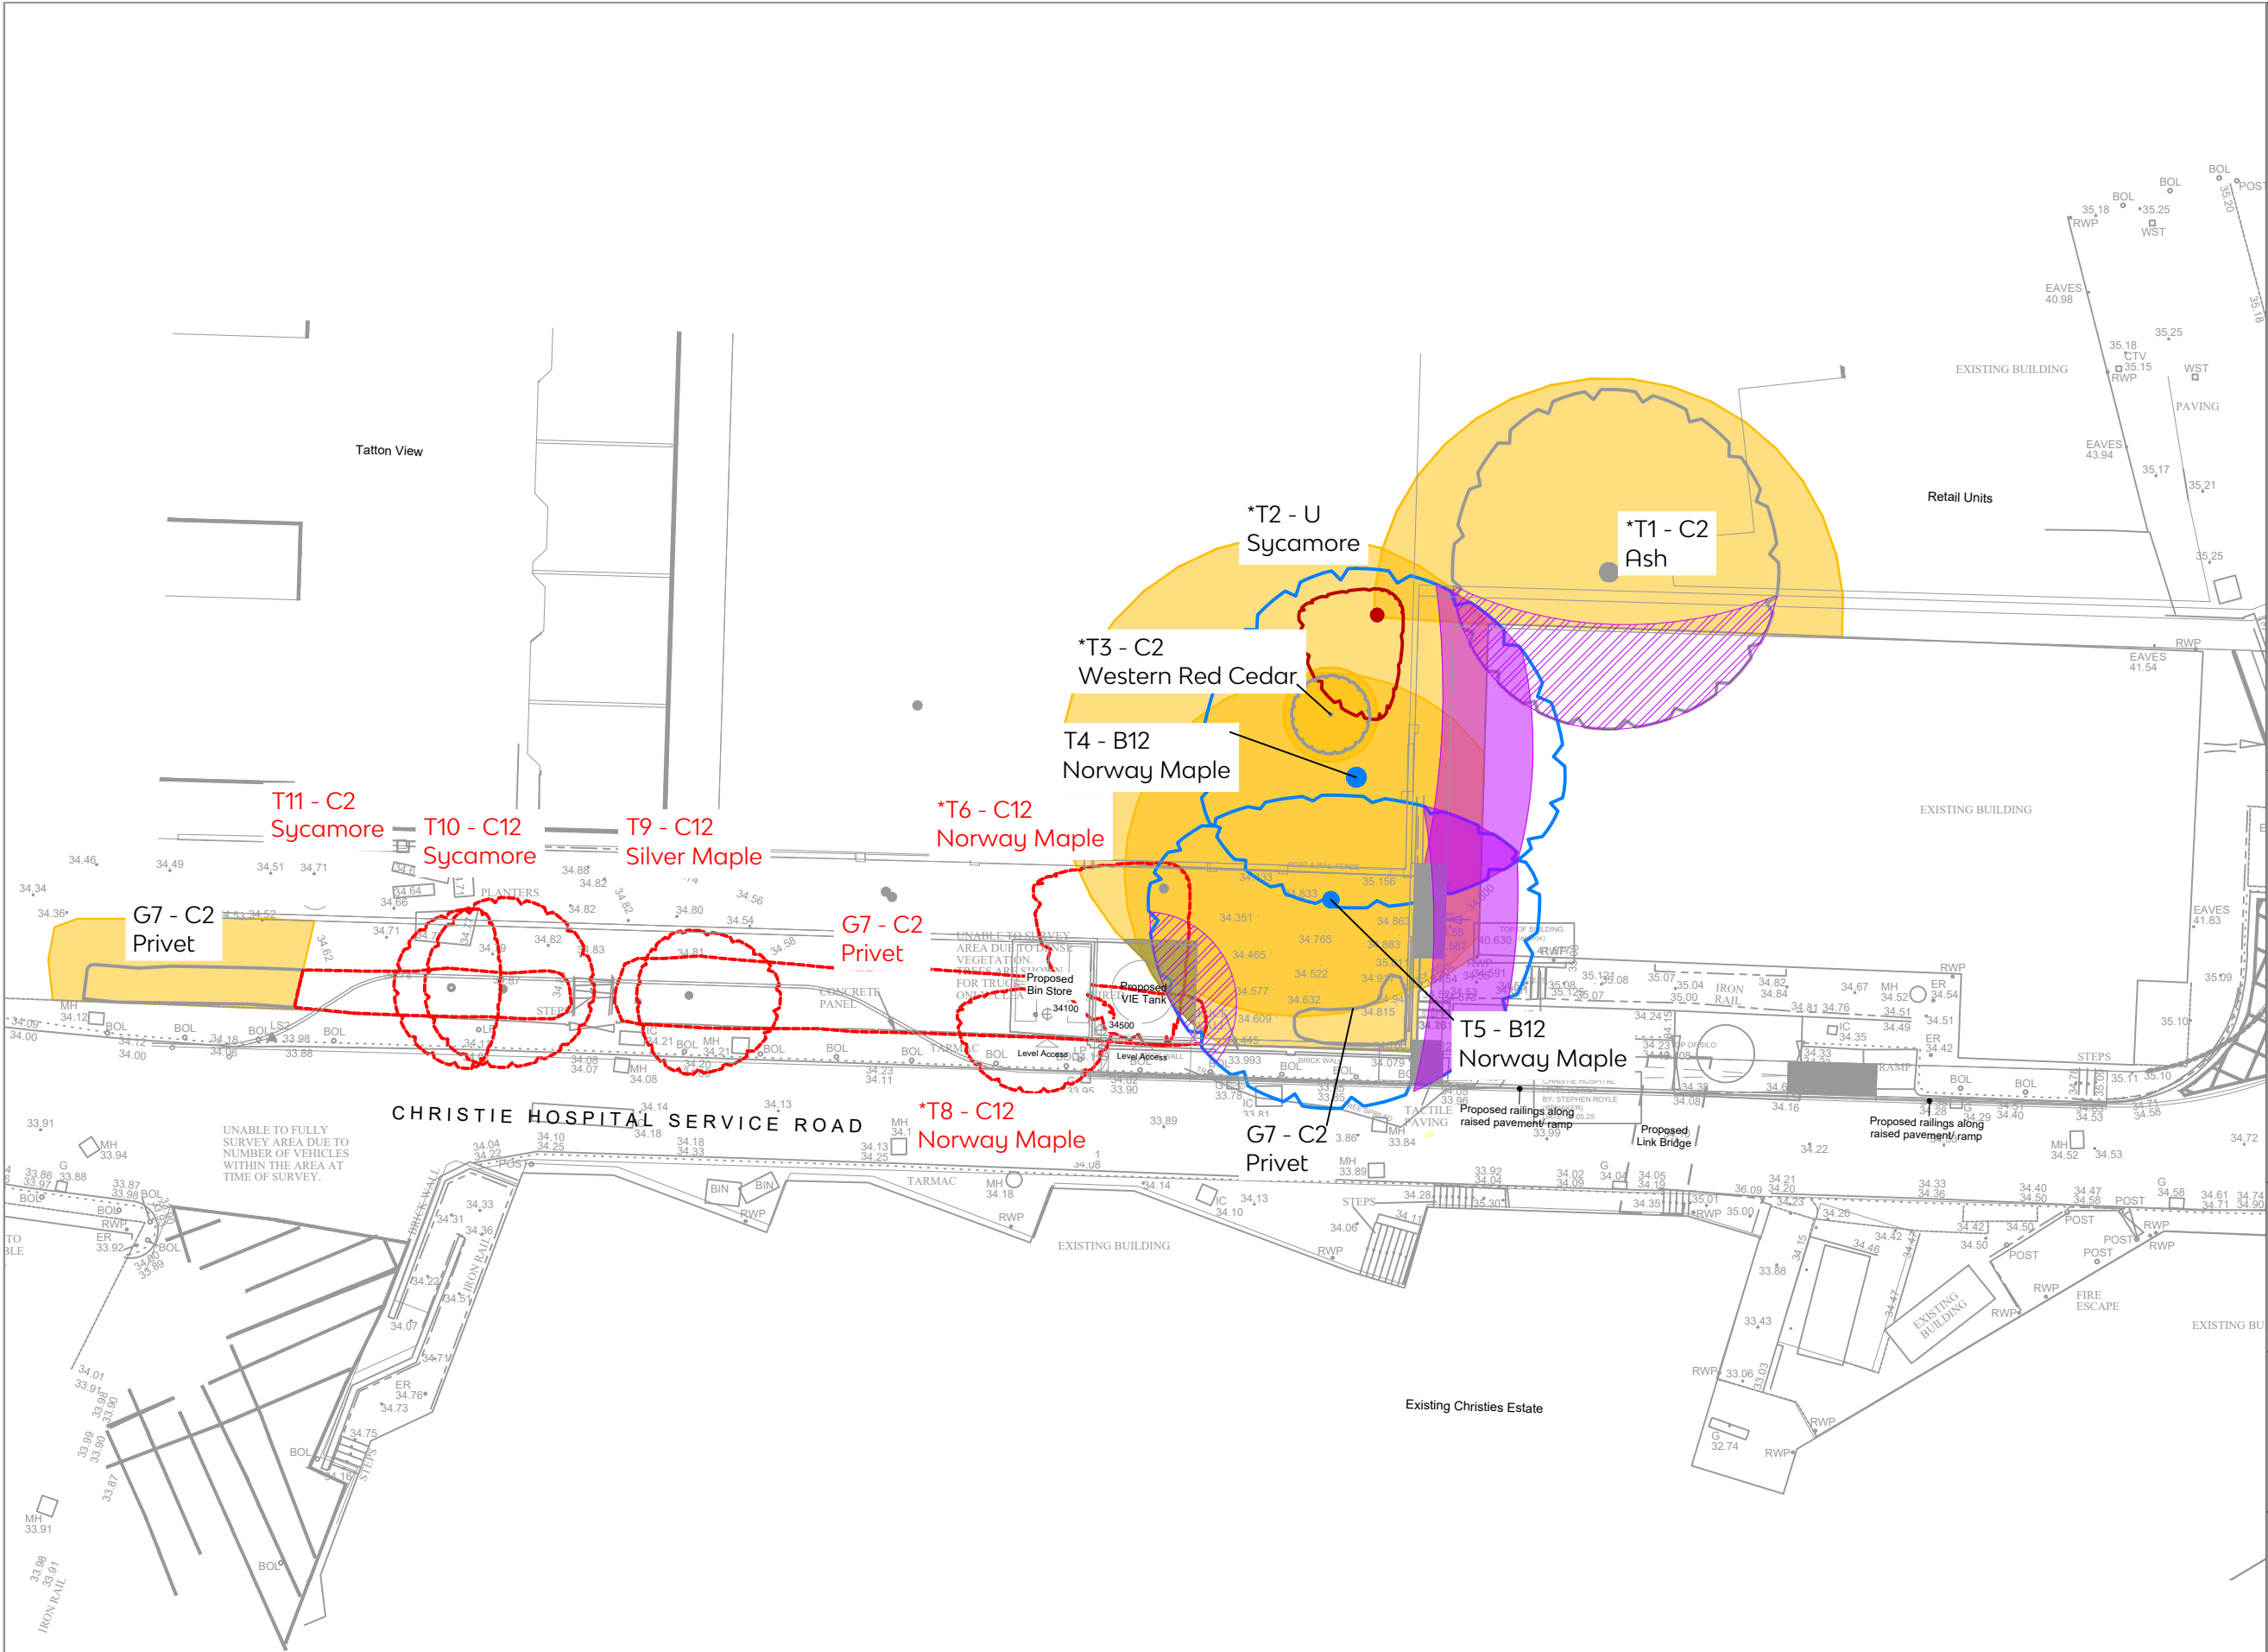
- Category B - Trees of Moderate Quality and Value
- Category C - Trees of Low Quality and Value
- Category U - Trees in Poor Condition
- Root Protection Areas
- Tree Removals to Facilitate the Proposed Development
- Extent of Tree Canopy Reduction Pruning to Facilitate the Proposed Development
- Extent of Tree Crown Lift Pruning to Facilitate the Proposed Development
- Extent of Excavation Works Inside RPA's

- 3.11. The TRRP (See Plan 2) identifies trees to be retained and removed. Trees to be removed are shown with a dashed tree canopy outline and red identification number. The removals will be restricted to and must follow the procedures as listed in Table 1 below.

- 3.15. The **TRRP** (See Plan 2) identifies trees to be pruned with a pink hatch. The pruning works will be restricted to and must follow the procedures as listed in Table 2 below.
