# TV/FM & DAB RECEPTION SURVEY REPORT

**DATE OF SURVEY:** 14th February 2025  
**REF NO:** TBAER077

This study was undertaken in February 2025, to investigate whether the proposed development at Boulton House, Manchester could cause interference to television and radio broadcast service reception. The report also details the baseline reception conditions for future reference.

Joyce,  
17 Chorlton Street,  
Manchester

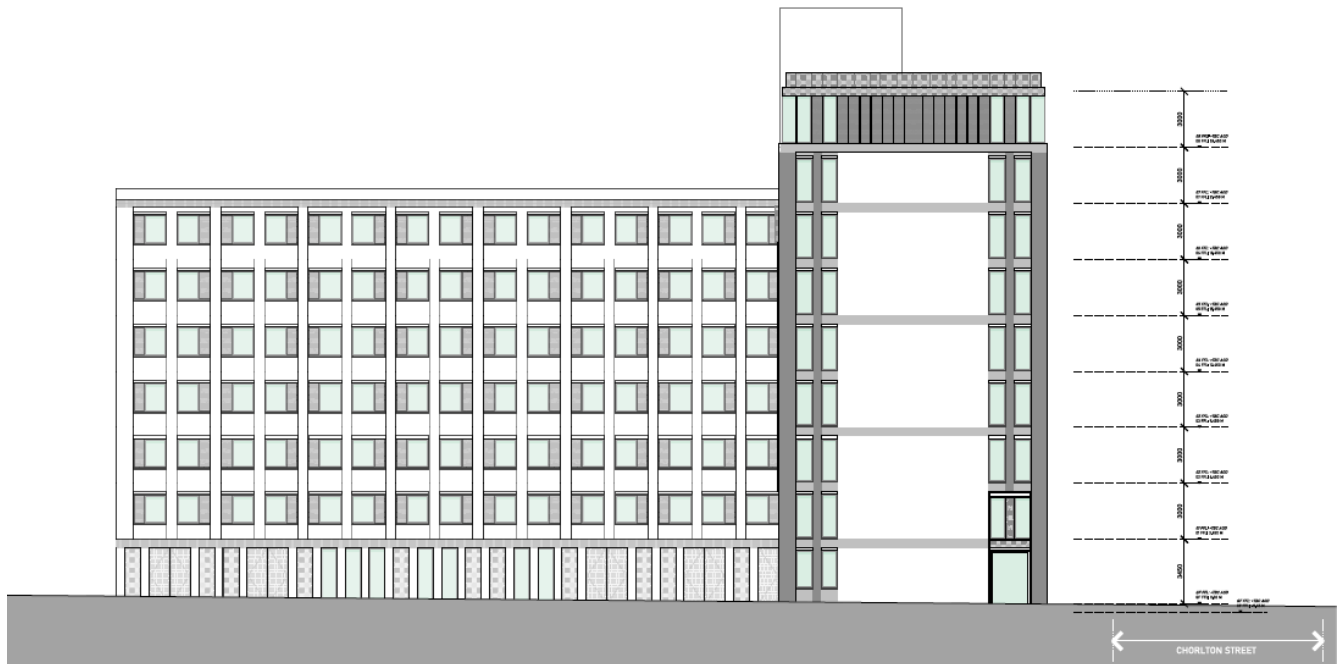
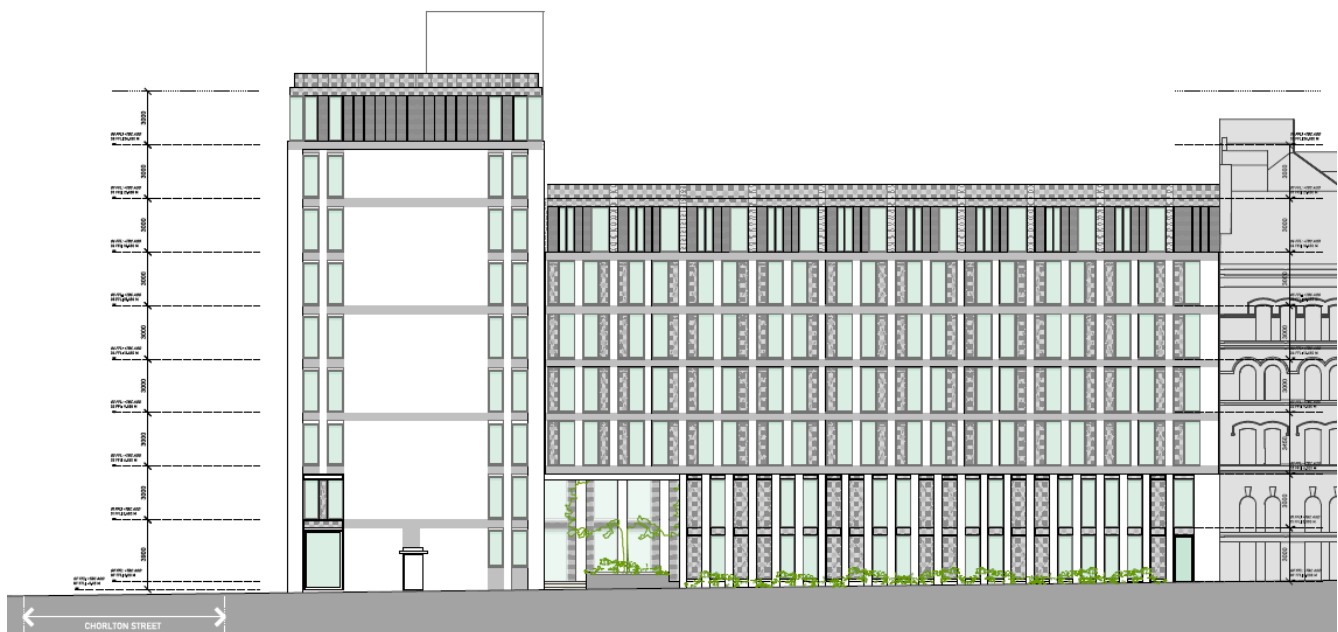
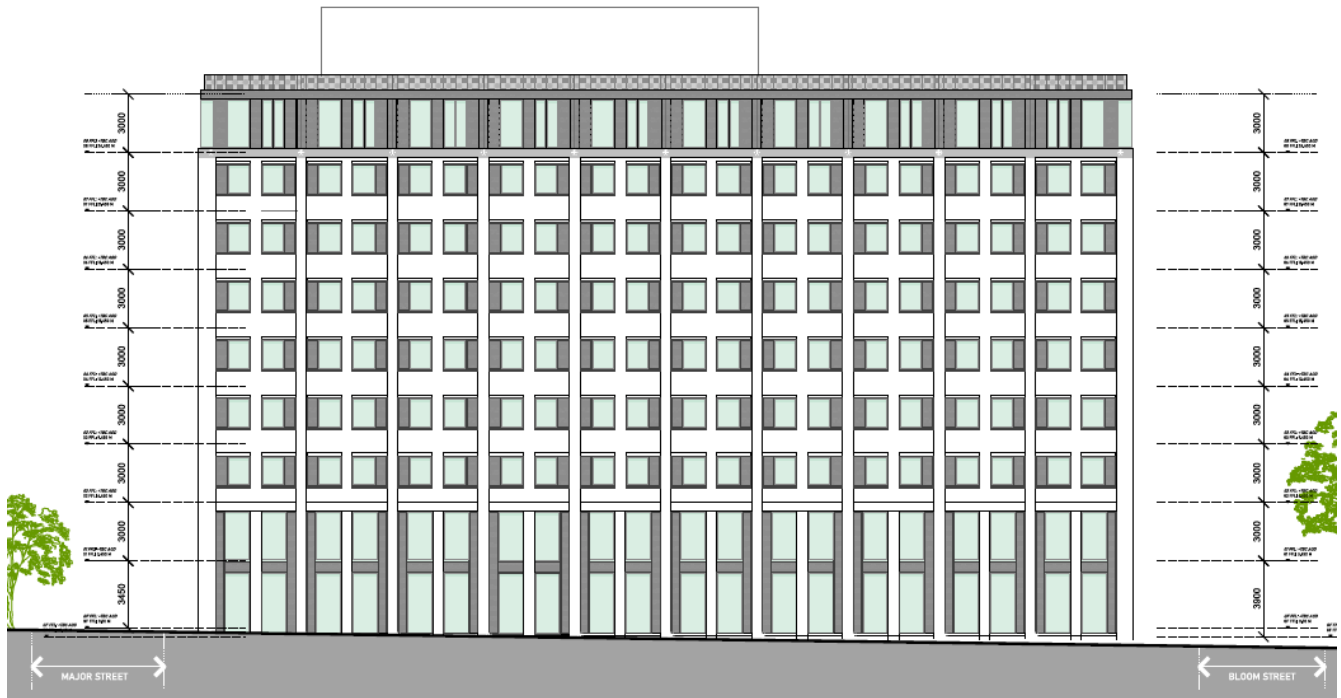
## PLAN B: THE PROPOSED ELEVATIONS

Proposed Building Height: The development is to have a maximum elevation of approximately 28m.

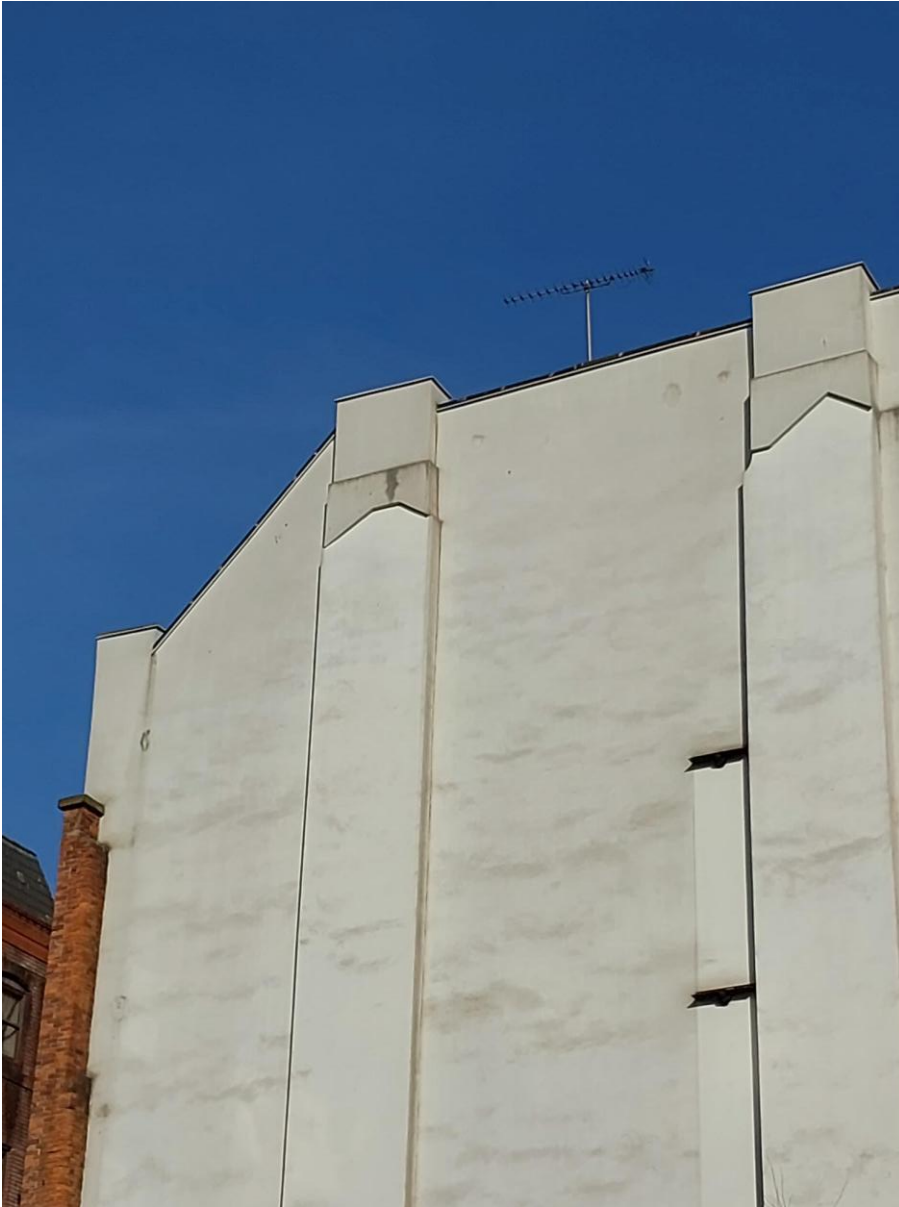
## VISIBLE TV AERIAL LOCATED IN THE AREA OF TEST POINT 1

**Visible Existing Aerial Arrays:** High gain aerials on 2m mast, mounted at rooftop height on 6 storey properties, directed towards the Winter Hill Transmitter

Television signal strengths are low, and corruption is being received.

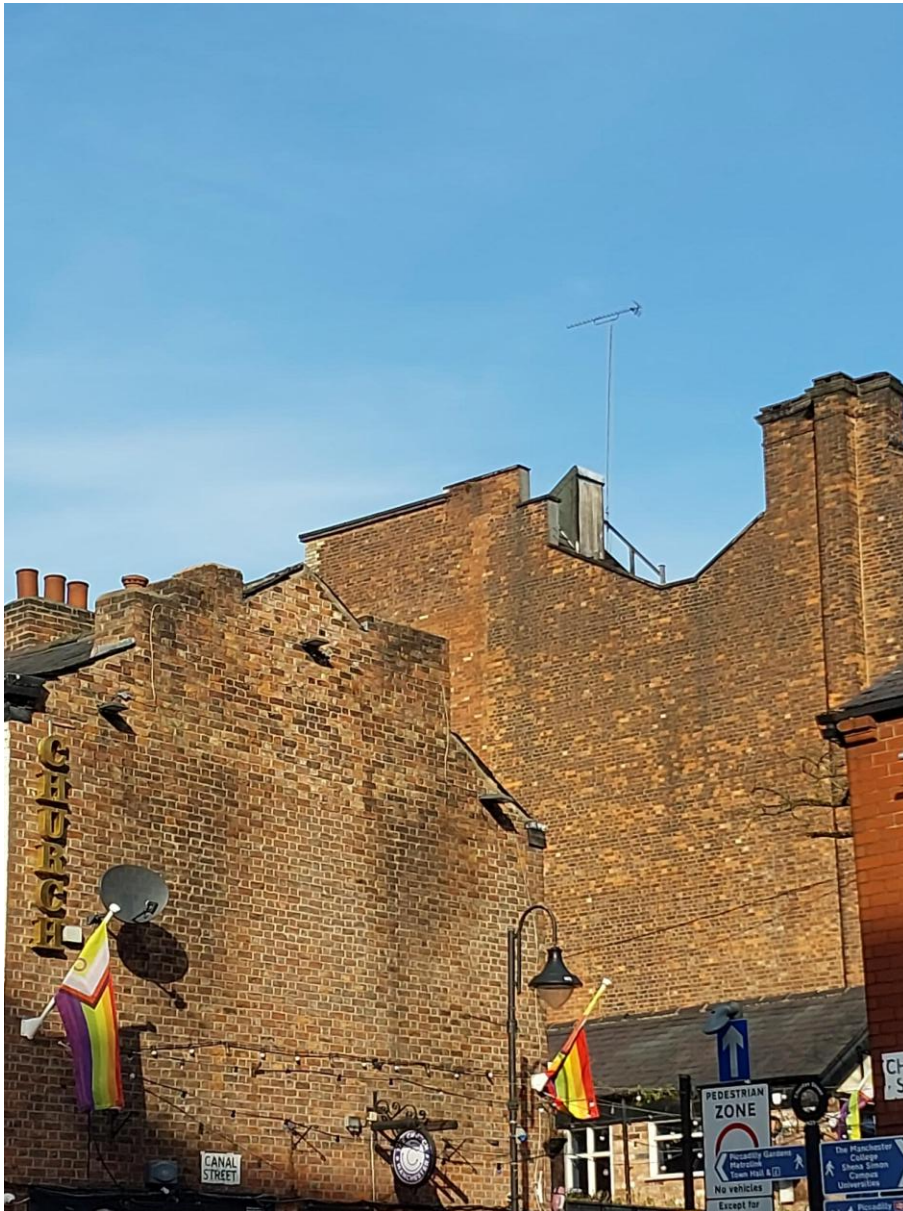
## VISIBLE TV AERIAL LOCATED IN THE AREA OF TEST POINT 5

Television signal strengths are low, and corruption is being received.

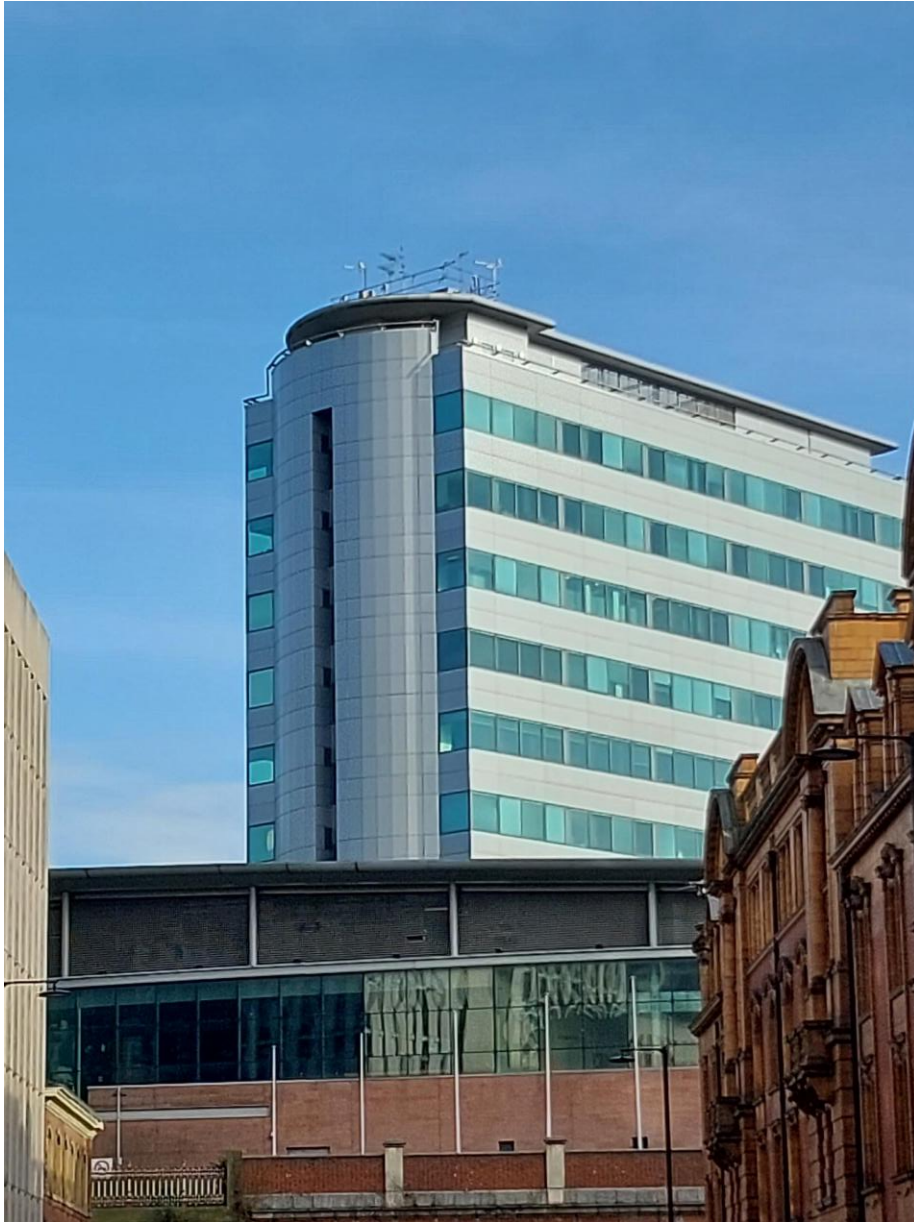
## VISIBLE TV AERIAL LOCATED IN THE AREA OF TEST POINT 6

Television signal strengths are low, and corruption is being received.

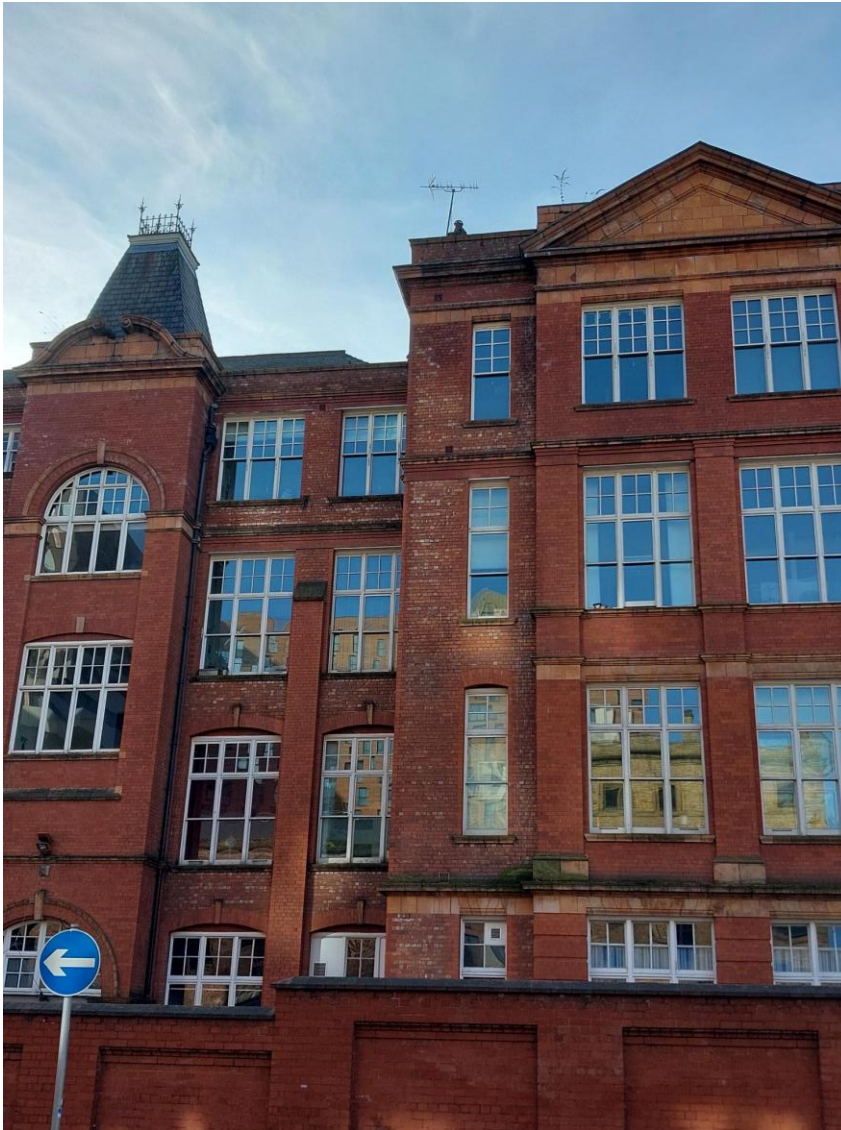
## VISIBLE TV AERIAL LOCATED IN THE AREA OF TEST POINT 7

Television signal strengths are low, and corruption is being received.

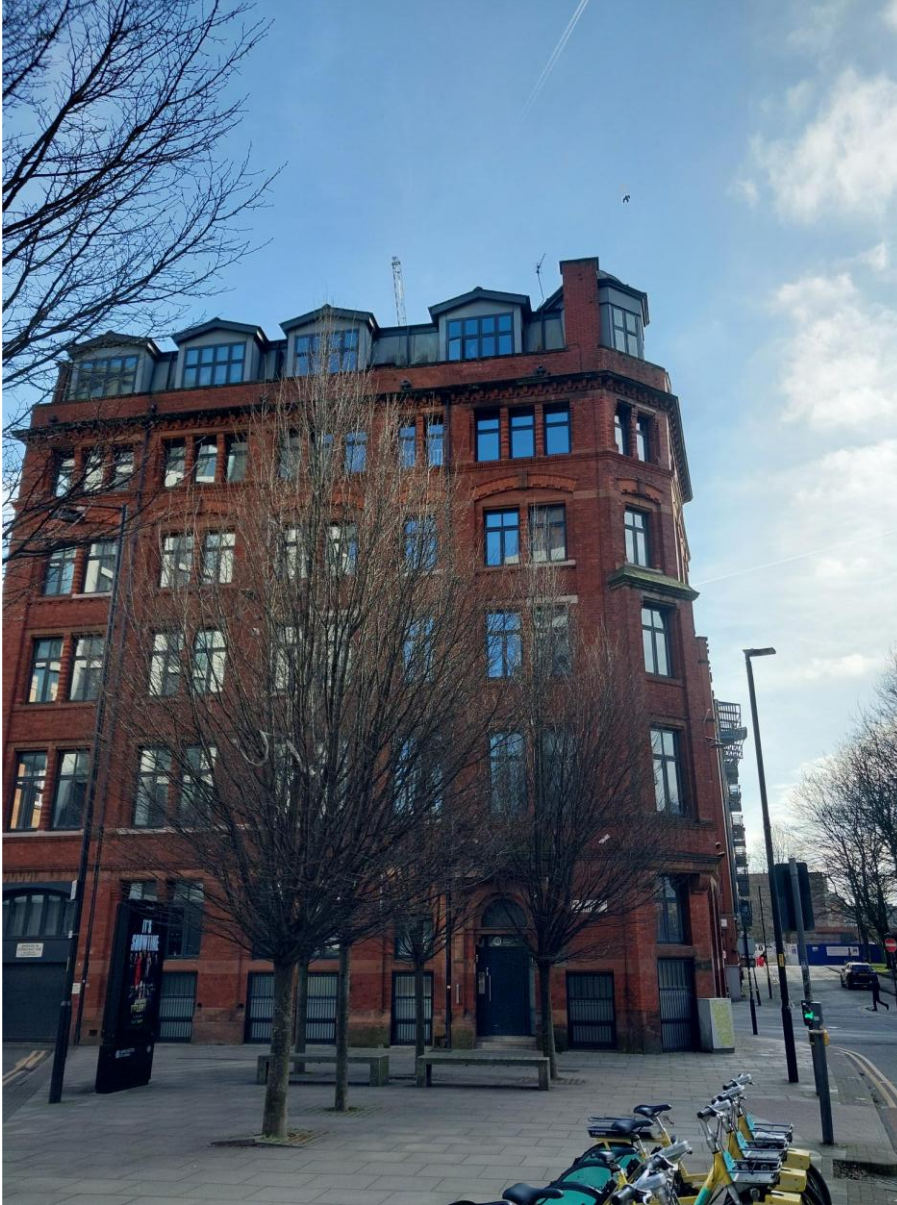
## VISIBLE TV AERIAL LOCATED IN THE AREA OF TEST POINT 8

Television signal strengths are low, and corruption is being received.
