# Wythenshawe Park

Multi-Sports Hub

TITLE  
Wythenshawe Park  
Multi-Sports Hub  
Spillage Comparison

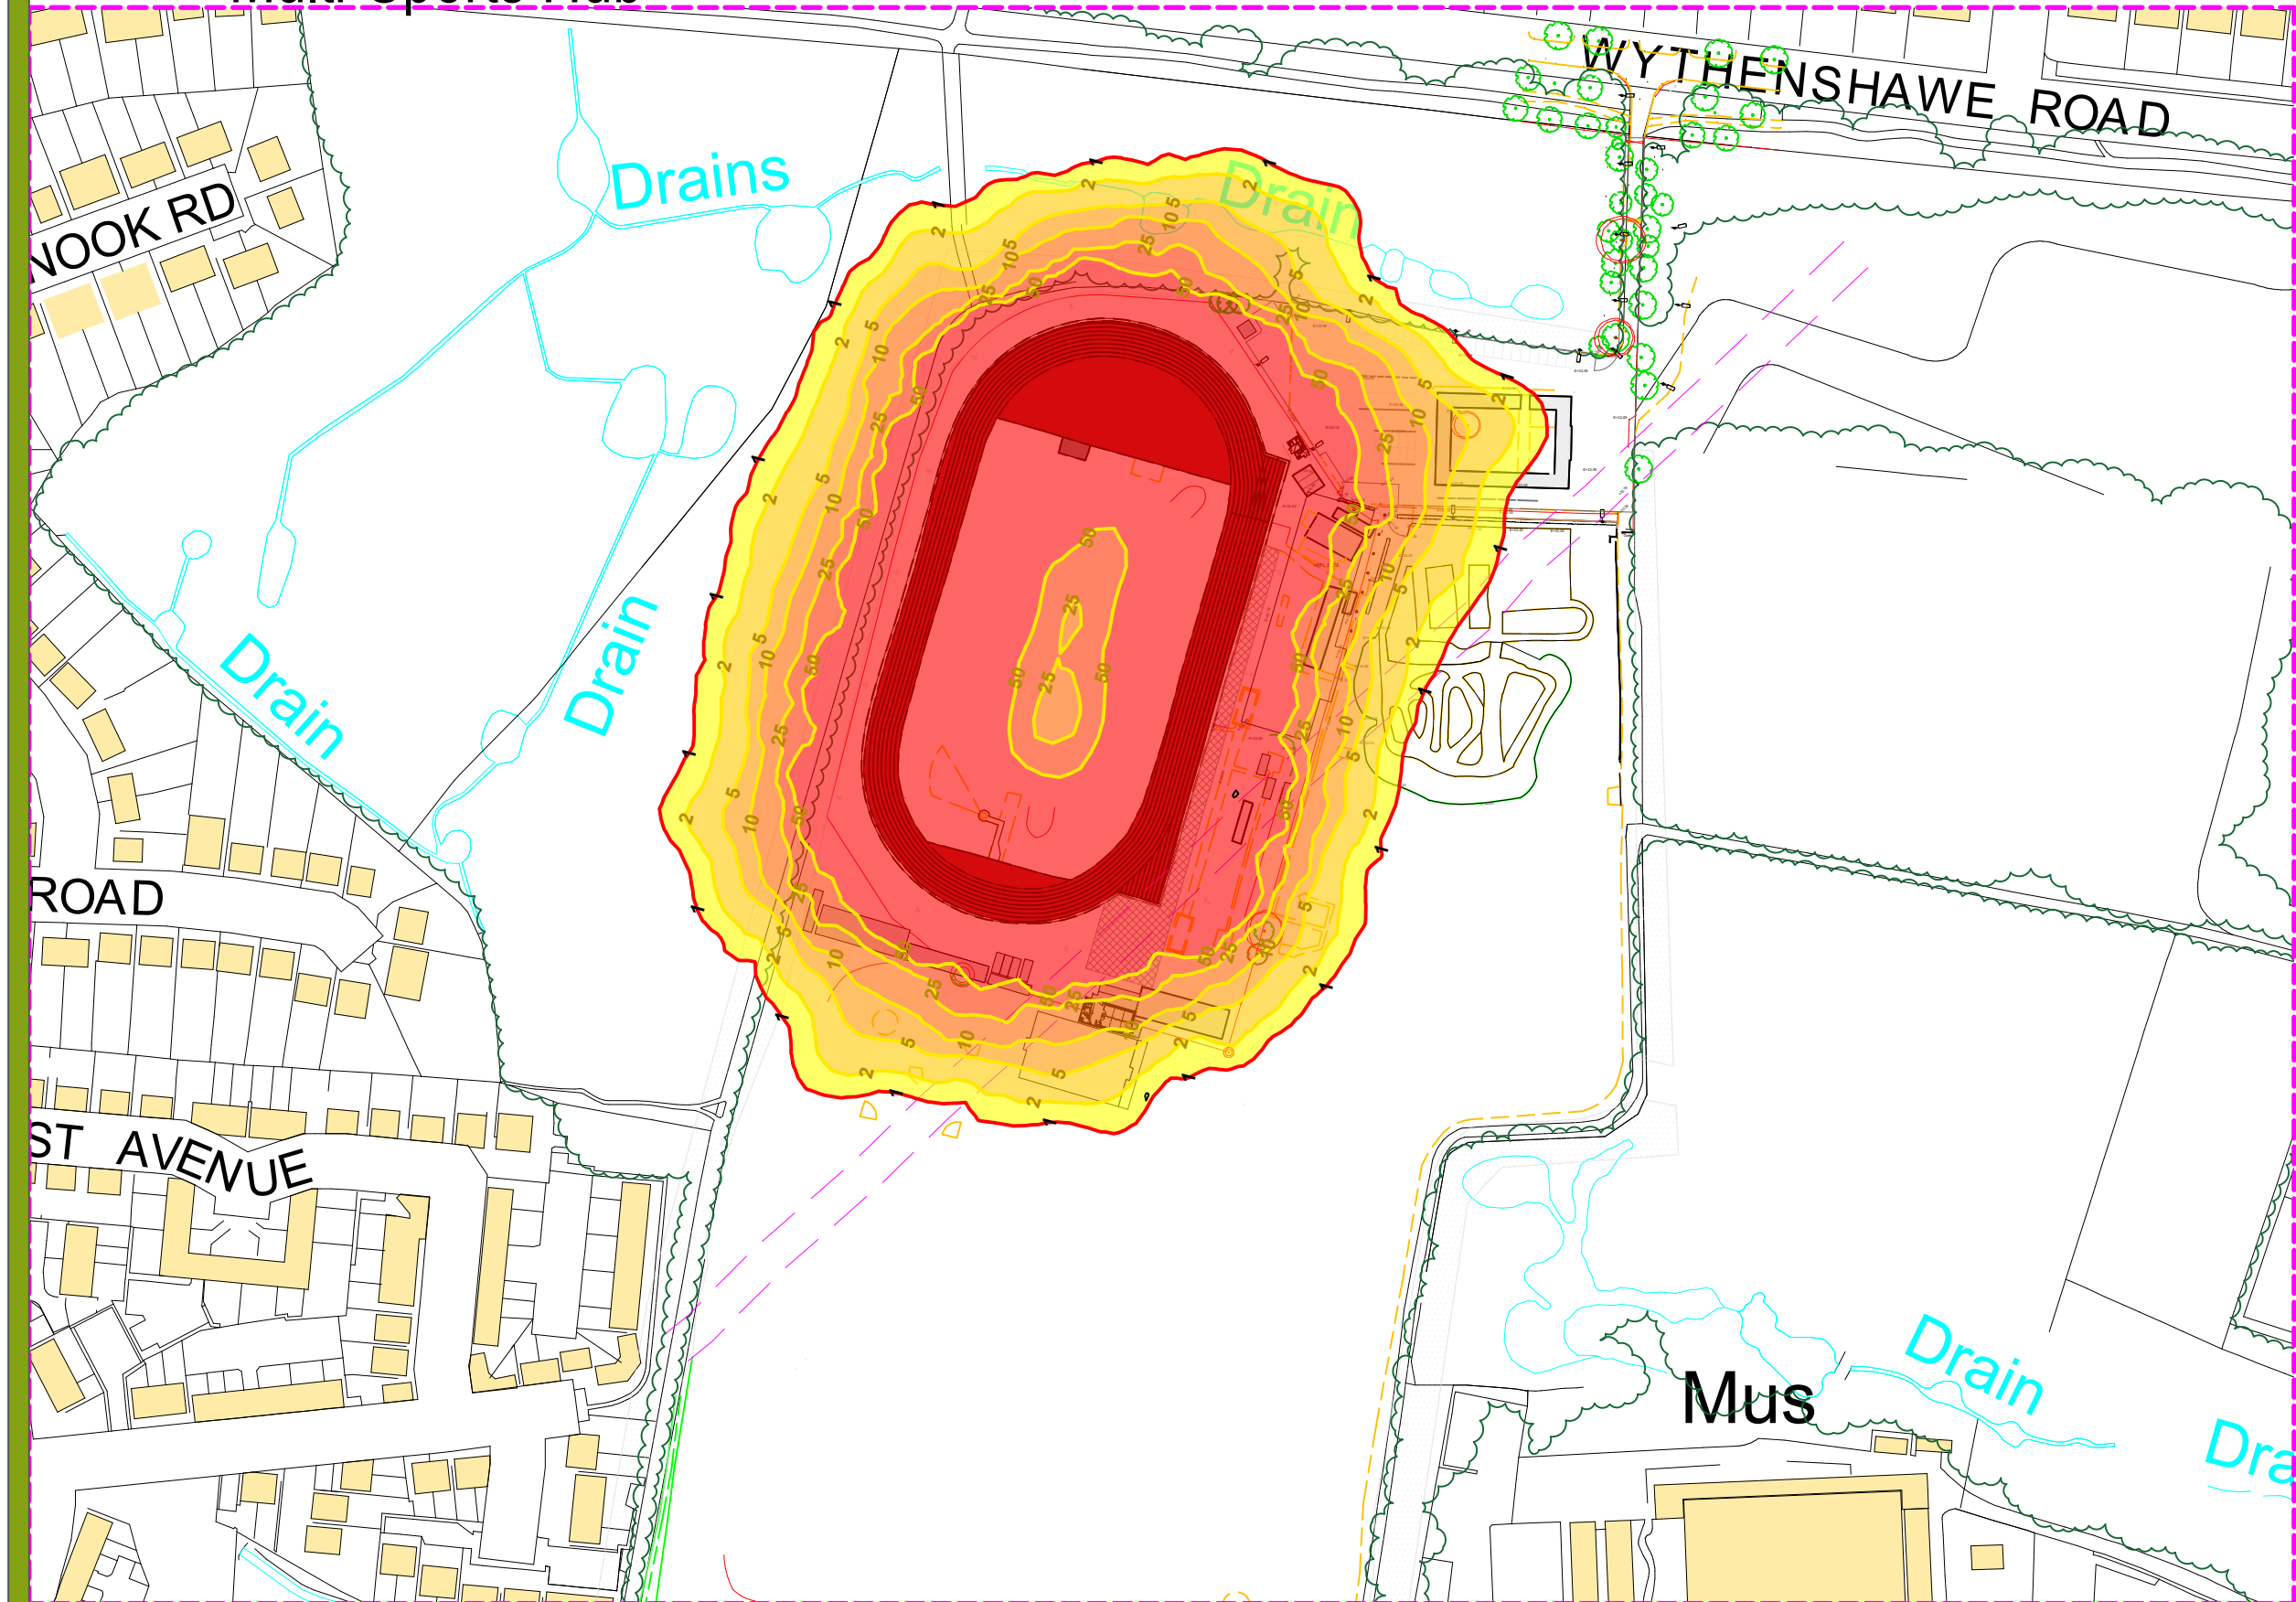
Existing Spillage

- The existing site spillage shows the spillage of the existing pitch metal halides
- The proposed site spillage shows the spillage of the proposed LEDs
- The spillage comparison shows both the proposed LED spillage and the existing metal halide spillage.

Please note the spillage shown for the AGP is shown without any obstruction, and are therefore a worst case scenario.
